CC8™ Bulk Rolls

Central Vancouver Island,
Canada

CC lining of a large
diversion channel at an
underground zinc and
copper mine in Canada.

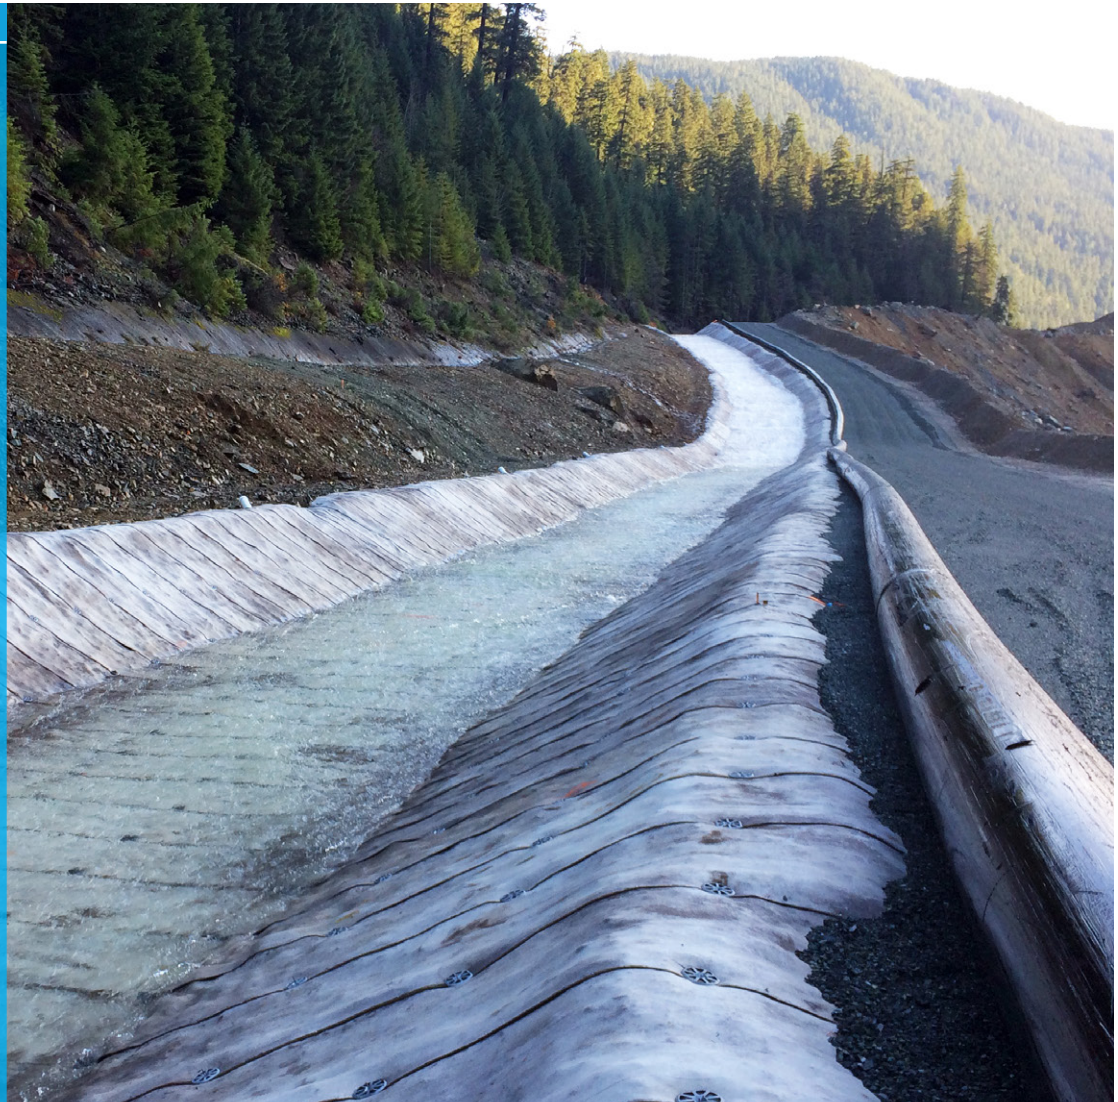
Completed CC lined channel with high flow 5 weeks after installation

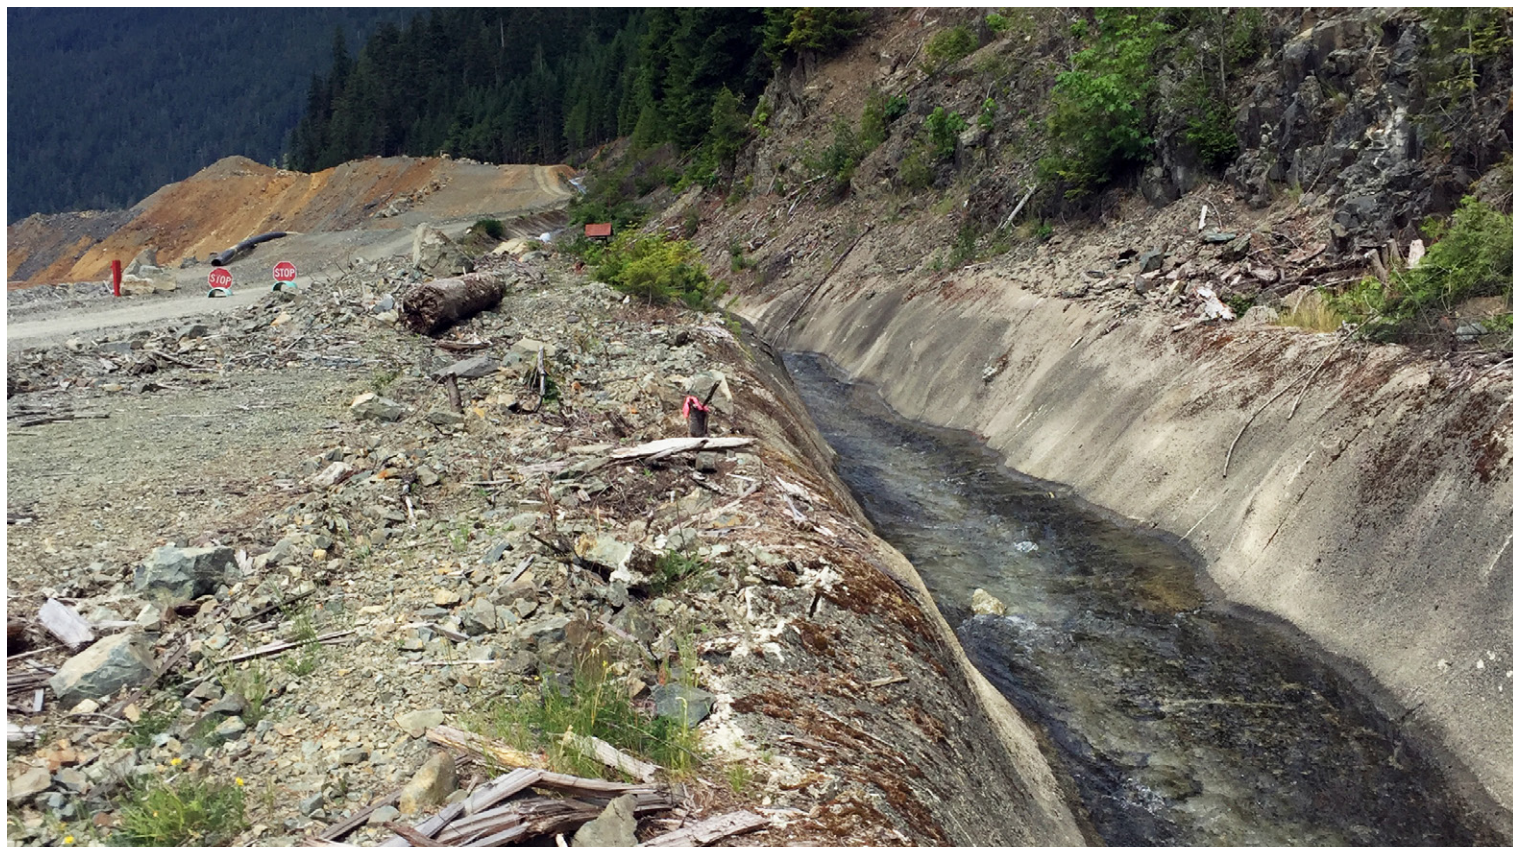
Previous channel section originally lined with shotcrete and showing signs of degradation

The diversion channel, which conveys clean water from the hillside above to a lower creek, was originally lined with shotcrete but the material had begun to degrade over time. It was recommended that the diversion channel should be enlarged and realigned to effectively handle the high-water volume and velocities.

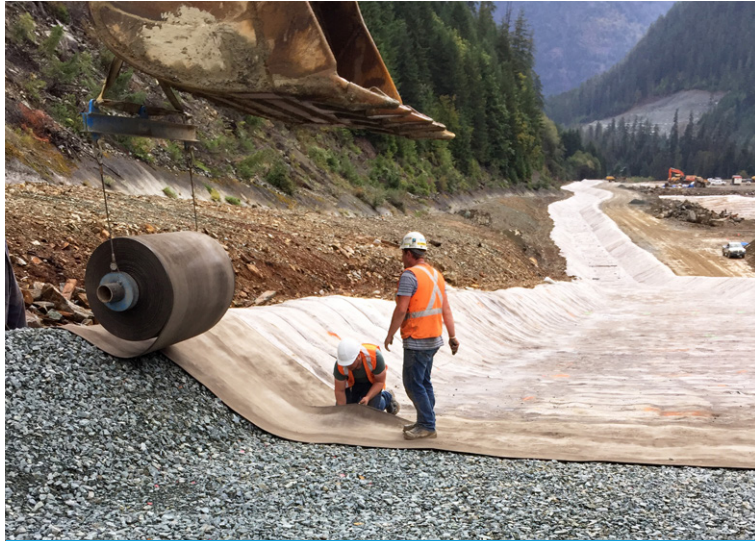
Dispensing of bulk roll CC8™ via spreader beam mounted onto excavator

To account for the variation in profile width, a transverse layup was specified and bulk rolls of CC8™ were deployed from a spreader beam mounted from an excavator to unroll the material across the width of the channel. Adjacent layers of CC8™ were overlapped by 100mm in the direction of water flow and secured using 1.5m earth percussion anchors with 3mm stainless steel cables every meter along the overlaps. These were used in conjunction with 8 stainless steel 1" screws at 150mm intervals. The CC was pinned into 300mm deep anchor trenches on either side of the channel using the 1.5m earth percussion anchors. The trenches were then backfilled with material to provide a neat termination and prevent water ingress. When fixing the CC to rock in some sections of the channel, Hilti rock anchors and 600mm rock bolts were used.

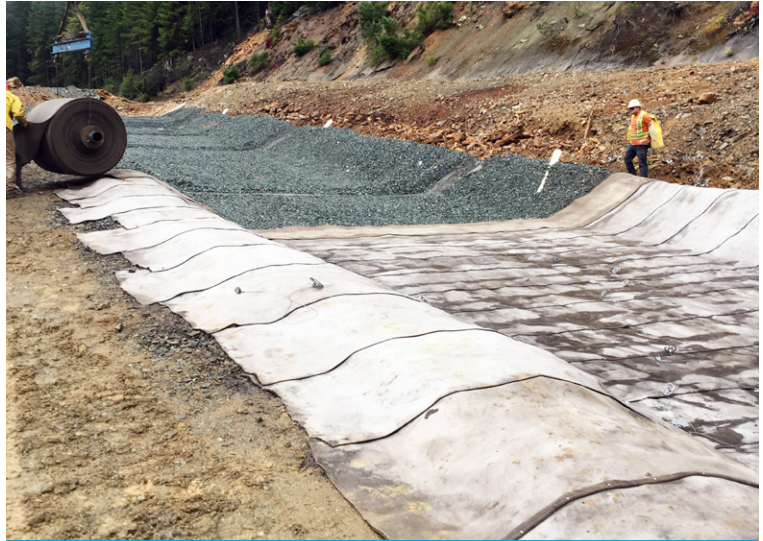
Anchor trench prior to backfilling

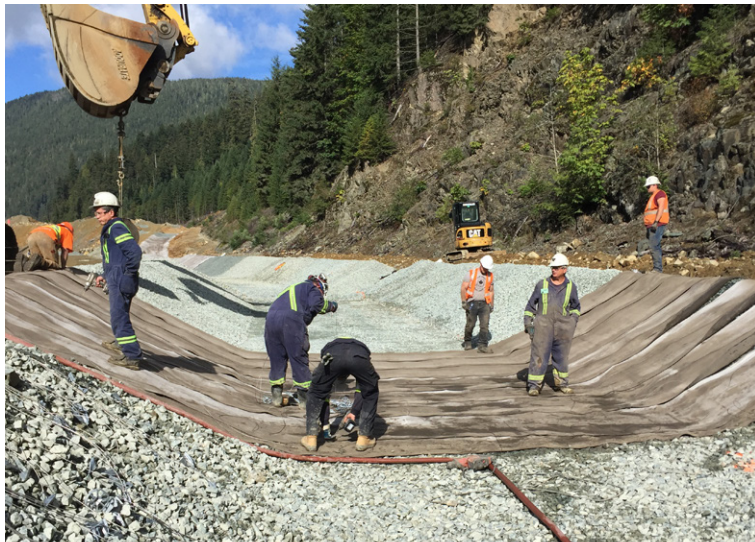
Screwing overlapped joints at 150mm centres

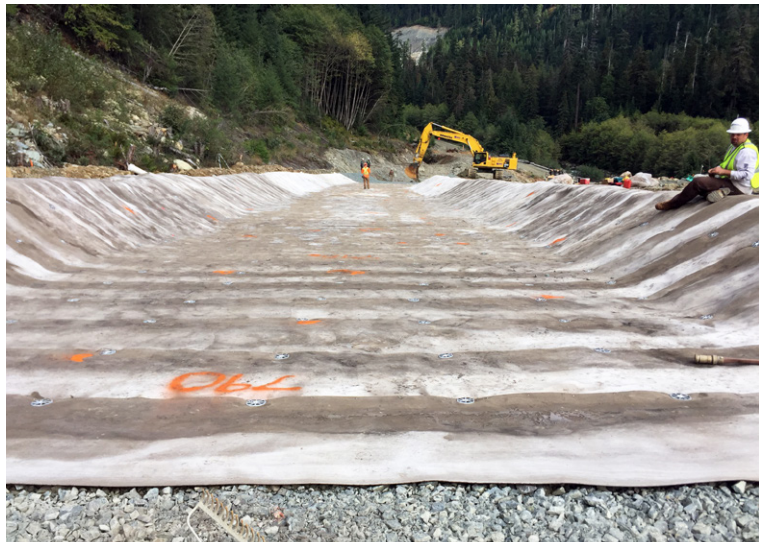
Spacing of percussion anchors through overlapped CC8™ layers

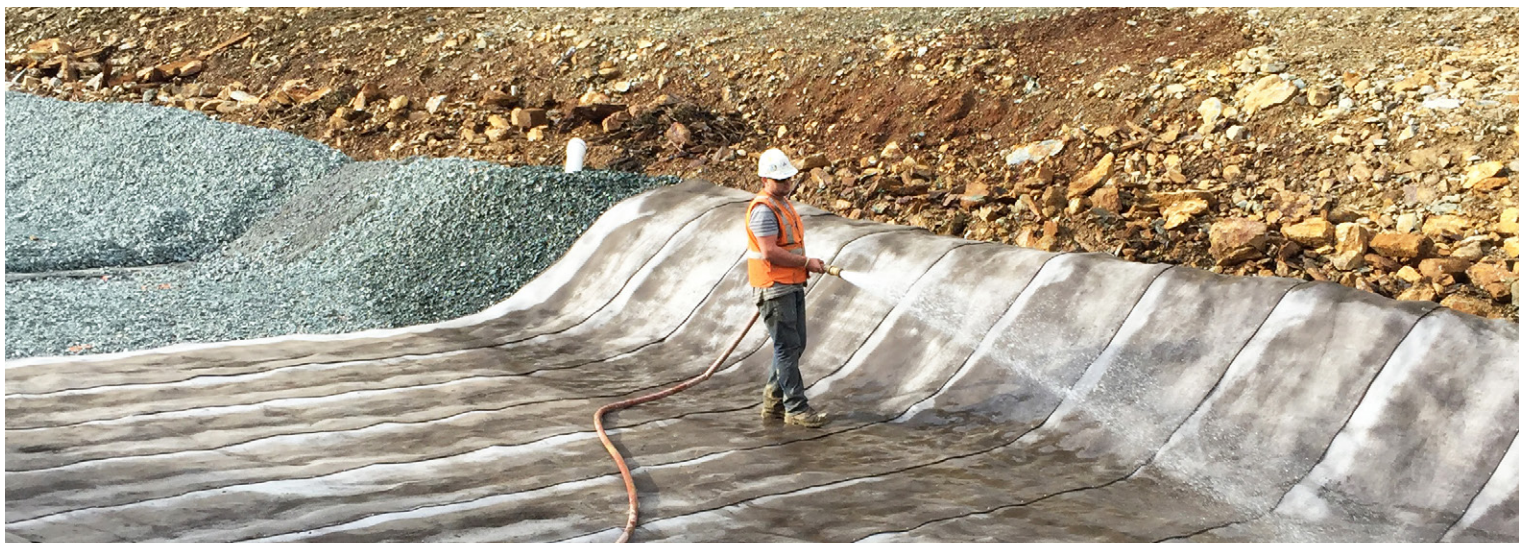
Hydration of the CC layers. CC run-off did not require treatment prior to discharge into the local water course

The material was hydrated using a water truck and due to CC having a very low wash out rate and low alkaline reserve, treatment of the run off from installation was not required. CC has a working time of approximately two hours from hydration, meaning that work can continue even in very wet conditions. This can reduce programme disruption typically caused by bad weather when using traditional solutions.

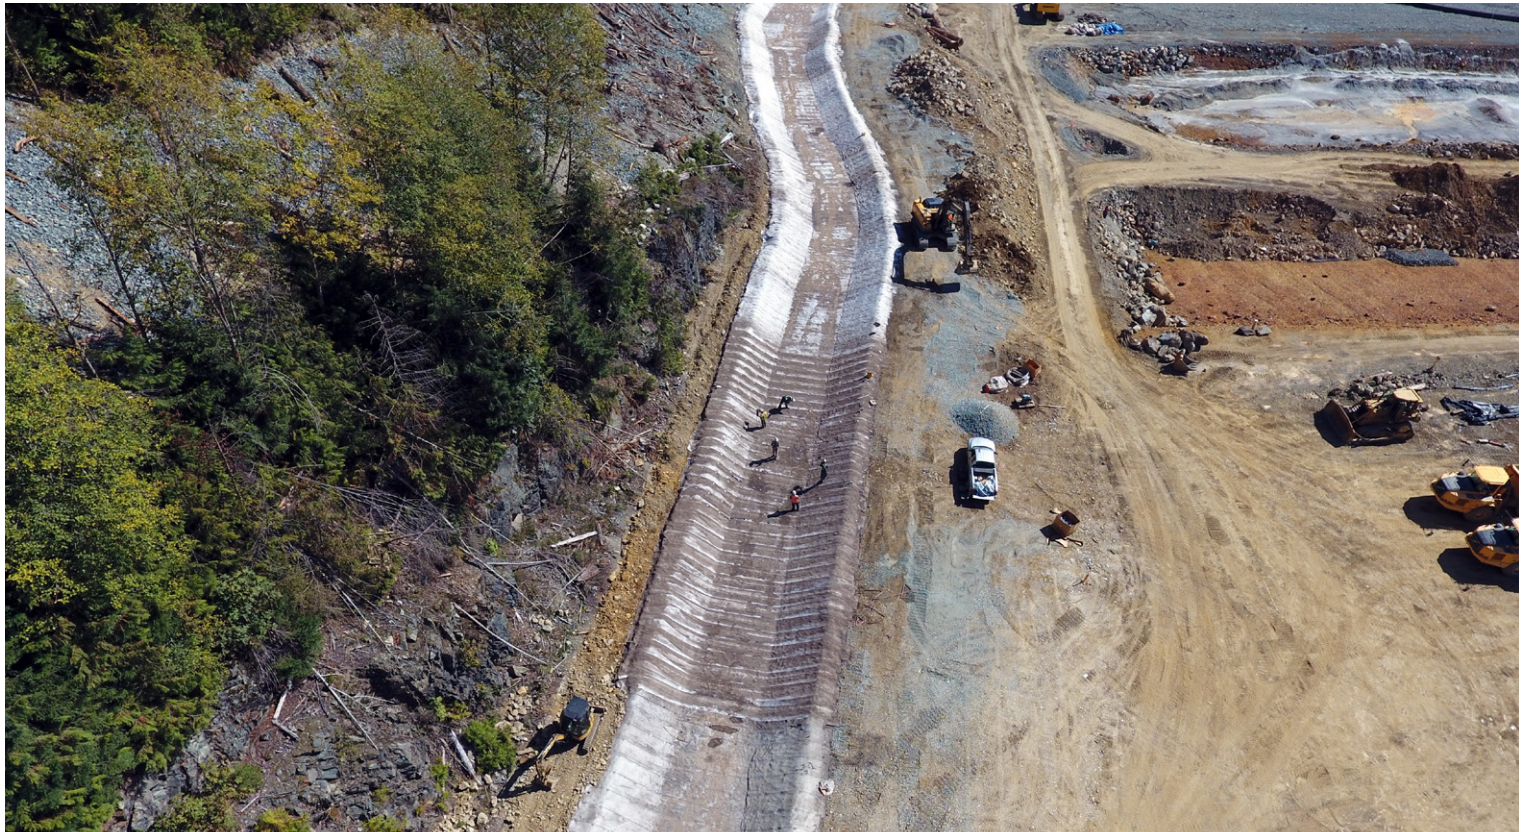
Aerial view of installation

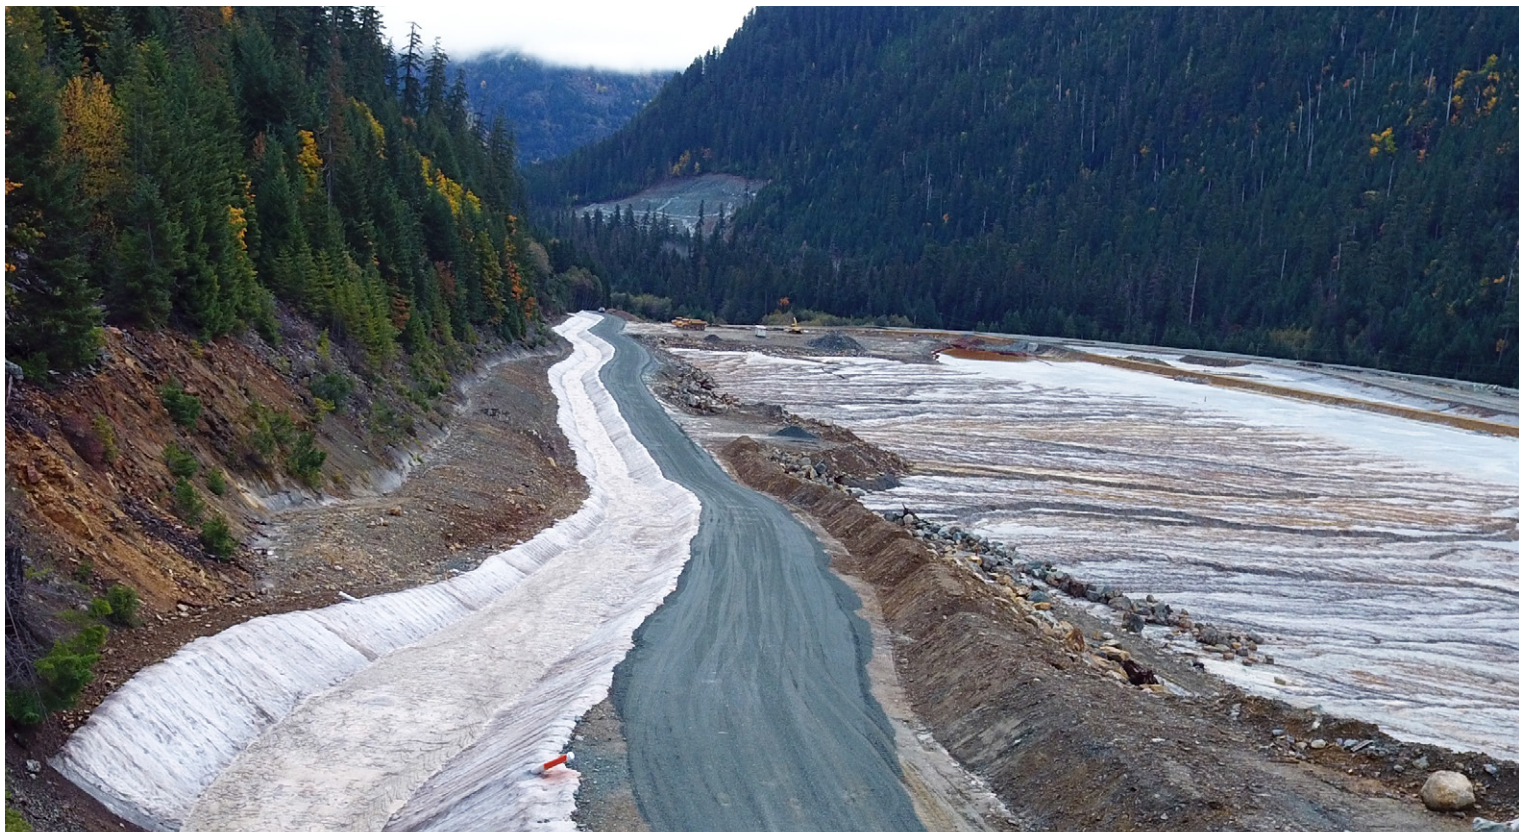
Aerial view of the mouth of the channel showing transition anchor trench

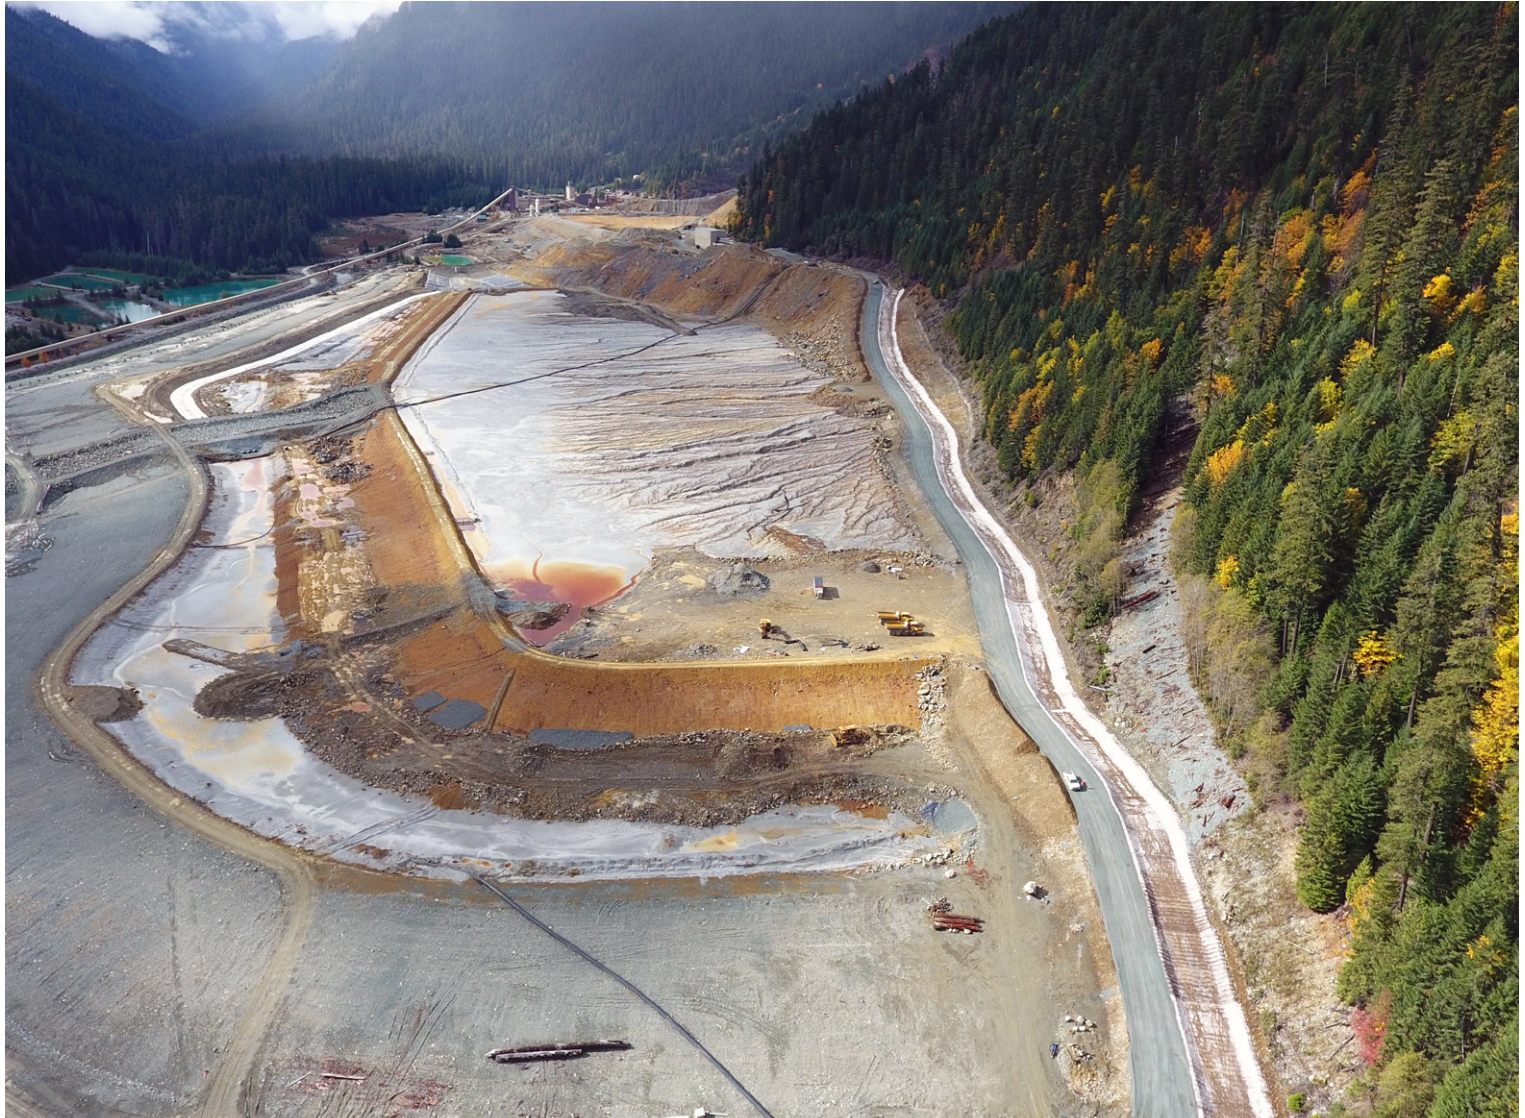
Aerial footage showing completed CC lined channel in relation to the mine
