Project Info

Redbank Station,
Queensland, Australia

CC used to line a
drainage channel
constructed as part of
a scheme to protect a
slope from erosion

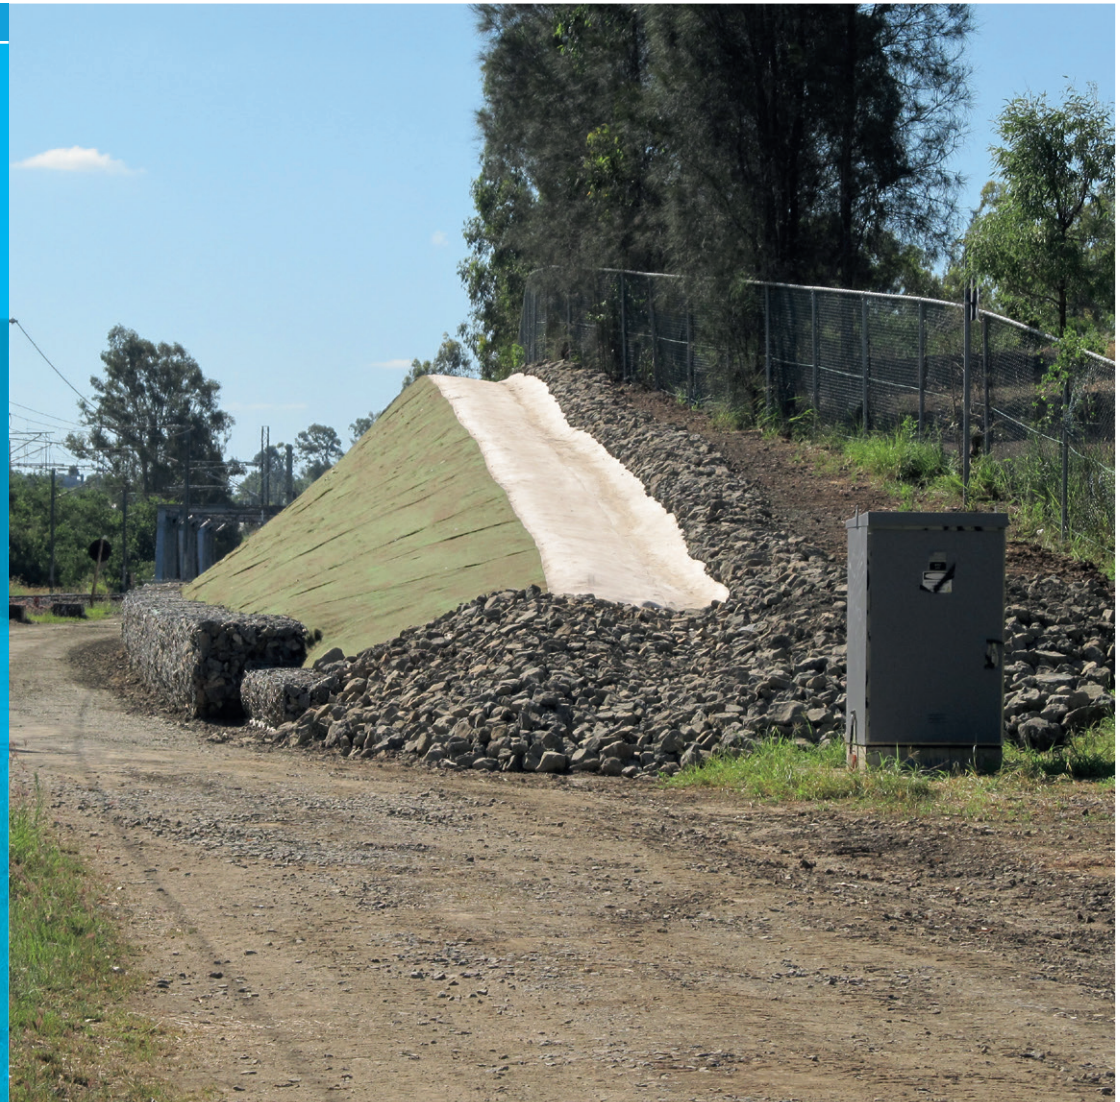
Completed channel lining installation in Queensland, Australia

Following the work on the slope, a 'V' drain was created at the slope's crest, directly behind the anchor trench previously created and filled following the securing of the slope's protective system. Once the drain was shaped, it was lined with CC material which was secured using ground pegs at the edges, which were then buried in an anchor trench.

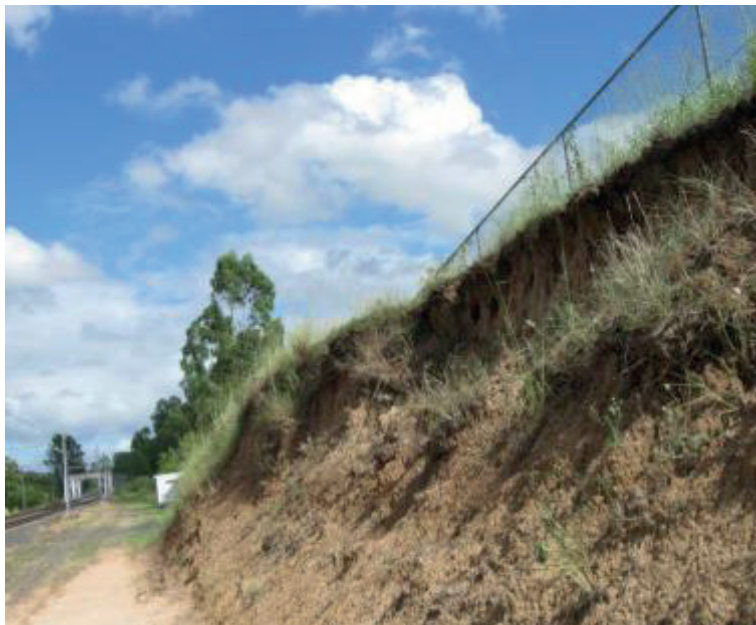
Slope prior to works

The slope in question was inspected in early 2017 and was found to be suffering from erosion caused by heavy sub-tropical rainfall and the moderately steep nature of the slope, which was also made up of highly erodible soils. Along with the limited access due to the proximity of the slope to the rail line, there were a number of 600mm deep service pits at the foot of the slope, the access of which was becoming compromised due to the eroded soil.

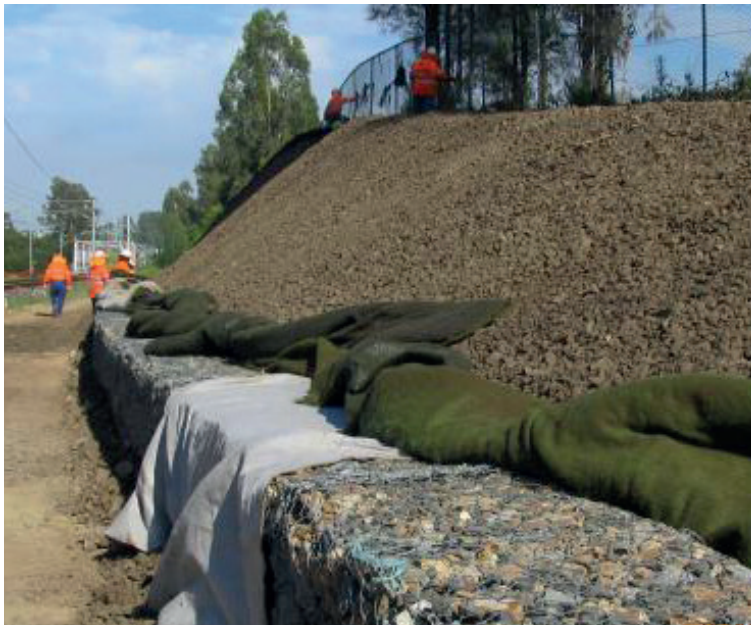
Slope following re-grading and gabion placement

After clearing the bank of vegetation, a single course of Gabions, 1m in height and width, were installed along the length of the embankment to form a permanent toe from which the slope could be re-graded, while ensuring underground services were protected and accessible. The slope was then protected using a three-layer system of the non-woven geotextile, the geoweb system, which was then filled with ballast materials, and the erosion control matting.

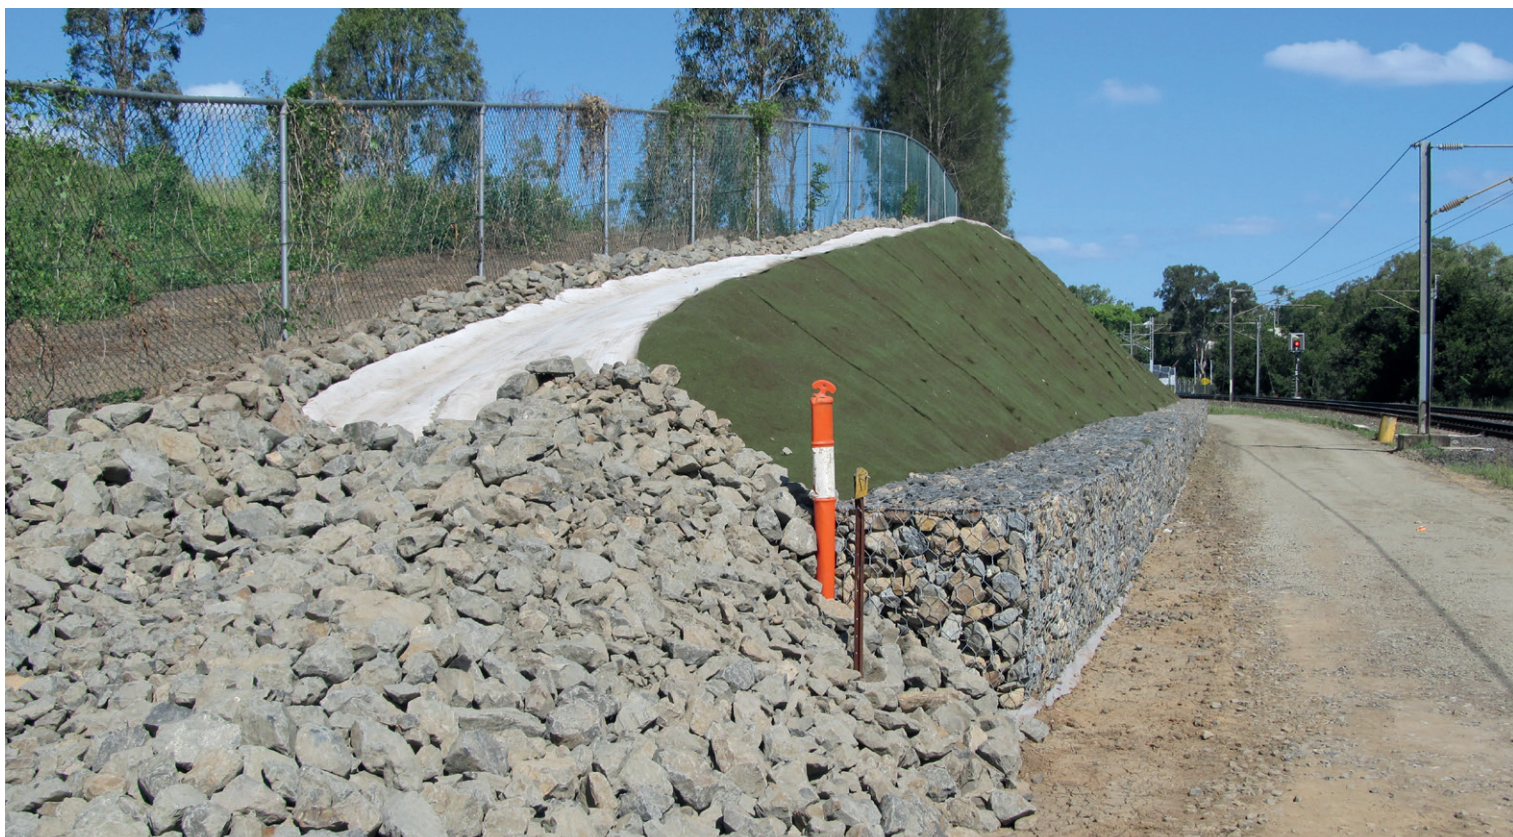
Completed installation

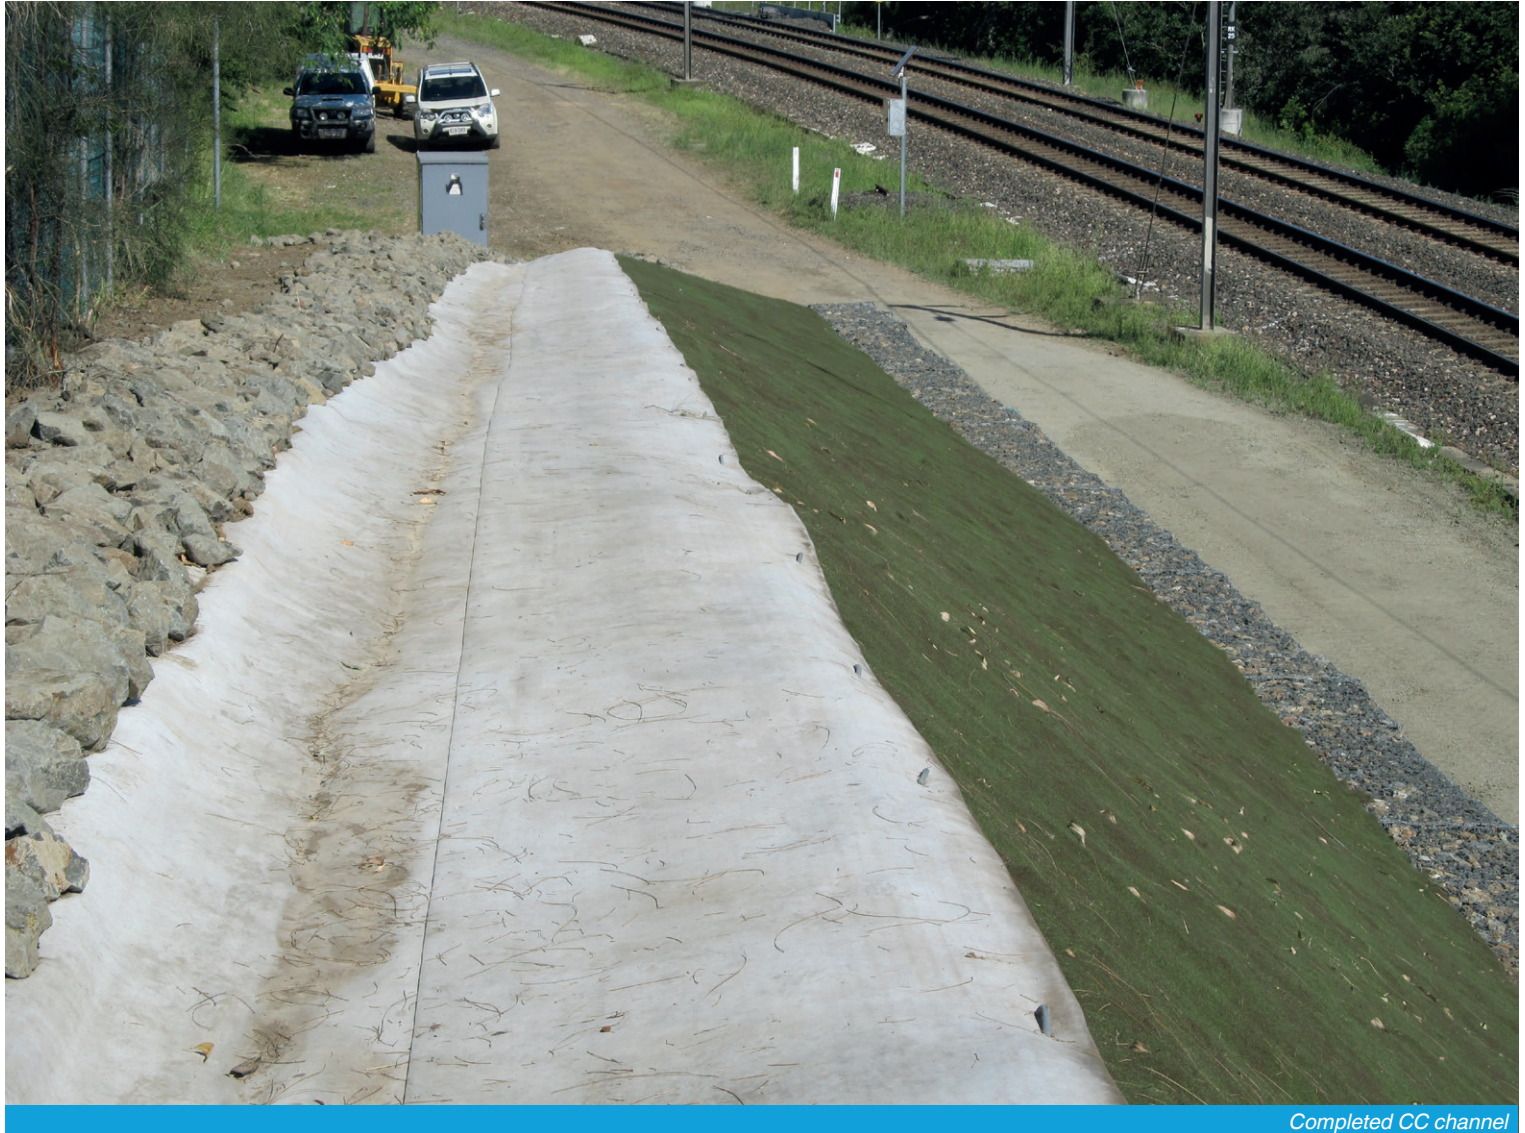
Completed CC channel

180m² of CC8™ were installed by 4 people. The use of CC allowed for easy installation despite the limited access on site, and restrictions created by the boundary fence. Had CC not been used, the process of lining the drainage channel would have been considerably more complex due to the limitations of using alternatives such as shotcrete, which would also produce rebound and require line closures. Due to the speed and ease of using CC, the installation team were able to install the CC quickly and meet their deadlines, completing the works before the Christmas holidays began.
