Project Info

CC5™ Bulk Rolls

CC5™ was used to line a drainage channel used to divert runoff water along a slope and prevent it coming into contact with a new gas line

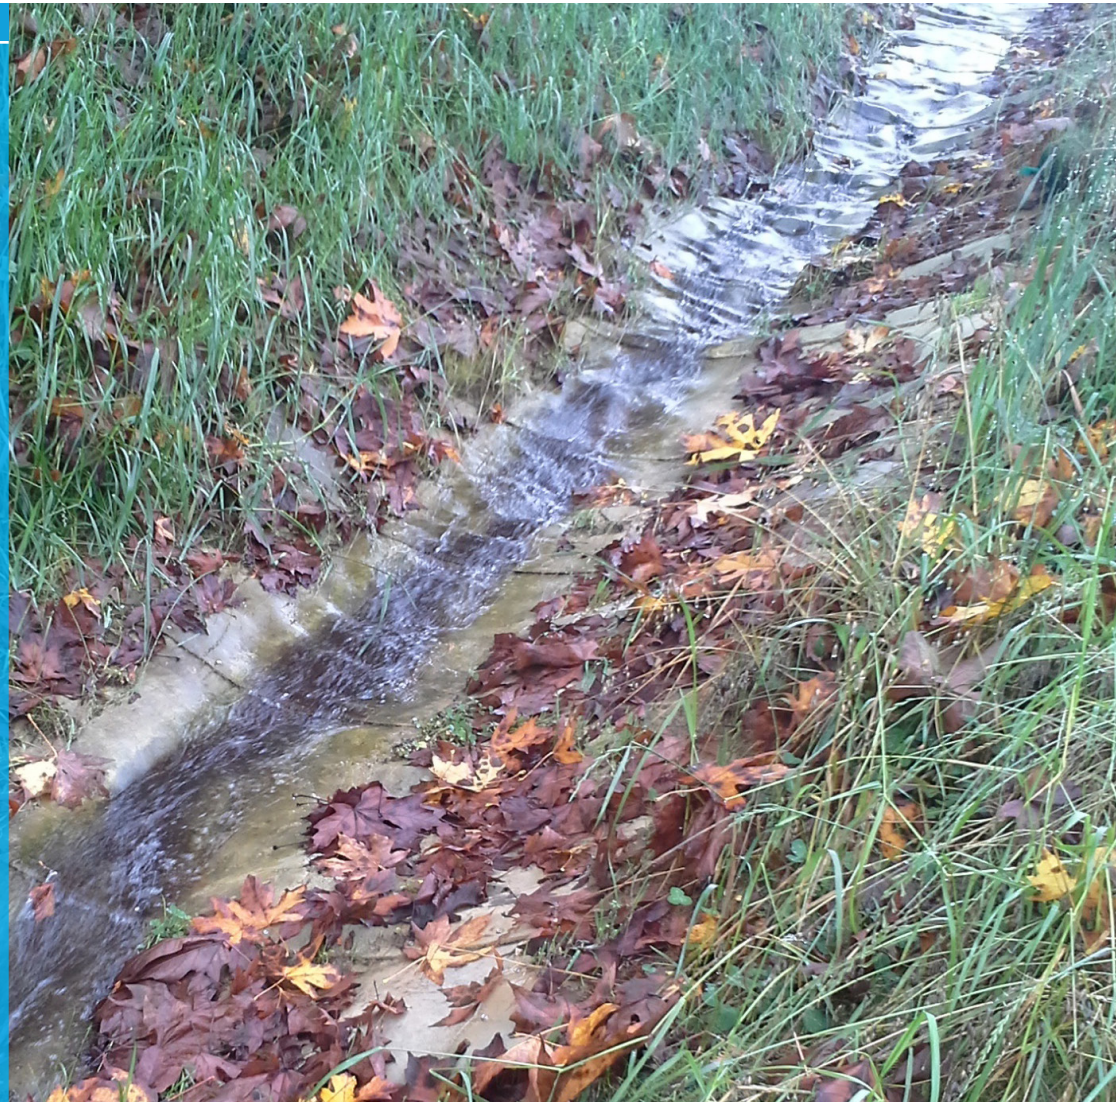
Section of completed channel

In total, 5202m² of CC5™ were installed in just 7 days. The use of CC has resulted in drastically reduced maintenance costs for the site, as well as improved impermeability and fire resistance of the berm. The client was very happy with the outcome of the project and are looking to install CC on other berms across their vase oil and gas network.

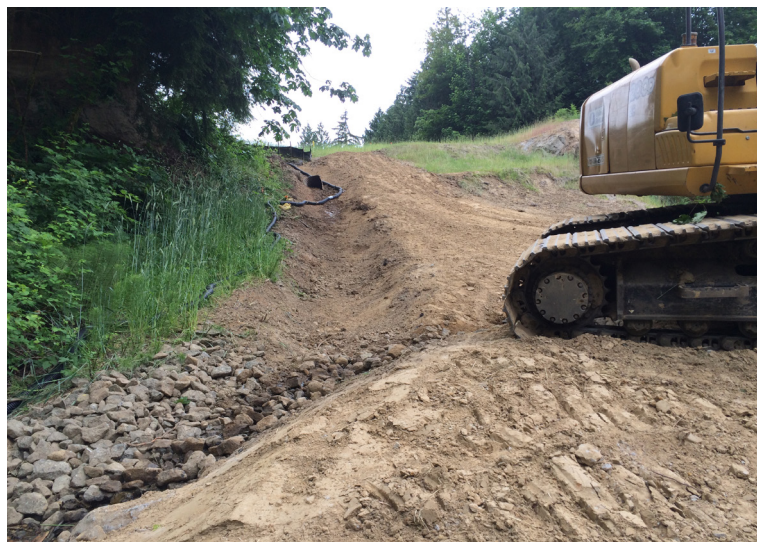
Site prior to installation

The new gas line had been installed on a steep 2:1 slope, which faced severe erosion issues due to the effects of heavy Pacific Northwest rainfall. A conventional rip-rap drainage channel was installed to control runoff, however, just weeks later, excess runoff water bypassing the faulty channel began eroding the soil near the gas line and potentially destabilising the bedding material around the pipe.

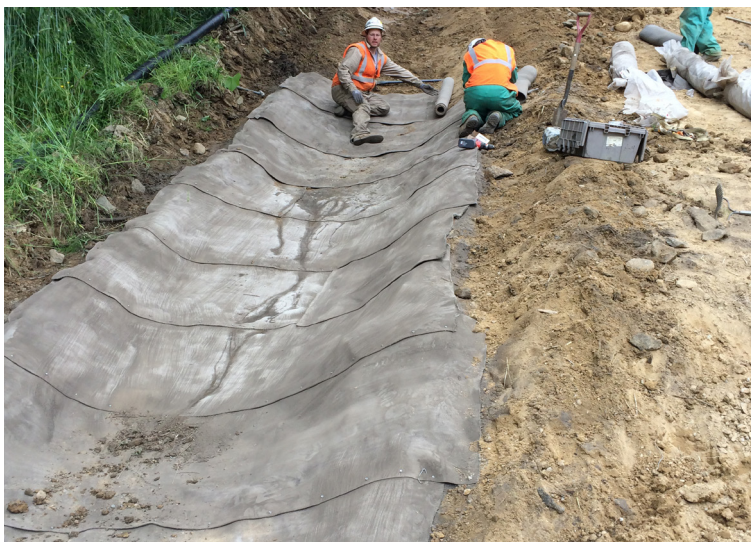
CC was laid transversely

Bulk rolls of CC5 were positioned at the crest of the berm and deployed, with the material installed transversely with overlaps of approximately 100mm, which were jointed using 19mm self-tapping screws at 300mm intervals. Sika 1-A sealant was then used to prevent water ingress along the joints. The edges of CC were either captured in an anchor trench, which was then backfilled and compacted with an asphalt road base material, or fixed to existing concrete infrastructure using masonry bolts. In areas where the berm had eroded to the extent of no longer meeting height requirements, sandbags were used to elevate it prior to CC installation. Infrastructure such as pipework was easily accommodated due to the drape characteristics and flexibility of the CC. Once installation was completed, the material was hydrated using a high volume mounted hose and water hydrant.

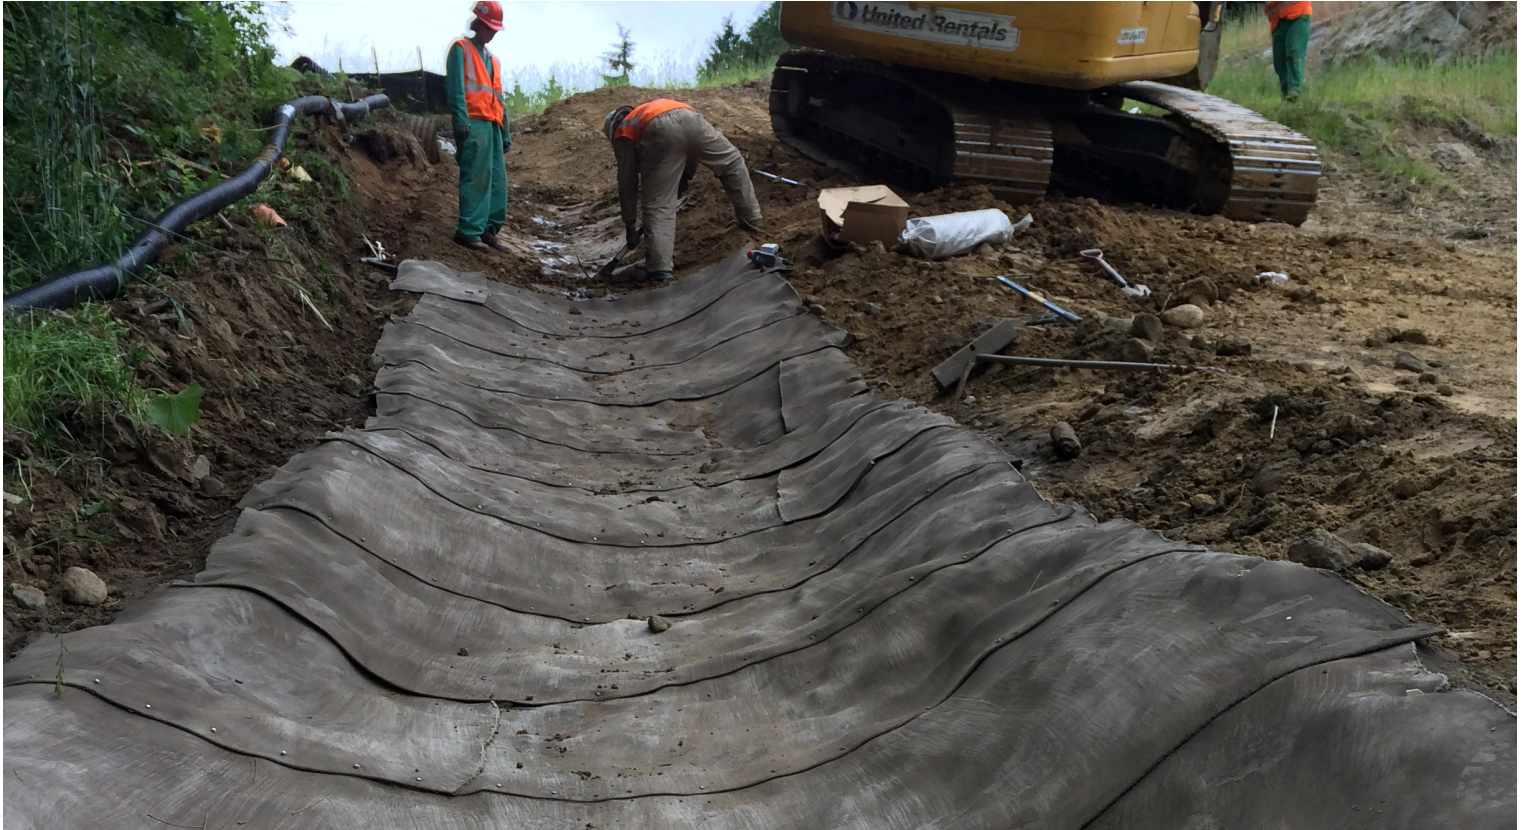
Ground preparation was carried out by digger and with hand tools

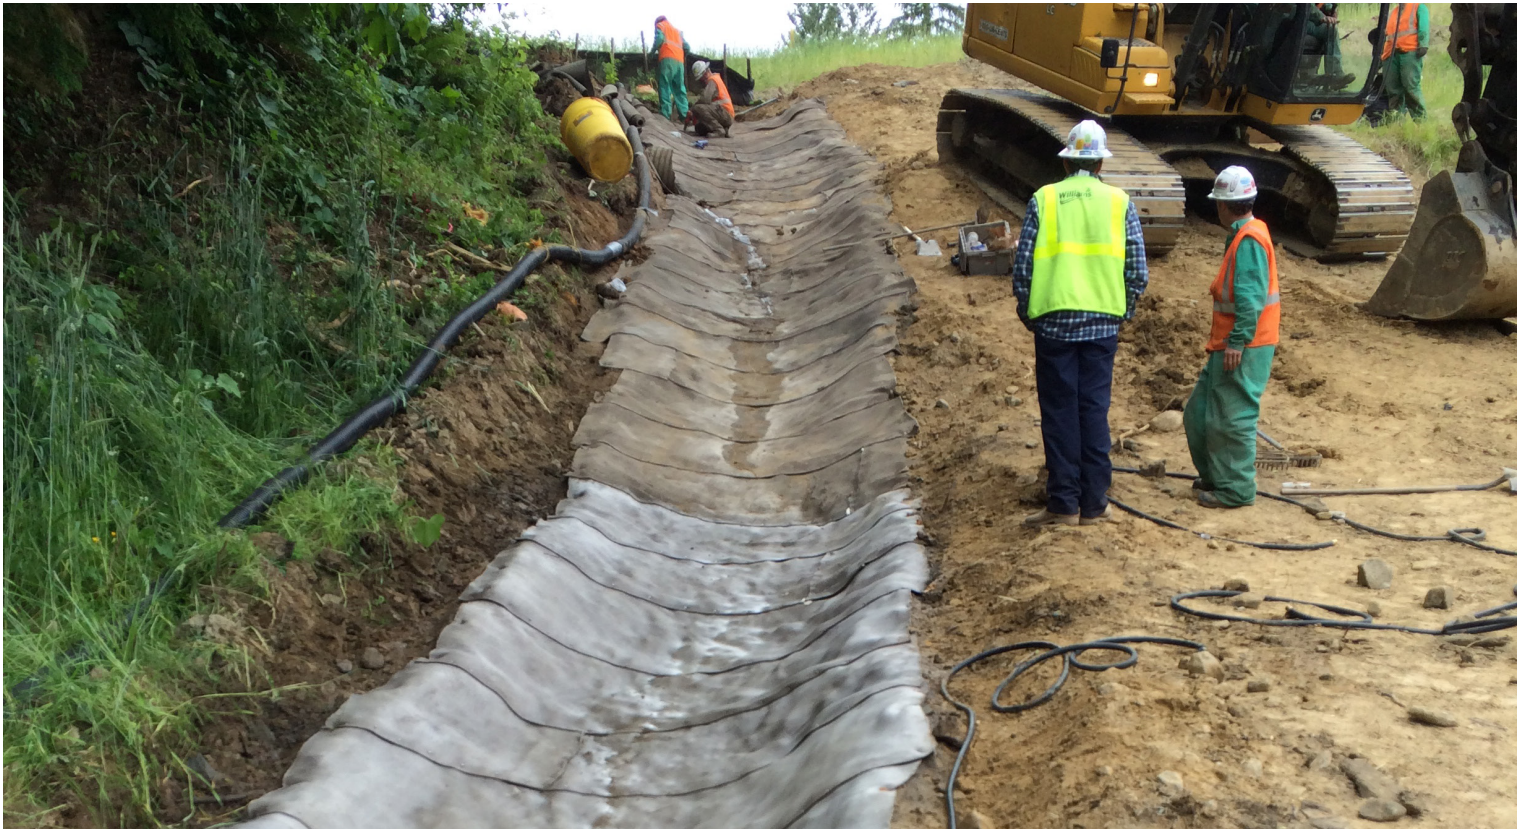
Completed section of hydrated channel
