CC8™ Bulk Rolls

Silkstone Mine Water Treatment Works, Silkstone, Barnsley

CC8™ was used to reline a channel at Mine Water Treatment Works to provide a robust, impermeable and flexible lining solution.

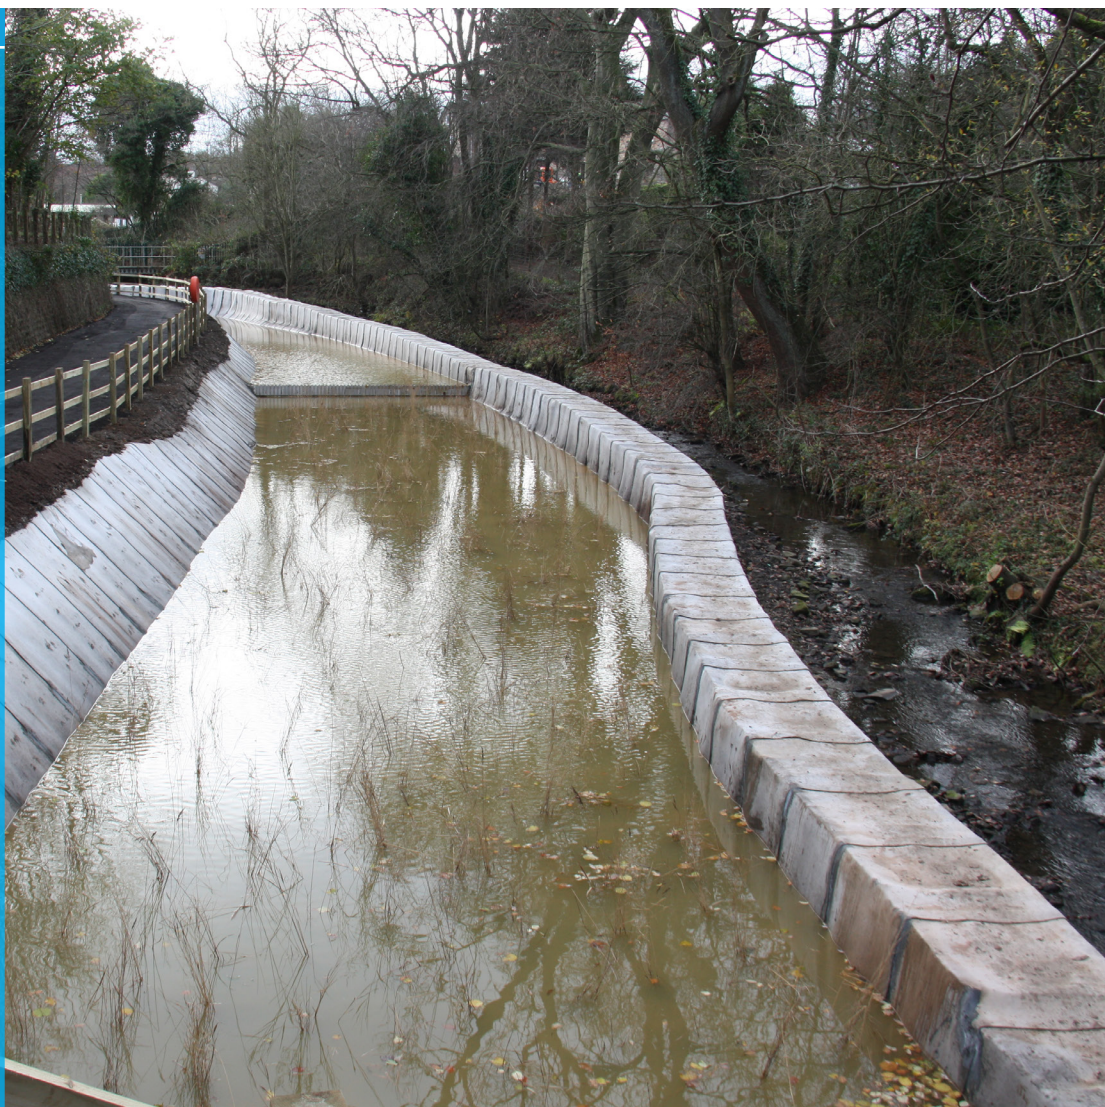
Completed channel at the Silkstone Mine Water Treatment Works, Barnsley

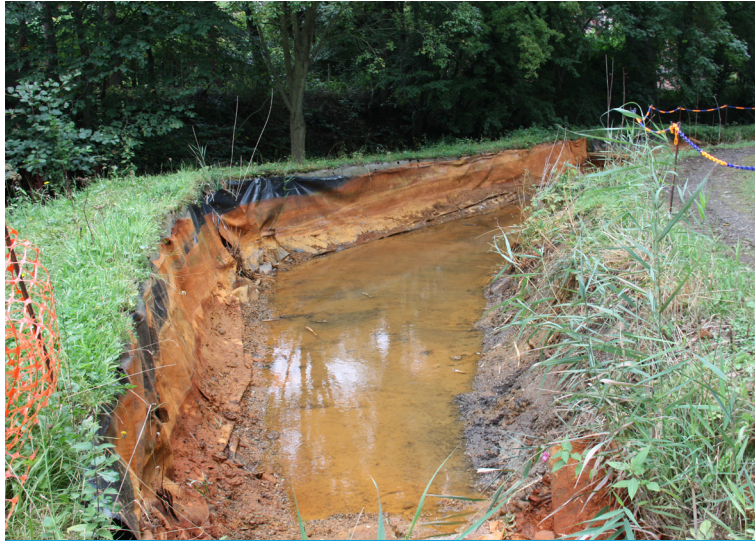
Build-up of ochre from the mine was contaminating the water

Before installation of the CC material could commence, there was a lot of ground preparation that had to be done. JN Bentley's team began by removing the build-up of ochre from the channel and regraded the channel along its entire length. Once this work had been completed, three new weirs were built within the channel out of breeze block and brick, which would be lined with CC later on in the installation. The channel is separated from a small stream via a row of gabion baskets and a number of these needed to be repaired or replaced prior to covering in CC.

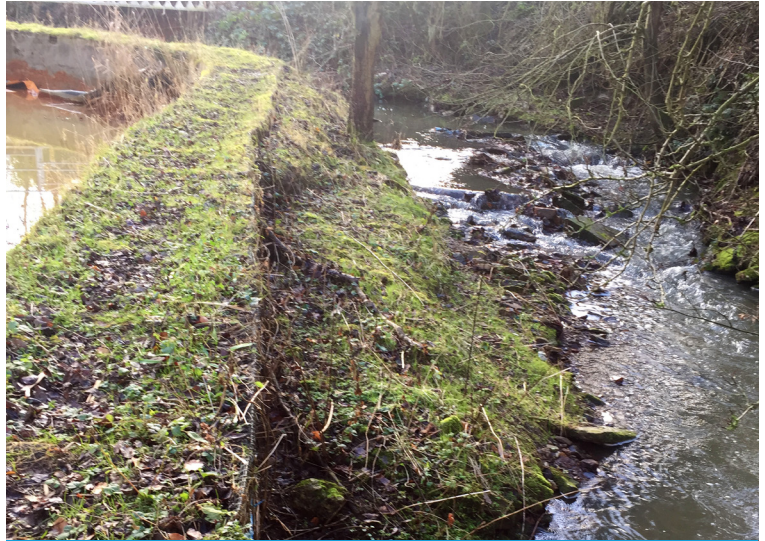
The stream and gabion wall were overgrown

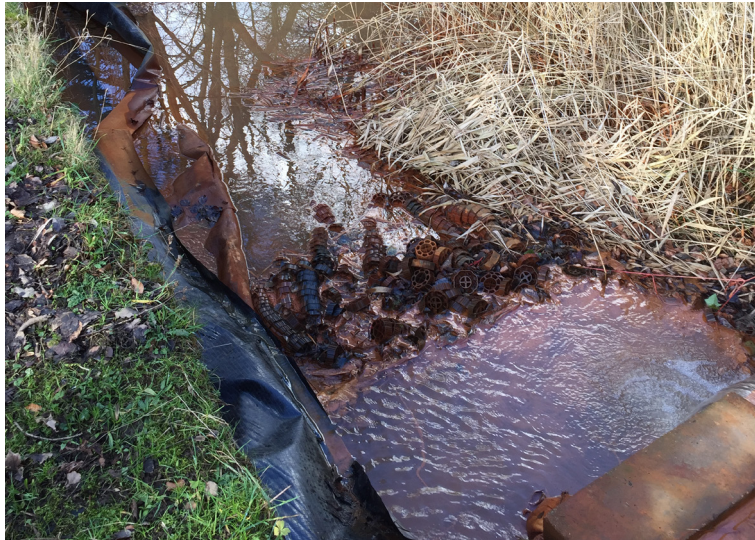
The original HDPE lining had disintegrated and come away

The channel had previously been lined with HDPE which had been damaged in recent flood events leading to the possibility of untreated water from the mine adit entering the nearby stream prior to the reed bed treatment system required for active filtration of the water. CC was proposed to reline the channel to provide a robust, impermeable lining solution that could be fixed to various surfaces throughout the channel.

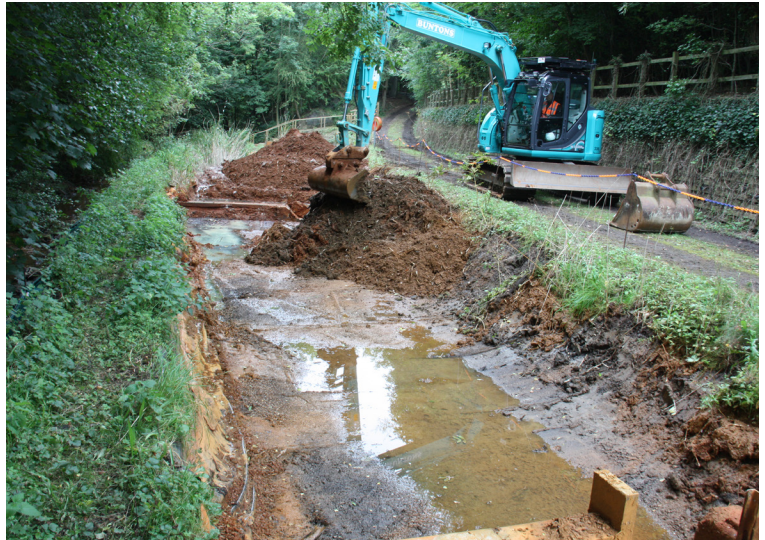
The channel was excavated to remove all ochre traces

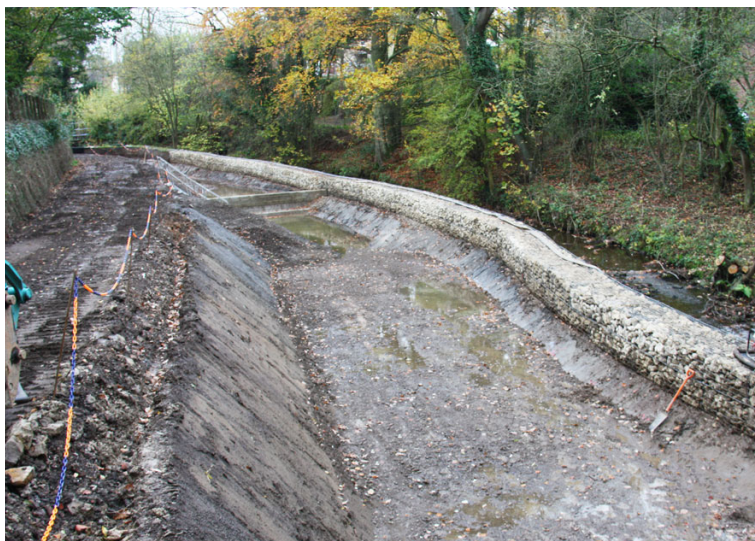
The substrate was then re-graded to provide a smooth surface for installation

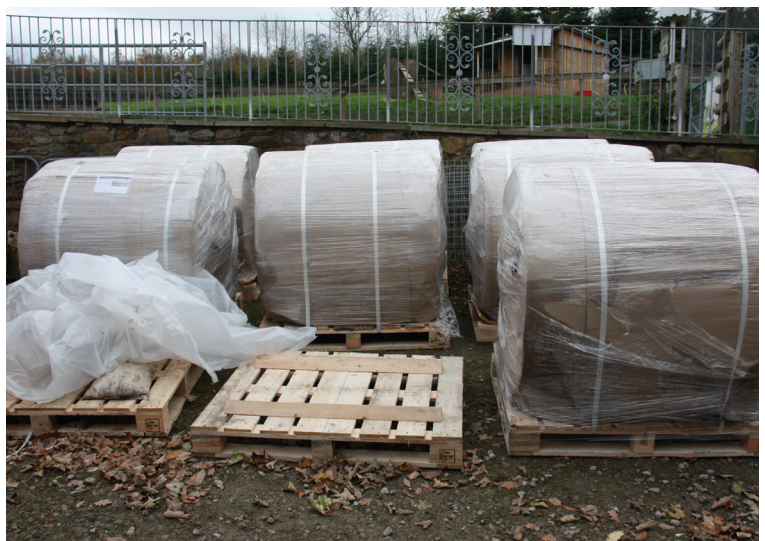
Bulk rolls of CC were delivered to site

Once groundwork had been completed and the channel profiled, CC8 was delivered to site in bulk roll format on dedicated flat bed wagons to help the contractor with the unloading of the material. The channel was lined from the gabion baskets along the entire width of the channel, terminating in an anchor trench. Subsequent layers of CC were overlapped by 100mm and secured in a variety of ways, including pneumatic hog ringing to the gabion baskets, shot fired nails to the new weir structures and stainless steel screws via an autofed screwdriver. The material was then secured in place with GMS pegs on each overlap into the anchor trench, before being hydrated at the end of each day using water from the nearby stream.

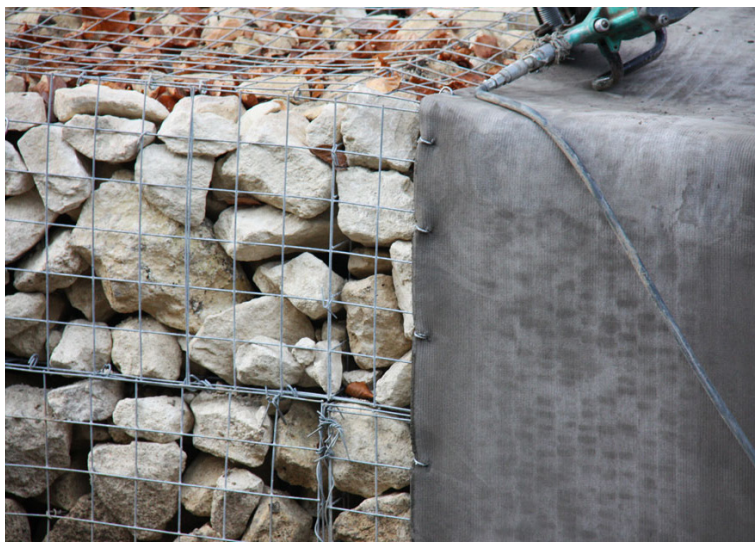
CC was attached to the gabion baskets using hog rings

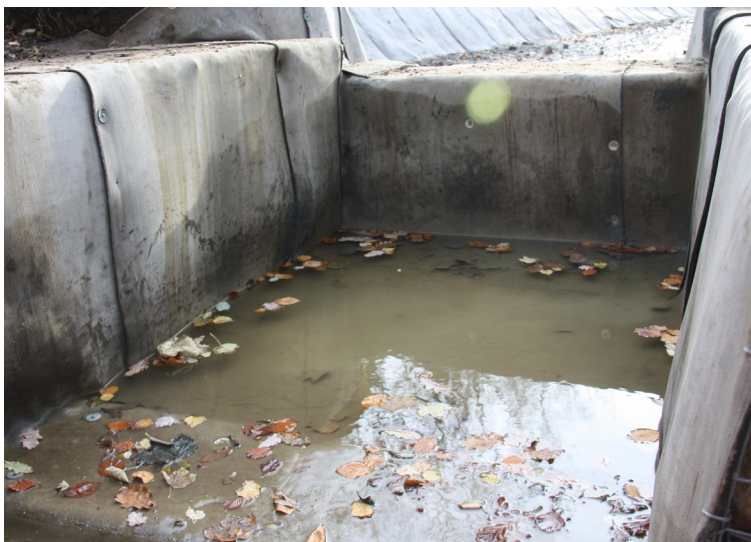
Flexibility of CC allowed for easy covering of complex sections

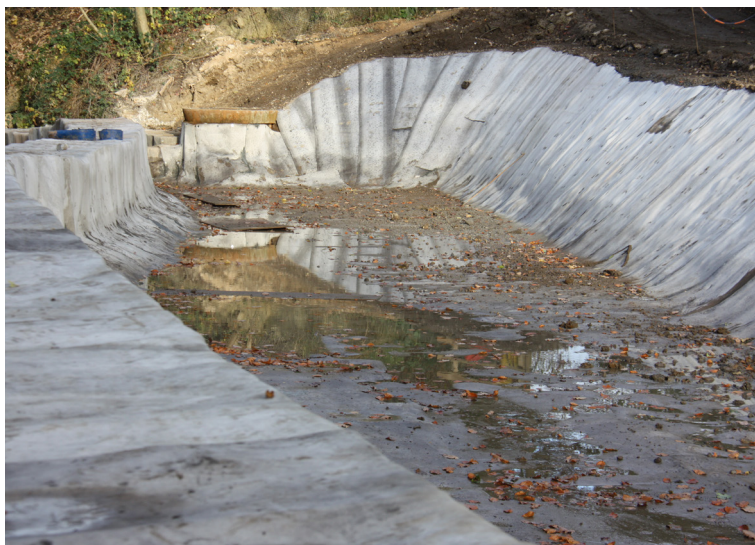
The material was laid transversely across the full width of the channel

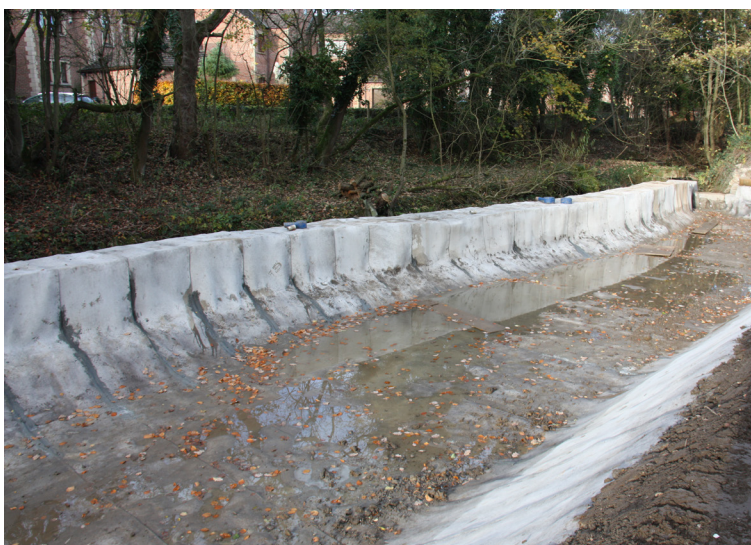
The joints were then sealed to further prevent ingress

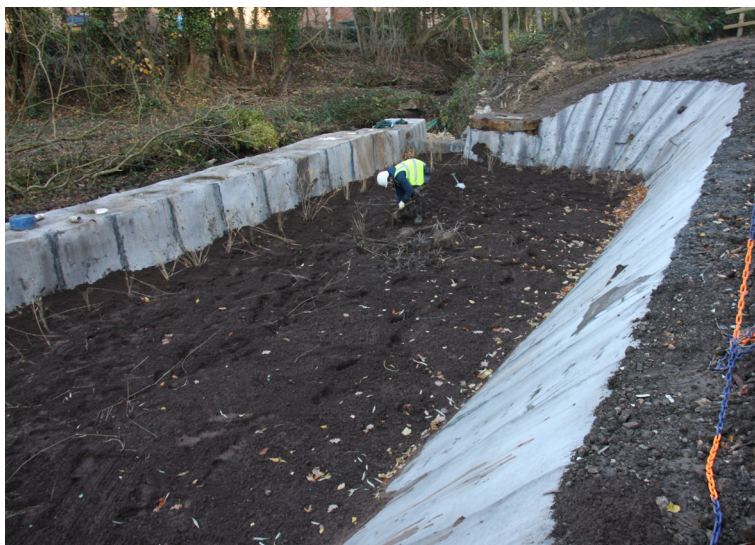
Following hydration, soil was laid and reeds planted

Once the CC installation was complete, a soil substrate was laid over half of the channel bed, and reeds planted across the channel floor. These reeds serve as an active filtration system, helping to remove the ochre from the water before it enters the stream.

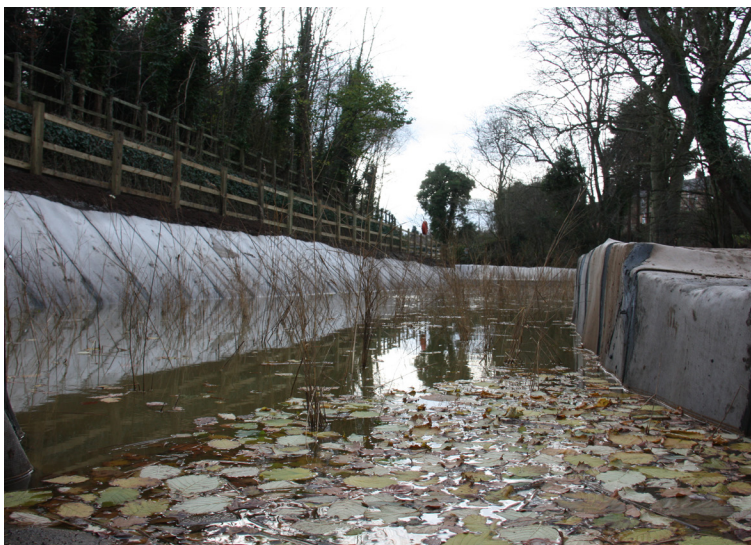
Completed channel in use

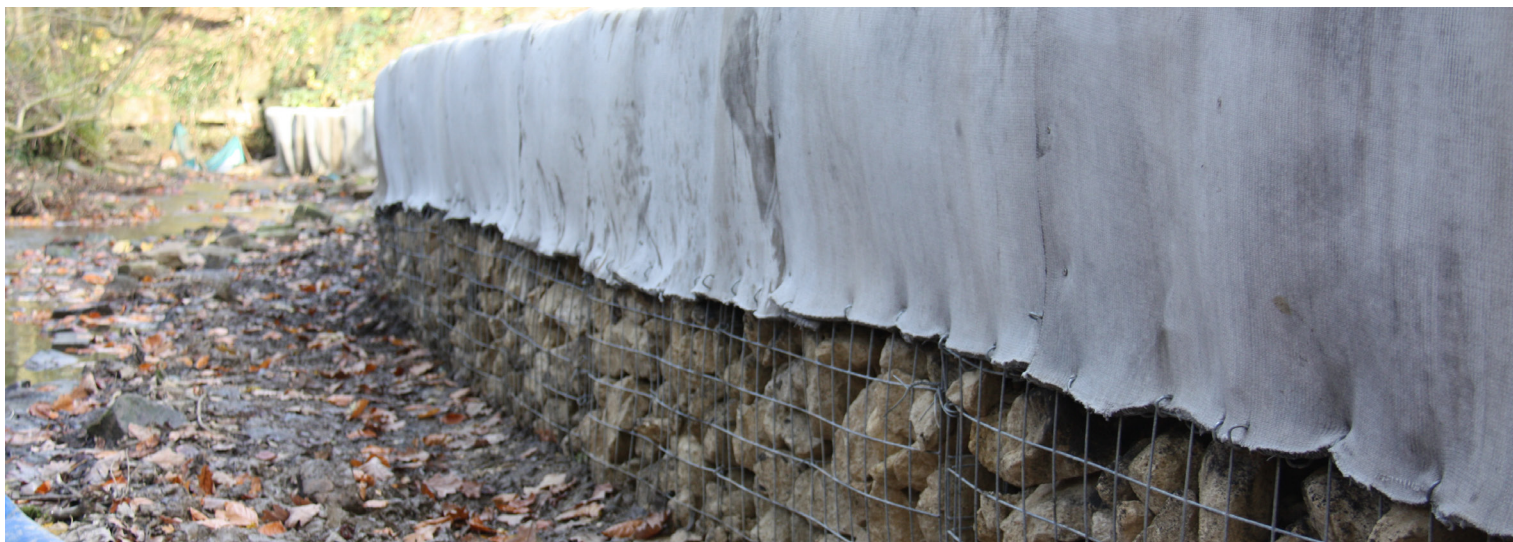
Completed gabion basket

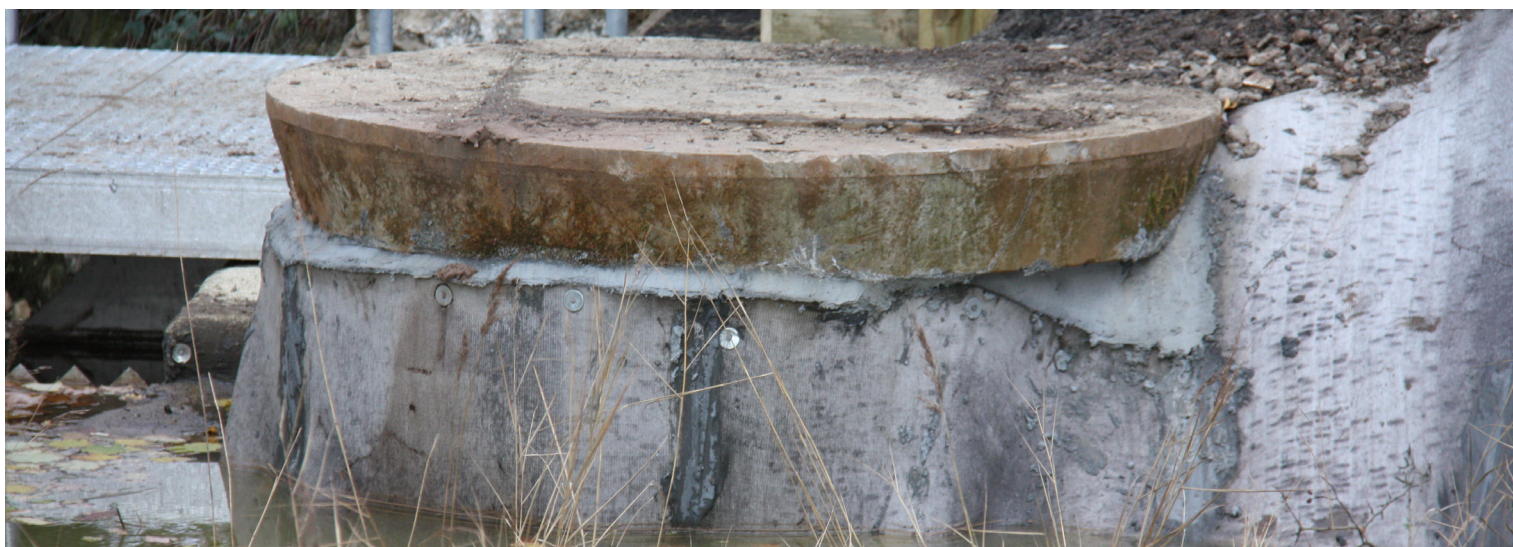
Termination detail around existing infrastructure

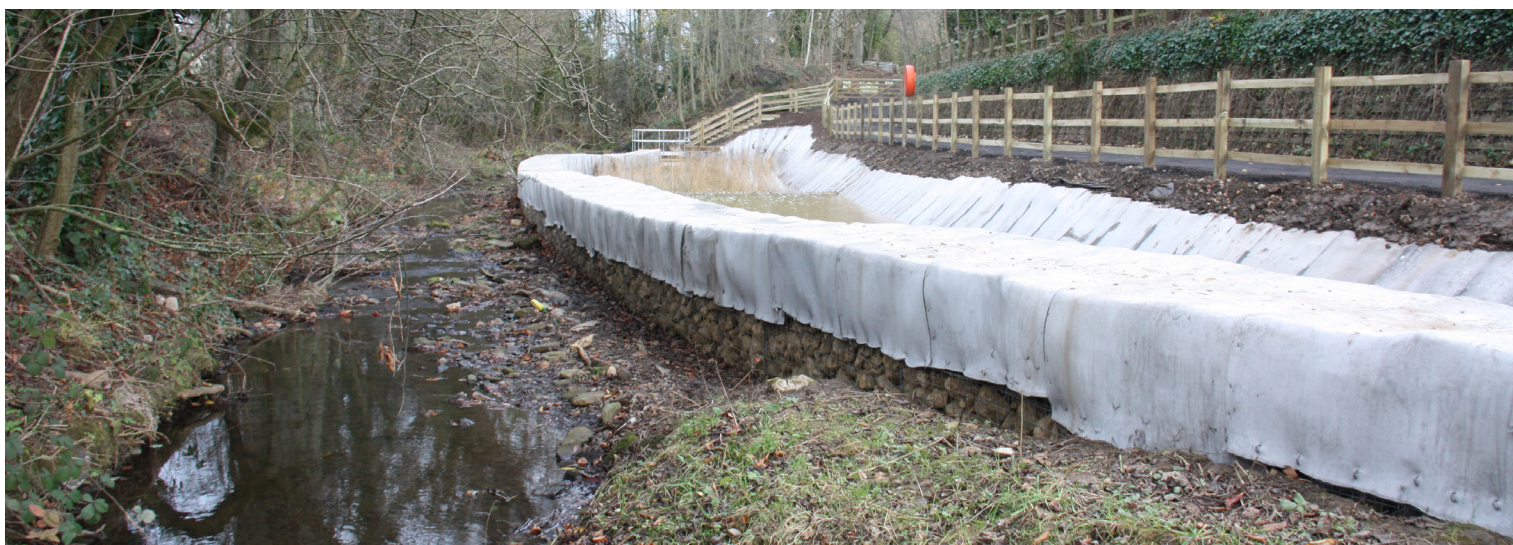
View of the channel from the adjacent stream

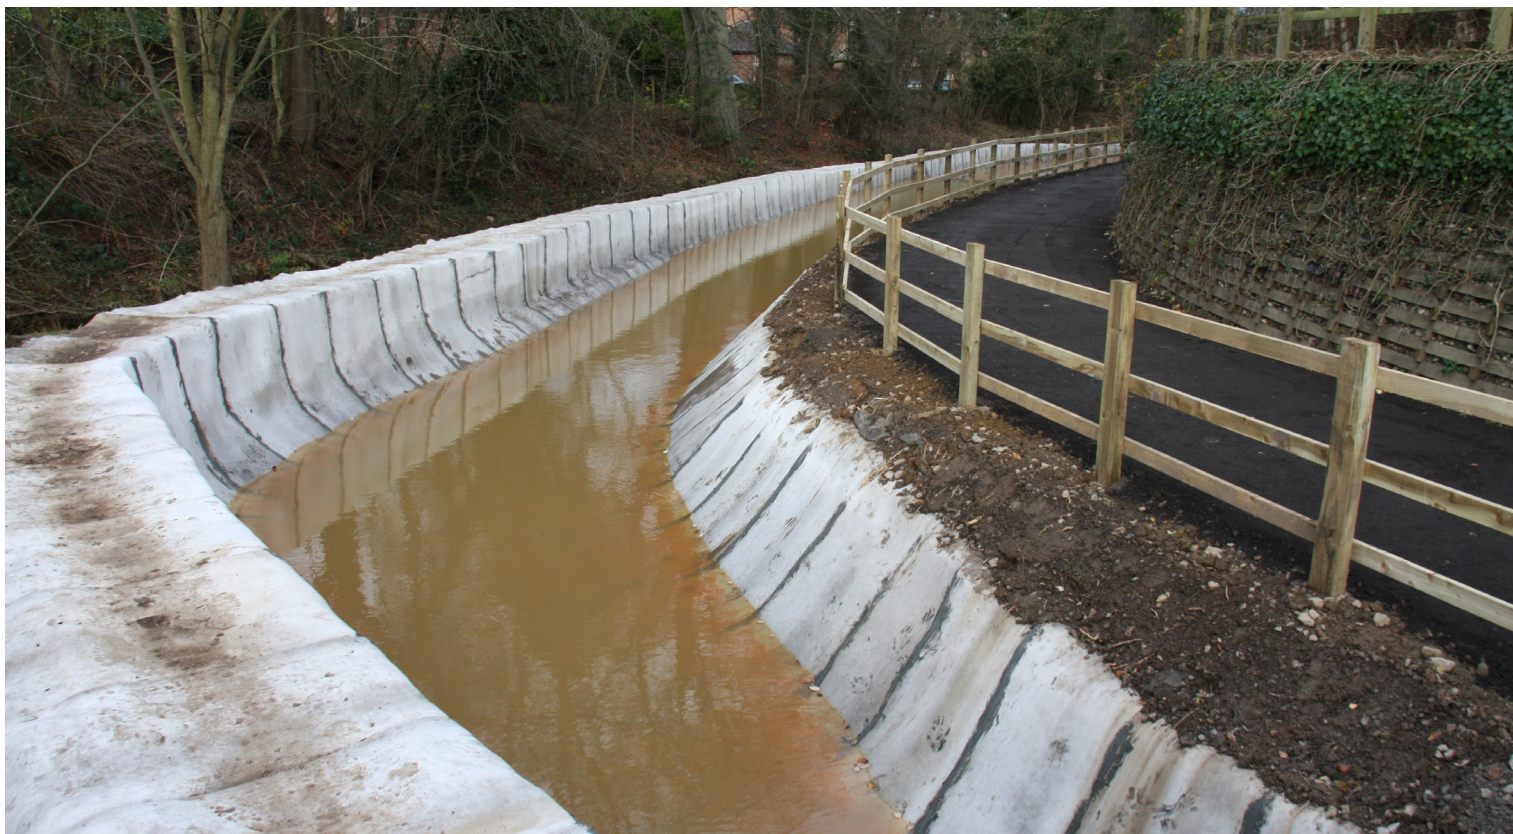
Section of the completed channel
