## CHANNEL LINING ( SLOPE PROTECTION

Concrete Canvas® (CC) GCCM\* was specified as a channel lining and slope protection solution for a scheme which involved creating a passage for rainwater, so it did not damage the work site. The installation of 13,200m<sup>2</sup> of CC5™ and CC8™ was carried out on a rig site in Dammam, Saudi Arabia. The works were carried out by FOQSCO for Saudi Aramco.

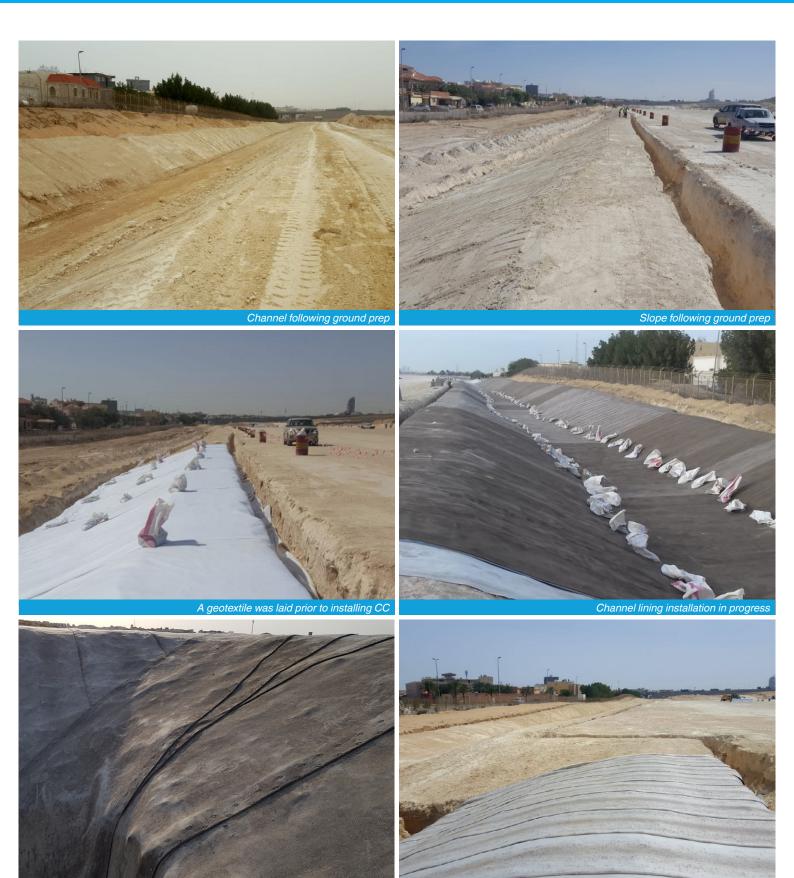
Completed installation along first section of slope

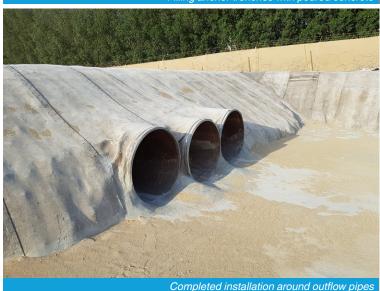
Completed slope protection installation following backfilling of anchor trenches

On both the channel and slope sections, hydration was carried out multiple times at the end of each working day using a hose with a sprinkler attachment. Steel bars were then installed within the anchor trenches to provide a neat and secure termination for the CC edges as per the request of the client, and sealed with poured concrete to prevent water ingress.

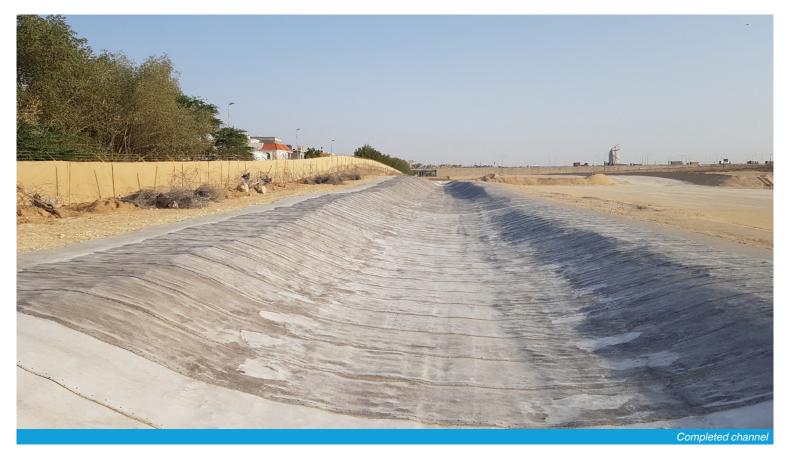
Prior to the installation, the channel was excavated and any vegetation and sharp rocks were cleared by hand using shovels and a pickaxe. The channel and slopes were then levelled and compacted with a roller-compactor.

For installation within the channel, anchor trenches were cut into its shoulders using a JCB Backhoe and a layer of geotextile applied prior to laying the CC. Bulk rolls of CC8™ were transported to the site and hung from a spreader beam for deployment. CC was then cut to length using hand tools and laid transversely along the inverts of the basin and across the ditch. A 100mm overlap was created between each subsequent CC layer and the overlapped joints were screwed together with stainless steel screws at 200mm intervals.
