In April 2018, Concrete Canvas® was used to prevent erosion of a French drain side wall, and line a drainage channel in Sohar, Oman.

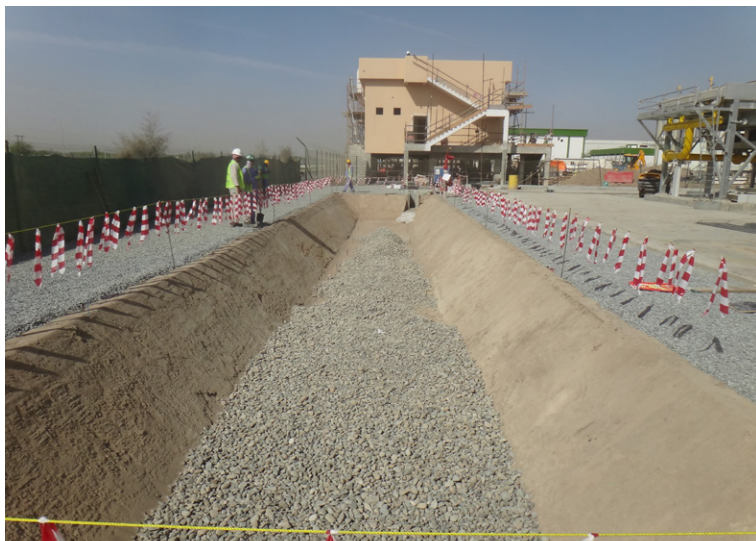
French drain prior to works

The site, owned by ORPIC, a Chinese engineering company, is a large power plant. As is typical with the region, the substrate is heavily sand-based, making it prone to water and weathering erosion. The French drain measured around 1.2m in depth and 30m long, with sloping walls and a stone-covered floor. The substrate had meant that the drain was not performing as well as it could be, and the client therefore looked into channel lining methods which would provide a durable, long-lasting solution that could provide an impermeable layer in order to prevent further erosion.

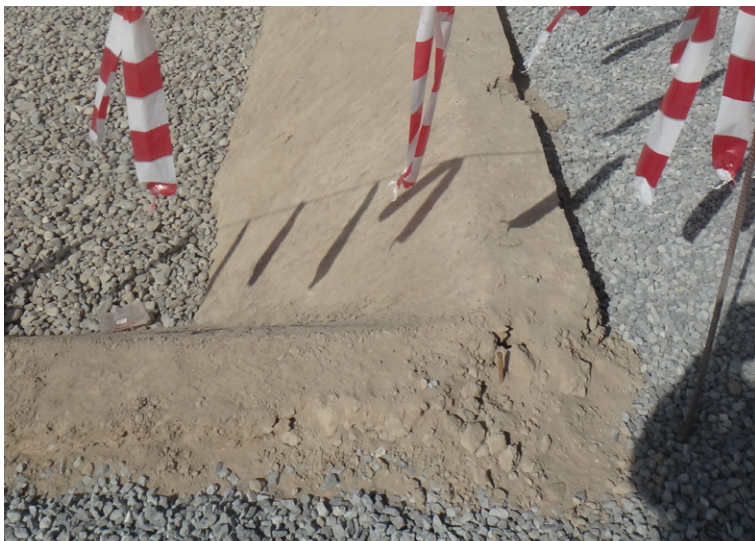
Soil-based substrate showing signs of erosion

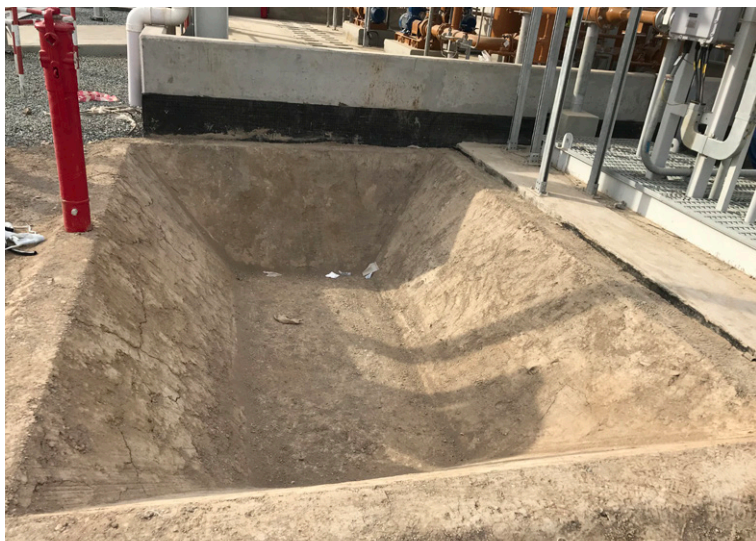
Smaller French drain prior to works

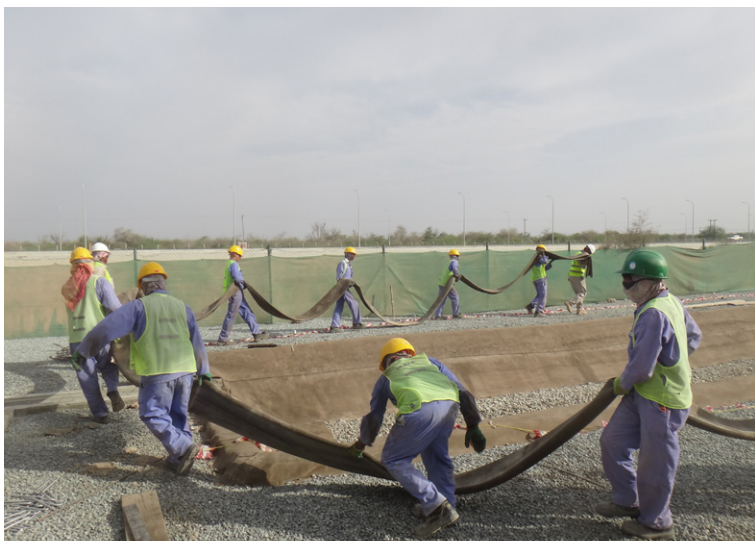
CC lengths manually transported

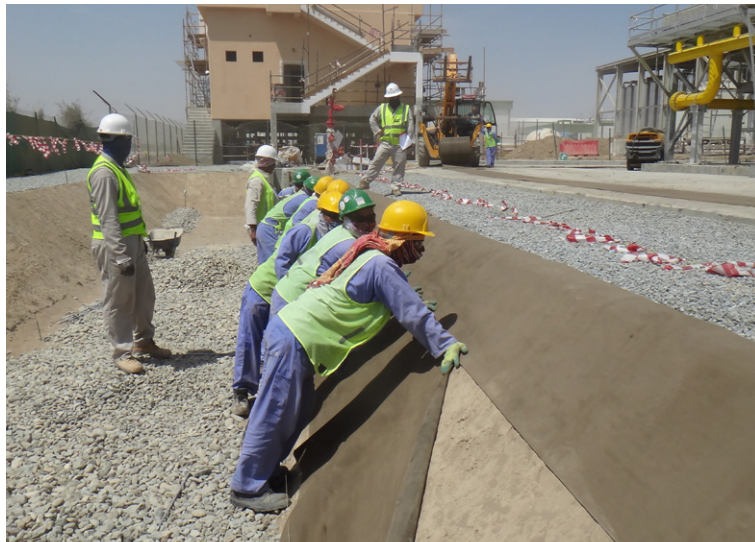
Installation of first CC layers

Longitudinal layers of the CC material were used in the installation. The team of 12 began the process with the trench and crest of the slope, manually placing a single length across one of the longer sides first, and working around the channel. The edge of the CC was pegged into the anchor trench to secure the material.

This was repeated along each side, before a second length was batched and placed, covering the bottom half of the slope, and a third to cover the toe of the slopes, and the channel base around the central drain. Once the lengths of CC were in position, the team arranged them to ensure the joints lay in the direction of overflow.

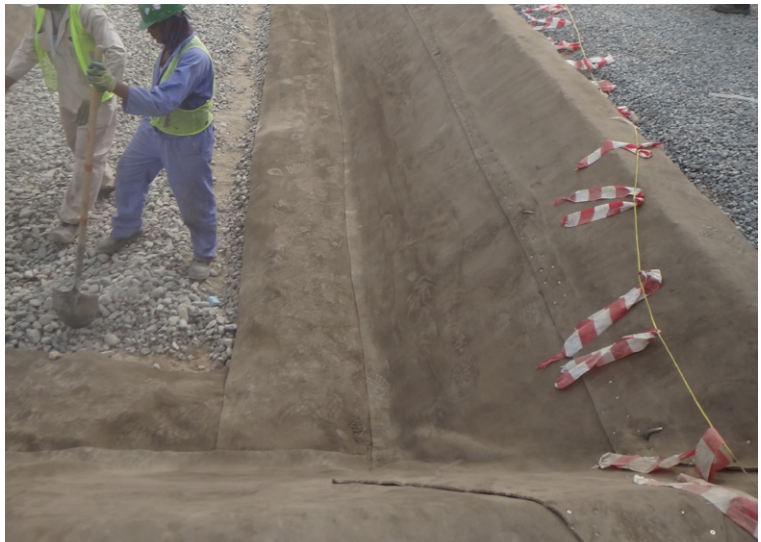
Completed installation of three CC layers

The CC lengths were secured using hoop pegs at intervals of every 3m. The overlaps were sealed using Clearfix adhesive sealant, piped in two parallel lines along the joint, before screws were inserted in a staggered line every 50mm. Once the sides were completed, the corners and inlet drainage channels at each end were then worked on. The inlets were sealed, jointed and the sealed again using mortar around the edges to prevent ingress.

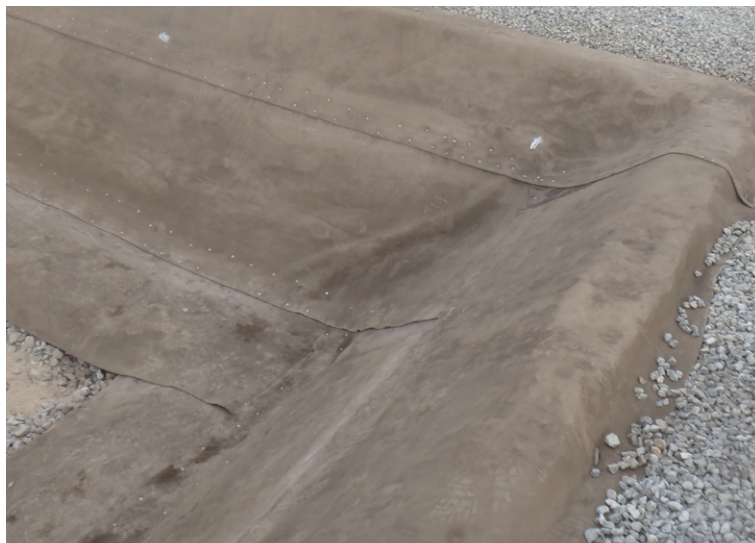
Corner detail

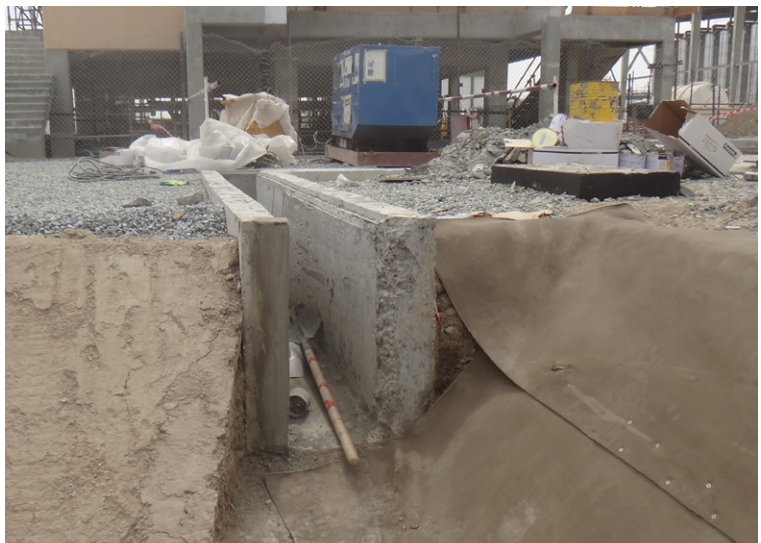
Installation of CC around drain inlet

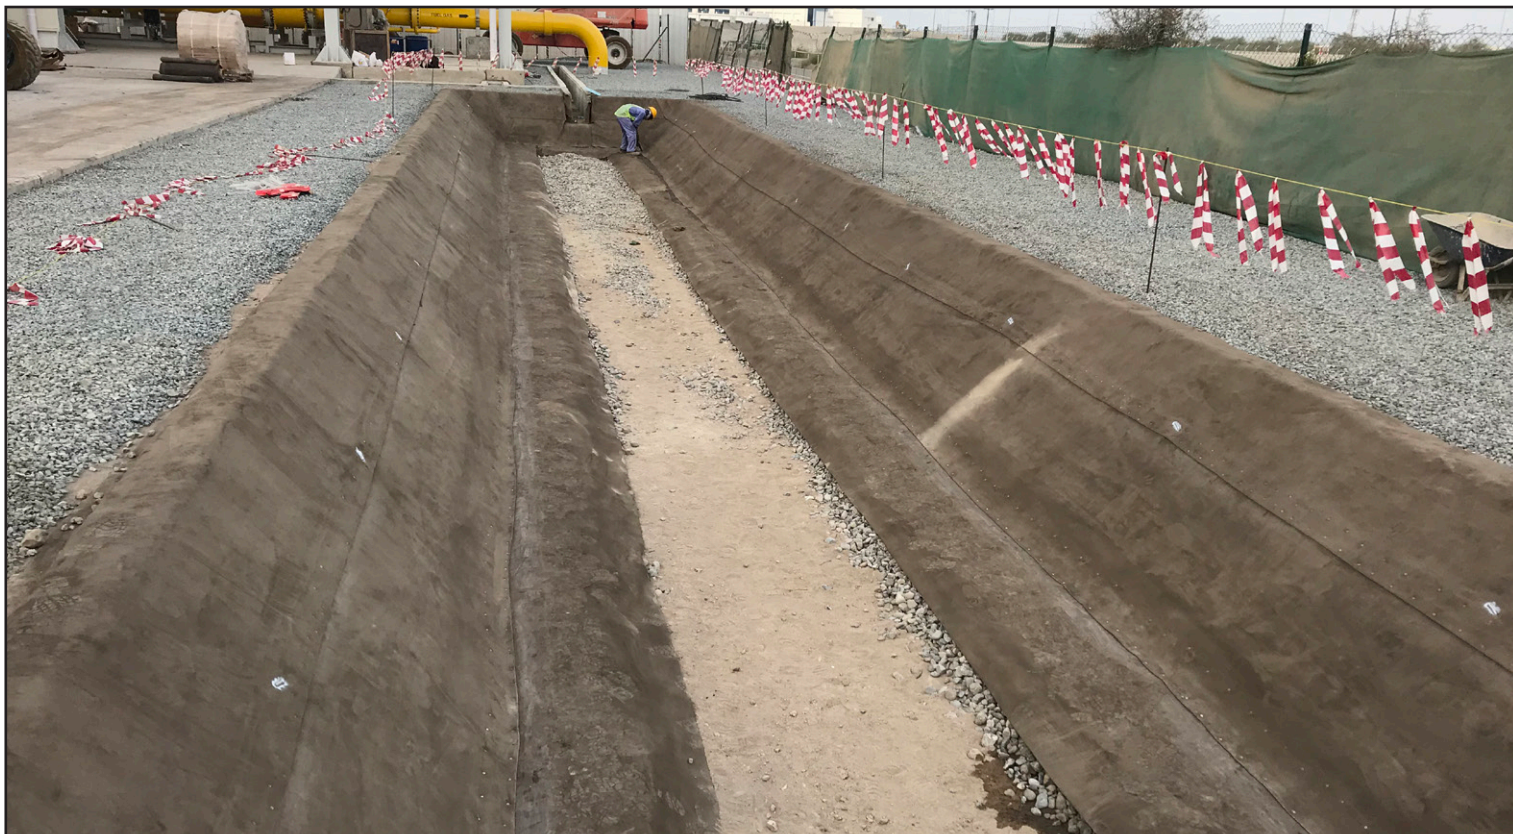
Completed installation prior to hydration

Once the installation was completed, the CC was hydrated using water from an on-site source, and a 5000-gallon tanker. Following the first hydration, the team waited an hour before hydrating the material again. A third hydration was given the following morning due to temperature increases over night.

The installation was carried out in 7 hours, using 400m² of CC5™, with a total of 6700m² of the material purchased for various works on the site. The installation took longer than anticipated due to issues with getting permission to work, and waiting for supplies. The team worked between 6:30am – 12:00pm, and 2:00pm – 6:00pm. The team took two hours for lunch, as is customary for the area, due to the increase in temperatures at this time of the day.
