CC5™ Batched Rolls

Suemasagawa River,
Okayama, Japan

CC5™ used to provide
a protective liner to
sand bags used to
rebuild damaged levee
banks

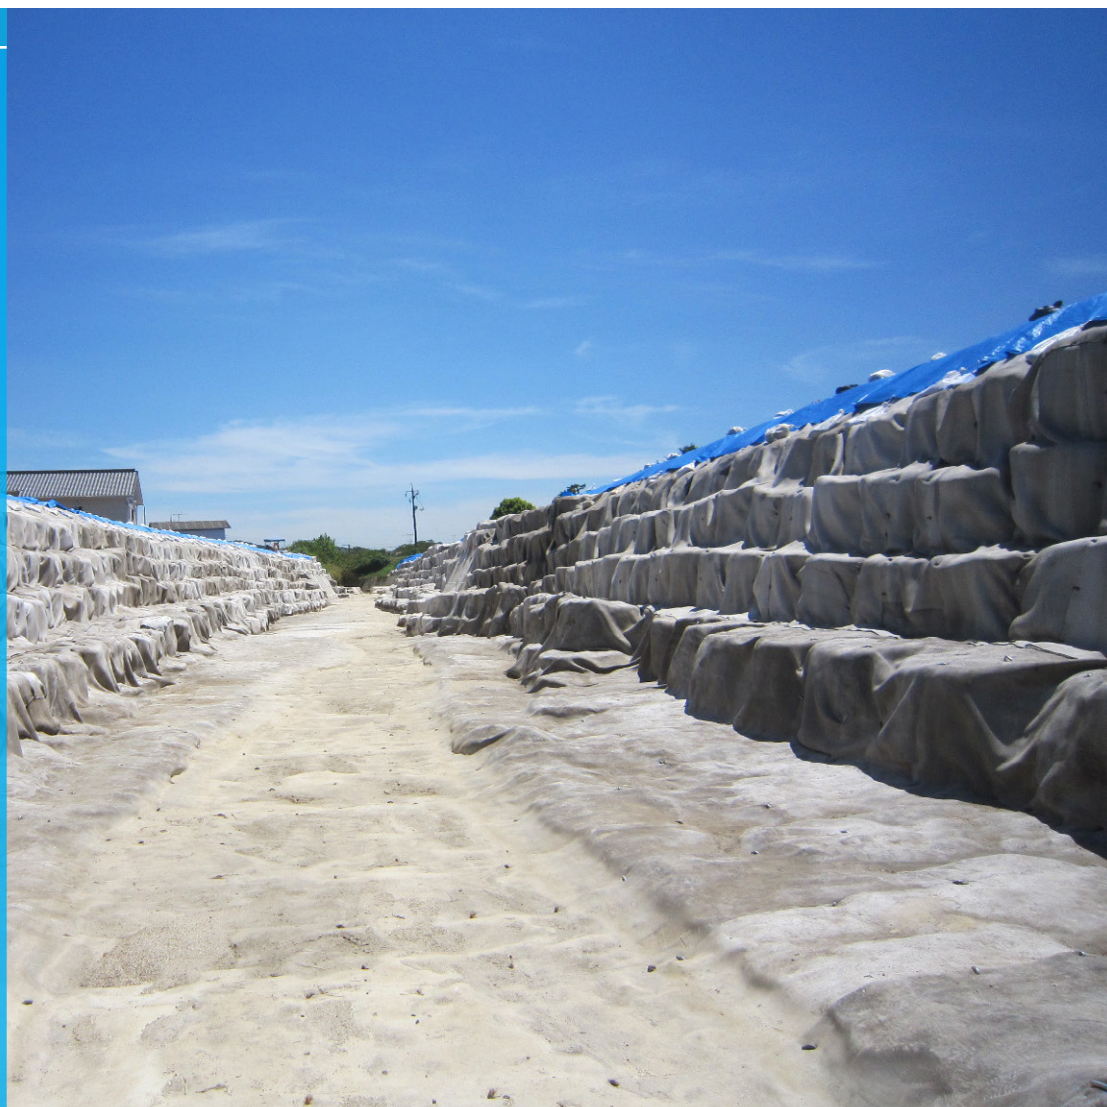
Completed installation at the Suemasagawa River in Japan

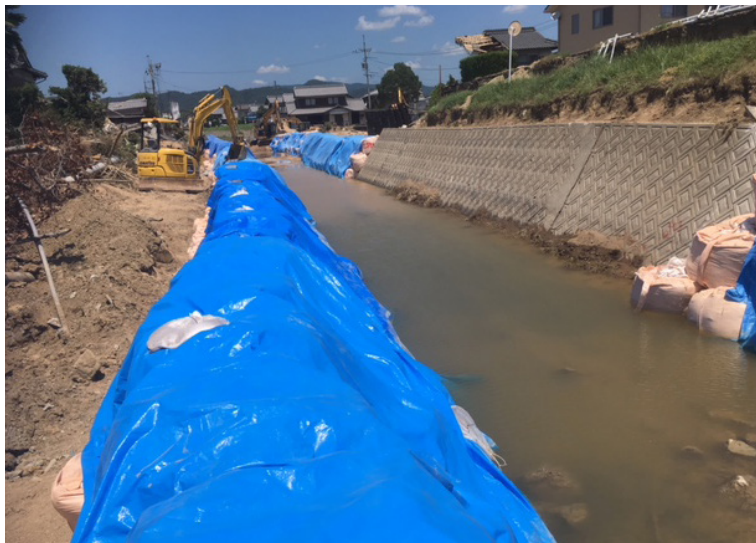
The levee was originally protected using concrete blocks; however, a heavy flood had damaged the concrete blocks and immediate repair was required to prevent further collapse.

Channel prior to works

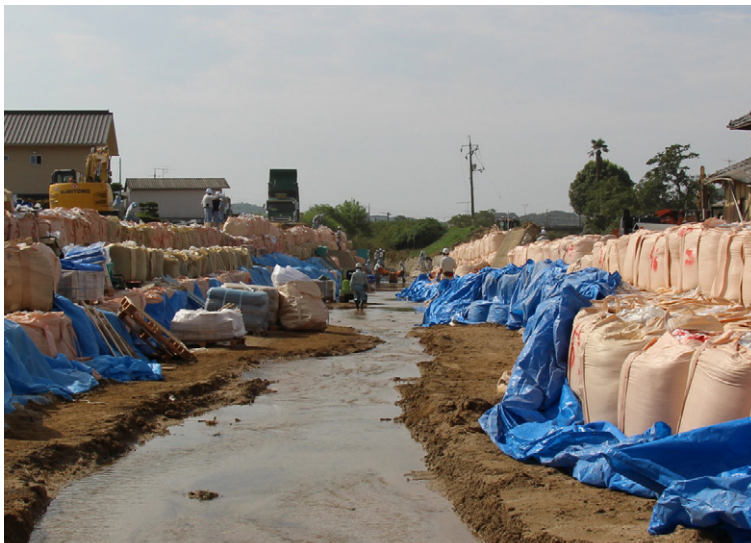
Sand bags in place prior to CC installation

Prior to the installation, the damaged concrete blocks were removed and the sand-filled bags were stacked on both sides of the channel. CC was laid over the bags, starting with the lower layer. The CC was captured behind the bags using anchor pegs, and laid transversely across the channel and pinned behind the lower level of bags on the opposite side. Material was then installed vertically down the banks of the channel, with the leading edge captured in an anchor trench at the crest of the levee, deployed down the height of the unlined bank and secured at the bottom. This was repeated along the length of the damaged section, with layers overlapped by 100mm and jointed using stainless steel screws.

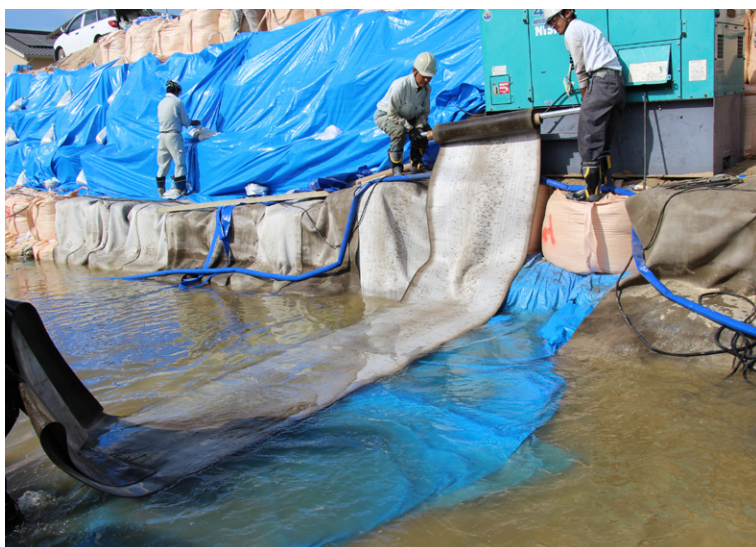
Deployment of CC batched rolls

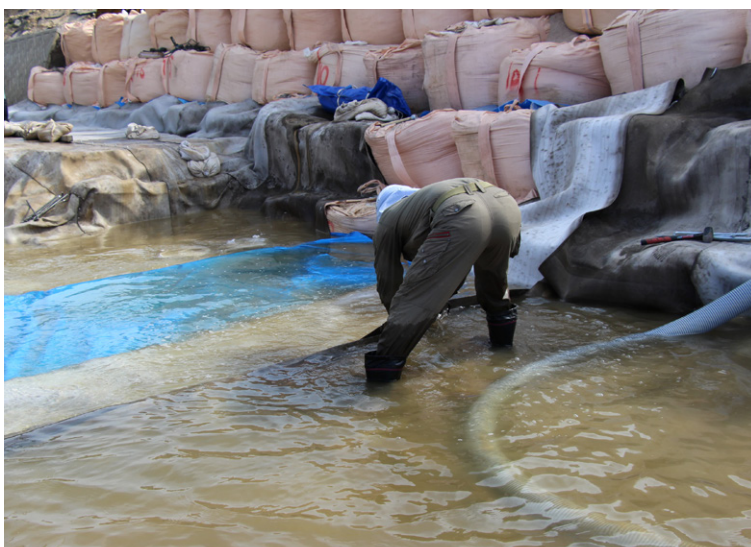
Placing CC below water

Water continued to flow through the channel during installation, and was used to hydrate the material post-installation. CC has a working time of around two hours following hydration, allowing the team to install the material without having to stop or re-direct the water flow. CC's low alkaline reserve and washout rate also meant that runoff did not require treatment prior to entering the watercourse.

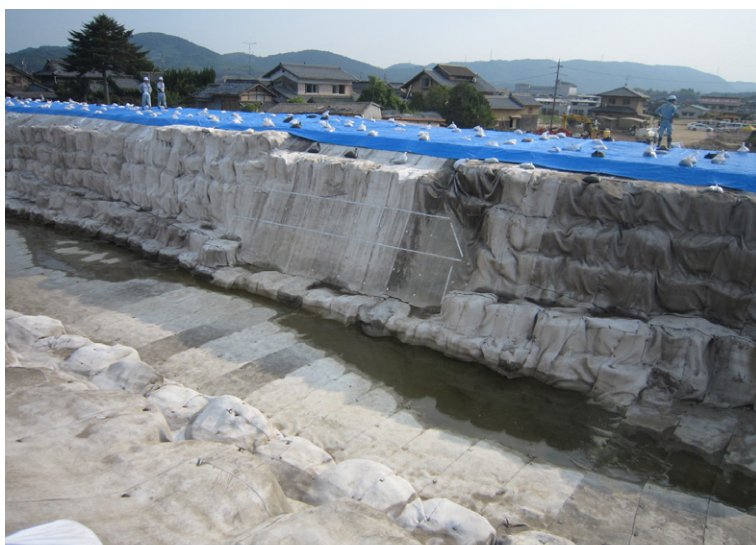
Completed section of installation

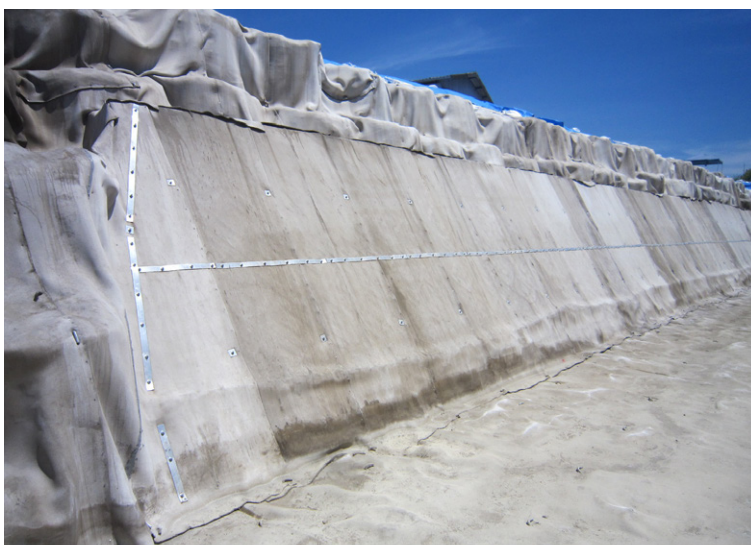
CC fixed to remaining concrete blocks using masonry nails & termination bars

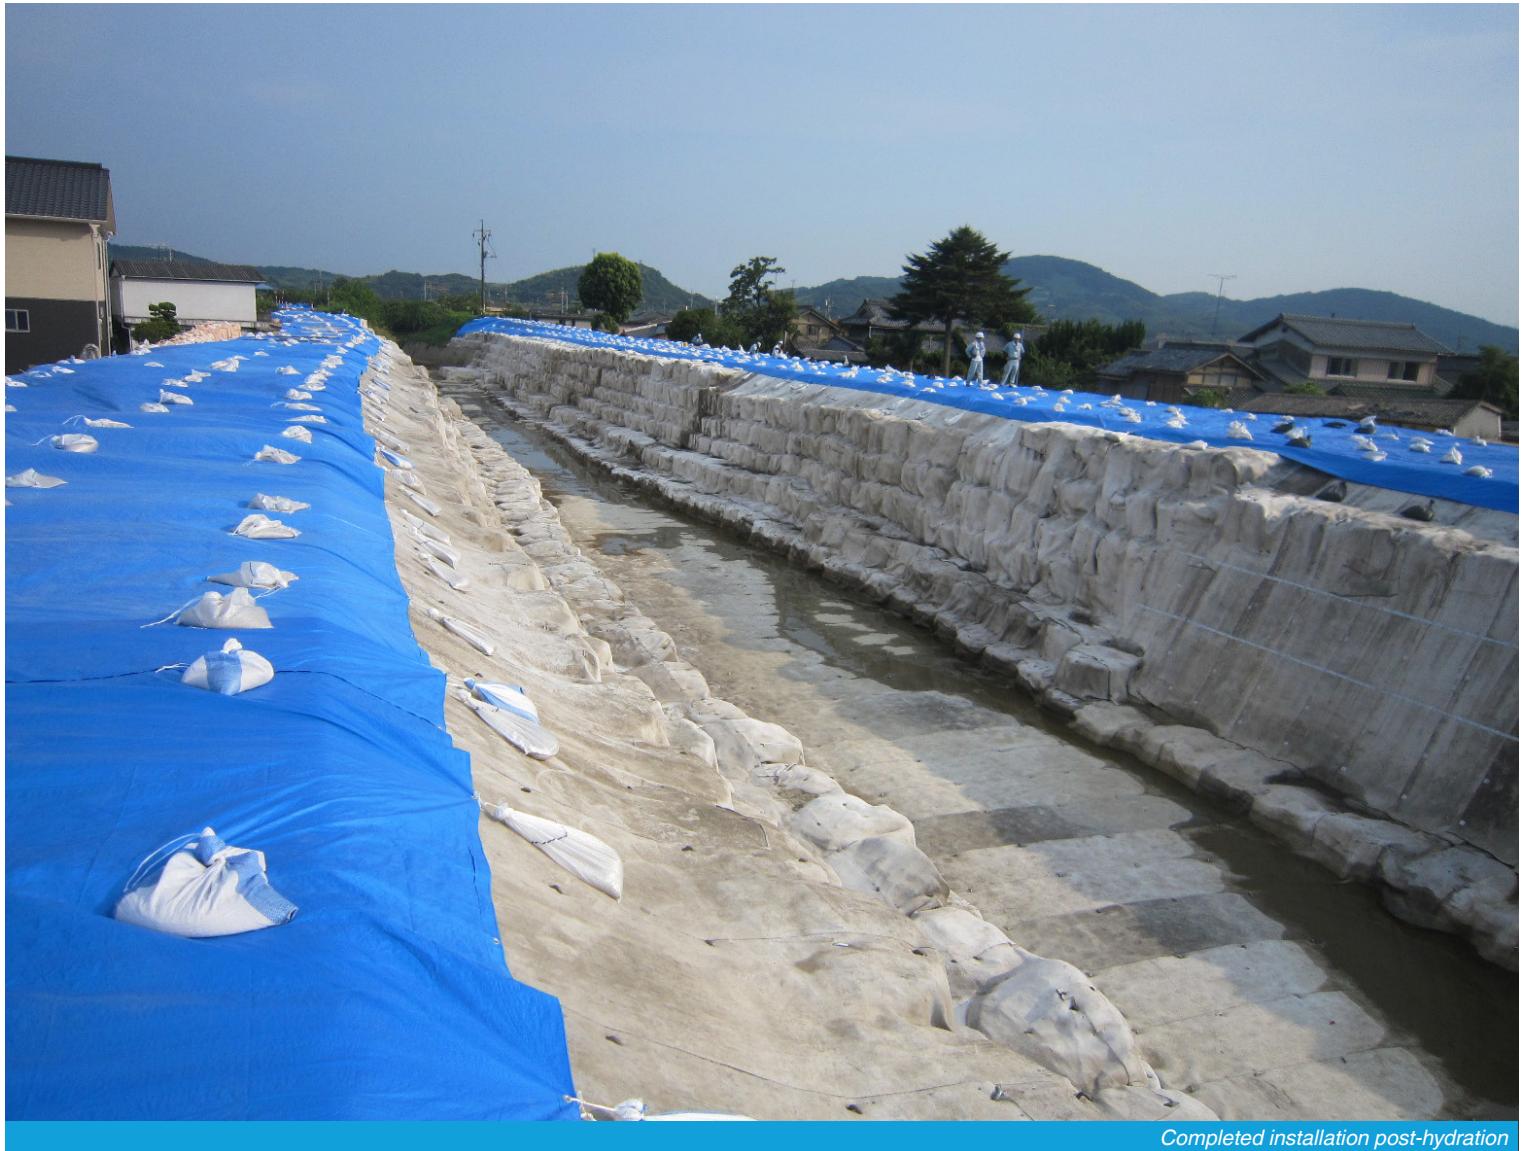
Completed installation post-hydration
