CC8™ Bulk Rolls

Templecombe, Somerset,  
UK

NW Rail / Osborne

CC8™ used to line a  
crest drainage channel  
to prevent saturation  
of a cutting and  
recurrence of slip

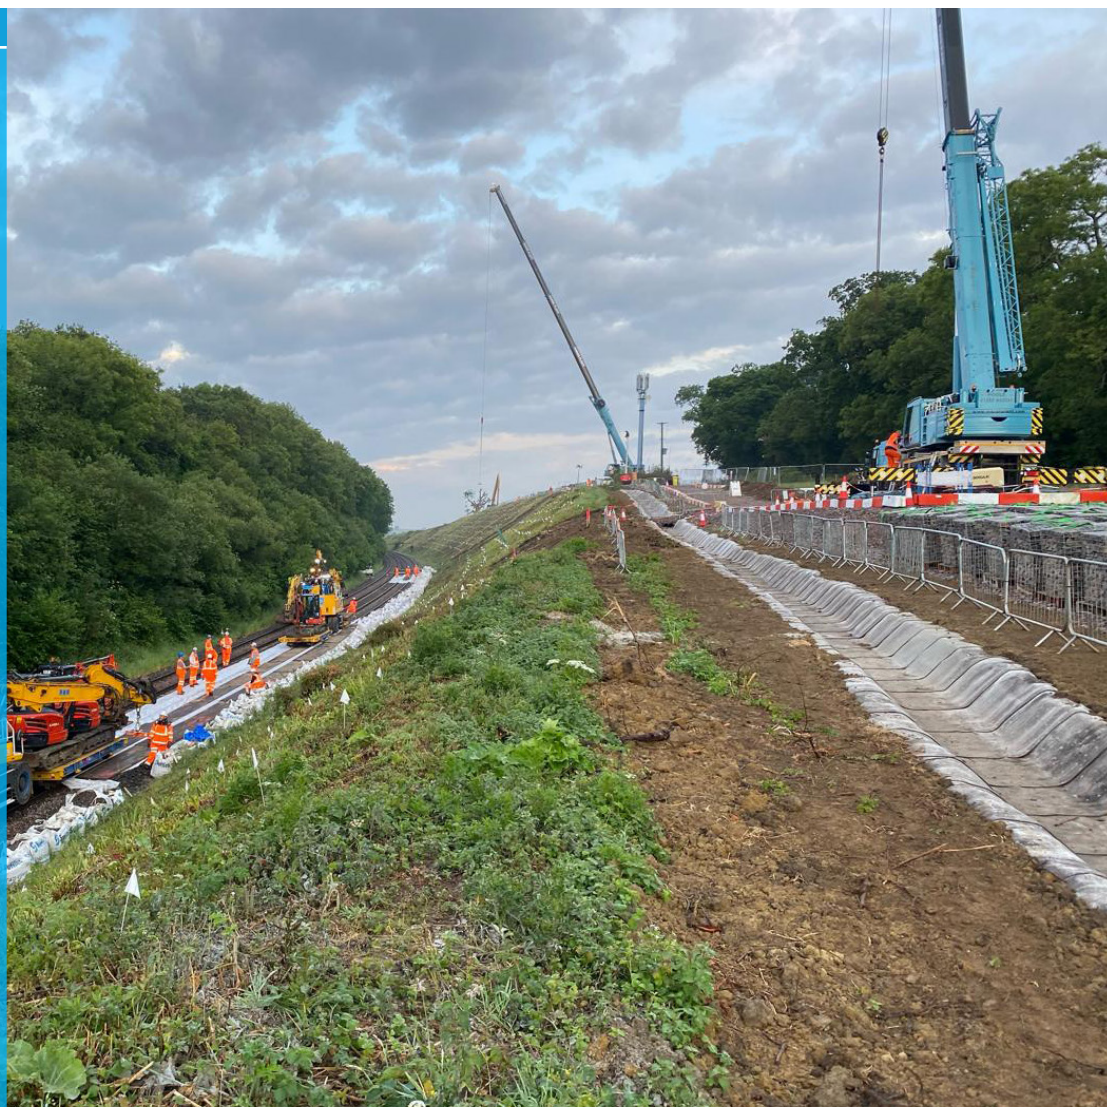
Completed channel lining installation on site in Templecombe; works ongoing on the rail line

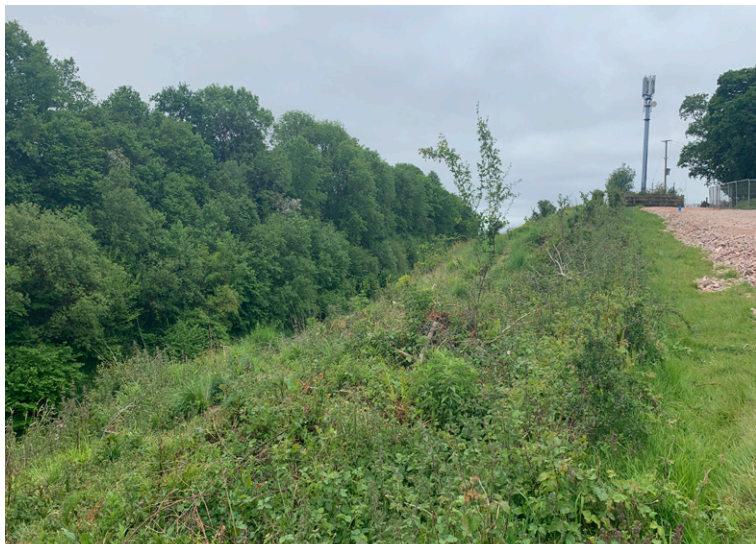
Site prior to works

In December 2019, bad weather and heavy rainfall caused a localised overburden and landslide at a cutting between Templecombe and Sherborne on Network Rail's Wessex Route.

Temporary repairs were made to reopen the line but a speed restriction was imposed for the safety of passing trains. Engineers returned a few months later to carry out a full repair.

The framework contractor, Osborne (working for Network Rail), initially considered clearing the existing crest ditch of vegetation in order to reduce blockages and build up on the channel invert. However, the channel would have still be prone to excessive erosion in the event of further heavy rainfall, and would inevitably have resulted in further slip.

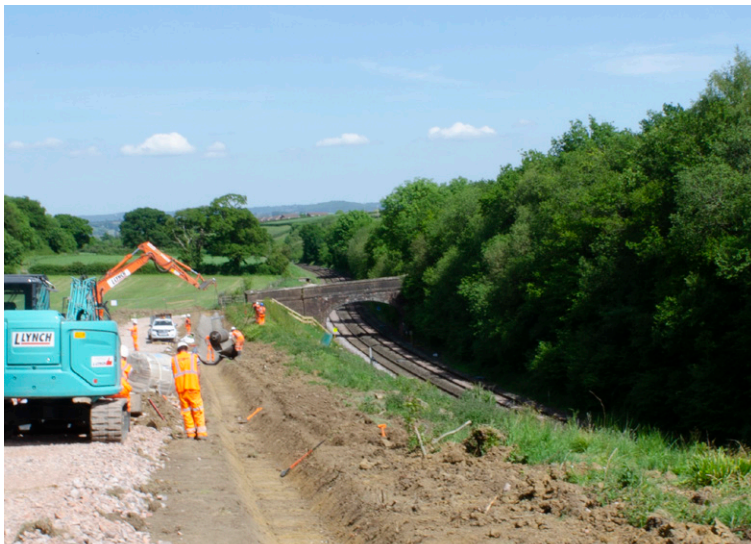
Proximity of crest drainage channel to rail line

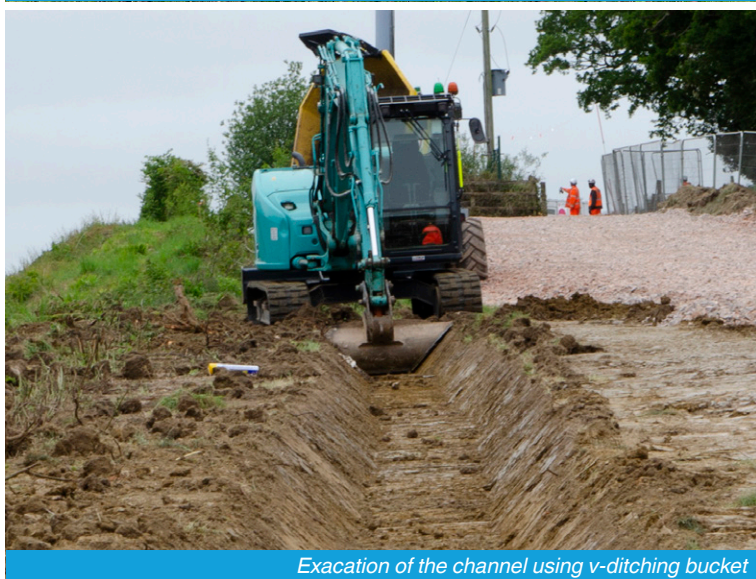
Excavation of the channel using v-ditching bucket

In May 2020, NW Rail (sub-contractor to Osborne) began works on the site. As planned, they prepared the channel by removing all vegetation and reprofiling it using an excavator and V-ditch bucket. Bulk rolls of the specified 8mm thick CC variant (CC8™) were delivered to the site and suspended from an 8T excavator with spreader beam attached for deployment.

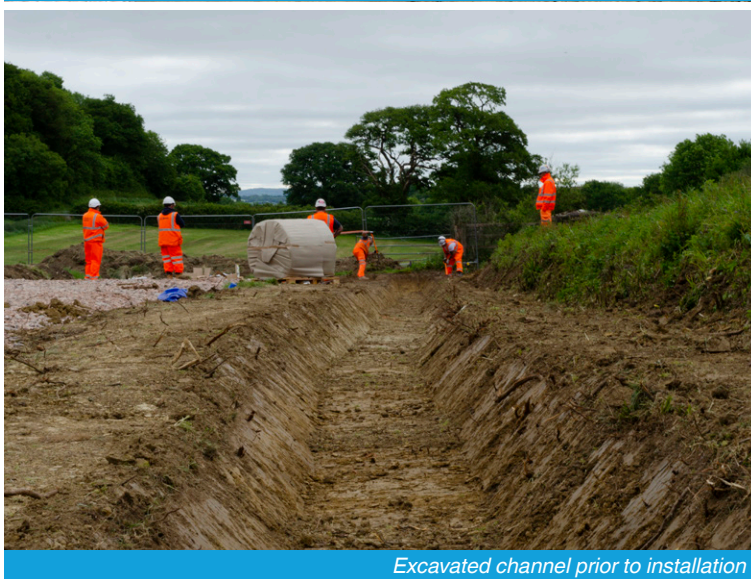
Excavated channel prior to installation

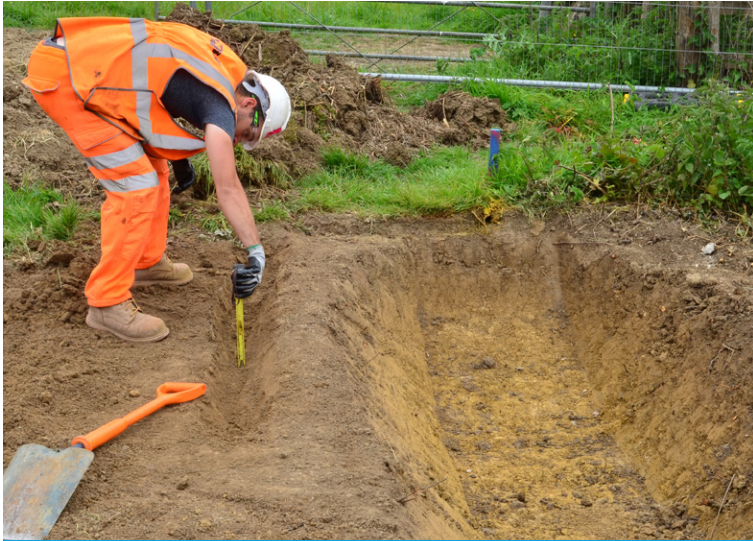
*Measuring and creating anchor trenches*

Beginning downstream, the first length of CC was secured within an anchor trench prepared on the far shoulder of the channel using 250mm long galvanised J-pegs. The material was laid transversely across the channel profile, cut to length in-situ and secured in the nearside anchor trench.

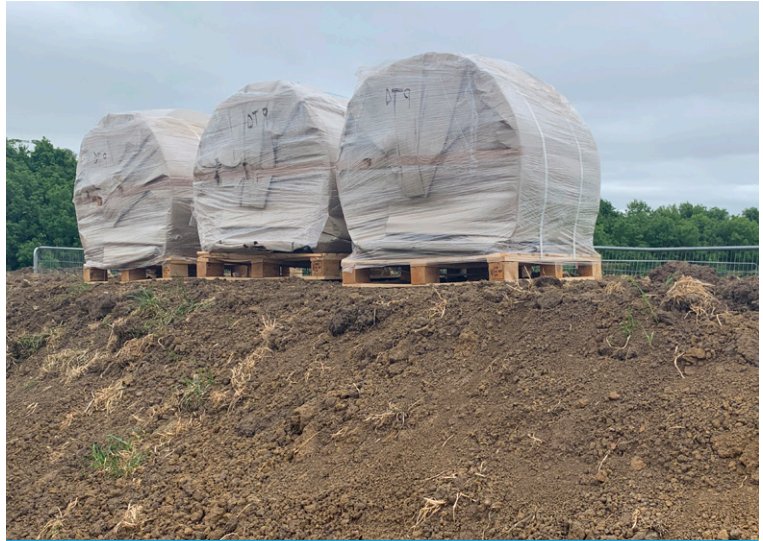
*Bulk rolls of CC8™ were specified for the project*

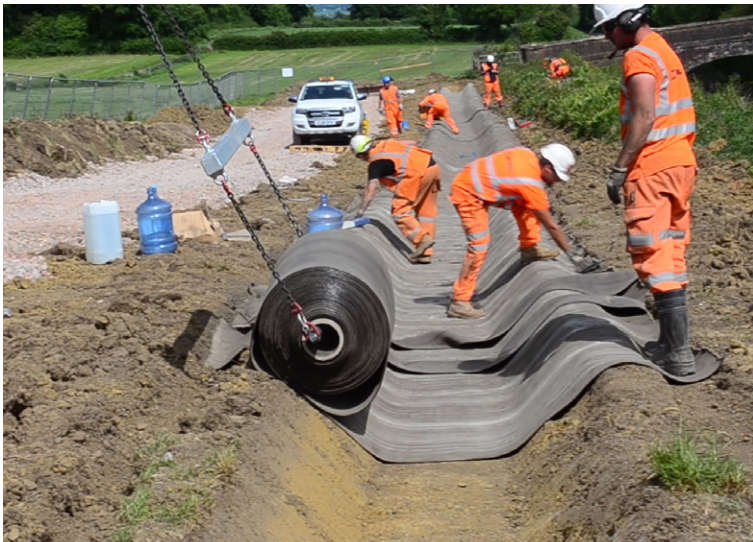
*Deployment of the CC bulk rolls*

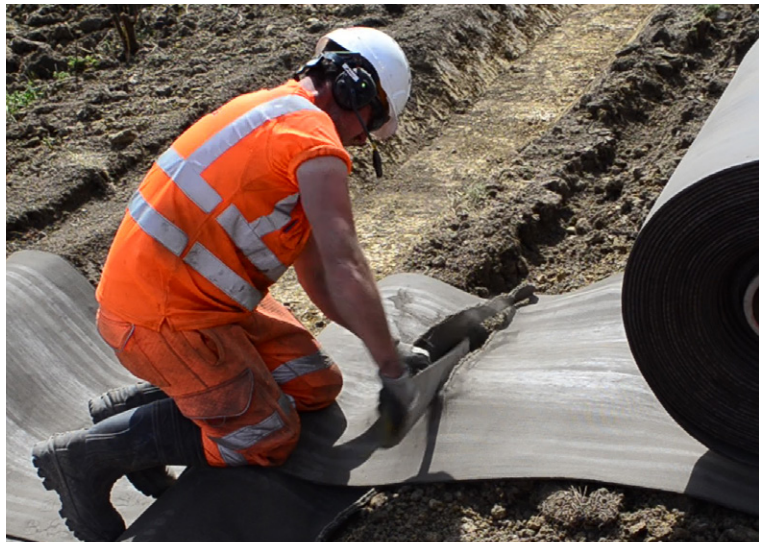
*CC cut to required length in-situ using hand saw*

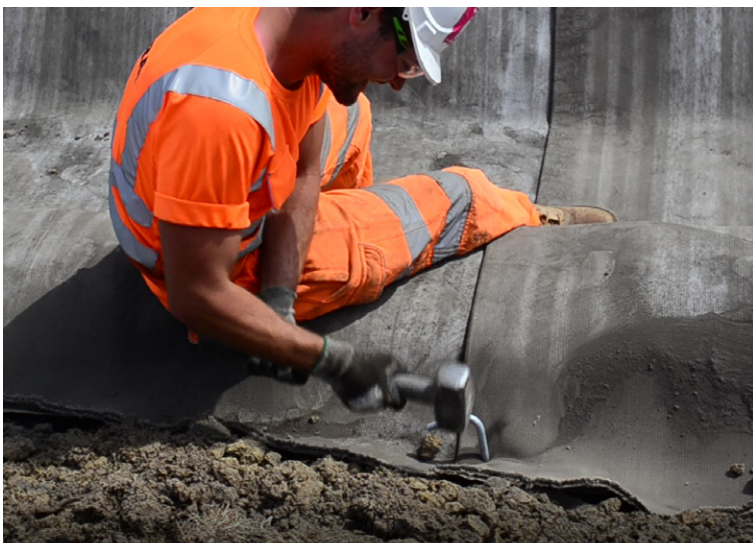
*Securing CC within anchor trenches using ground pegs*

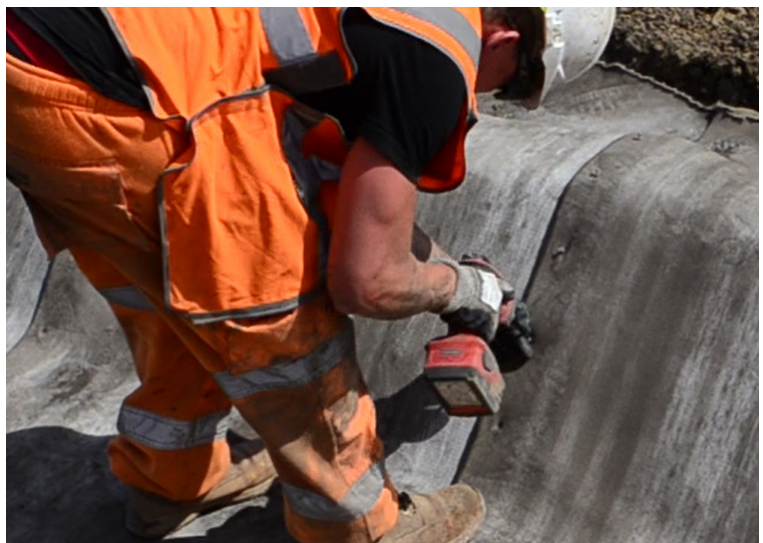
*Jointing overlaps with stainless steel screws*

Subsequent layers of CC were shingled in the direction of water flow with layers overlapping by 100mm. The material below each overlap was hydrated prior to the application of an 8mm bead of Soudaseal adhesive sealant and then jointed using 30mm stainless steel screws.

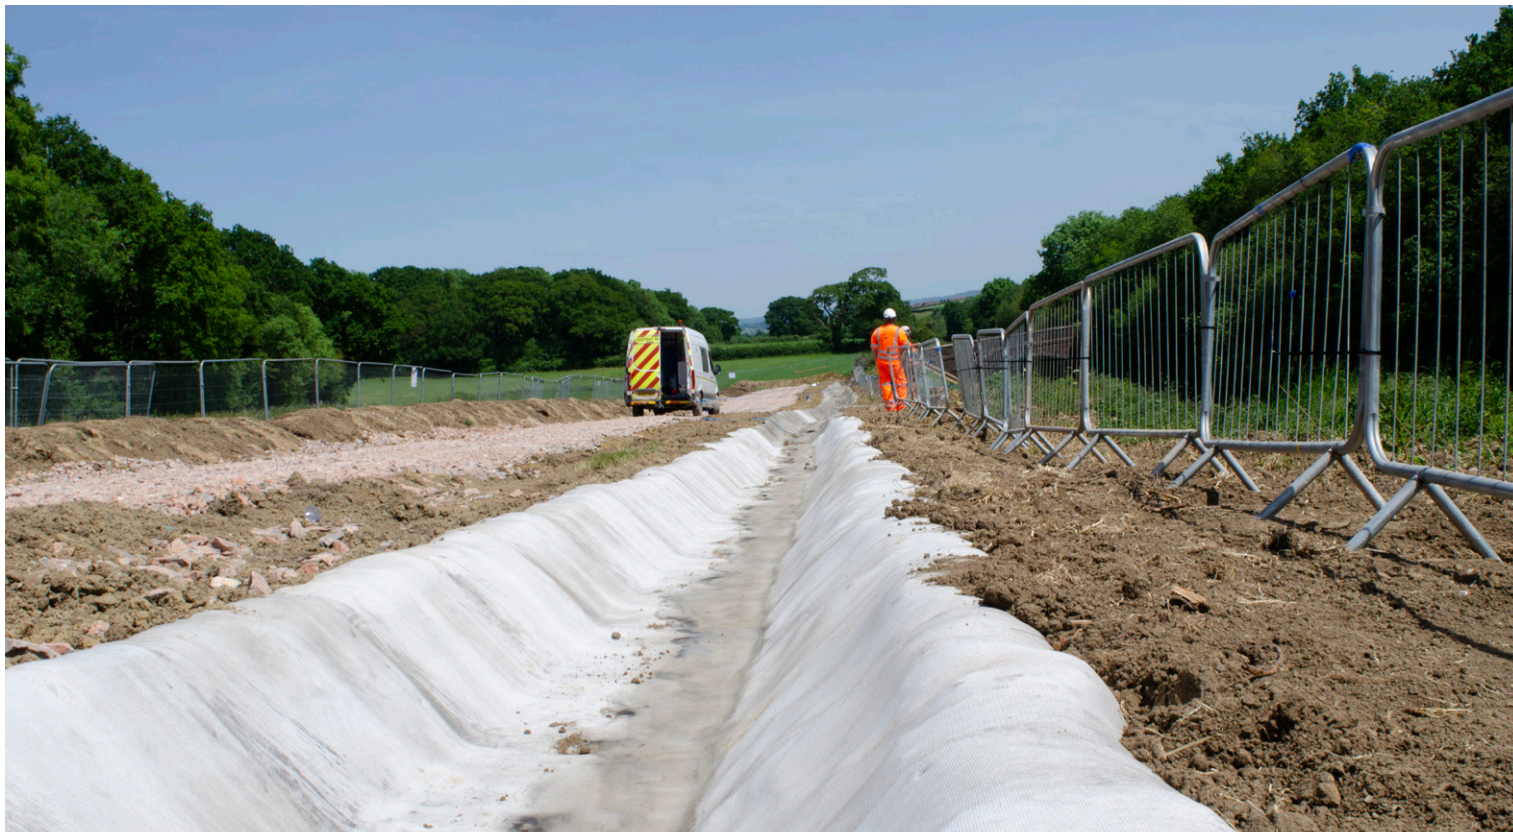
*Completed Concrete Canvas® crest drainage channel lining installation*

Once the installation was completed, the material was hydrated using a 10,000L bowser and hose attachment; the anchor trenches were then backfilled to prevent ingress of water and wind. At the upstream end of the channel, the CC was terminated under a 250mm diameter plastic pipe; downstream, the CC was terminated into a precast concrete headwall.

A total of 658m<sup>2</sup> of CC8™ were installed in five days by a team of five, with around 150m<sup>2</sup> installed per day. The works were carried out in dry, sunny weather, with the team able to work while social distancing in line with the government's guidelines for COVID-19.
