In February 2018, Concrete Canvas® GCCM* (CC) was used to line a channel which runs adjacent to the Grand Western Canal, between residential properties and a Devon County Council owned jetty on Atherton Way, Tiverton in Devon, UK.

*Geosynthetic Cementitious Composite Mat

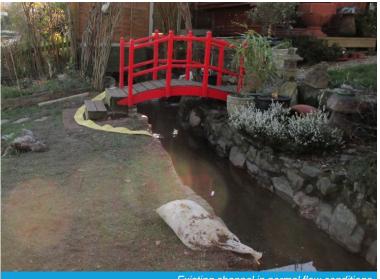
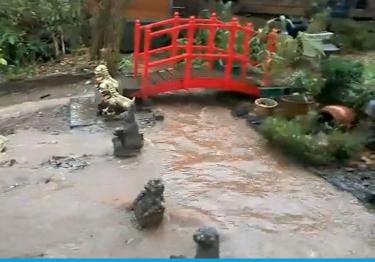
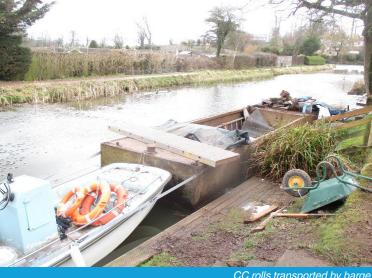
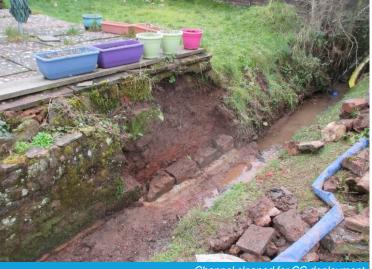
Design drawings for installation

A representative from Concrete Canvas Ltd. visited the site to advise the contractors on fixing methods. Due to the varying side slope materials (slabs, stone, masonry and wood), it wasn't possible to use the traditionally specified ground pegs on all sections. Instead, Hilti fixings, specialist resin and screws were used when fixing to anything but the earth bank.
