## Project Info

**A59, North Yorkshire, UK**

**i** CC13™ was used to line a re-profiled aggregate drainage channel as part of land slip protection works along an important section of the A59 in North Yorkshire.

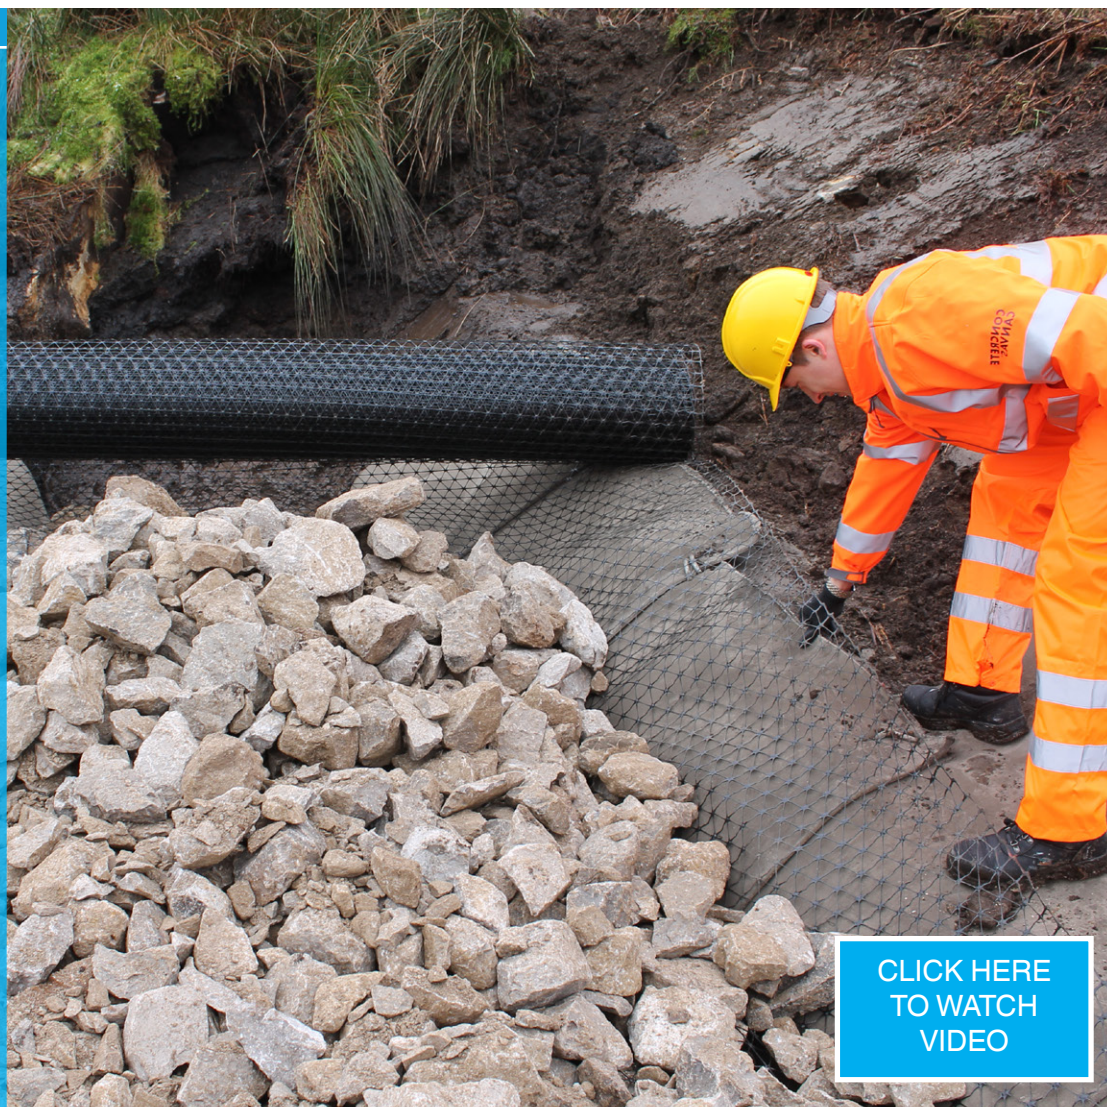
*The completed channel installation along the A59 in North Yorkshire*

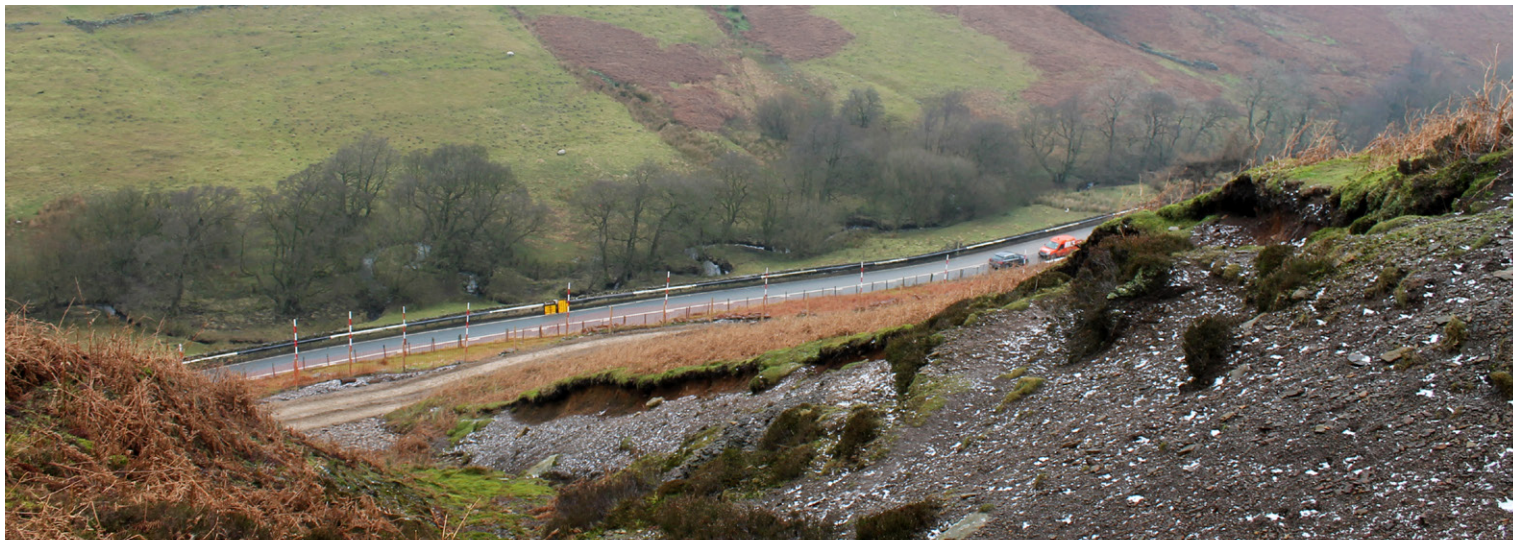
*Evidence of landslide on section of the A59 road in North Yorkshire*

Sections of the road are particularly prone to flooding and drainage issues, the A59 between Skipton and Harrogate has a history of landslips above the road to the west of Blubberhouses at Kex Gill. A landslip in January 2016 led to the road being shut for eight weeks and when closed, a diversion of more than six miles (10km) through towns unsuitable for heavy traffic was used. The A59 is often trafficked by heavy laden aggregate vehicles and the extra diversion incurred considerable expense to the local quarries, overloading local roads and causing considerable disruption to the local townspeople.

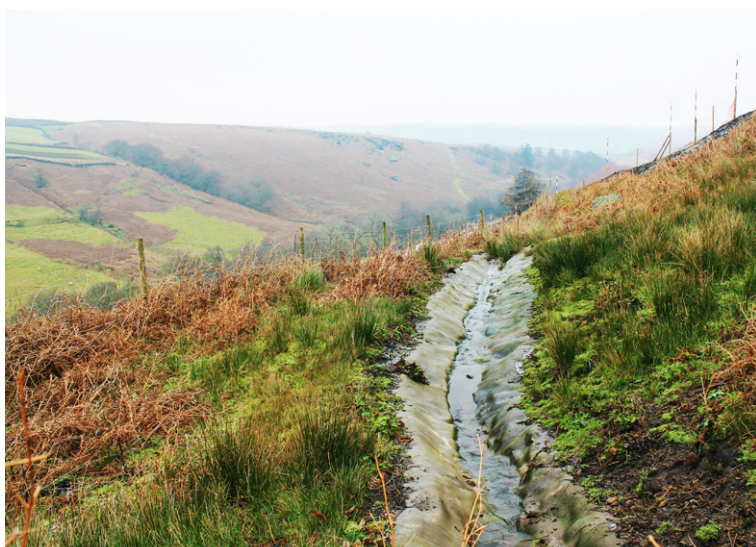
*Adjacent CC lined open channel minor works originally installed in 2014*

In order to prevent scour of the channel, provide an armoured impermeable lining and prevent wash out of the aggregate, the channel was lined with CC to increase the operational life of the structure. CC had successfully been used to line minor open channel works in the same area two years prior. The channel detail was produced by Capita in conjunction with North Yorkshire County Council Highways, with further input from Highways England. The works were carried out by HACS Group.

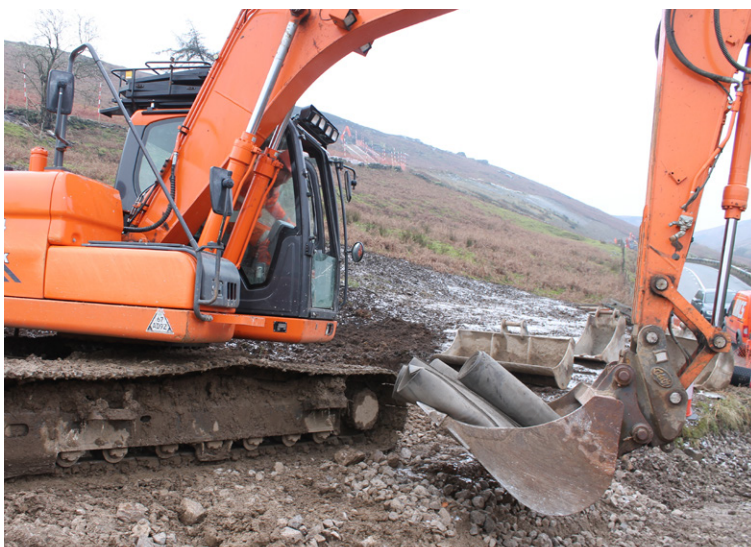
*Transporting pre-cut lengths of CC13 to site area*

The CC was installed concurrently with the preparation of the channel using pre-cut lengths of CC13. These lengths were laid transversely and fixed using ground pegs. A 150mm layer of larger aggregate and rock then formed the base, before applying a geogrid and 300mm of smaller stone above. A layer of non-woven geotextile was applied to the rock surface before compacted earth and fine dust formed a trafficable road surface above.

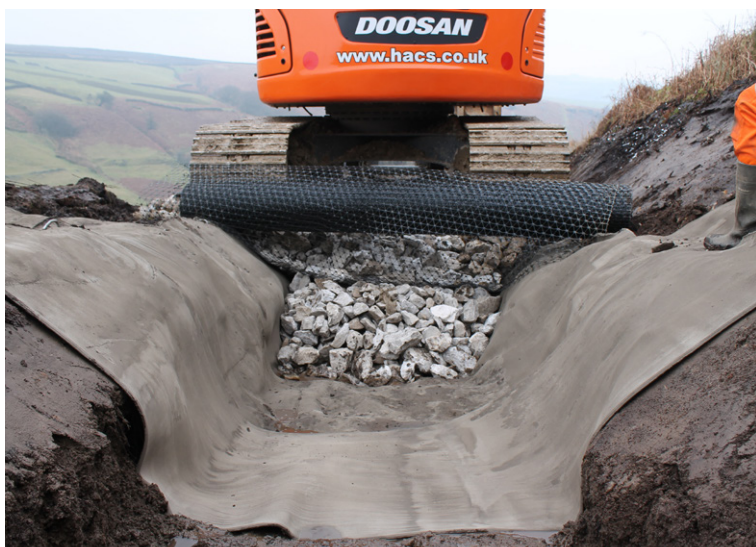
*Transverse layers of CC13 deployed in conjunction with aggregate and grid*

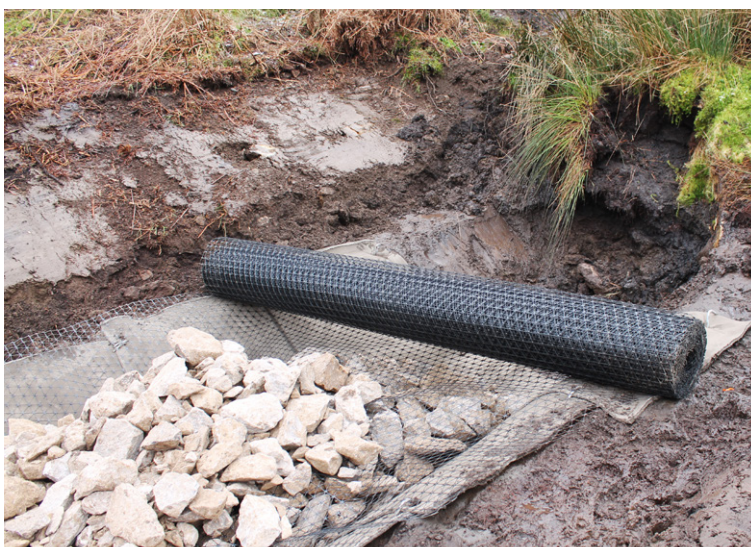
*Second aggregate layer applied on top of geogrid*

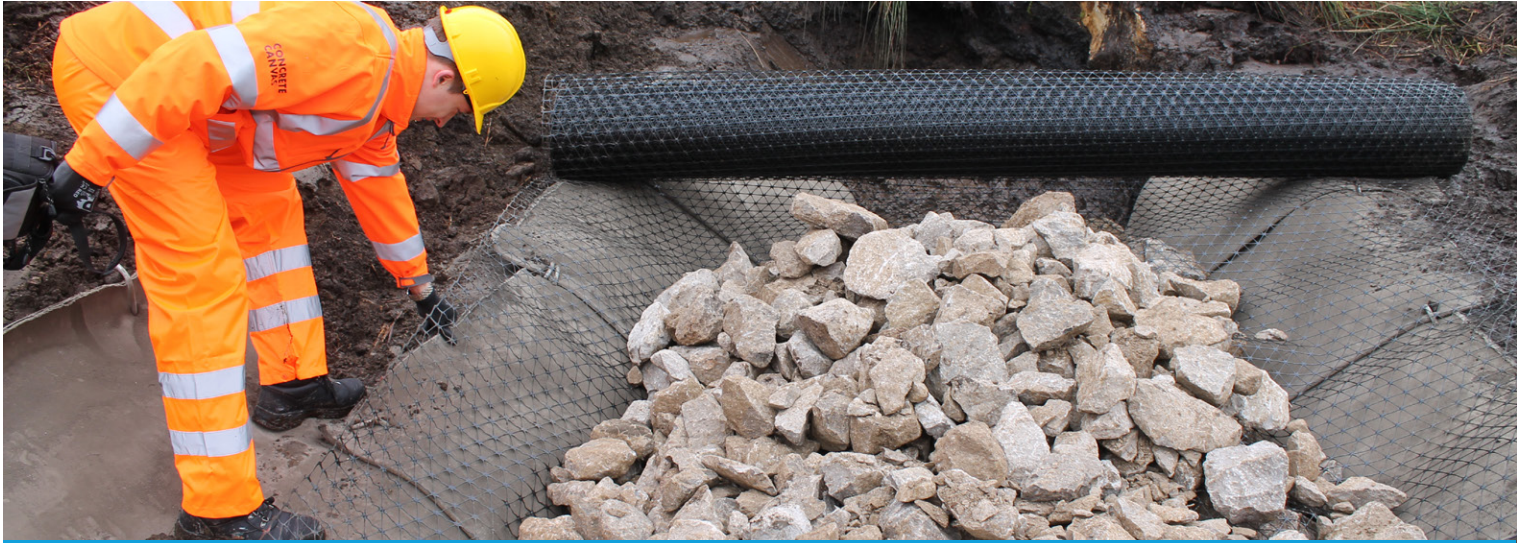
*Inspecting second layer aggregate layer and geogrid*

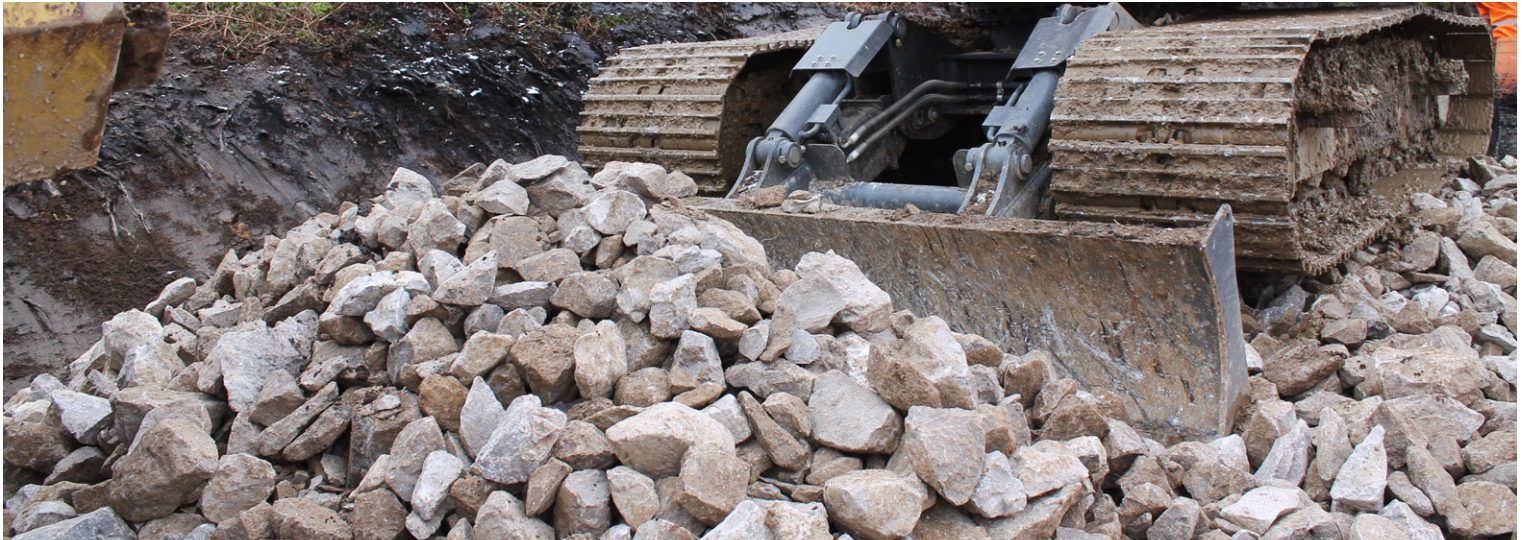
*Applying top surface aggregate layer*

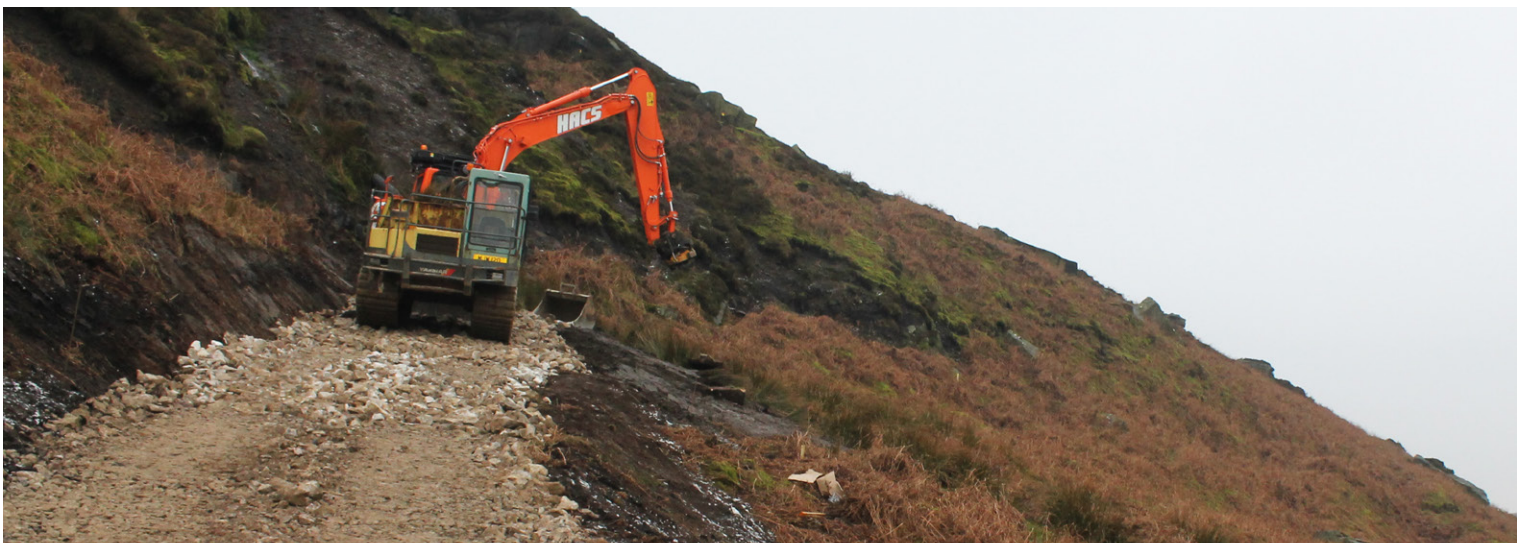
*Applying top surface layers and compacting access road*

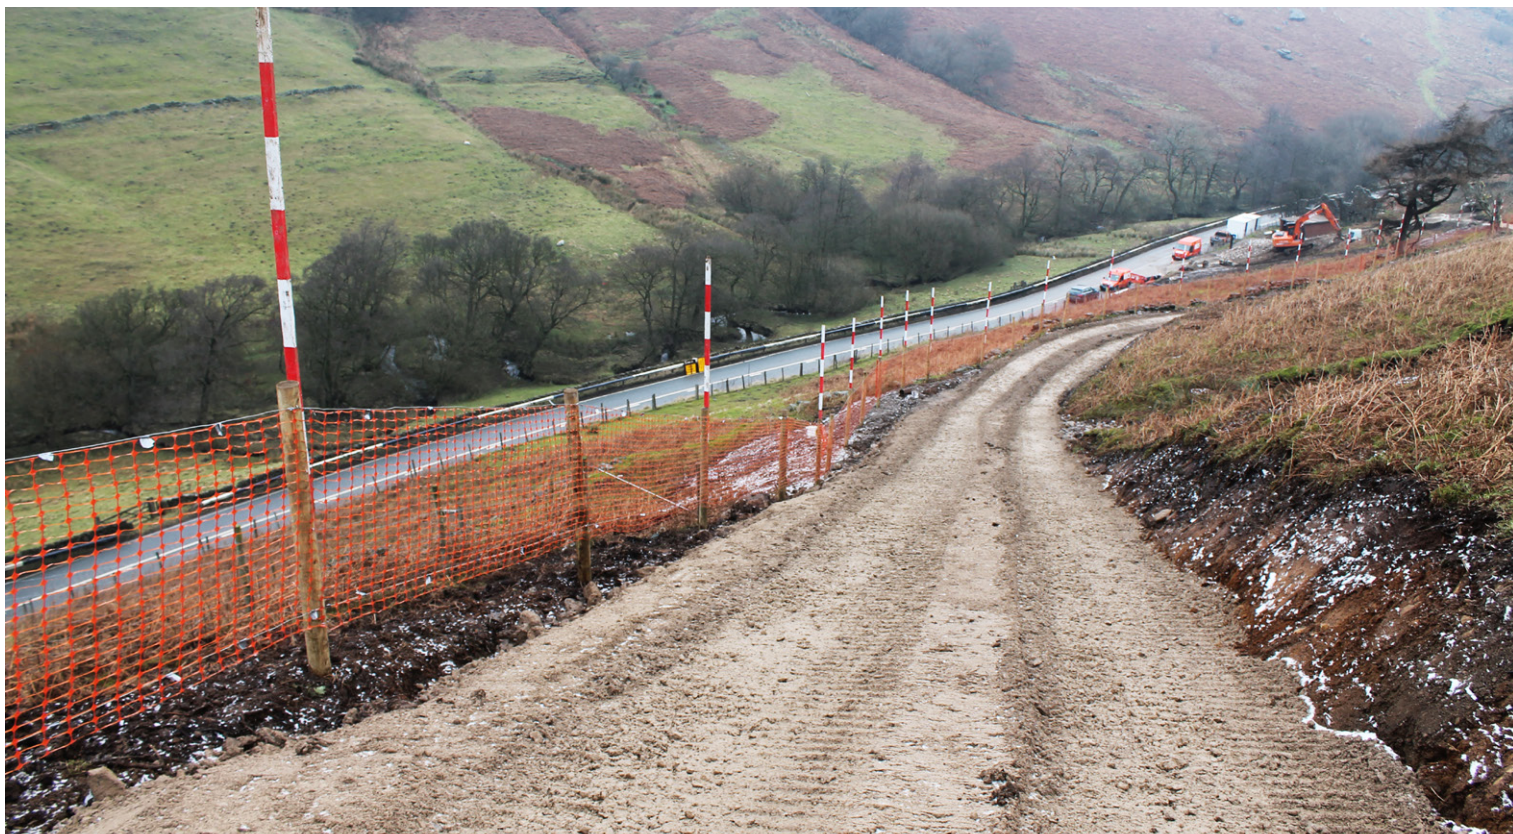
*Completed aggregate drainage channel overtopped with temporary access road*

Part of the temporary drainage improvements involved creating a 400m long aggregate drain underneath a compacted temporary access road in the northern bank of the roadside.
