CC8™ and CC13™ Bulk
& Batched Rolls

Glenridding, Ullswater,
Cumbria

Re-lining of an existing
channel on top of a
tailings dam, using
Type II & Type III GCCMs
to prevent severe flooding
& storm damage.

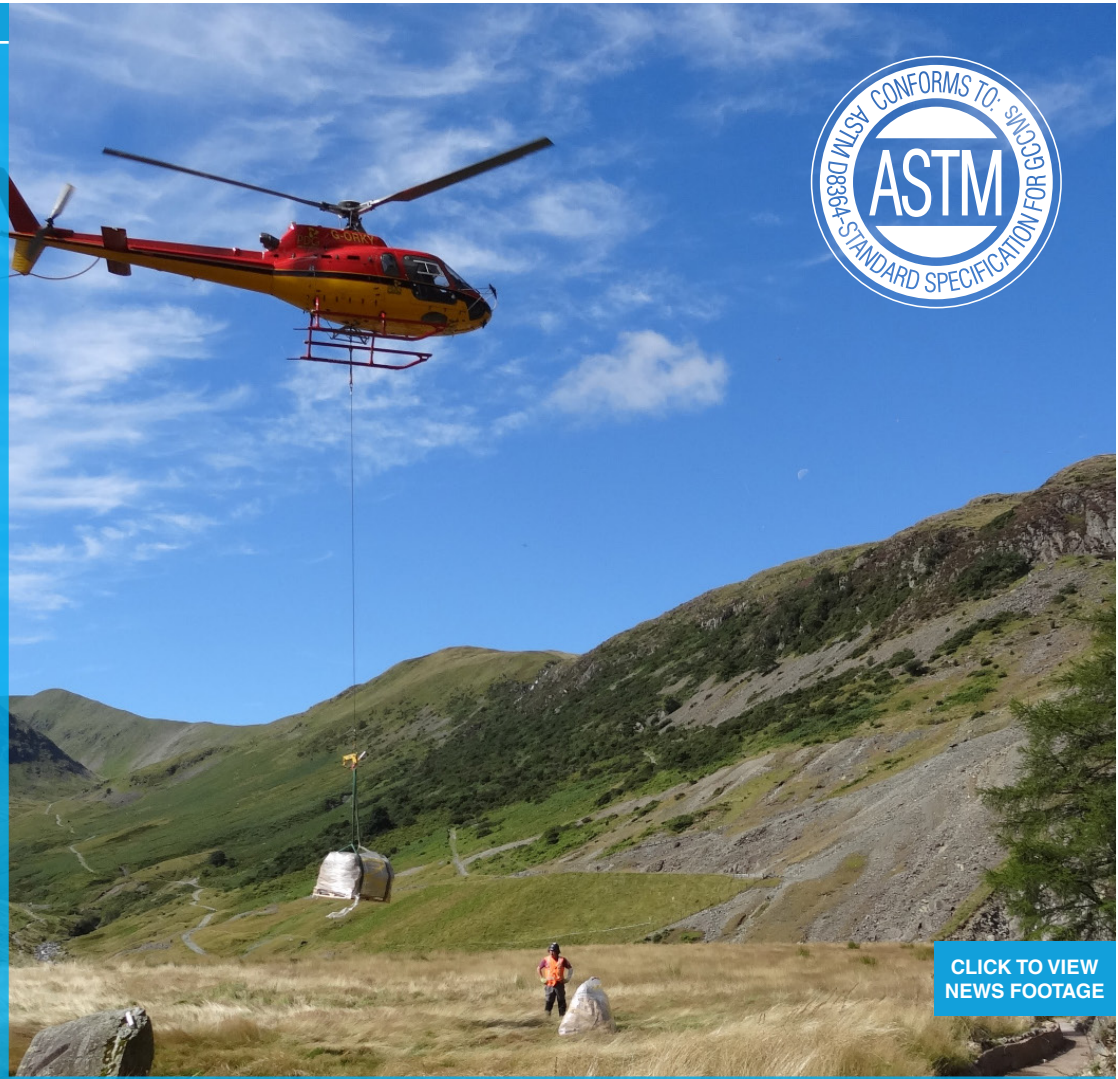
Batch & Bulk Rolls of Type I & Type II Concrete Canvas® being delivered via a commercial helicopter

The mine site is on a steep hillside 2 miles up a remote track, presenting a number of logistical issues in regards to delivery. With no possibility of off-loading on site, the project manager organised delivery of palletised material by HIAB wagon to a point 500m away, with pallets then being flown into position by commercial helicopter. The rolls of CC8™ were batched to specific lengths to accommodate the different profile the channel takes along its 200 metre length. Concrete Canvas Ltd ensured that the hand-portable batch rolls were all labelled correctly and palletised to the customers' requirements into loads that each weighed less than 950kg, allowing them to be subsequently lifted and accurately positioned by helicopter. Getting the logistics correct was key to enabling a rapid delivery and the success of the project. With no wheeled or tracked machinery able to access the site, correctly positioning the pallets by helicopter meant the volunteer Army workforce was then able to focus on the installation of CC in the channel rather than waste time moving materials by hand.

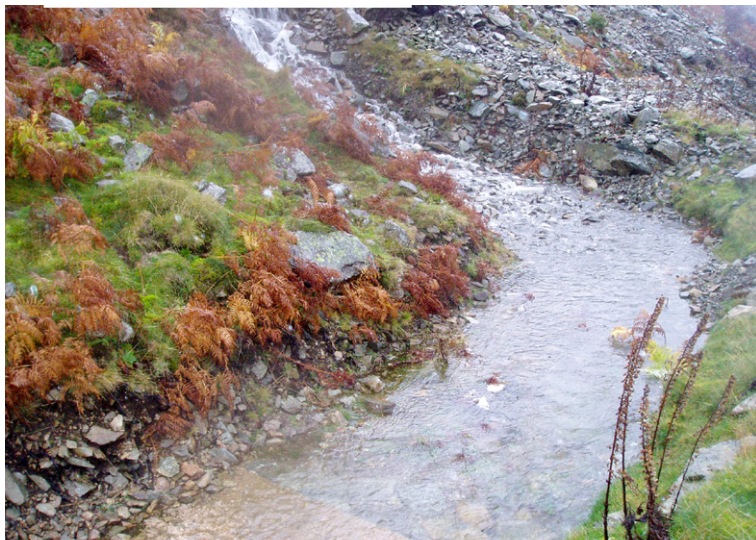
The channel prior to remediation

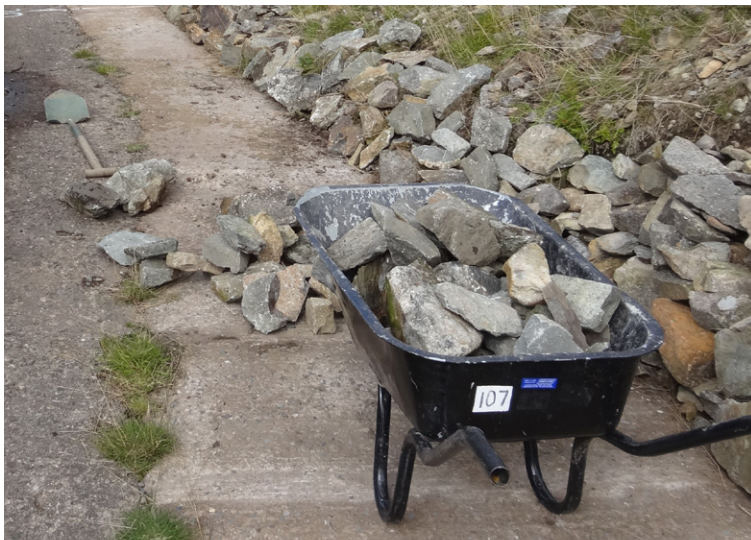
Large stones and debris were cleared to be re-used after CC installation

Removal of some of the dry stone walls and overburden on one side of the channel took place prior to installation. The CC was trimmed using knives, and anchored to the ground using steel pegs and heavy rocks. The overlaps were jointed using stainless steel screws at 20cm centres. An army issue portable temporary 10,000 litre reservoir was used for hydration. In total, 837m² of CC8™ & 128m² of CC13™ was installed for this project.

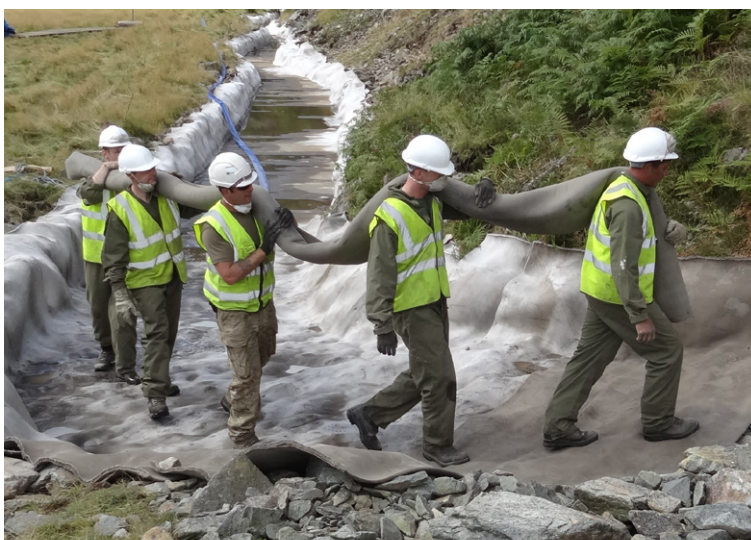
The site was extremely difficult to access, all work was carried out by hand

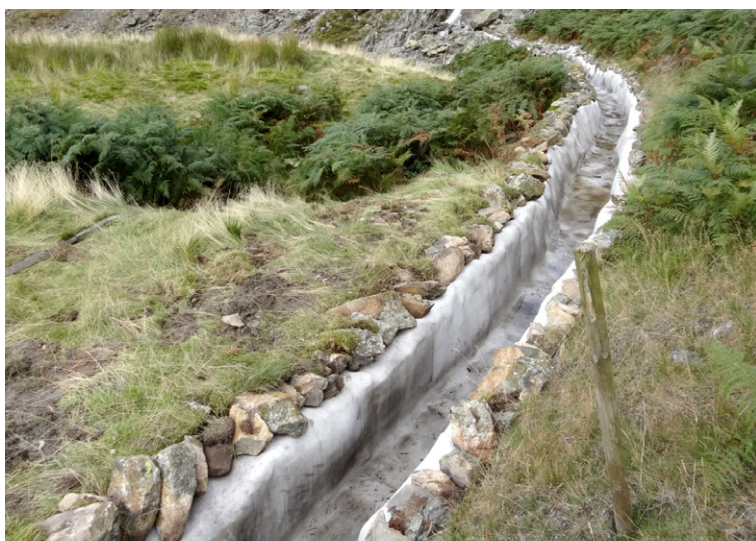
The completed lined channel at Glenridding, Ullswater

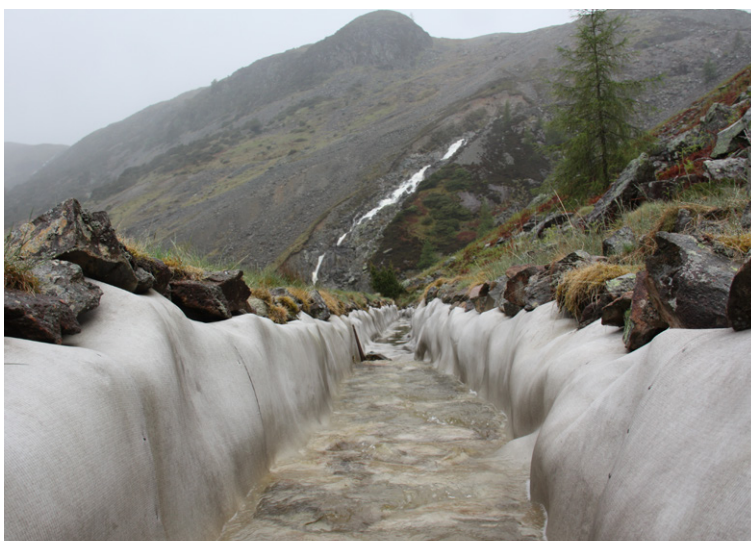
Two years later - May 2017 - the channel at Glenridding

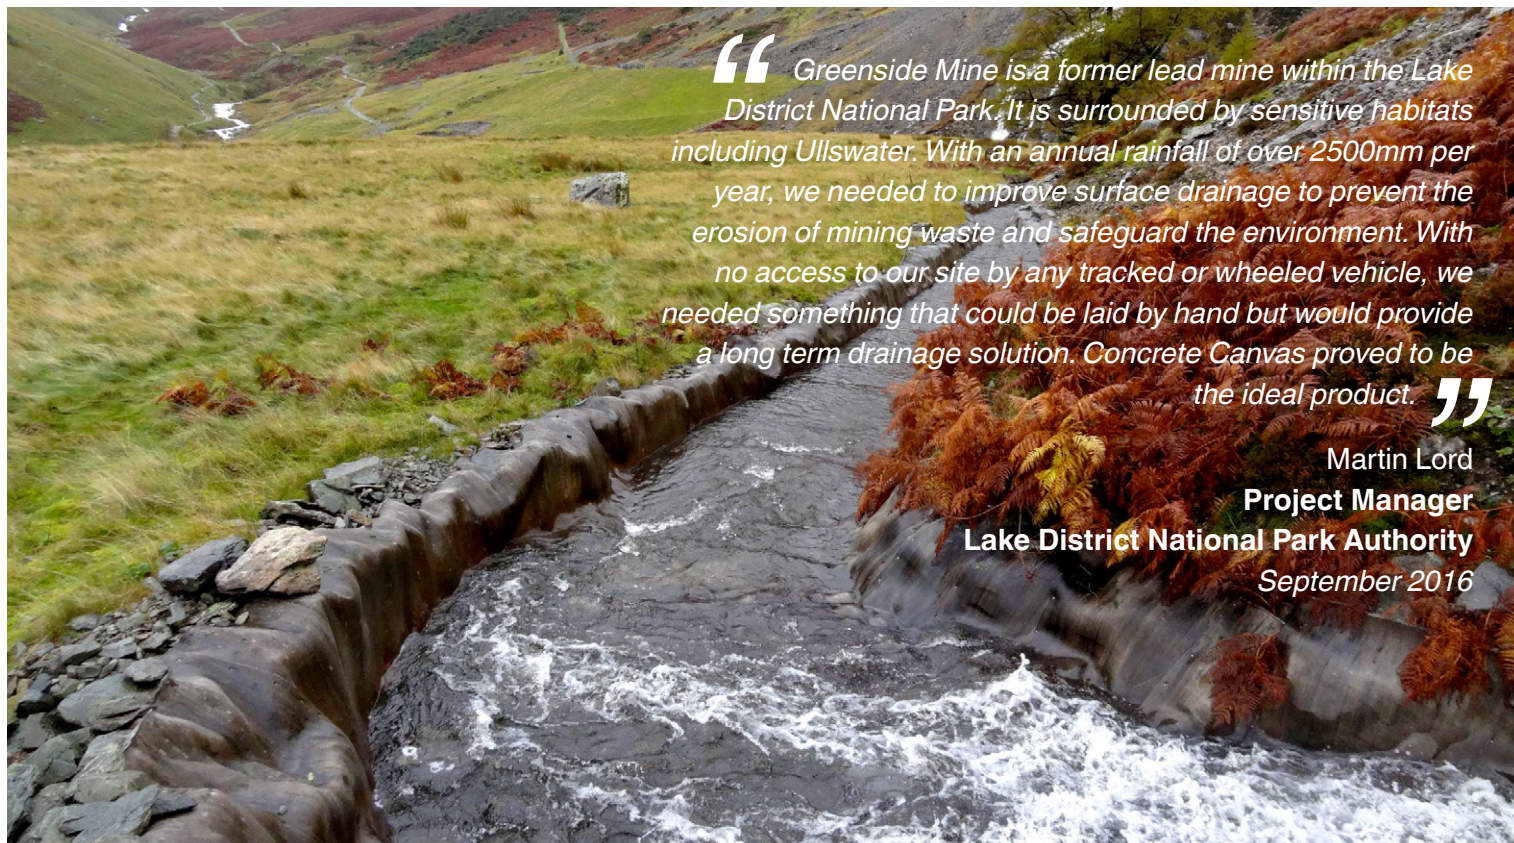
The installation five years later - October 2021 - CC is BBA certified with durability in excess of 120 years when used in erosion control applications.

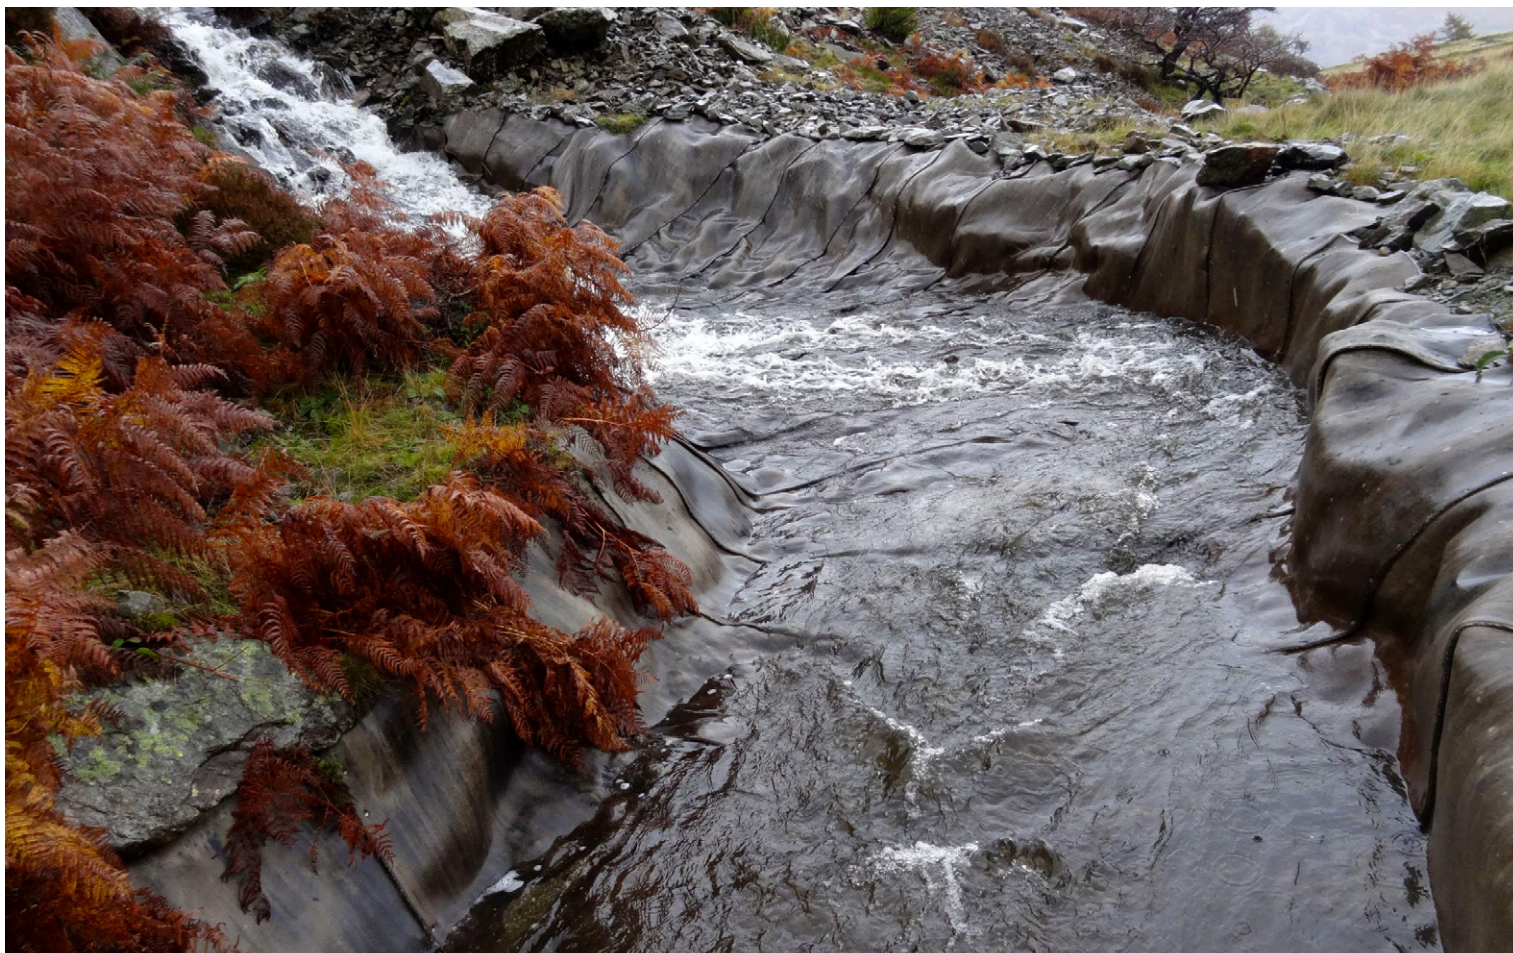
The installation five years later - with an average rainfall of over 2500mm per year, 400mm fell in just six days at the end of October 2021.

“The concrete canvas is still working as effectively as when it was installed. We’ve had about half a dozen really heavy rainfall events since it went in and on every occasion the runoff from the hillside above the tailings dam has been intercepted and safely conveyed directly into the beck without causing any erosion of mine material. At the end of October 2021 the site received 400mm of rainfall in six days, the wettest week since Storm Desmond in December 2015. The Concrete Canvas performed exactly as it needed to and there was no erosion of any mine material.”
