CC8™ Bulk Rolls

Angus, Scotland, UK

QTS Rail

100 linear metre Network Rail drainage channel, lined with CC8™ and observed over a 5 year period. The channel, with no maintenance and after years of sustained challenging weather, was clear of root growing vegetation.

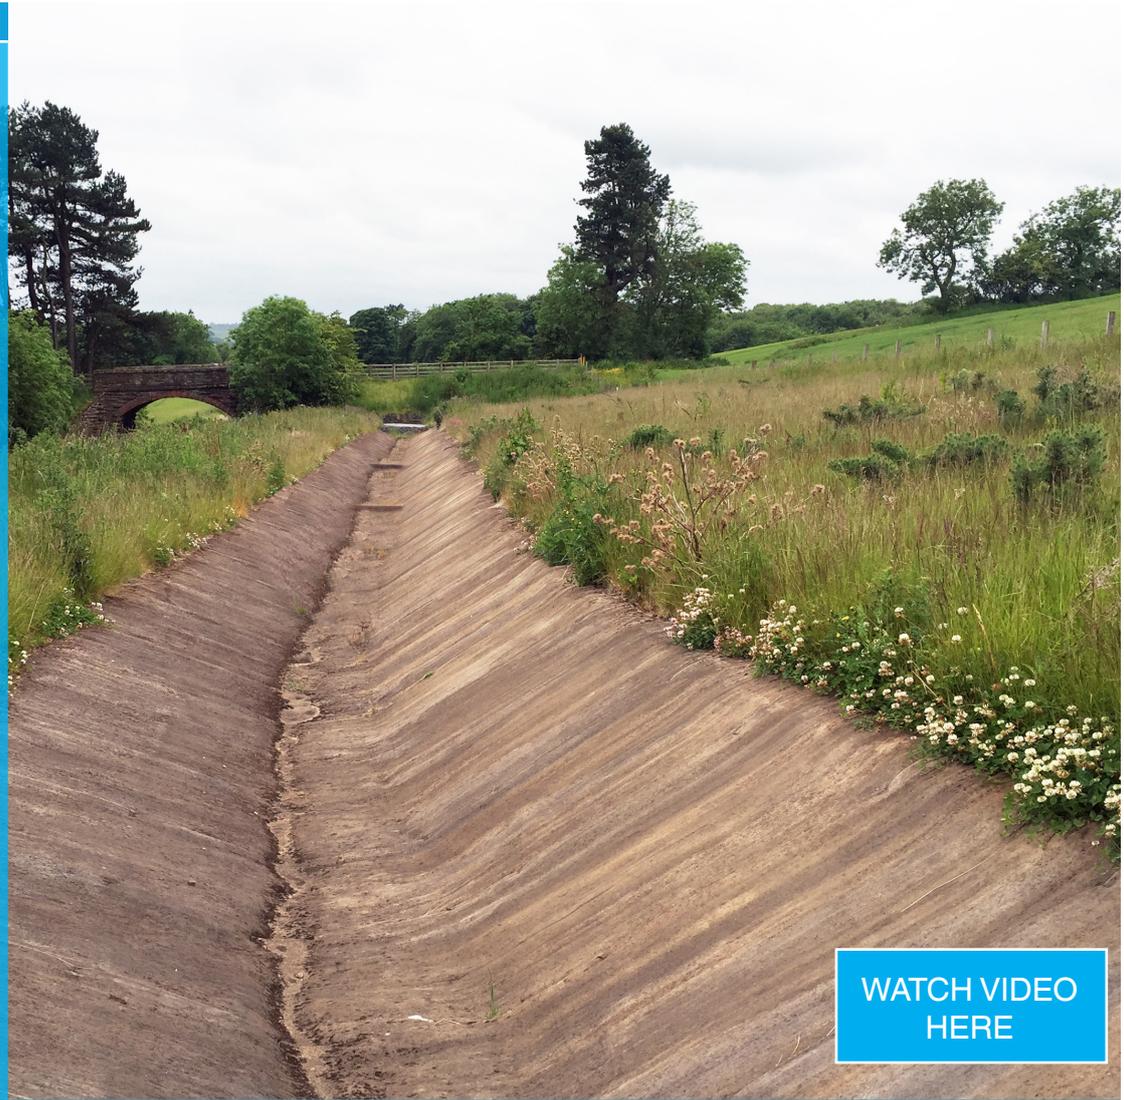
CC lined drainage channel, unmaintained for 5 years showing little vegetation growth

A site inspection in February 2016 showed that after nearly five years without maintenance of any sort, the lined channels were performing exactly as originally designed and the CC had provided a long term and hard wearing erosion protection to the ditch invert which showed no signs of degradation. Small sections of the channel immediately behind the silt trap baffles had a small degree of vegetation growth, which although not required, were easily cleared using basic hand excavation in a matter of minutes. The installation is now being used as a model example for CC maintenance.

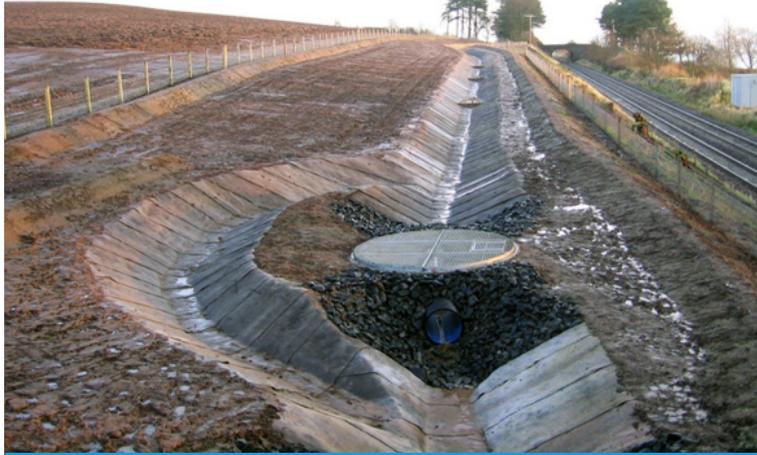
View of installation in 2011

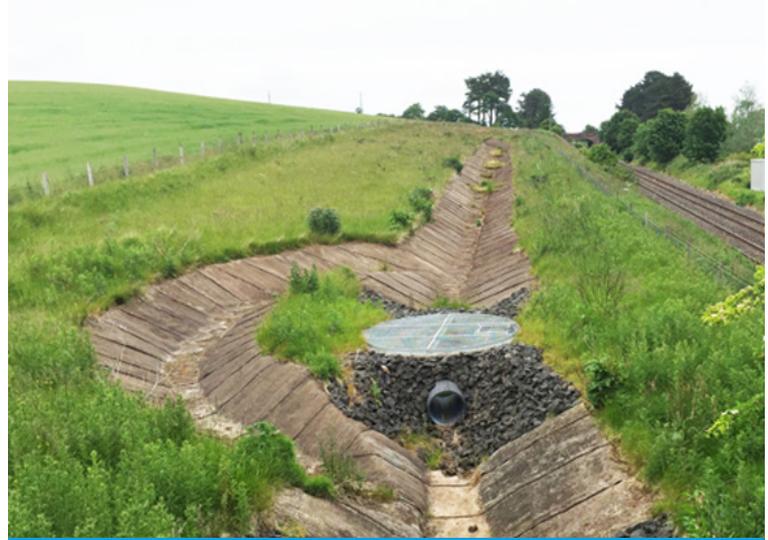
View of installation in 2015

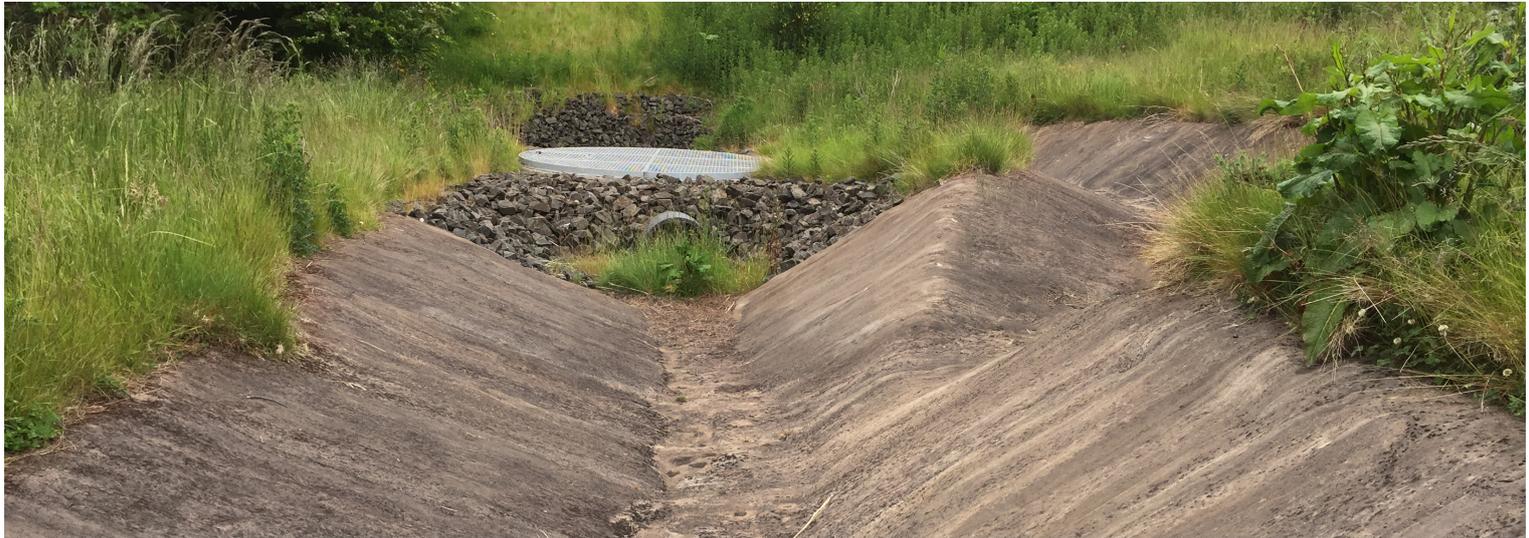
Widest section of ditch, showing overspill route and silt trap entry

The channel varied in width from 3-6m in sections and by deploying CC in transverse layers across the ditch, QTS were able to cut the material to the exact lengths required greatly reducing wastage. The channel terminated into a large silt trap with an adjoining overflow bypass section. Unlike with rigid plastic liners or concrete precast sections, CC was able to accommodate the undulating profiles, intersections and steep batters of the various sections of the channel.

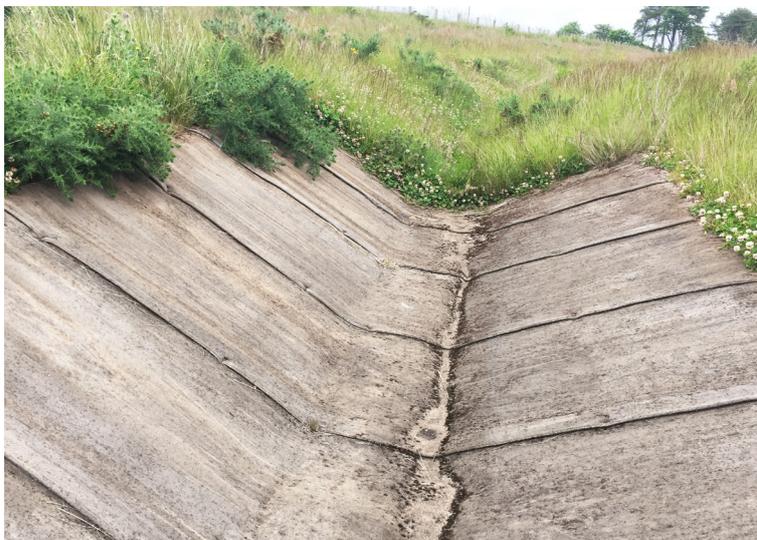
Start of CC lined section, showing vegetation growth on unlined sections

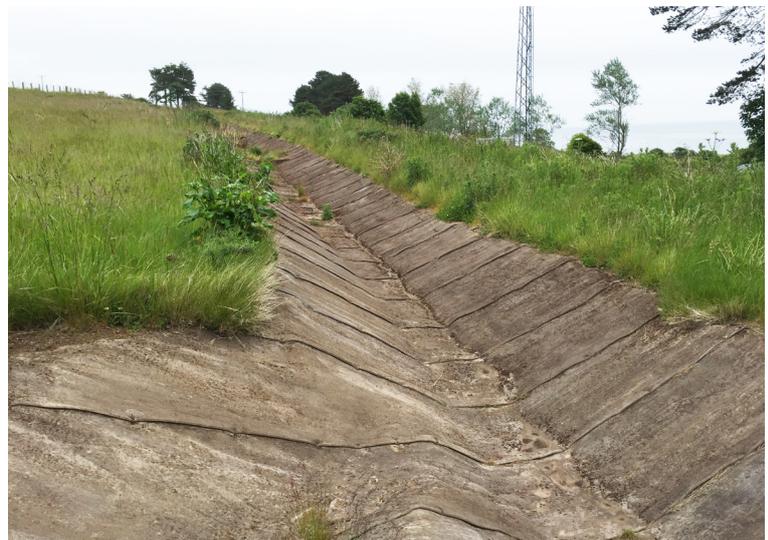
CC lined junction

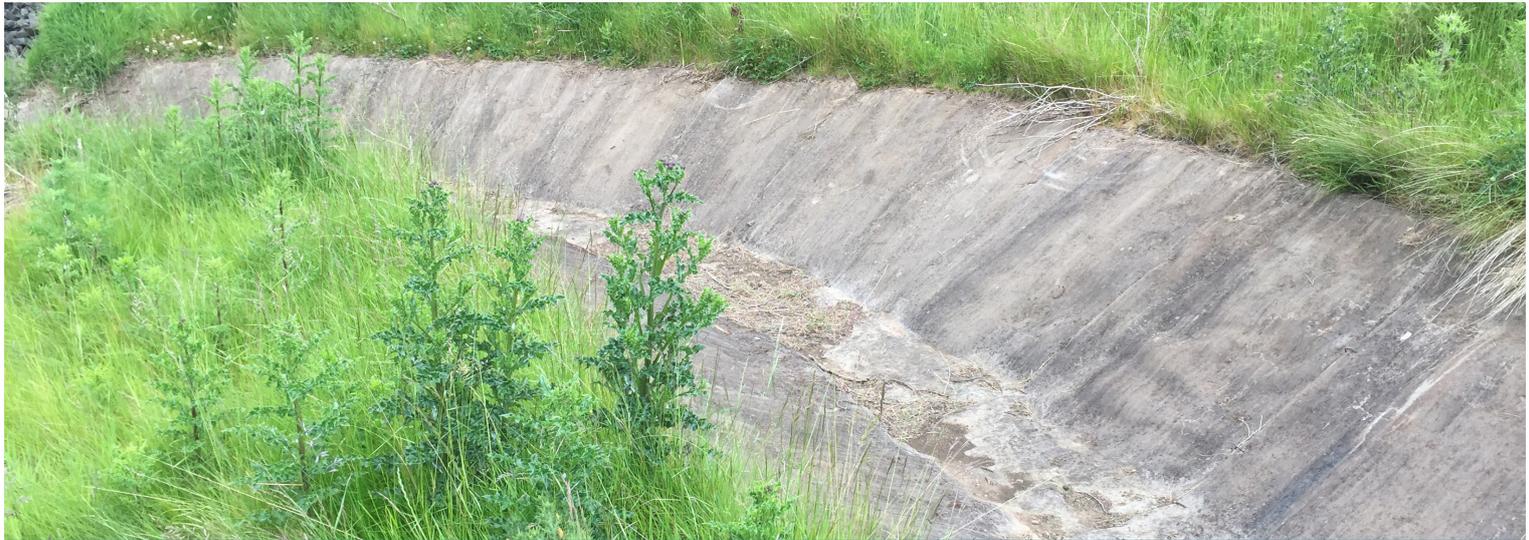
*Overspill CC lined ditch section*

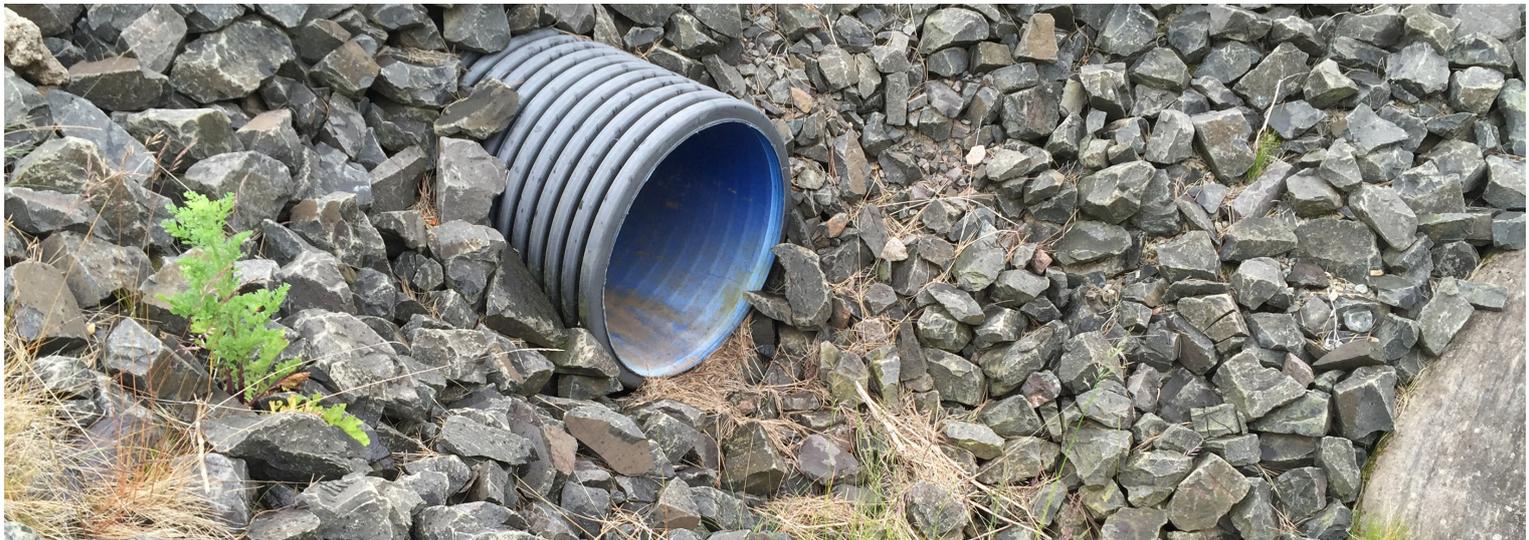
*CC lined channel terminating at silt trap outlet*

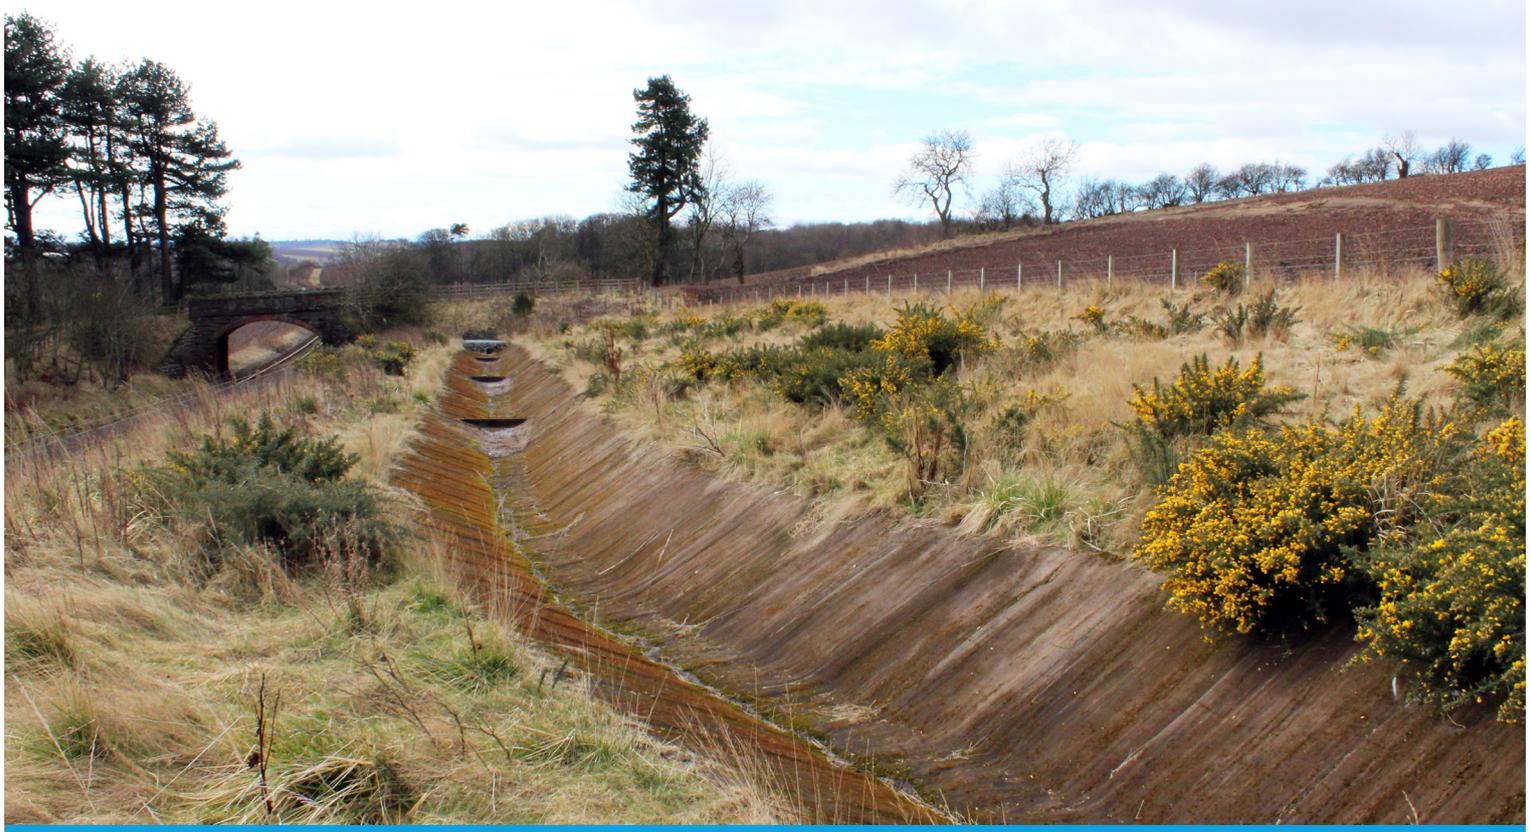
Completed southern section of lined channel, 5 years after installation (2016)
