CC8™ Bulk Rolls

Undisclosed, UK

Collins Earthwork

CC8™ was used to provide a drainage channel around the perimeter of pads at a mine to manage rain water runoff from drilling platforms.

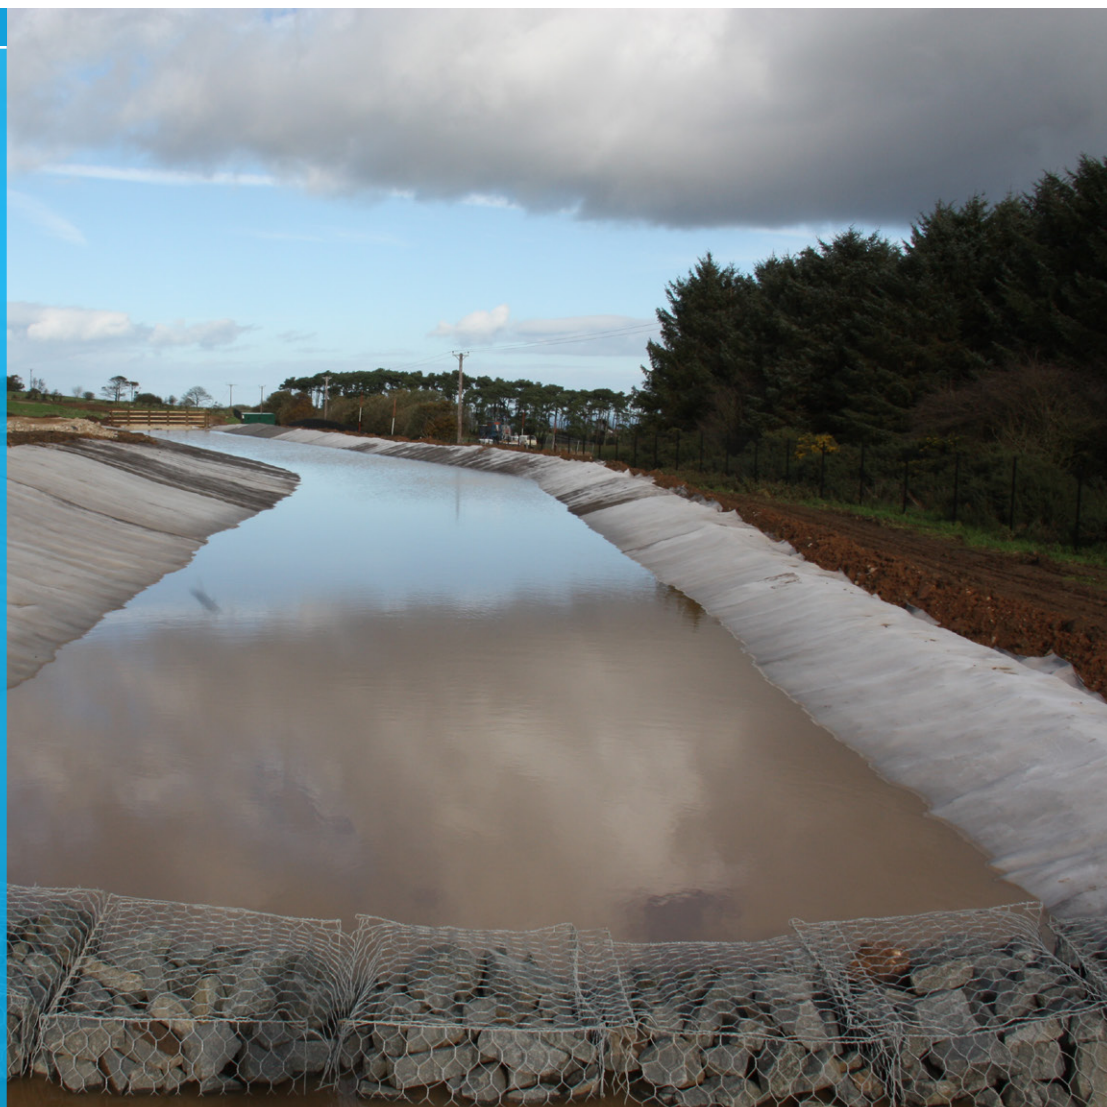
Completed section of channel

In August 2017, Concrete Canvas® GCCM\* (CC) was used to provide a drainage channel at a mine in the UK.

The channel was created around the perimeter of the North, South and Lower pads of the site, with the purpose of managing rain water runoff from the drilling platforms. The works were carried out by Collins Earthwork.

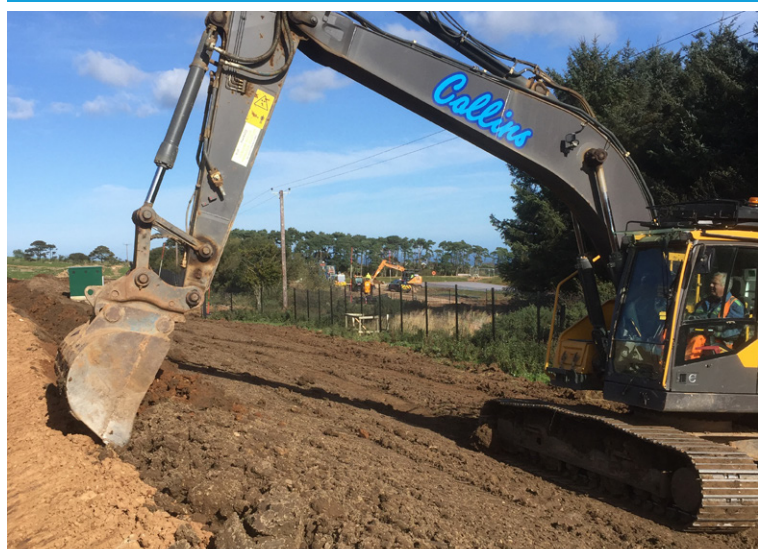
Collins carrying out ground works using a digger

Prior to installation, a huge amount of work was done to profile the channels in rocky ground for this area, while on the south and lower pads, the contractor used a lime agent mixed into the soil dug from site to help create an even channel profile. Once the ground preparation had been completed, bulk rolls of CC8™ were delivered to the site.

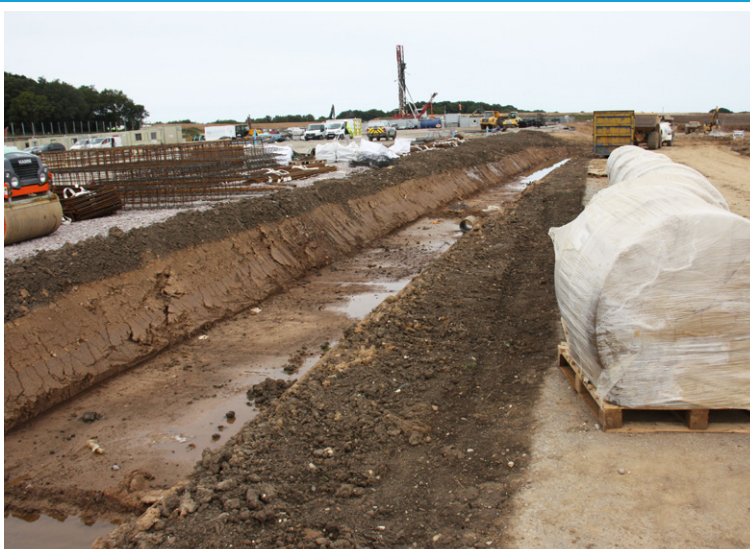
Bulk rolls of CC8™ were delivered to site prior to installation

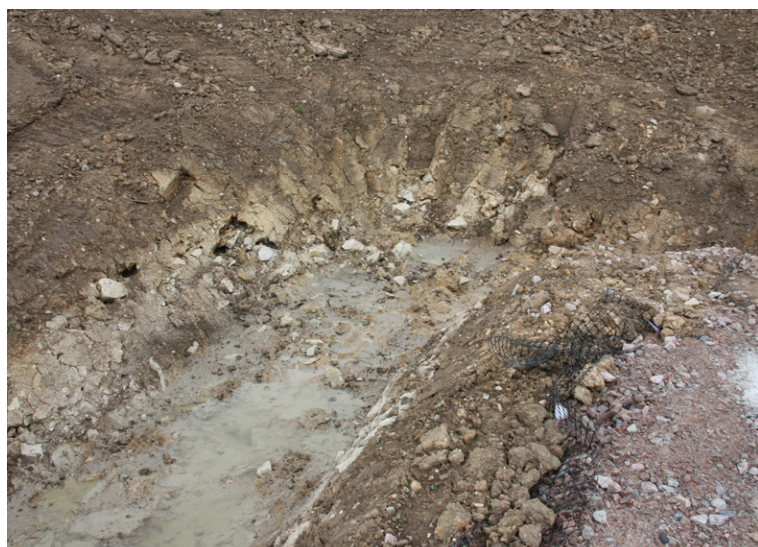
Installation began at the top right corner of North pad

Installation began on the right top right corner of the North pad. The CC was mounted onto a spreader beam hung from a crane and unrolled across the channel's profile, cut to length using hand tools and secured in anchor trenches using ground pegs. Additional layers of CC were laid with 100mm overlaps which were hydrated prior to being fixed at 200mm intervals, approximately 20-50mm from the edge of the material, using stainless steel screws and an electric screwdriver.

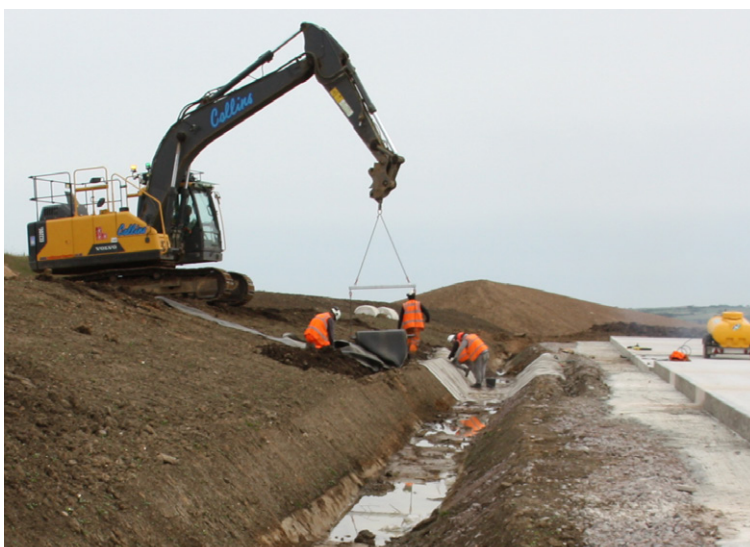
Bulk rolls of CC were mounted onto a spreader beam for installation

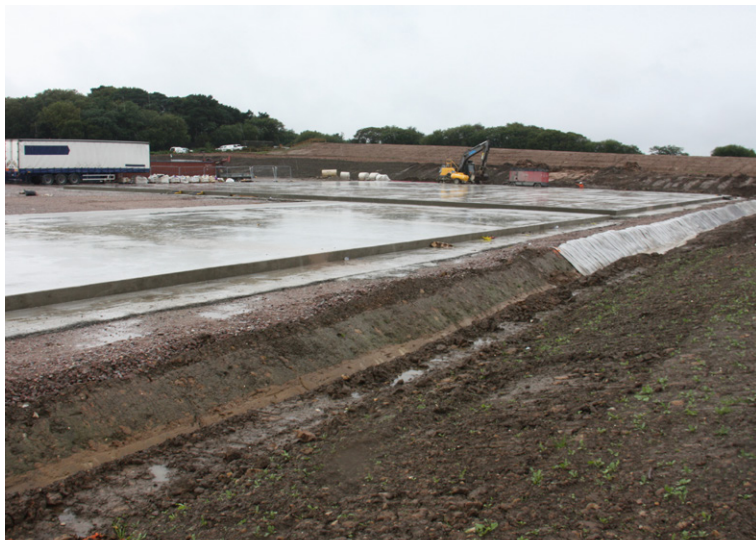
*CC was laid transversely*

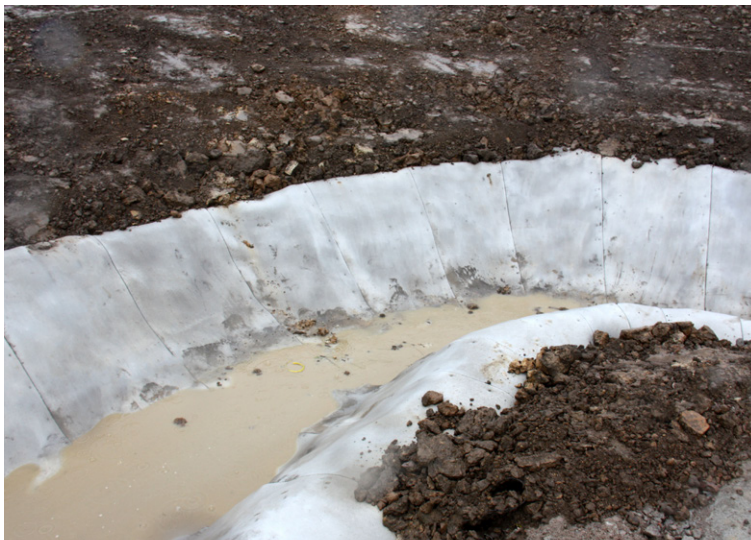
*Top right corner of North pad following installation*

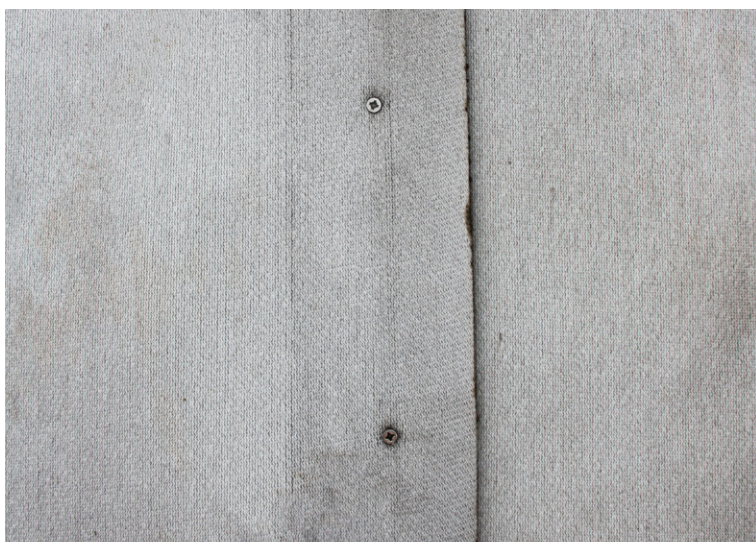
*Stainless steel screws were used to fix overlaps*

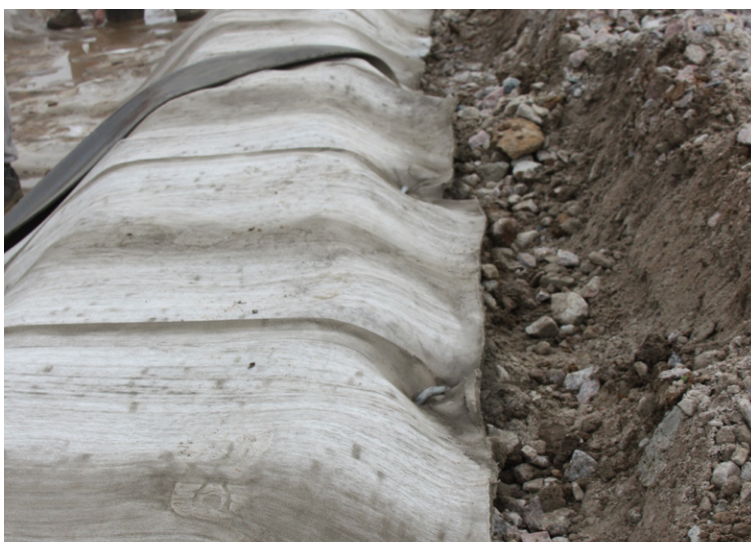
*Edges of CC were secured in anchor trenches using ground*

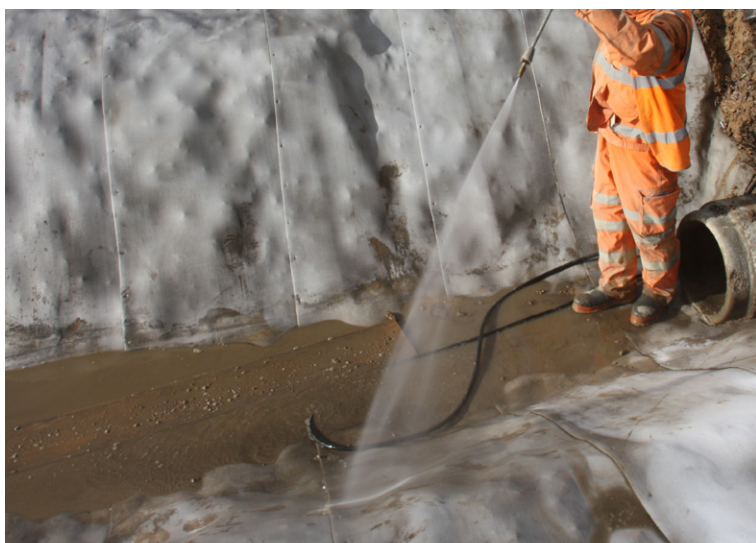
*CC was hydrated following installation*

Once the installation process was completed, the CC was hydrated and the anchor trenches backfilled to bury the edges of the material in order to prevent ingress and provide a neat termination.

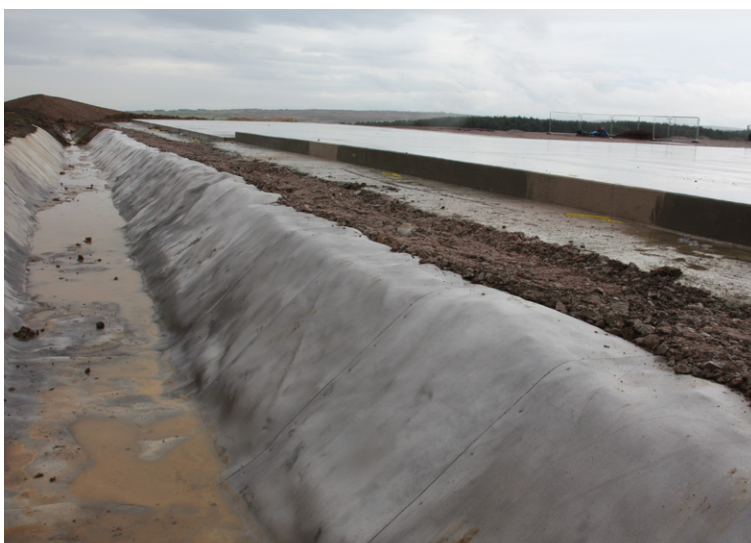
*Anchor trenches were backfilled to prevent ingress*

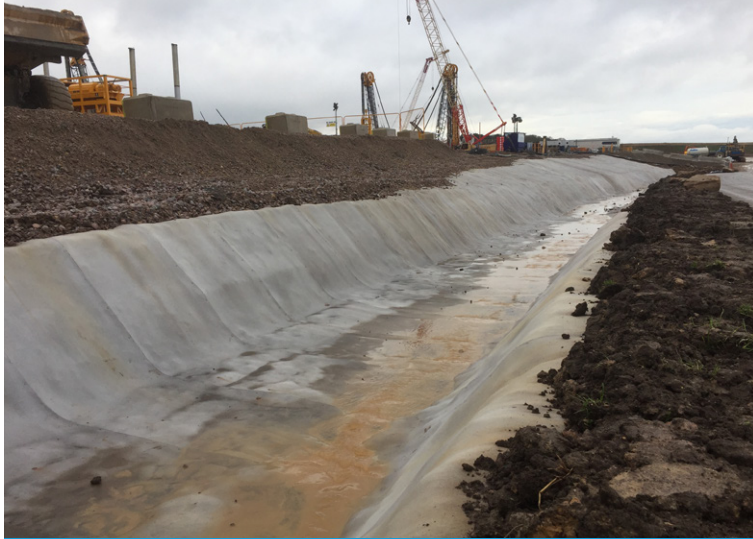
*Completed channel section at South pad*

Once work on the North pad was completed, installation on the South pad was carried out following the same process. The project was then completed on a slope and adjoining channel between the north pad and Lower pad, which was extended into a basin-like section, and then away from the site. Each of these sections were lined or protected using CC, with overlaps created so as to face the direction of waterflow. As before, the overlaps were hydrated, then fixed using screws, and edges of the material secured in the anchor trenches using ground pegs before the exposed material was hydrated.

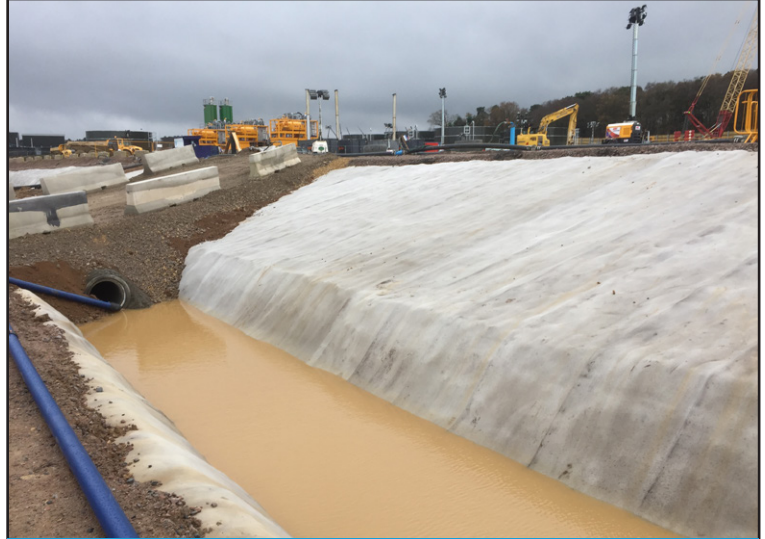
*South pad termination detail*

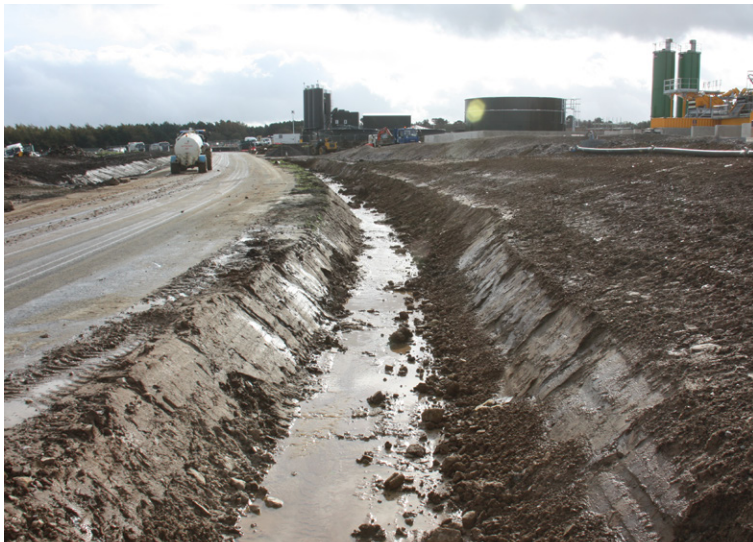
*Slope and adjoining channel between North and Lower pads*

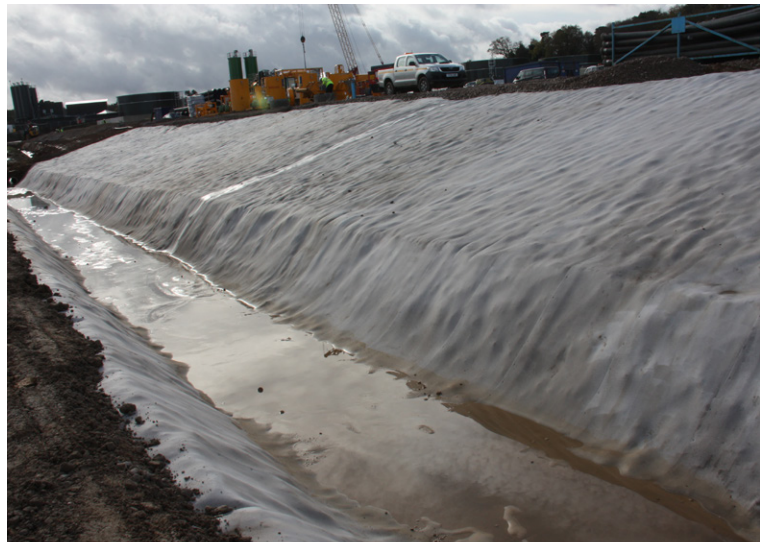
*CC installed on slope and channel between North and Lower pads*

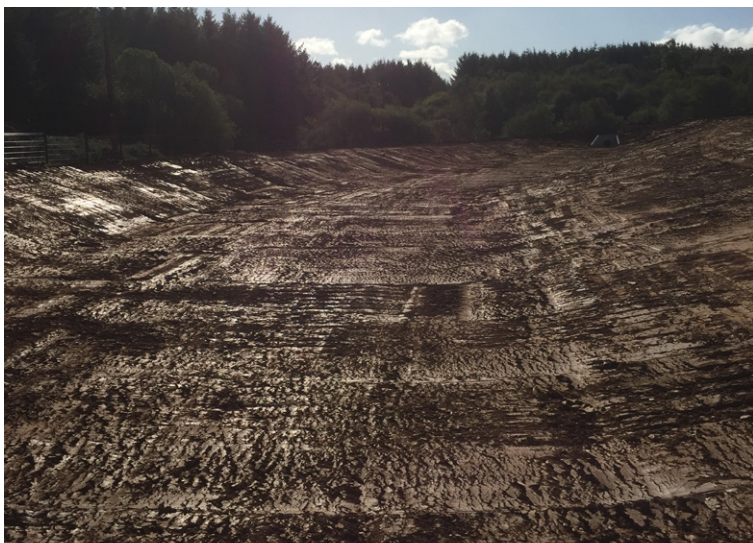
*Basin section of channel*

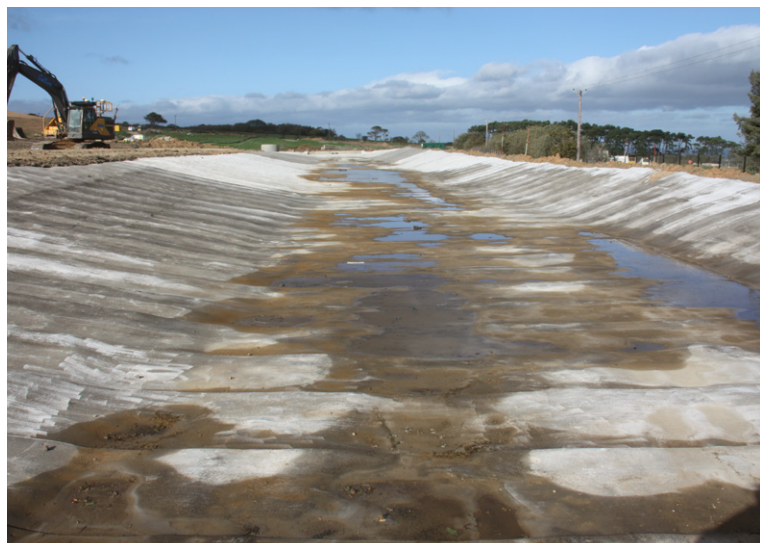
*Completed basin section*

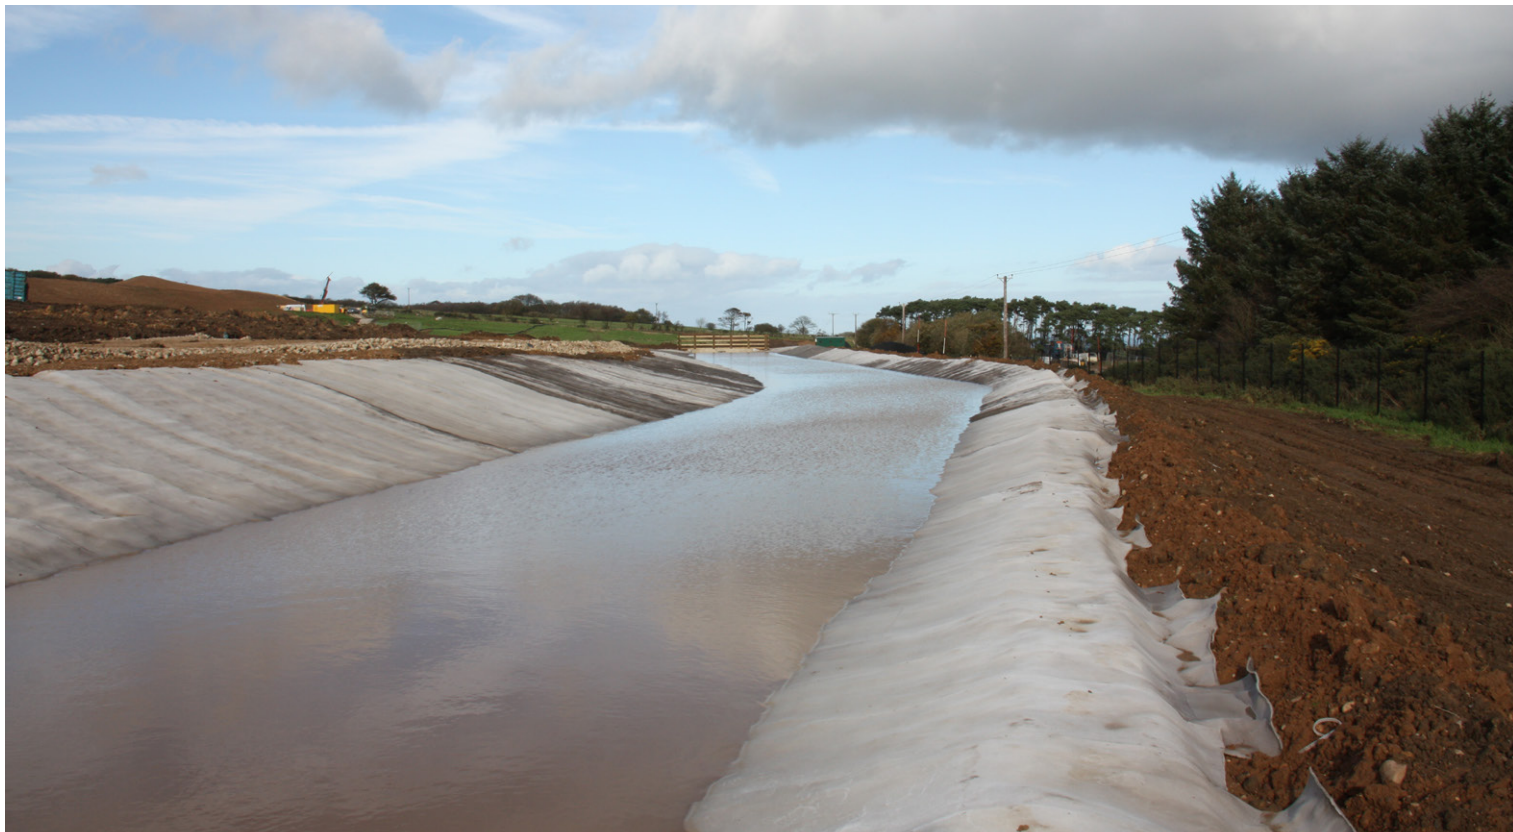
*Completed basin section*
