CC13™ Bulk Rolls

Ulceby, Lincolnshire, UK

CC13™ was installed as a channel lining and erosion protection solution above a gas pipeline for Cadent Gas

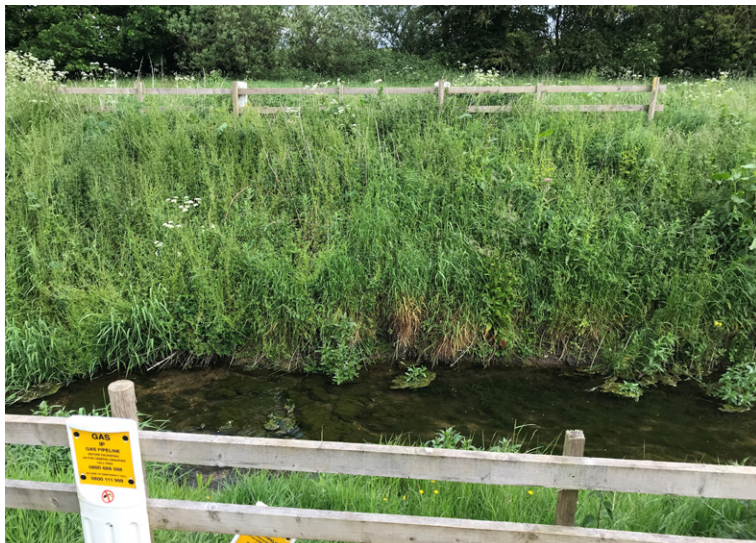
Site prior to works

The project was carried out as part of the shallow cover gas pipeline works that have been running since 2016. The section of the channel which required lining was overgrown with weeds. As a result, prior to installation, the vegetation had to be removed and the banks graded to provide an even, formalised and smooth surface on which to install the CC.

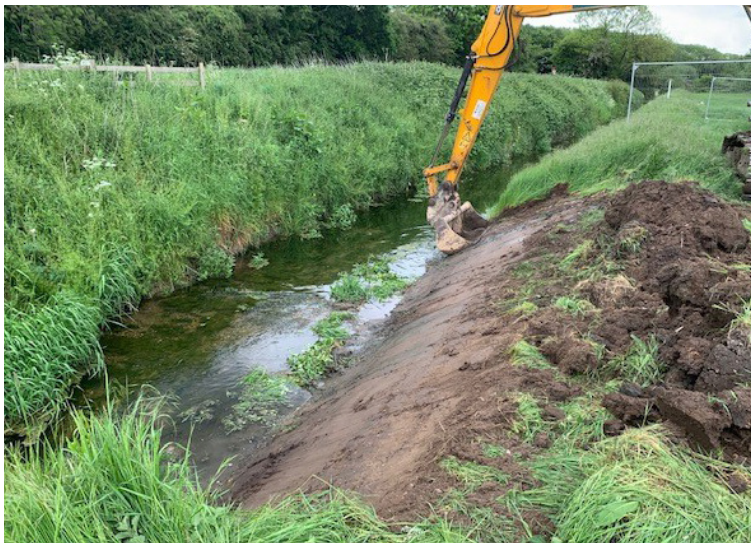
Grading of the channel banks

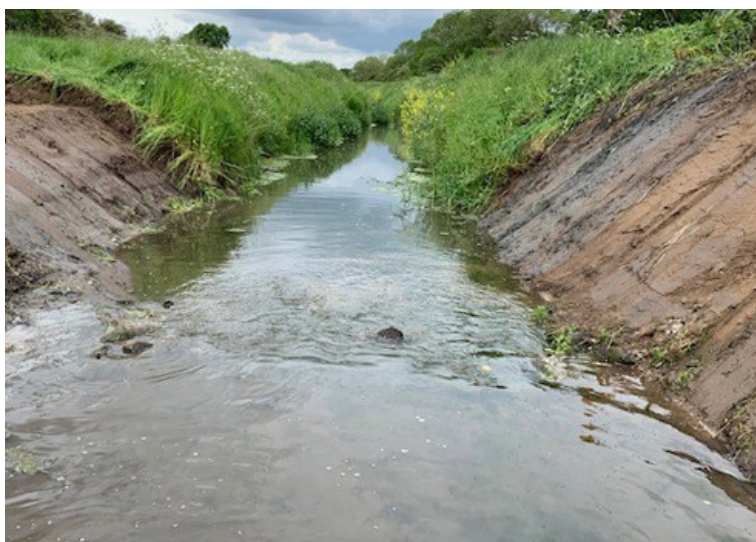
Channel following ground preparation

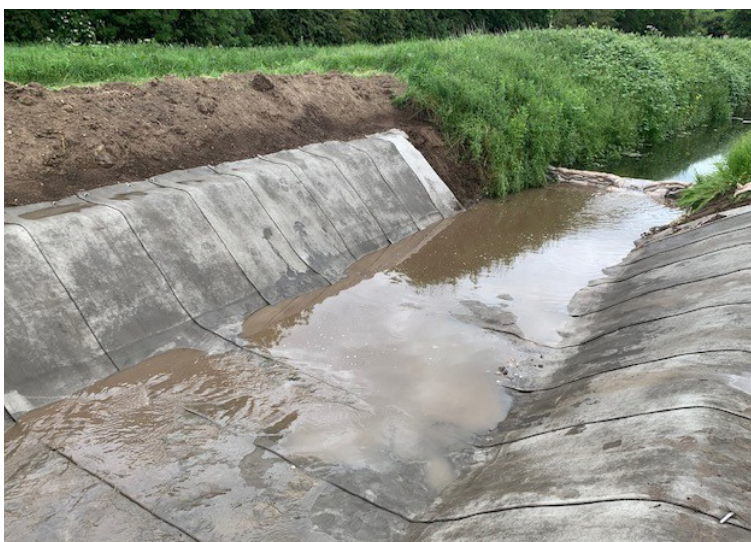
CC edges pinned within anchor trenches half way up the slopes

CC13™ was specified for the project and delivered to site in bulk rolls. The gas pipeline was identified in the invert of the channel, the CC was installed above with the leading and trailing edges of the material buried in anchor trenches that were dressed with hardcore after the installation of CC had taken place. The material was deployed from a plant-mounted spreader beam and laid transversely across the channel's profile, with perimeter edges terminated in anchor trenches around half-way up the banks of the channel and secured using GMS ground pegs. Overlapped layers of CC were jointed using stainless steel screws.

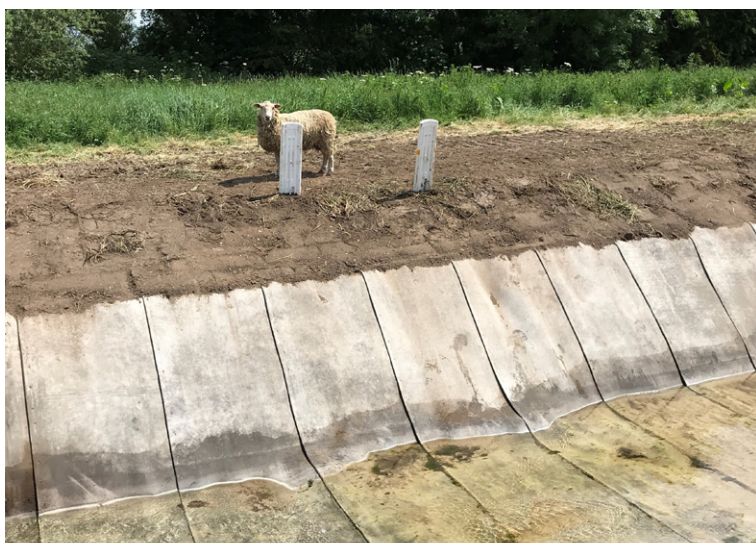
Anchor trenches backfilled following hydration

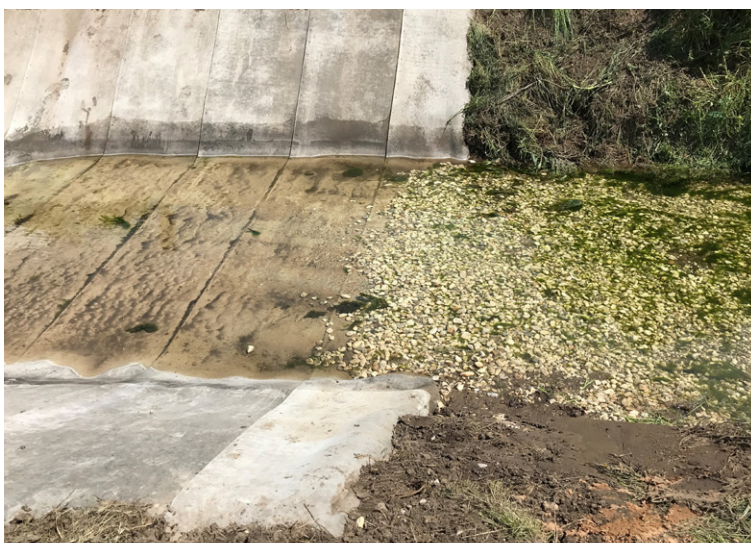
Termination of leading edge

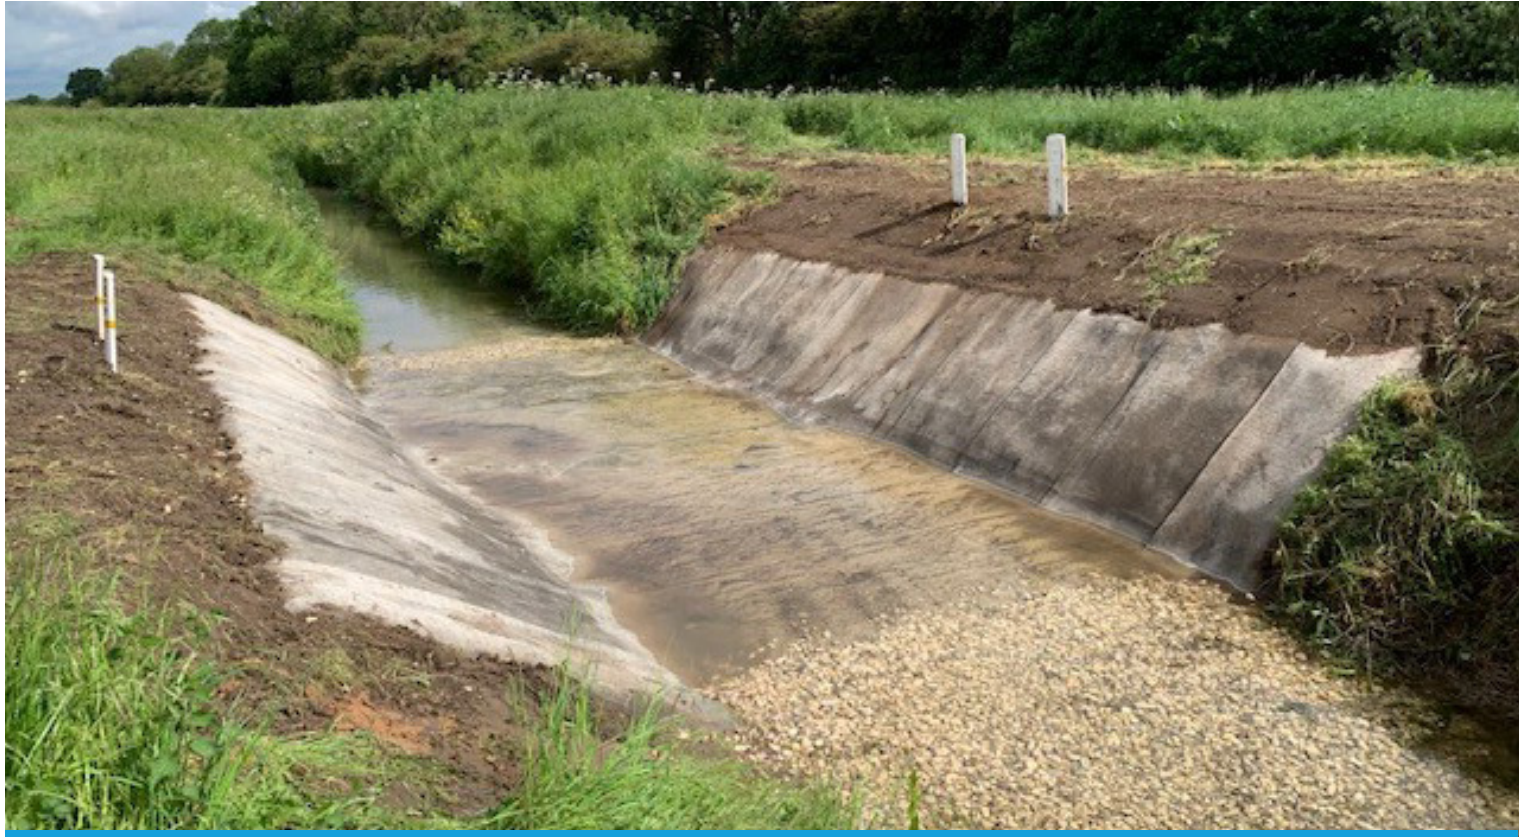
Completed channel lining installation for pipe protection

The scheme as a whole was completed in five days; the installation of 120m² of CC13™ was completed by a team of three in just two days. The client, Cadent Gas, was pleased with the outcome of the project.
