CCT2™ Bulk Rolls

Irish Rail Waterford
Plunkett Station,
Waterford City, Ireland

Installed to line a crest
drainage channel,
diverting water away to
prevent landslips and
rock falls caused by
saturation.

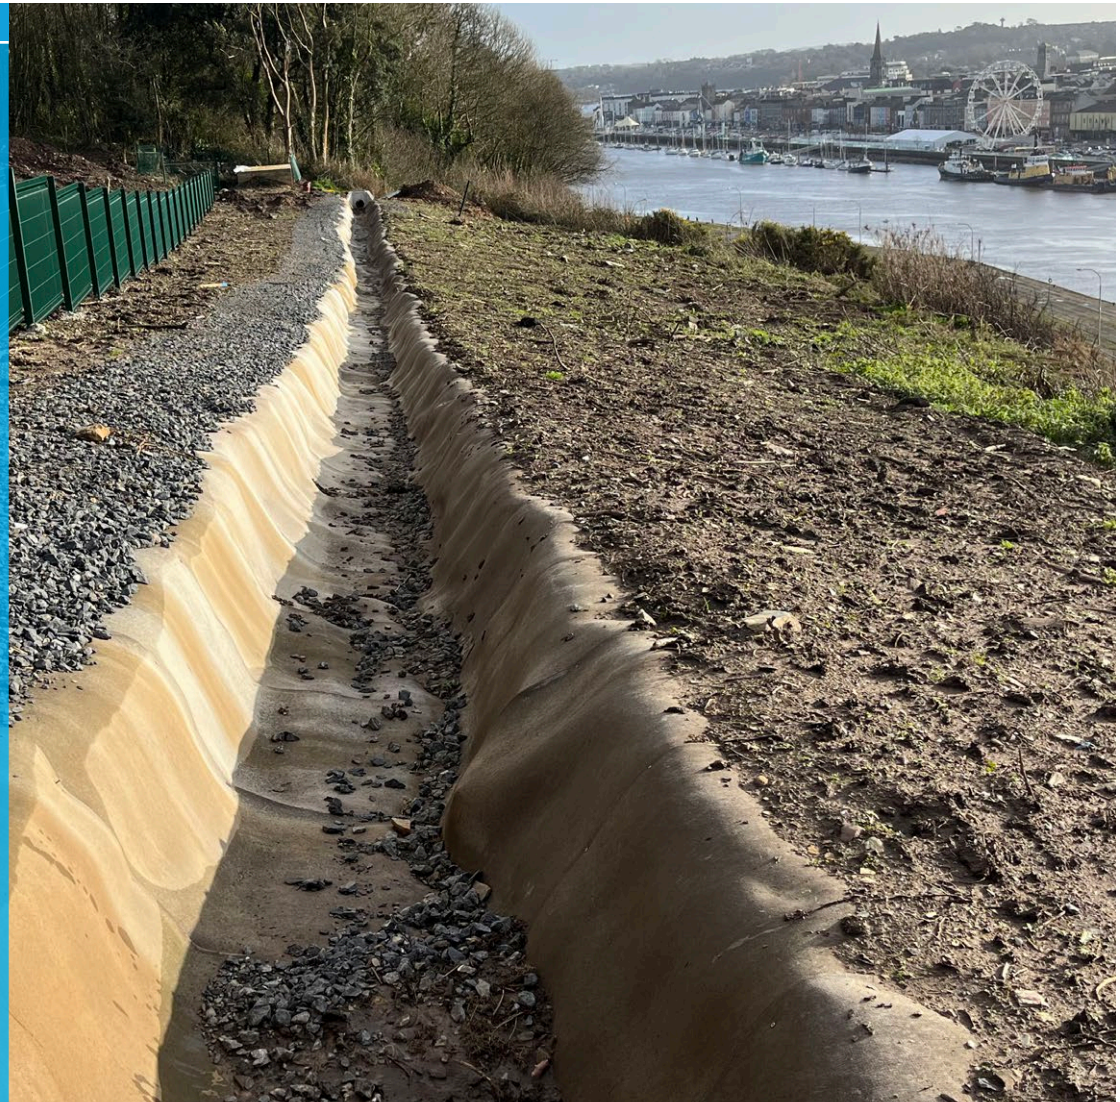
Completed Installation

The material was fully hydrated at the end of every shift with a hose from a 2000L water bowser. In total 250m² of CCT2™ was installed in 2 days with a team of five including the machine operator in a difficult to access location and inclement weather. By lining the channel with CCT2™, any future maintenance has been greatly reduced and the lined crest drainage channel will help manage the flow of water and prevent any slope failure in the future.

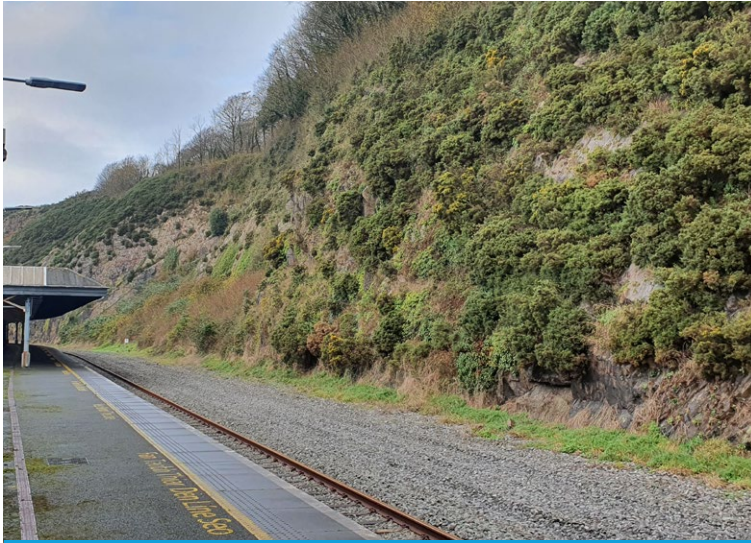
Plunkett Station rock face prior to works

Historically, a number of landslides have occurred along the extents of the rock face at Plunkett Station. Irish Rail track inspection records provide evidence of this with rockfall of varying size being recorded frequently over the past 50 years. In order to secure the safety of this railway line, it was deemed that approximately 400m of the rock cutting, located immediately adjacent to the line in the vicinity of the existing Plunkett Station, would require remedial works.

The remedial works, included rock face stabilisation and formation of a 100m long interceptor channel at the crest of the in order to divert water away from the rock face.

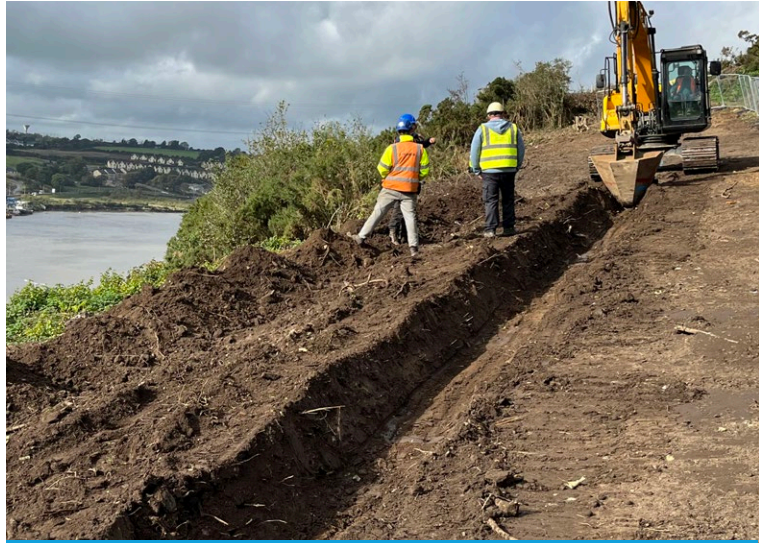
V-Bucket excavation

Prior to the installation of the CCT2™, Cumnor Construction Ltd cut a new open channel at the top of the slope using a 13-tonne excavator with a v-ditch bucket attached. The CCT2™ Bulk Rolls were delivered to site and deployed using a spreader beam mounted on tracked plant machinery.

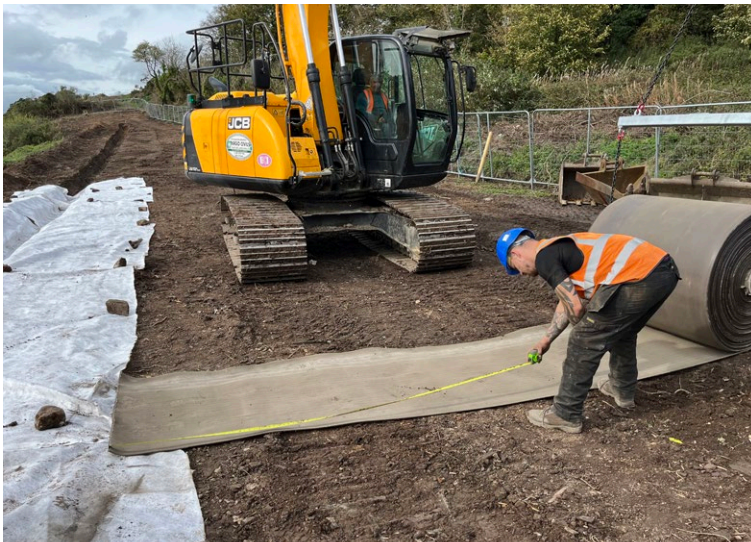
CCT2™ Measured prior to cutting

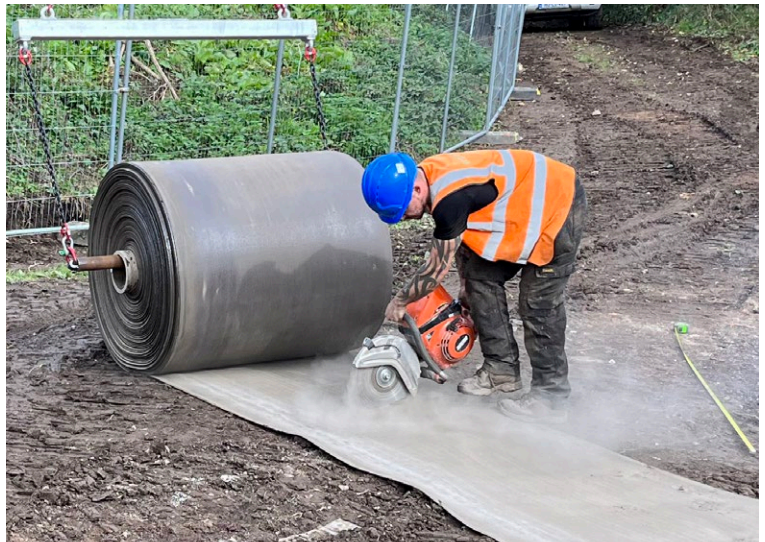
CCT2™ cut to desired length

The contractor placed a non-woven geotextile underneath the CCT2™ material to compensate for the irregular subgrade and to keep the working area clean and tidy. The material was laid into the channel transversely and cut to specific profile length to eliminate wastage. The CCT2™ layers were overlapped by 100mm in the direction of water flow and were then screwed together at 200mm intervals using 30mm stainless steel screws.

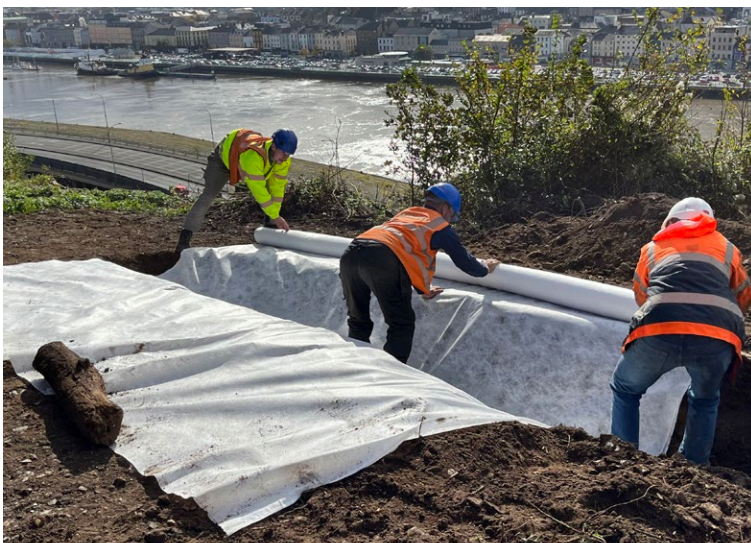
Non-woven geotextile laid into channel

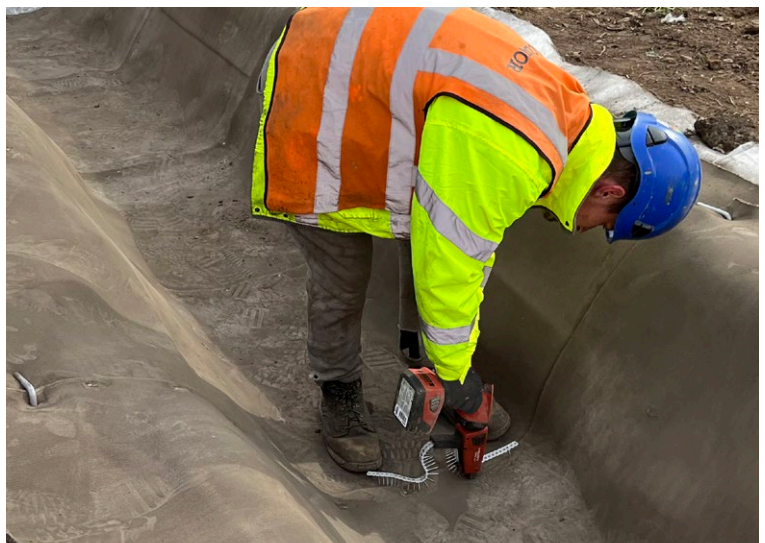
CCT2™ laid transversely & secured with 30mm stainless steel screws

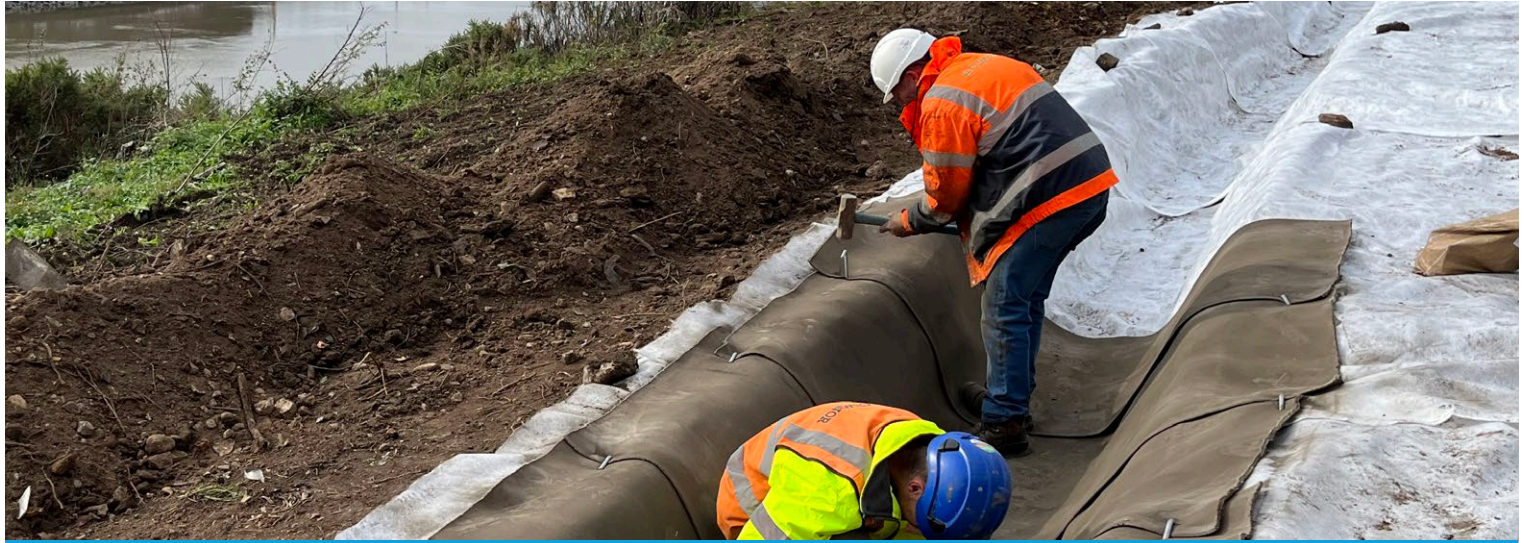
CCT2™ pegged into anchor trenches

The material was terminated into 150mm anchor trenches on either side of the channel and fixed to the substrate using 250mm ground pegs prior to being backfilled with material to prevent water undermining the material. The channel terminated into a newly installed precast headwall with a 300mm pipe which guided the run-off down the steep rock face and through a stilling tank and eventually into the River Suir.

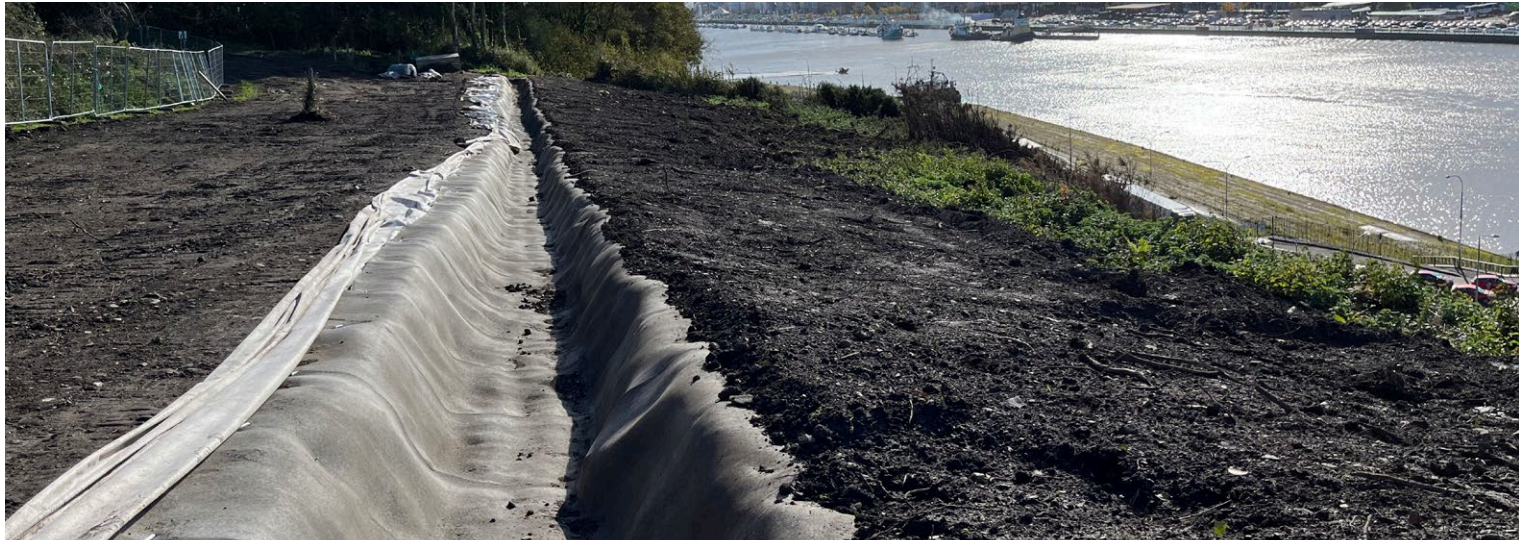
CCT2™ material prior to hydration

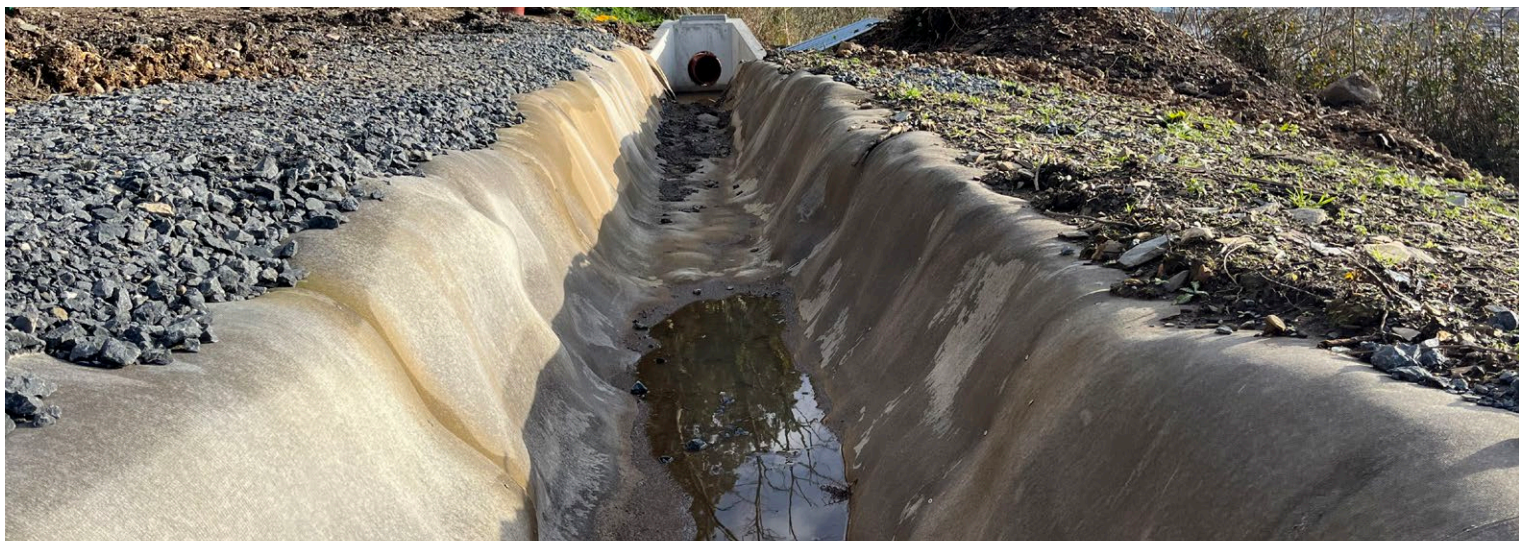
Channel terminated into precast headwall with 300mm pipe

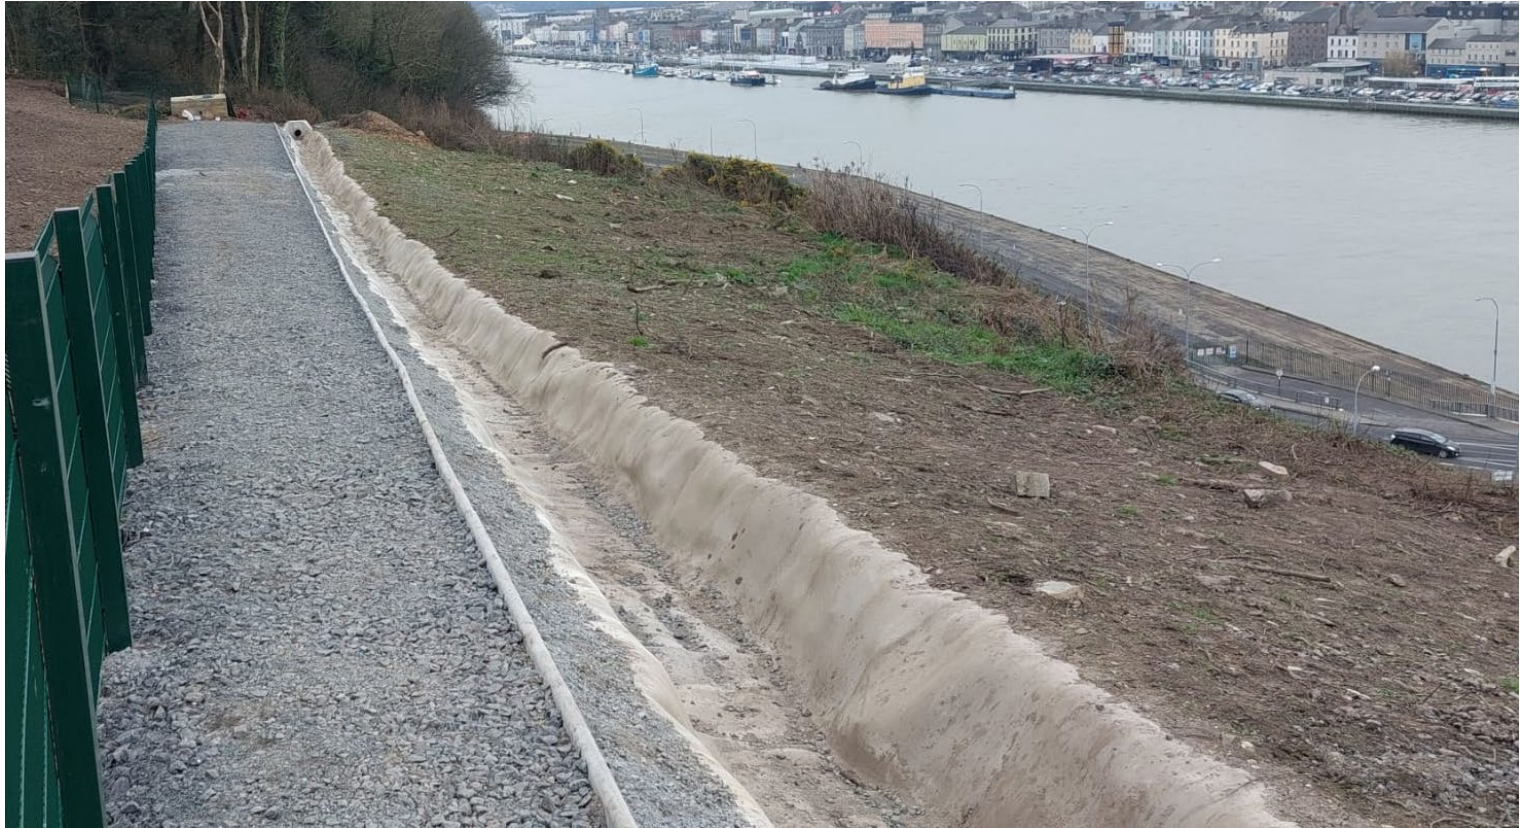
Completed installation bedded in
