CC8™ and CC13™ Bulk Rolls

West London Football Club Training Ground

CC13™ and CC8™ were used to line a channel at the training ground of a West London football club to prevent erosion and silt generation which was causing drain blockages and limiting pitch and land draining capacity.

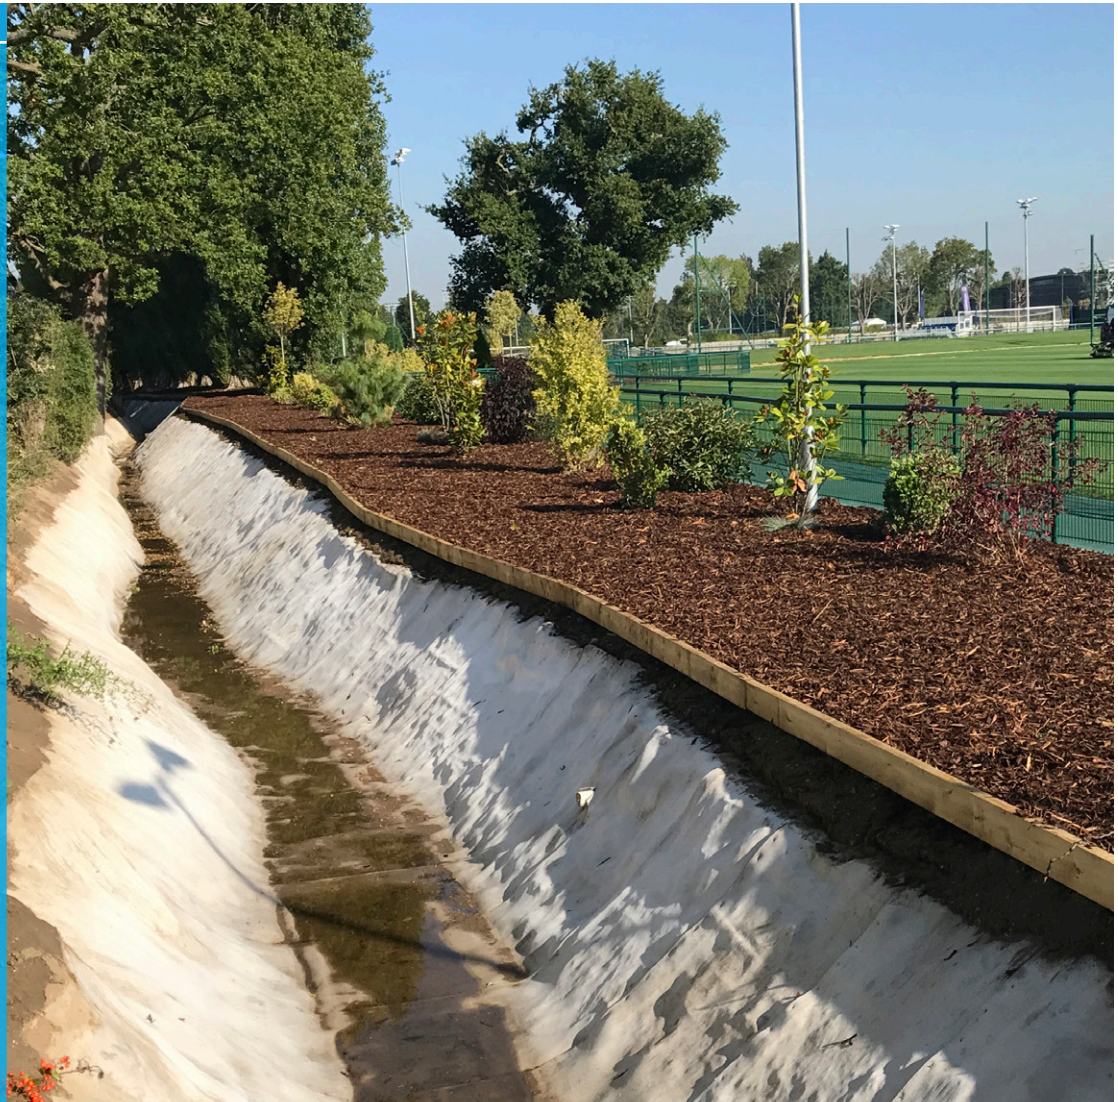
Completed installation at Cobham Training Ground

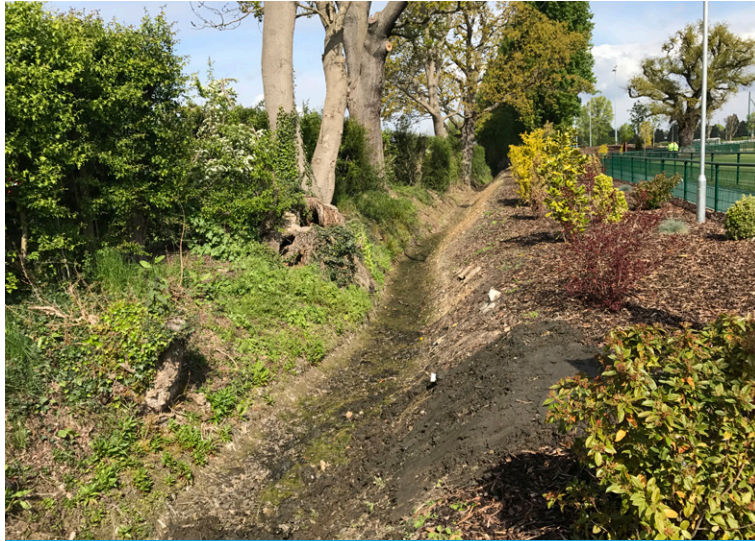
Channel prior to works

The existing channel, which sat alongside some of the training ground's pitches, was approximately 640m long with shallow falls. As a result, silt and leaves quickly built up, caused drainage issues and required regular maintenance. The client wanted a solution which could not only improve drainage on the site, but also significantly reduce maintenance and make clearing debris and blockages from the channel considerably easier and less time consuming.

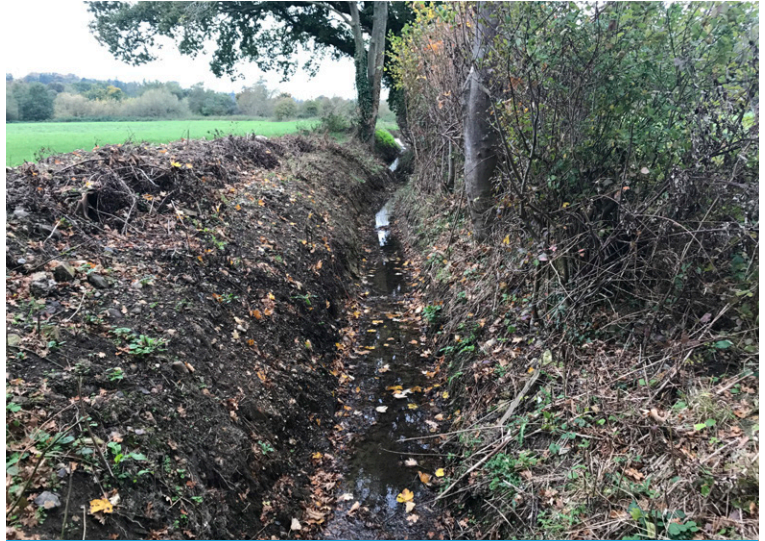
Original channel was causing blockages and poor drainage

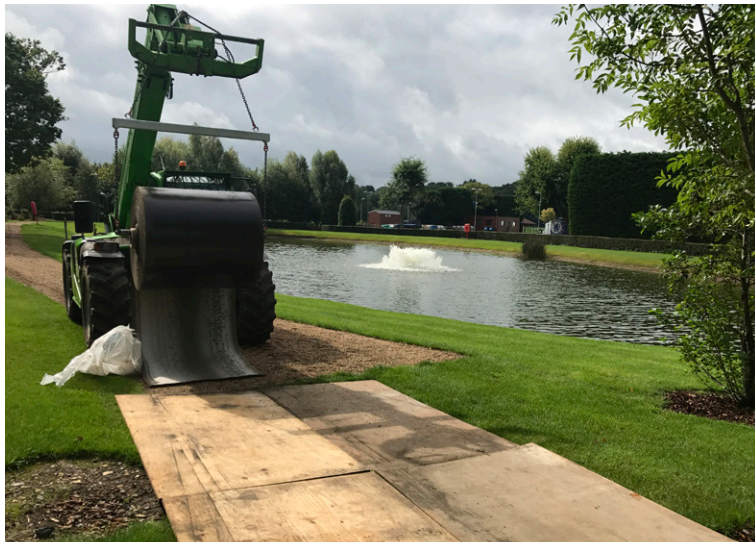
CC8 and CC13 Bulk rolls were batched on site

In preparation for the installation, the channel was excavated, using excavators or a pick-axe and shovel in areas with restricted access. All vegetation and debris were then removed from the channel, and soft areas of the invert were replaced and filled with crushed concrete. Bulk rolls of CC8™ and CC13™ were then delivered to site, mounted onto a spreader beam on a stand, and cut to profile length before being transported to the channel. The CC was then laid transversely across the channel, the ends laid in pre-dug anchor trenches and fixed using 250mm ground pegs. Additional layers were then laid with 100mm overlaps which were jointed using stainless steel screws and an auto-fed screwdriver. Anchor trenches were then either backfilled using clay, excavated soil, or in some places, gravel boards were placed on top of the CC end, with stakes through the material, and bark chippings placed on top. In restricted areas around footpaths, the edges of the CC were captured in tarmac. Once installation was complete, the CC was hydrated, and when set, the material was jet-washed to remove mud and create a cleaner channel.

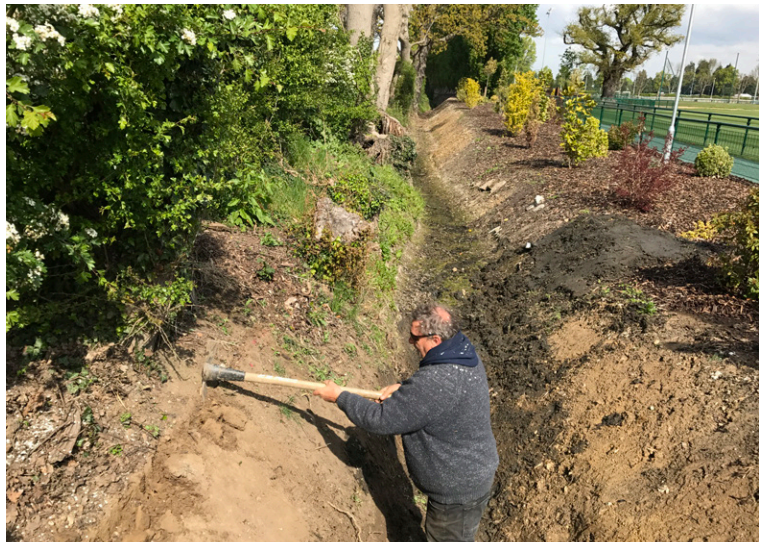
A pick-axe and shovel were used to regrade in restricted areas

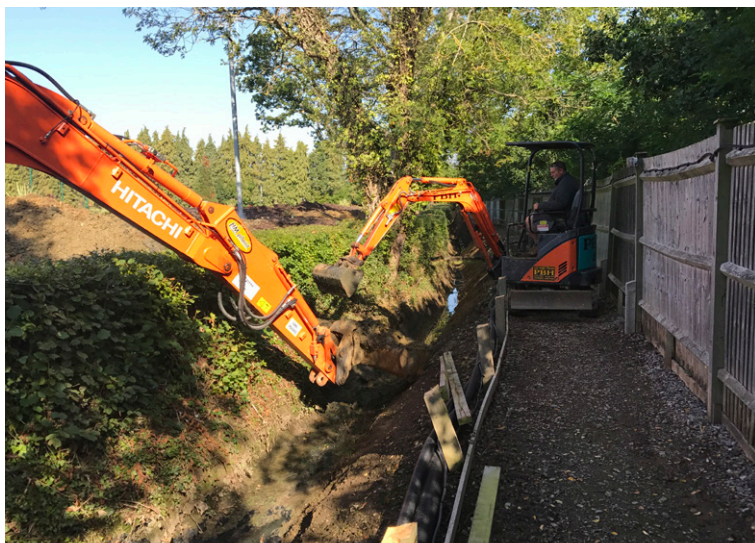
Excavators regraded the channel prior to installation

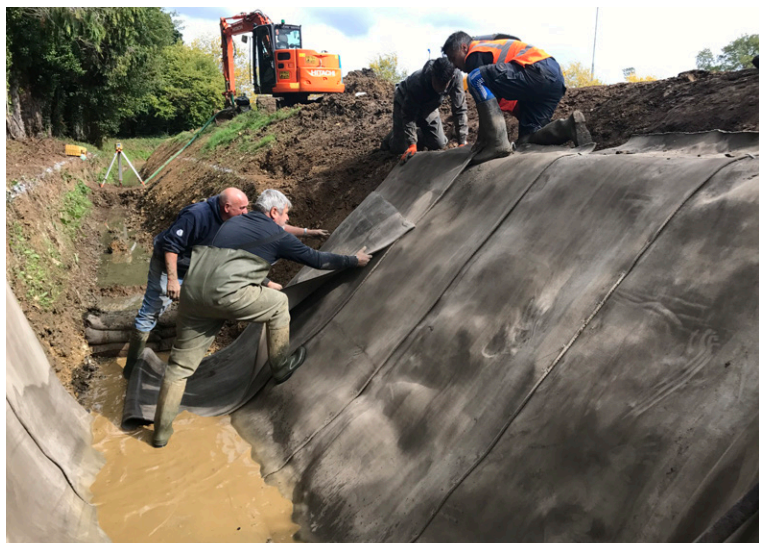
CC8 was laid transversely across the channel

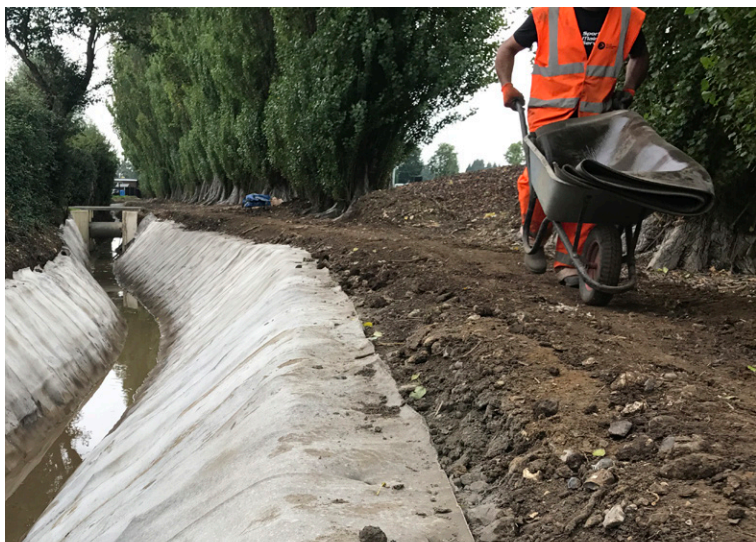
CC was batched and transported by wheelbarrow

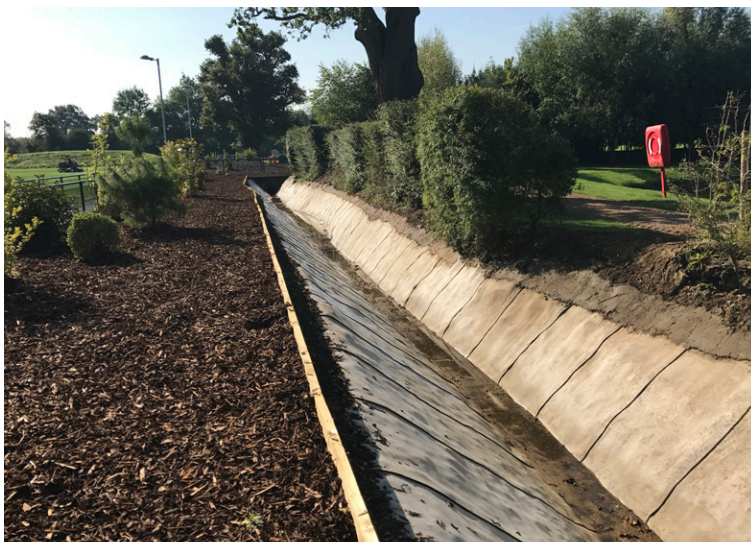
Edges were buried in soil anchor trenches or timber edging & bark chippings

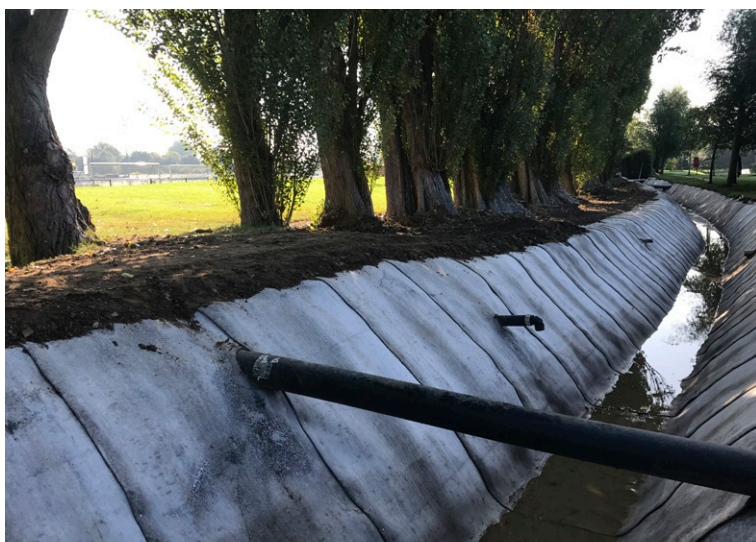
CC was cut to accomodate pipes and outfalls

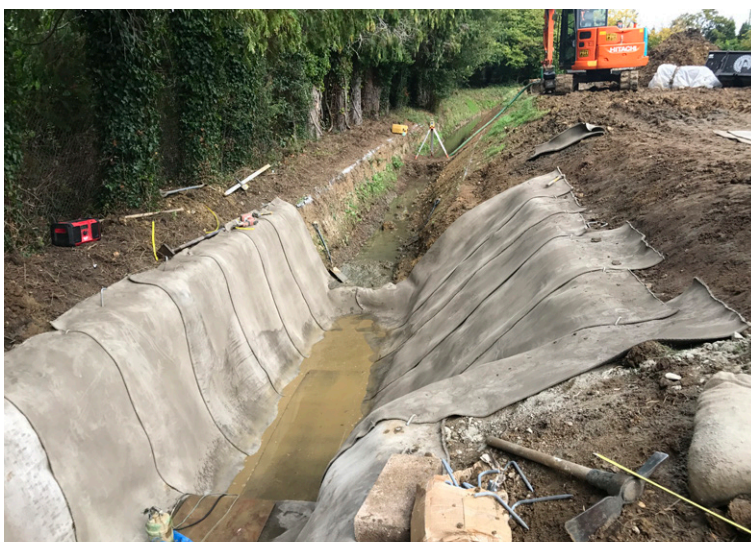
Sump areas were created using CC13

Since the installation, silt generation has been greatly reduced and the creation of the sump areas, using CC13™, has allowed for easy future maintenance for the removal of leaves and other debris.

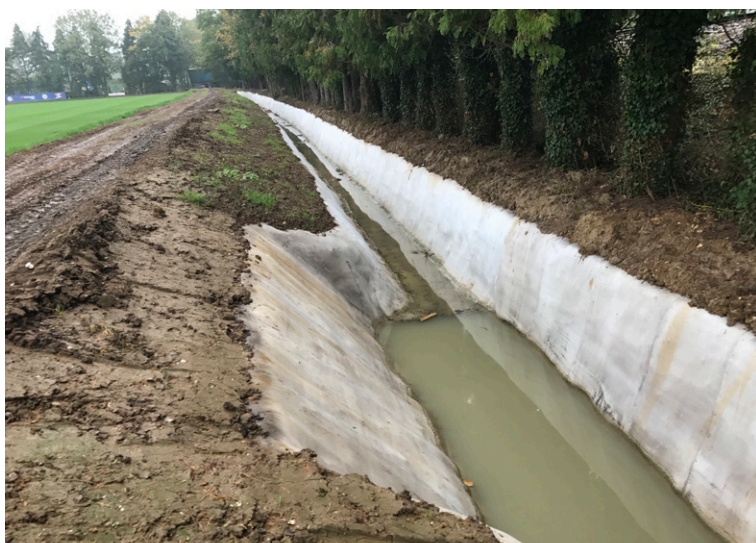
Completed CC13 sump area

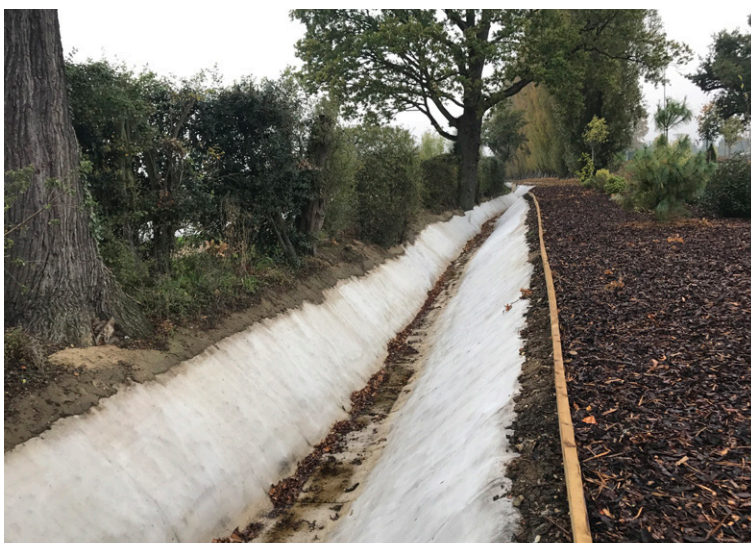
CC was jet washed after hydration to remove mud stains on surface

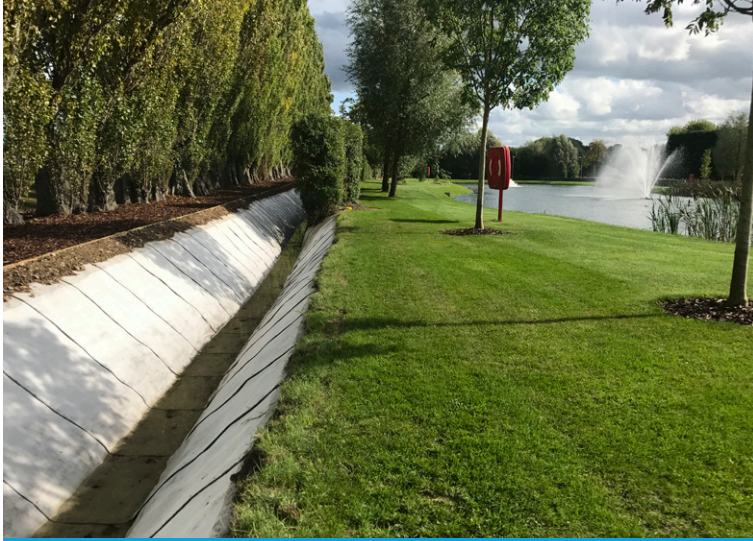
Completed channel

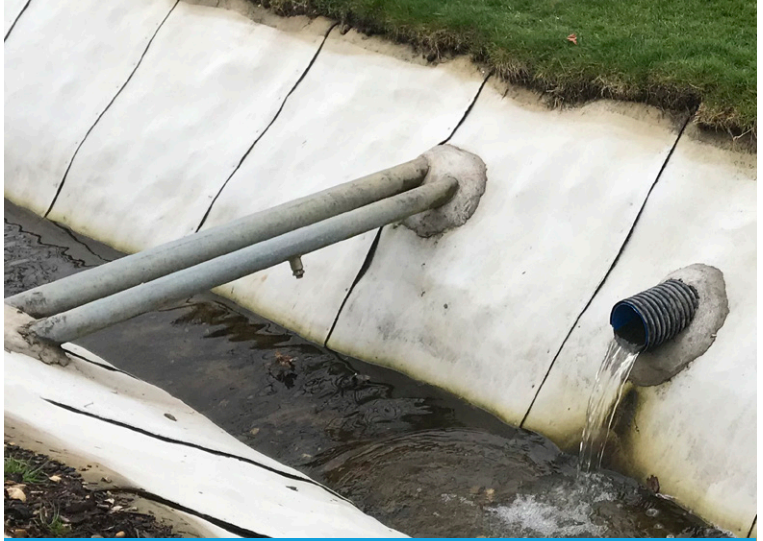
Sealed pipe detail, 9 months after installation

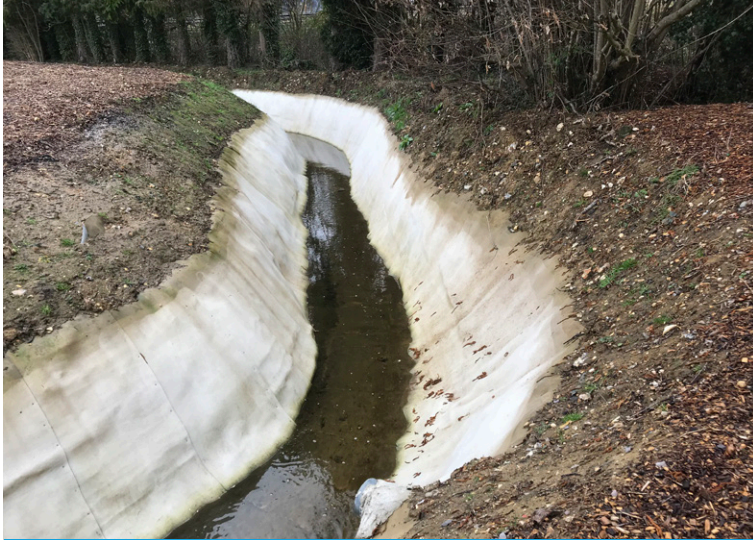
Corner section of channel during re-visit

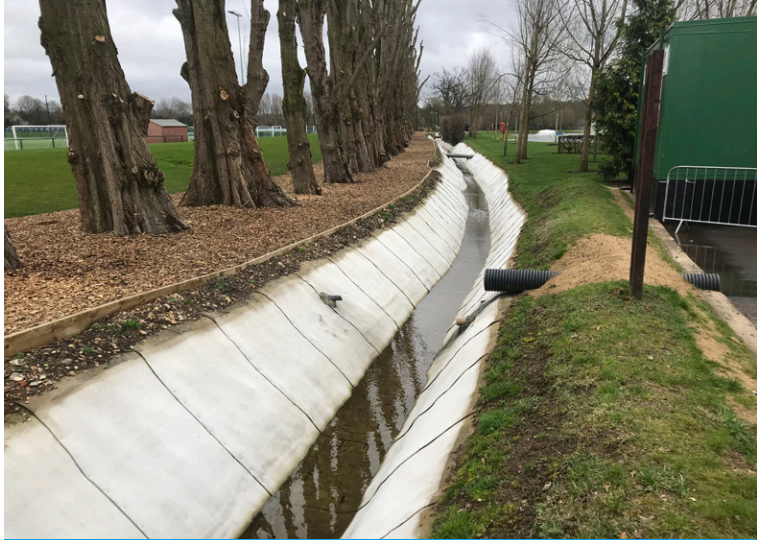
Outfall pipe and section of completed channel

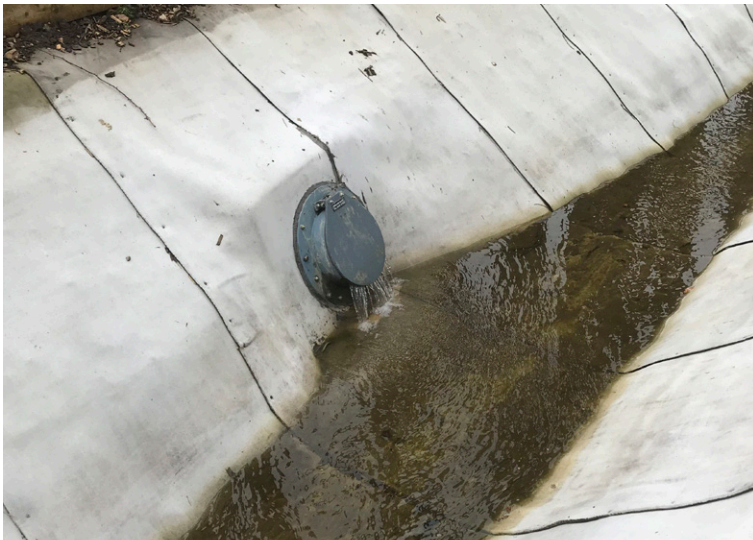
Capped outfall pipe covered with CC

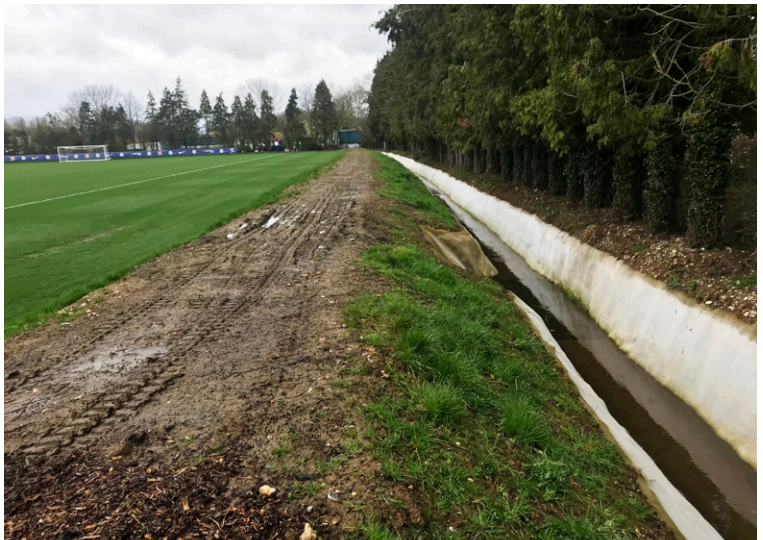
Sump area and completed channel alongside training pitch (re-visit)

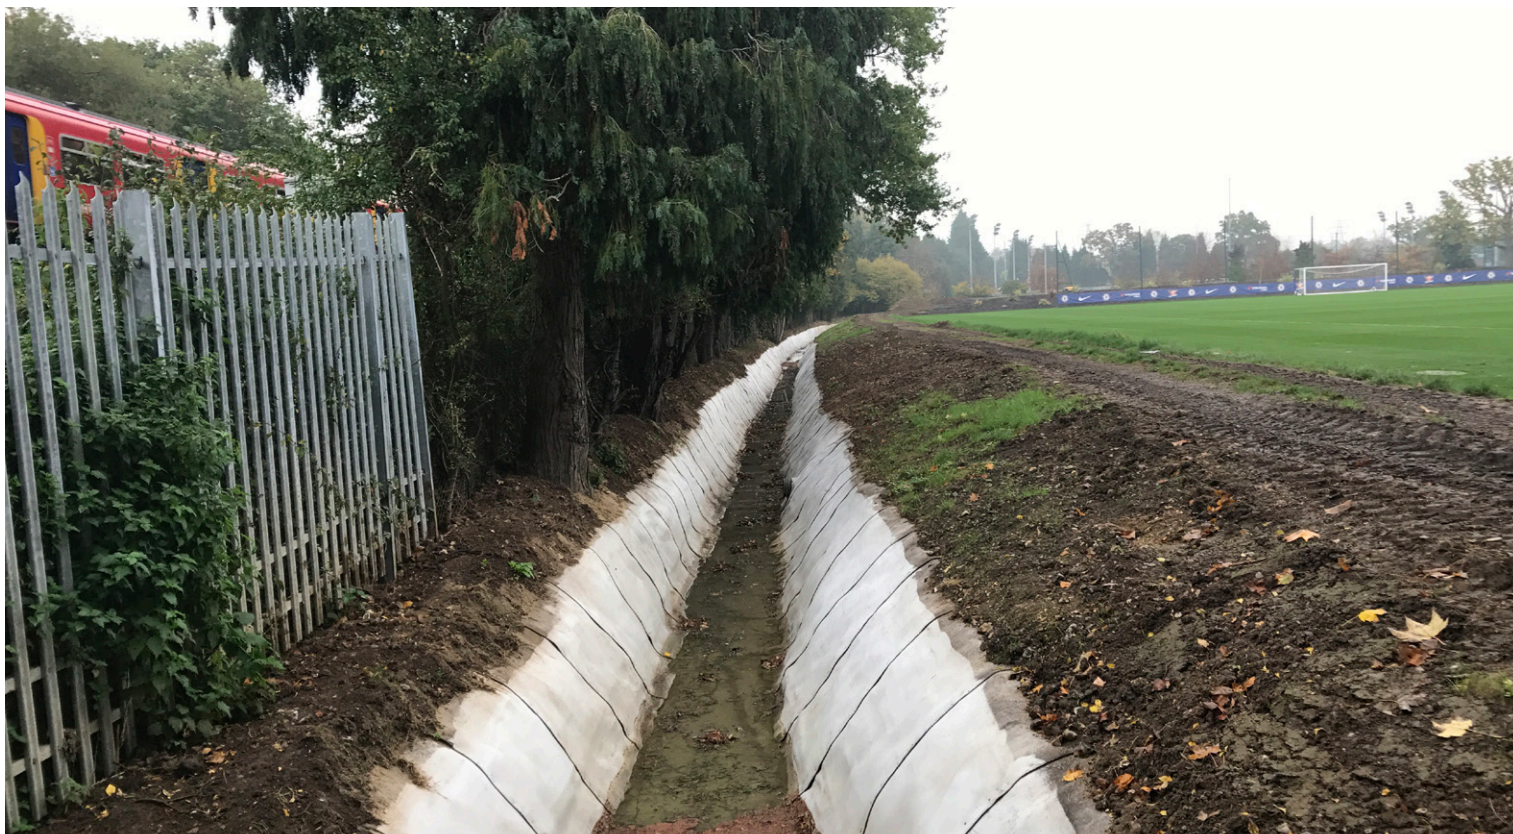
Channel runs along a Network Rail track

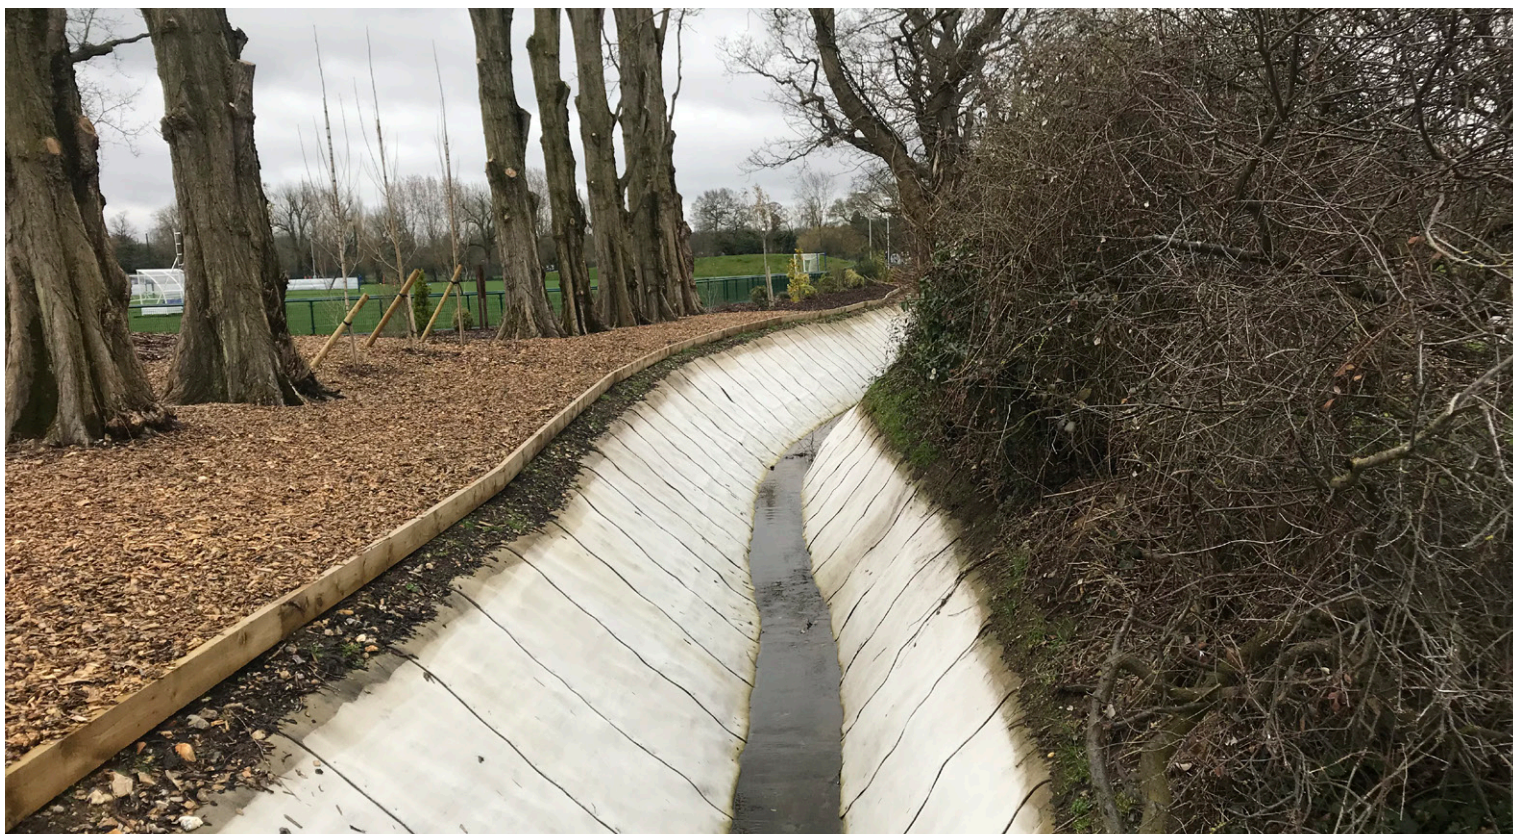
Completed channel 9 months after installation

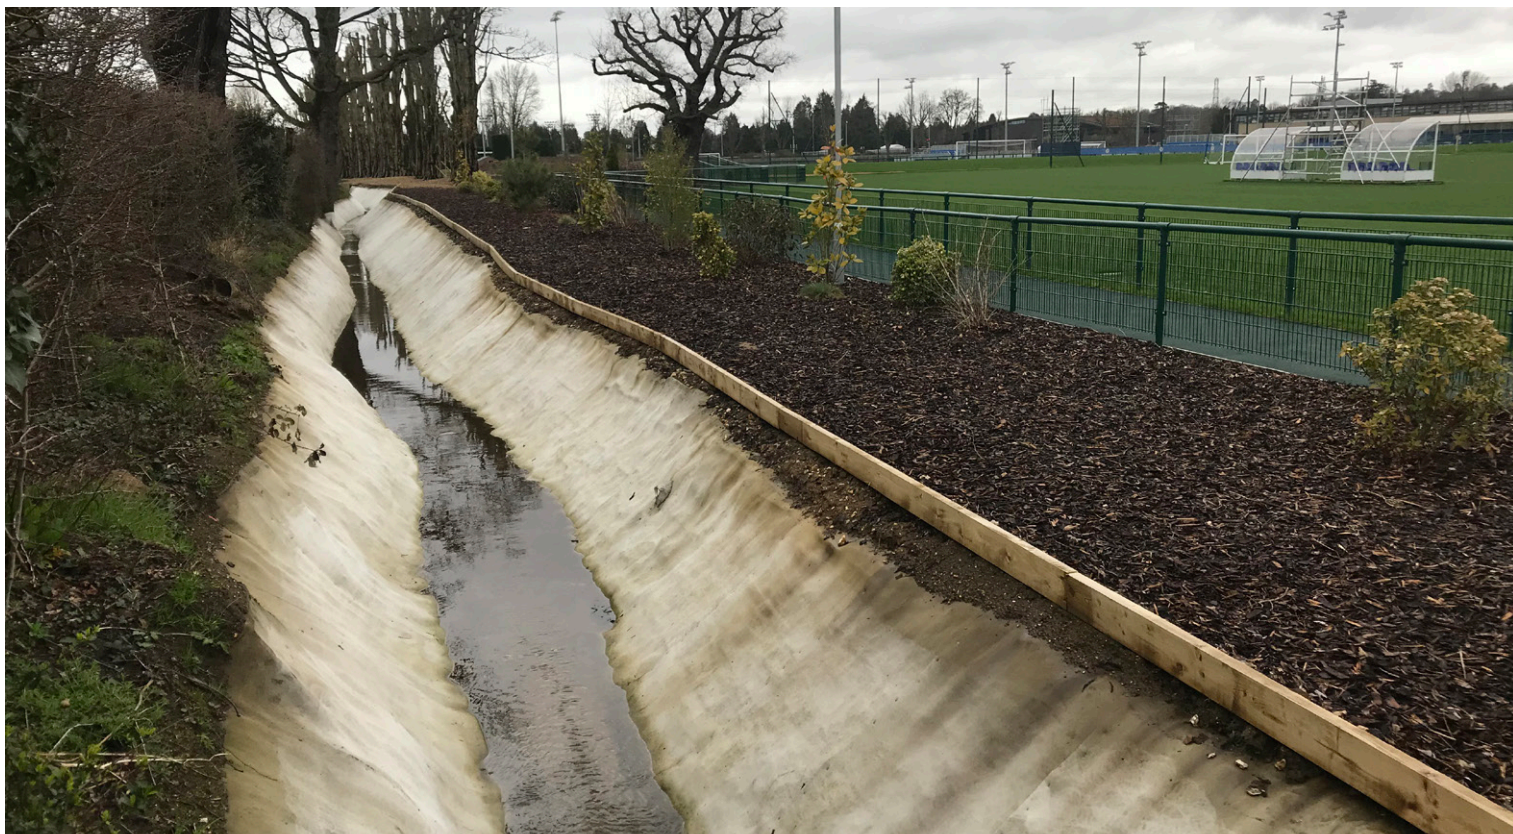
Completed channel installation
