Hermerdon Tungsten Mine, Plymouth, UK
-

CC was used for temporary works to prevent water from seeping through bedrock and flooding the lower area of a mine site

In February 2015, Concrete Canvas® GCCM* (CC) was used to temporarily line a drainage channel at Hermerdon Tungsten Mine, Plymouth, UK.

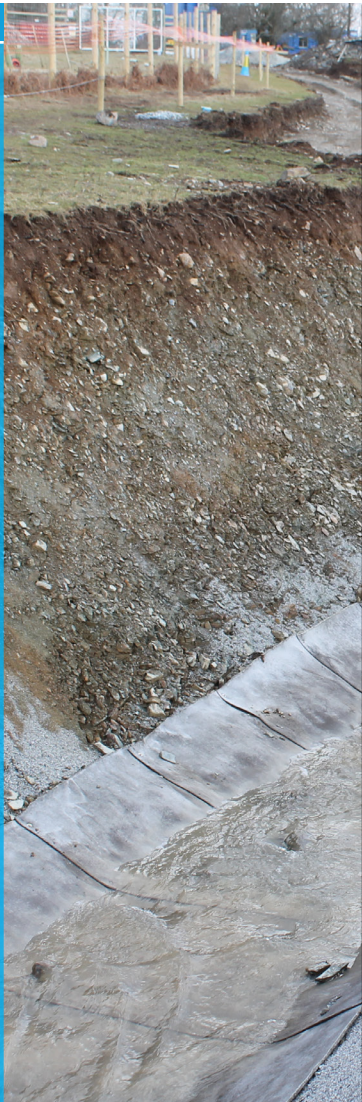
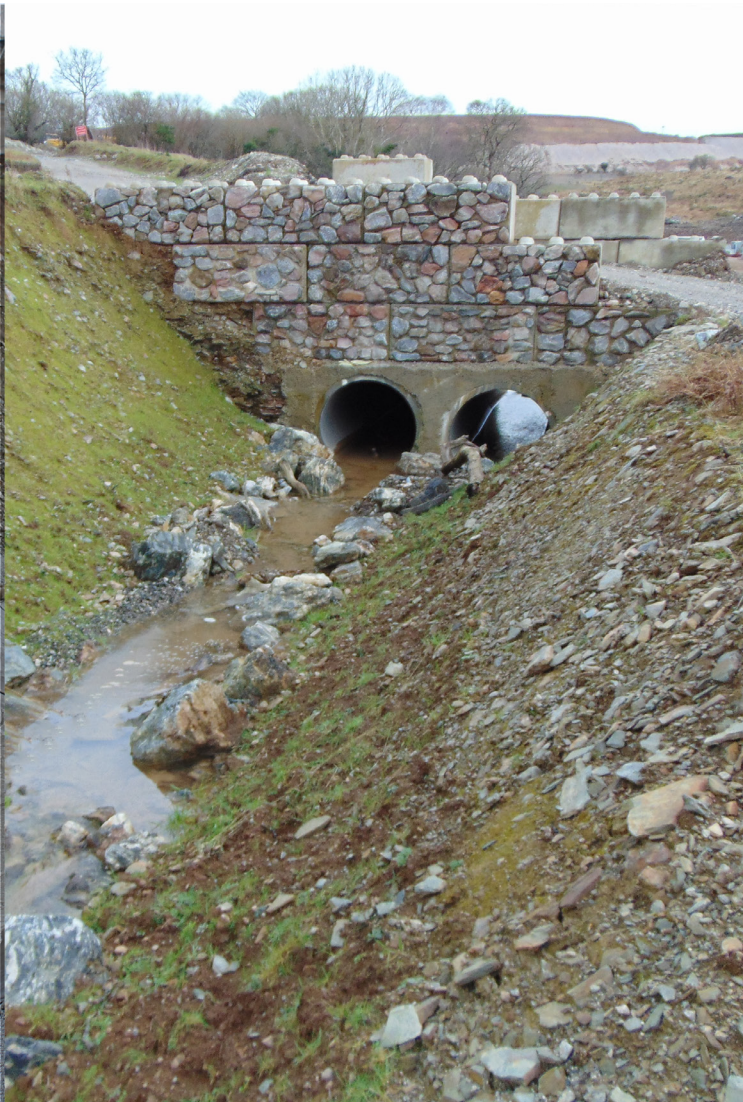
Project immediately after installation
Channel 9 months after installation

The channel was graded and any loose stones and vegetation removed. Bulk rolls of CC8™ were batched to specific profile length on site and laid in the channel, with a 100mm overlap between layers in the direction of water flow. The material was jointed using screws at 200mm intervals. As the CC was required to temporarily contain the flow of the existing water channel, the standard anchor trench detail was not needed.

Later in the year, following completion of the construction of the settlement ponds, it was decided to keep the CC in place. Stones, soil and logs from the existing channel were placed into the new channel to help establish a natural habitat and allow the migration of eels and fish.

By January 2016, vegetation had grown on the soil above the CC and the migration of eels had been observed, with both the client and the EA deeming the project a success.

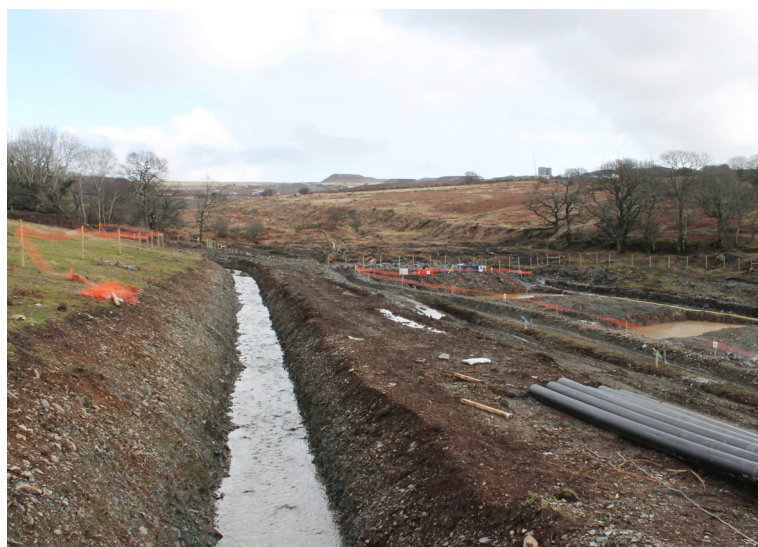
Site before works began

In order to facilitate the construction of settlement ponds it was necessary to divert the Hooksbury Channel which ran through the site. The bedrock was found to be allowing water to leak into the construction site, so an impermeable lining was required. Poured concrete was considered, however this would have required complex logistics and treatment of any water run-off to prevent harm to the local ecology. CC has a low alkaline reserve and low wash out rate which allows any run-off to be discharged into water courses without treatment and with negligible impact on the environment. Installation was carried out by Daniels W Plant Hire with consultation from SLR Consulting and the EA.

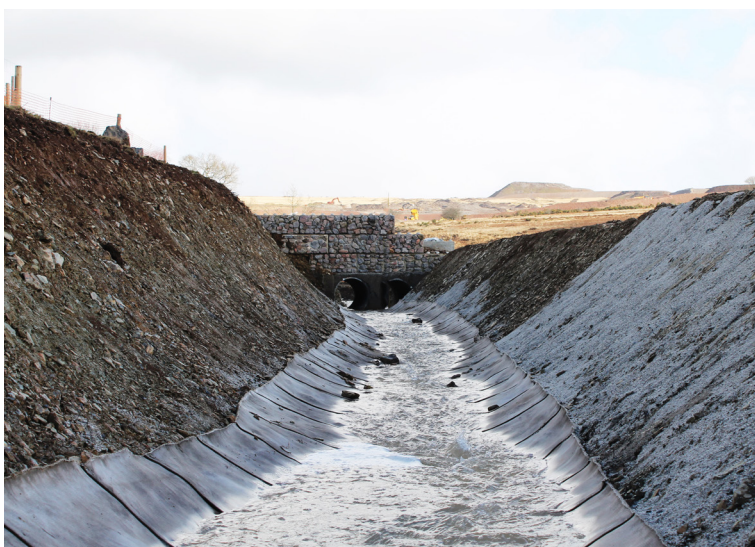
Initial installation completed

A total of 250m² of CC8™ were installed in just one day.

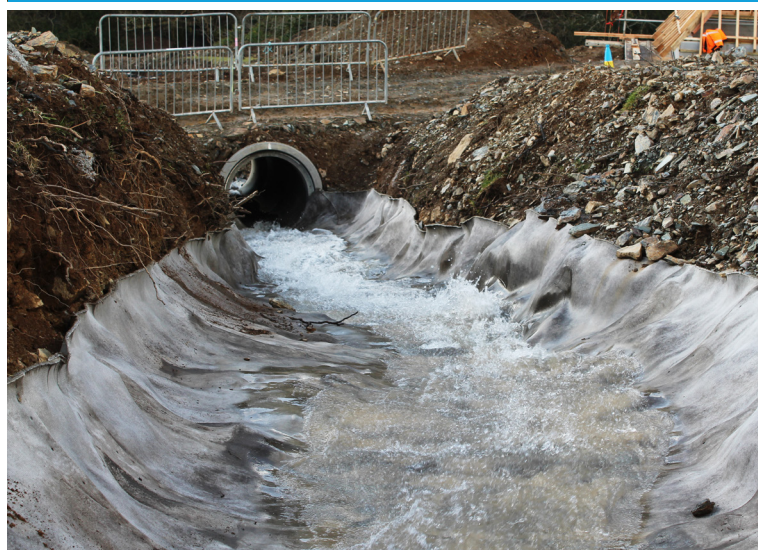
Culvert interface

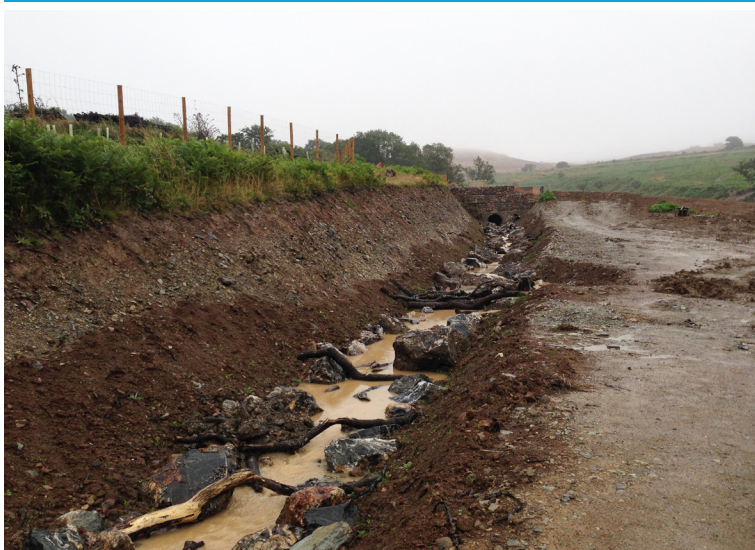
Stones, soil and logs placed

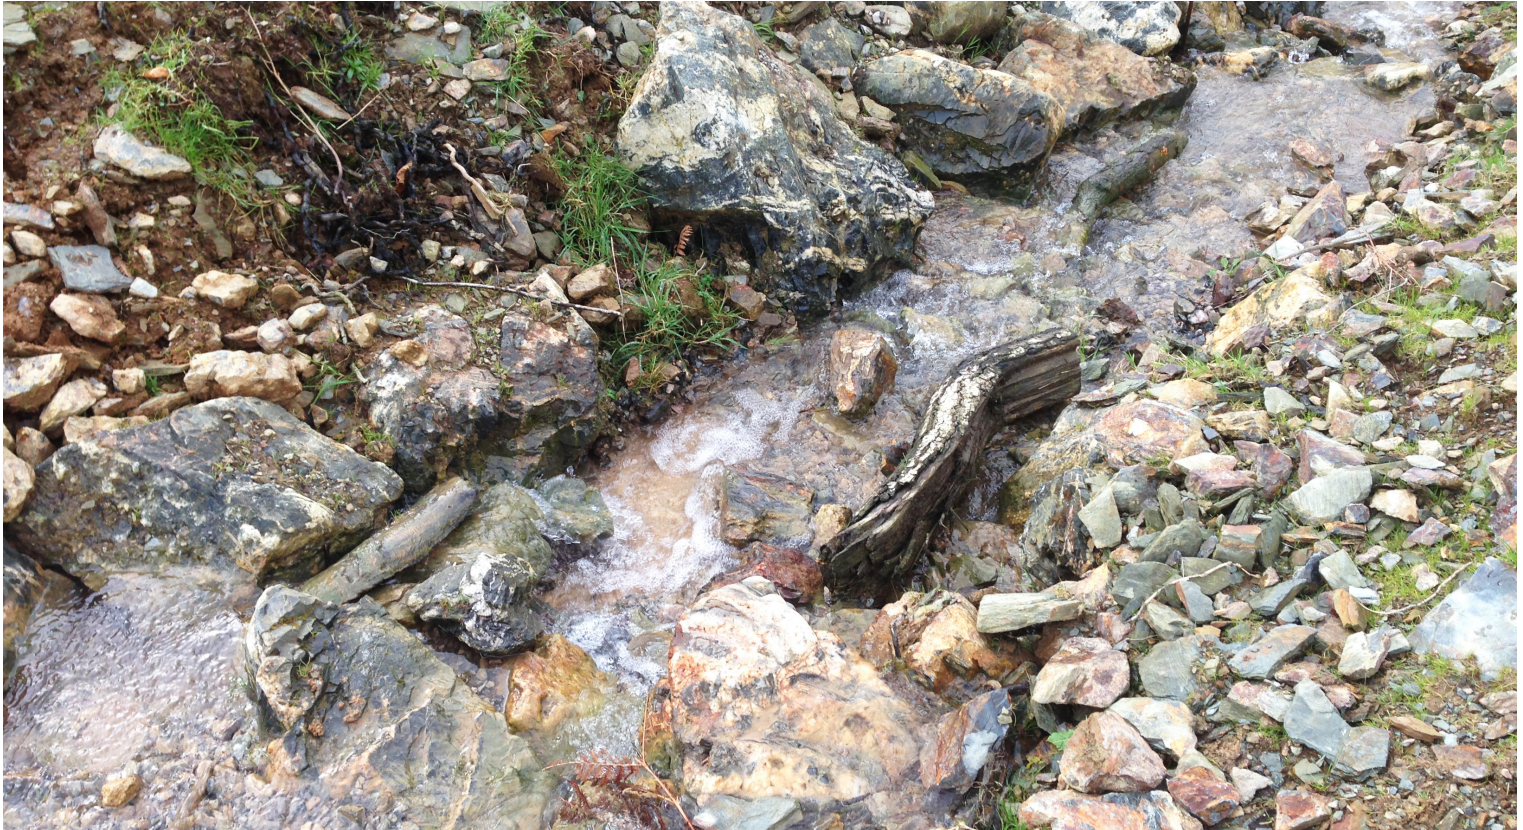
Natural habitat establishing

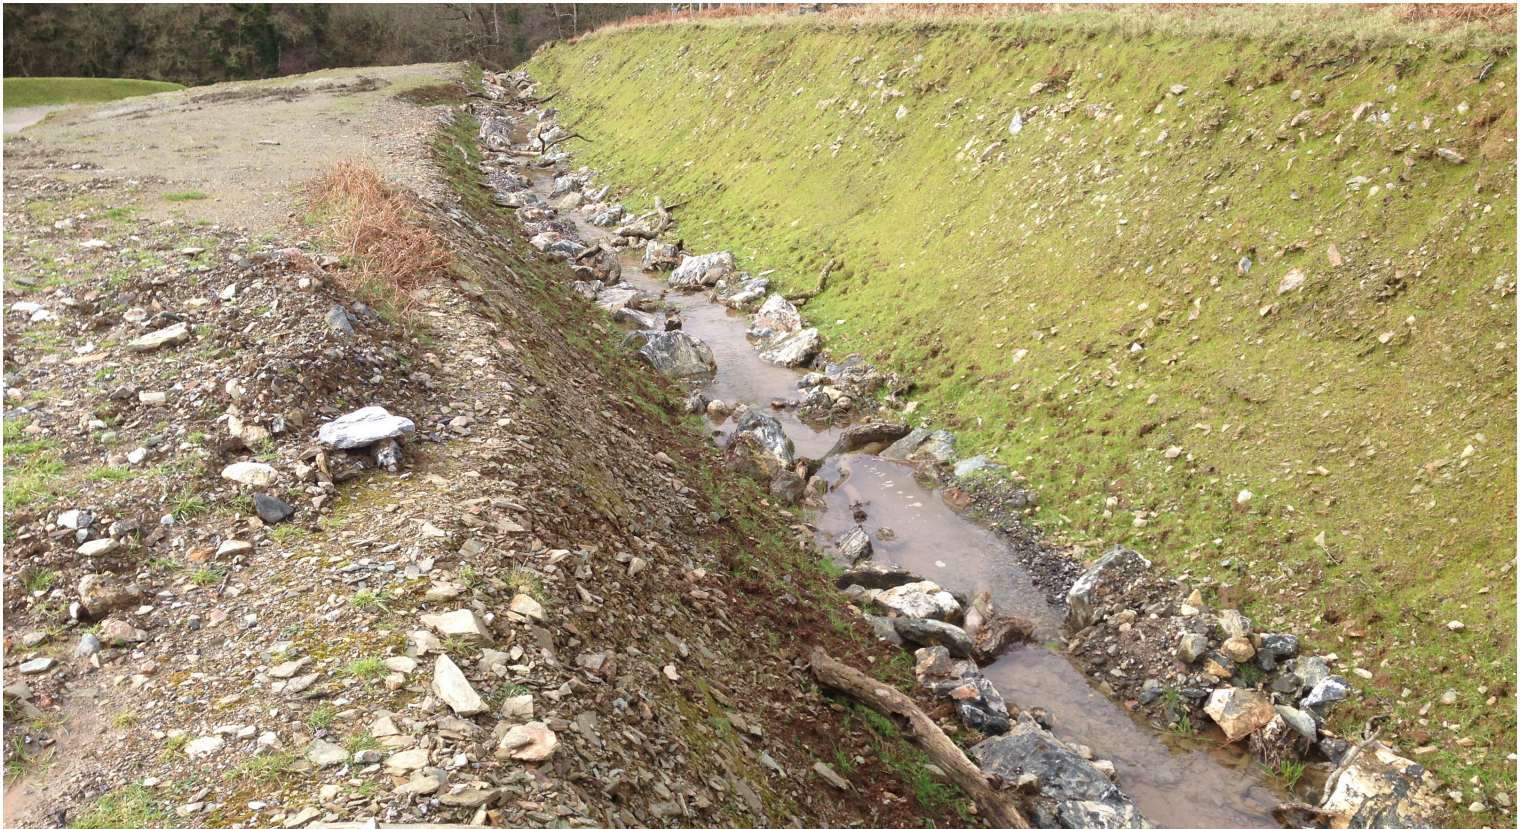
Completed project
