CC5™ and CC8™ Bulk Rolls

Wallumbilla, Queensland, Australia

CC5™ and CC8™ used to provide a channel and slope lining solution to prevent erosion and scour.

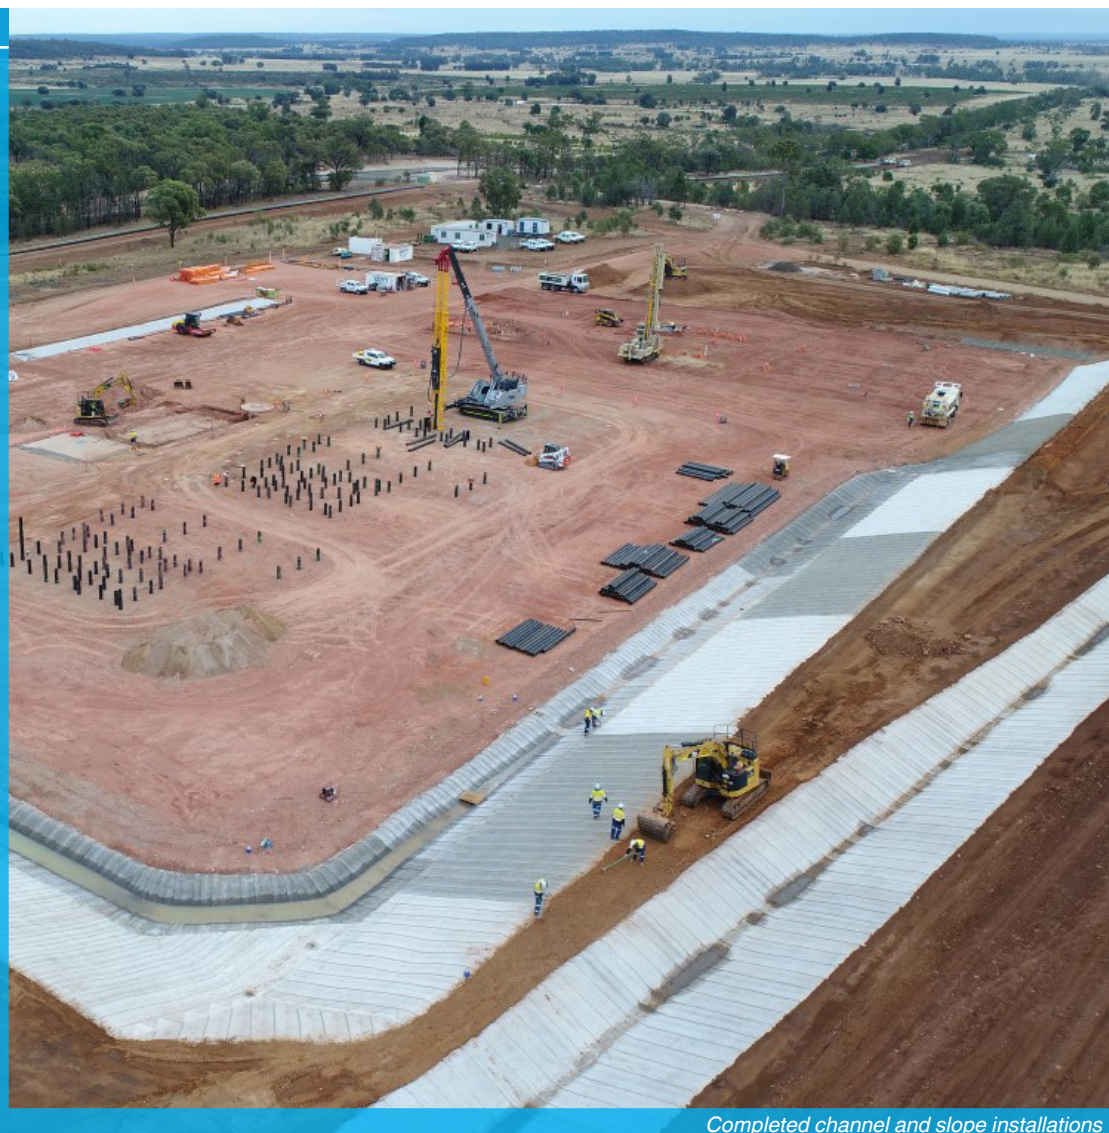
Completed channel and slope installations

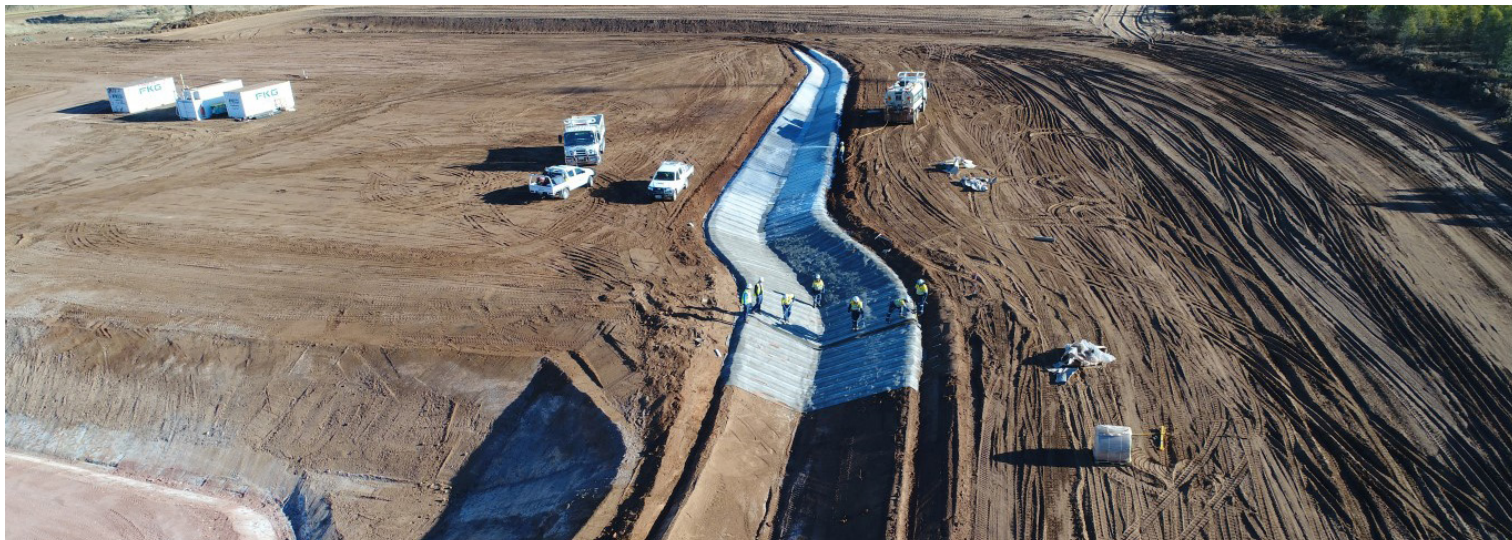
*Installation of CC in channel*

Prior to the installation, vegetation was removed on cut batters in drains and adjacent to working platforms. The bulk rolls of CC5™ and CC8™ material were mounted on a spreader beam, hung from a 20-tonne excavator, and the CC5 laid vertically down the slopes, and CC8 laid transversely across channels.

CC was laid transversely after the removal of vegetation on cut batters in drains and adjacent to working platforms. 20mm stainless steel screws were used to joint overlaps at 200mm intervals, with 250mm and 375mm ground pegs used to fix the CC to the substrate, inserted at 2m intervals at the material edges. An adhesive sealant was also used to increase impermeability along overlaps. Hydration was completed using a watercart via direct spray and soaking methods.

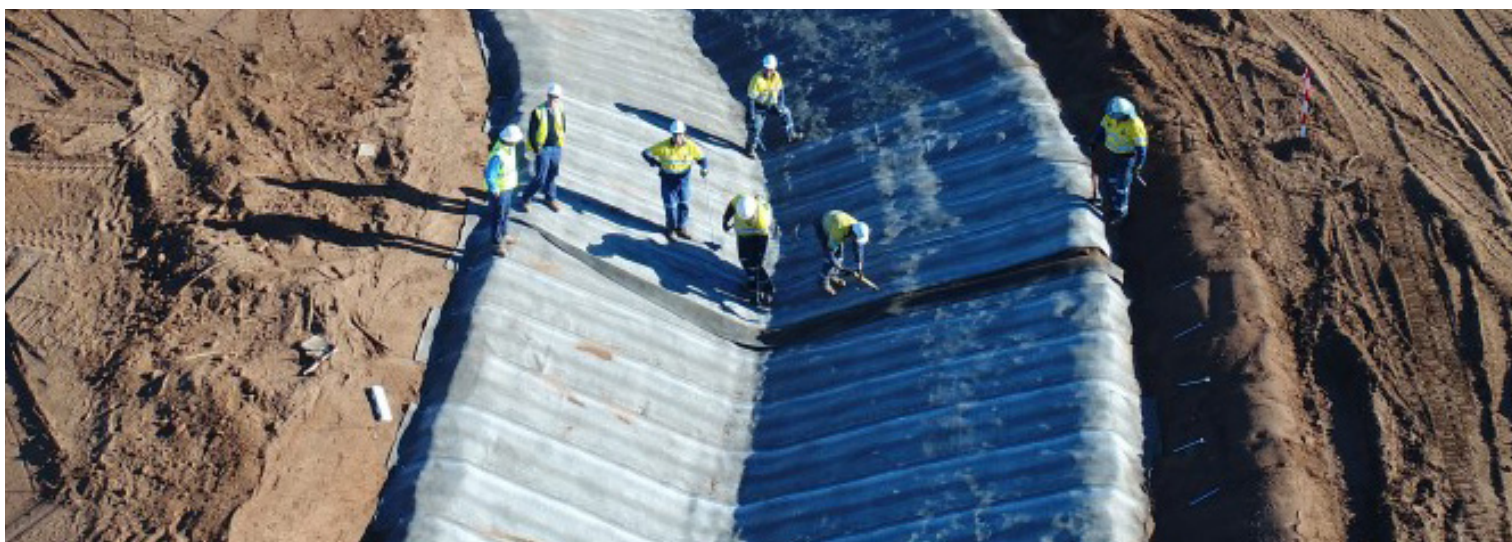
*Joining CC overlaps with adhesive sealant*

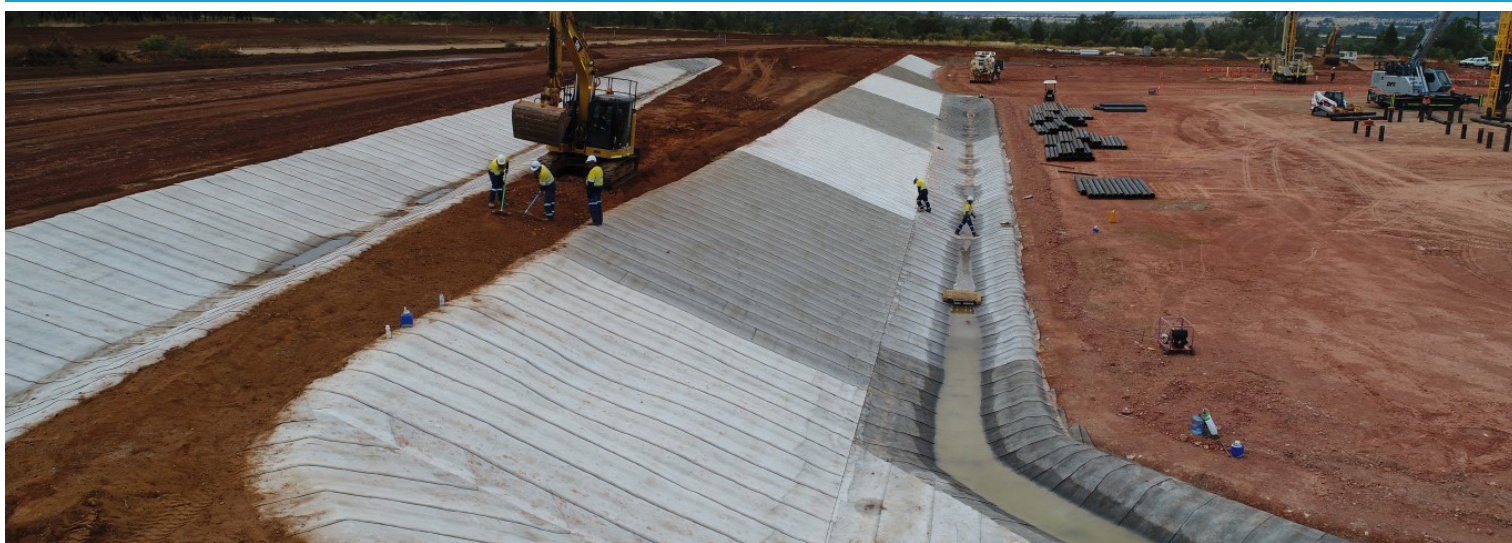
*Overview of channel and slope installations*

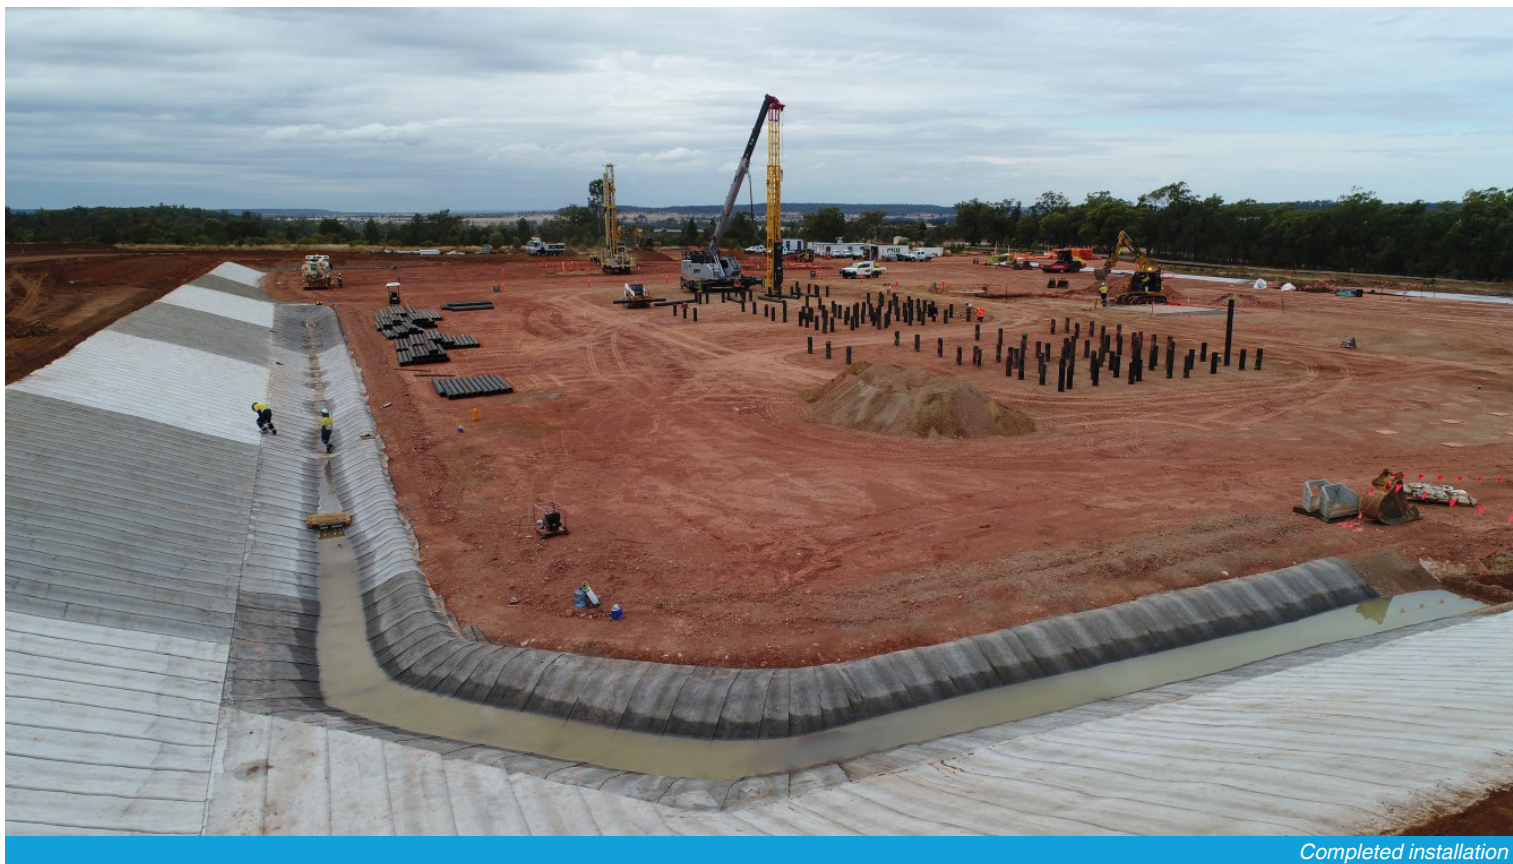
*Completed installation*

A total of 5,500m<sup>2</sup> of Concrete Canvas® materials were installed on this project, taking approximately 0.2-man hours per square metre to install. The overall project is still under construction, but the CC installation component is completed and was successful. This solution saved money during installation and will provide a maintenance free slope and drainage channel for the life of the project.
