# CONCRETE CANVAS®

## AGED CASE STUDIES

Accelerated age testing has been conducted by Concrete Canvas Ltd on Concrete Canvas® GCCM\* (CC) products: CC5™, CC8™ and CC13™. Testing is based on British Standard BS EN 12467:2004 and is designed to assess the effects of environmental degradation on fibre cement sheets.

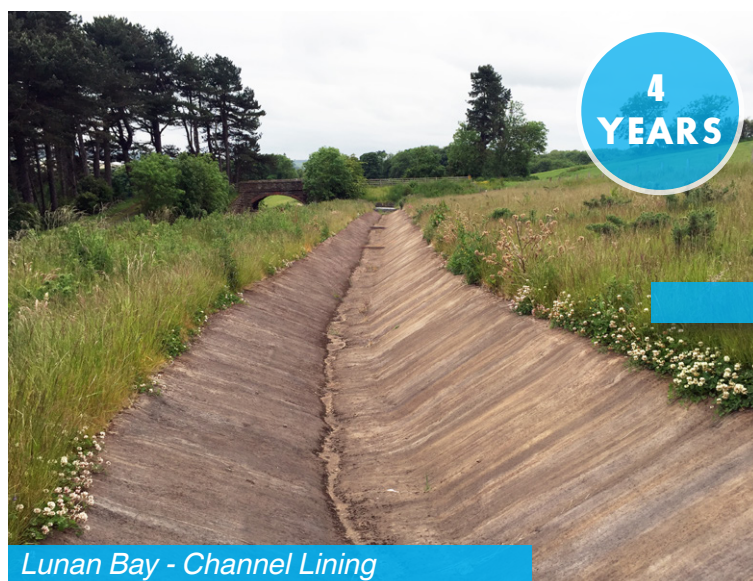
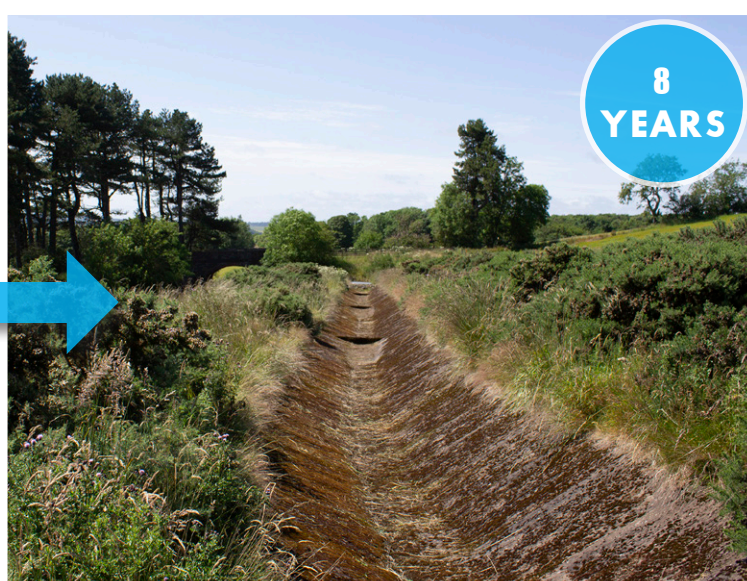
Concrete Canvas® (CC) was used to line a 100 linear metre drainage channel near the track to transport surface run-off from the adjacent potato field.

Eight years after installation, the CC was found to be performing well, and showed considerable moss and algae growth established on the fibrous top surface of the material, creating a mottled brown appearance and making it more homogeneous with the surrounding environment.

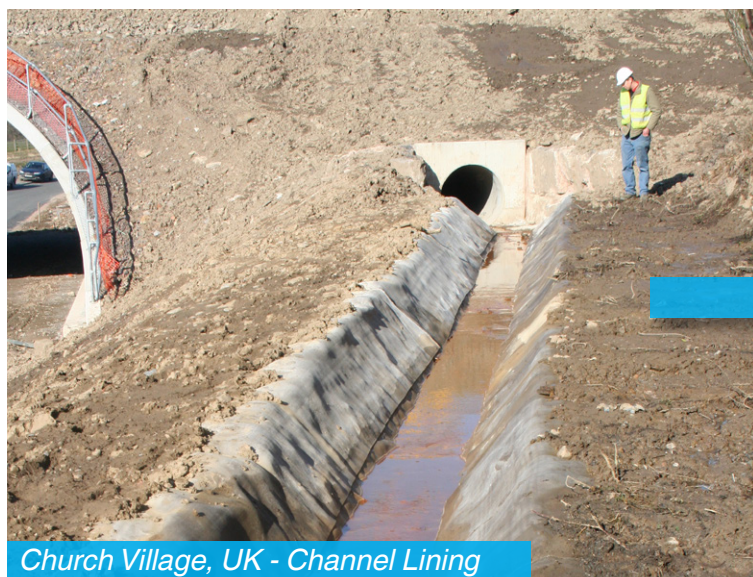
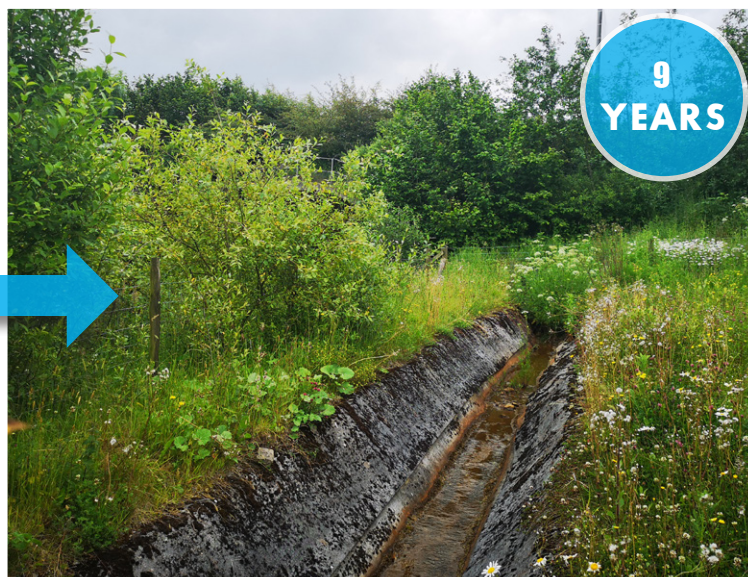
*Church Village, UK - Channel Lining*

Concrete Canvas® (CC8™) was chosen by the contractor, Costain, for lining a purpose-built drainage and water management channel along the crest of a slope which runs adjacent to an existing road below the bypass. CC met requirements for alternative materials which would minimise the environmental impact due to its eco-friendly properties.

Nine years on, the CC is showing significant algae and moss growth, and is successfully continuing to suppress vegetation growth within the channel, despite established and overgrown vegetation and weed growth around the channel.

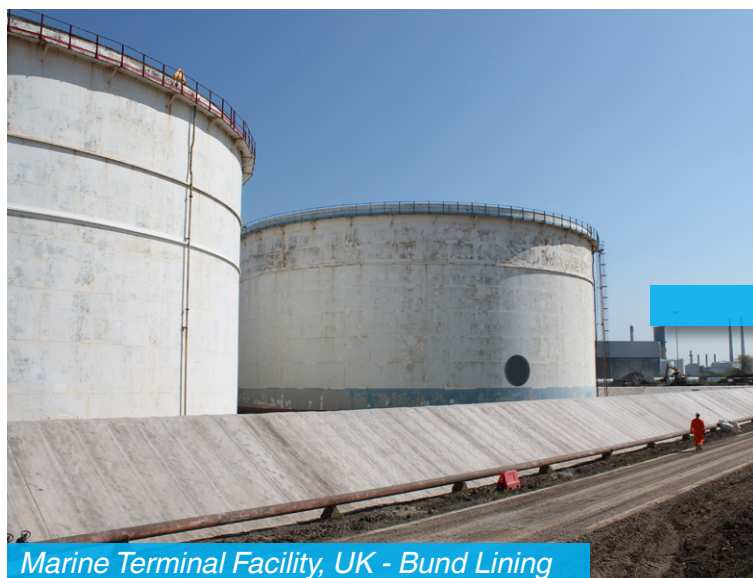
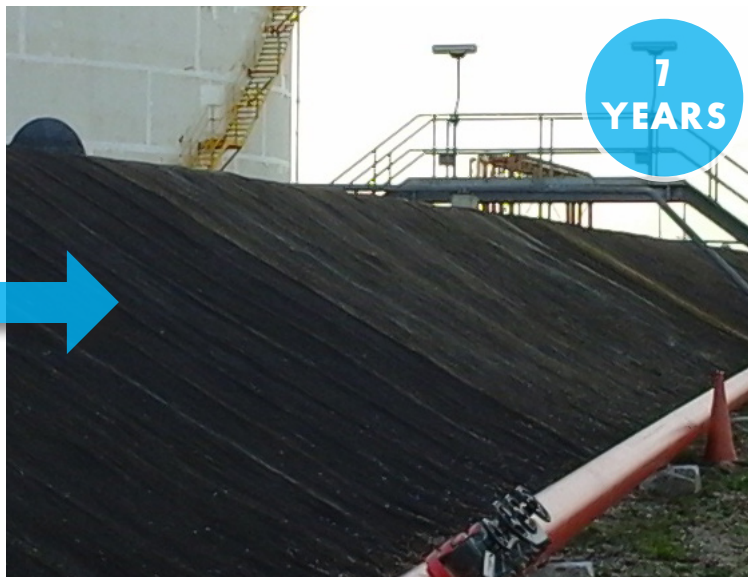
*Marine Terminal Facility, UK - Bund Lining*

In November 2012, CC was used to line refurbished secondary containment bunds at a Marine Terminal Facility in the UK. The bunds surrounded a series of tank farms storing hydrocarbons as part of the larger onshore facility. CC provided hard armour weathering protection, effective weed suppression, protection against animal damage and additional levels of containment and fire protection.

A return visit five years on showed the CC was still performing well and had darkened as a result of the settlement of dust and the growth of dark mosses on the material's fibrous top surface.

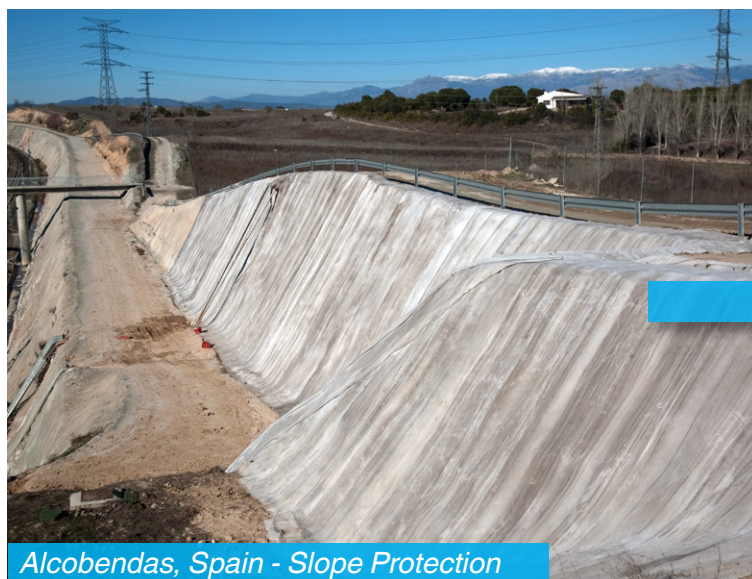
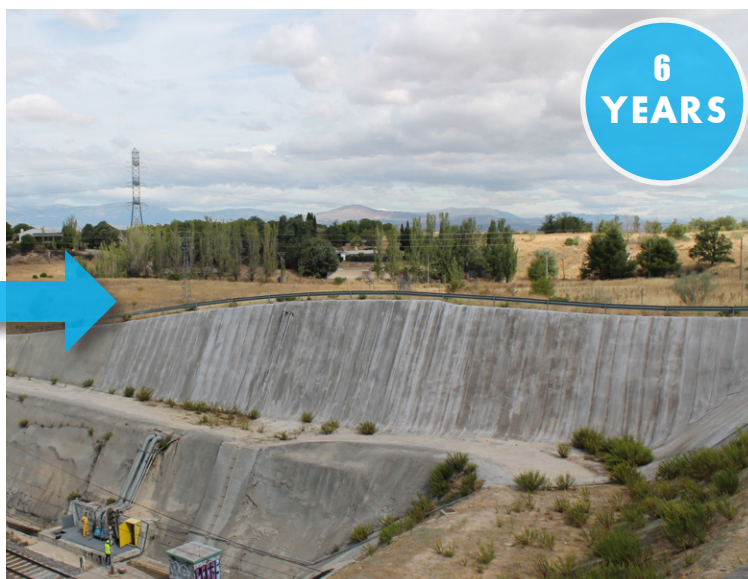
In December 2010, ADIF, the Spanish authority for railway infrastructure management, specified CC for slope protection at a railway station in Madrid. CC was installed along the length of slopes on either side of the track to provide erosion protection and address associated issues affecting the entrance of a tunnel station.

Six years after the completion of this installation, the site was re-visited to assess CC's performance. The material was found to be performing exactly as designed, and was providing effective erosion protection to the slope and in turn protecting the rail line and its users. Some changes in colour were evident, with minor 'greening' due to algae growth in places.

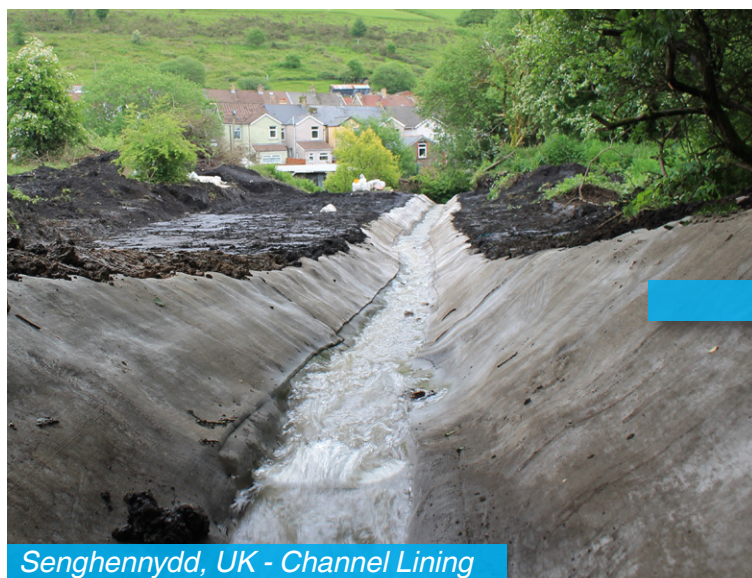
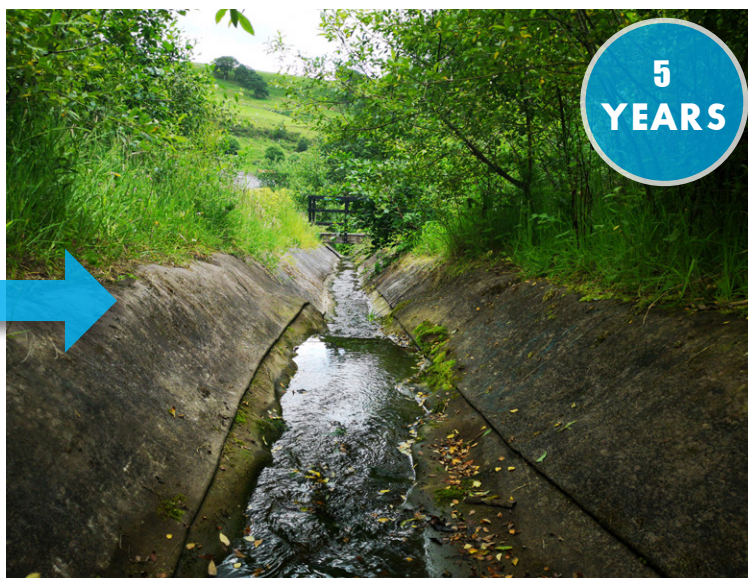
In 2014, CC was installed on a former ash tip site near new housing as a channel lining solution. The installation was carried out by representatives from Concrete Canvas Ltd and was observed by representatives from French Rail authority SNCF who were considering specifying the material for a project in France.

The site was re-visited five years after the installation to assess its performance. Despite the growth of new trees and other vegetation, and the addition of a small foot bridge, the material is intact and performing as designed. The CC has bedded in well, blending in with its surroundings with moss and algae growth covering the material's surface.

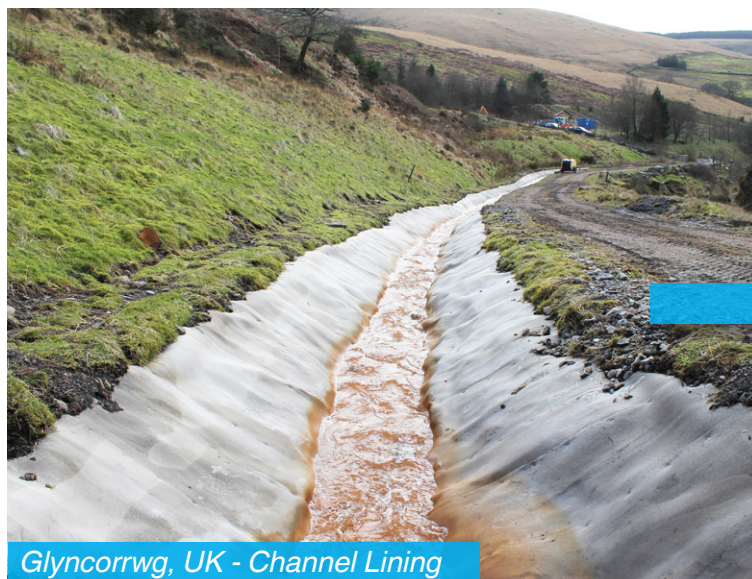
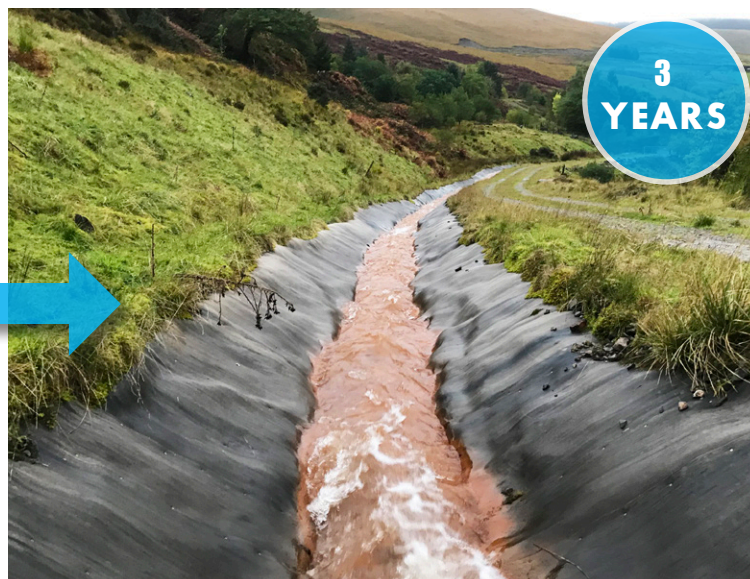
In January 2016, CC was used to line a series of drainage channels at Glyncorrwg Colliery, South Wales and provide scour protection to the system. The site required an effective and impermeable solution which could contain and effectively transport ochre-contaminated water on the site. The client also required a solution which could provide UV, puncture and wear resistance as well as vegetation suppression as their previous solution, an LLDPE liner, had failed as a result of exposure to these conditions and became overgrown and blocked with vegetation growth.

Three years on, the material has greyed due to the environmental conditions of the site and is still providing effective water management, preventing the contaminated water from adversely affecting local watercourses and wildlife.

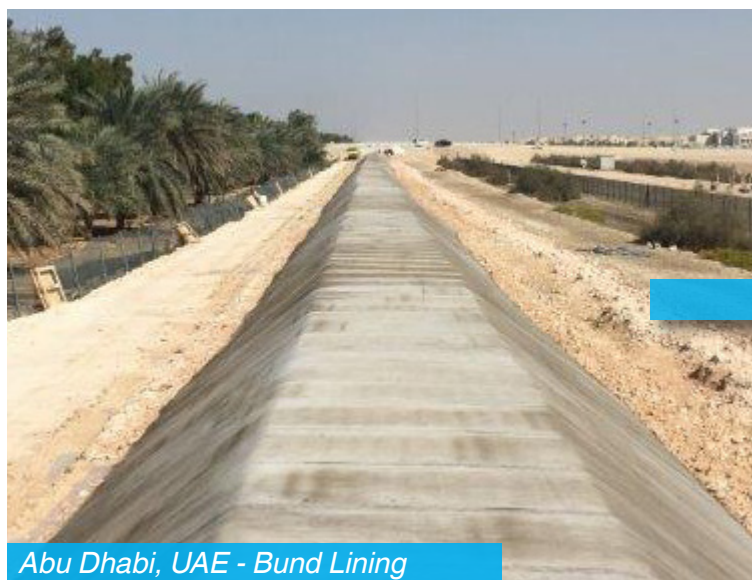
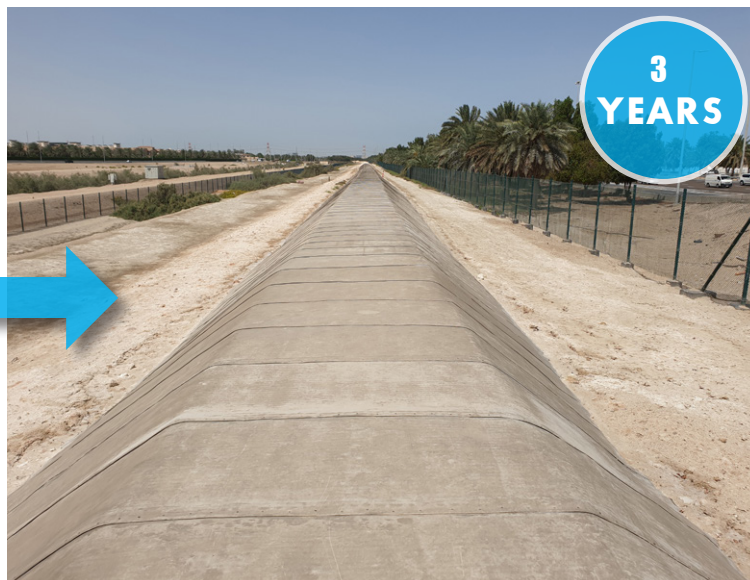
In January 2016, CC was specified to line a pipe protection berm in Abu Dhabi, UAE to provide erosion prevention. The bund was at risk of weathering erosion, due to the fine sand-based substrate, which could have led to exposure of the gas transport pipe beneath. This risk to the infrastructure and the environmental damage that would occur as a result of damage to the pipe. A total of 3000m<sup>2</sup> of CC5™ was installed in this project.

Three years on, the material is performing well in the arid climate of Abu Dhabi and the surface of the material is showing no signs of UV degradation or evidence of weathering erosion.

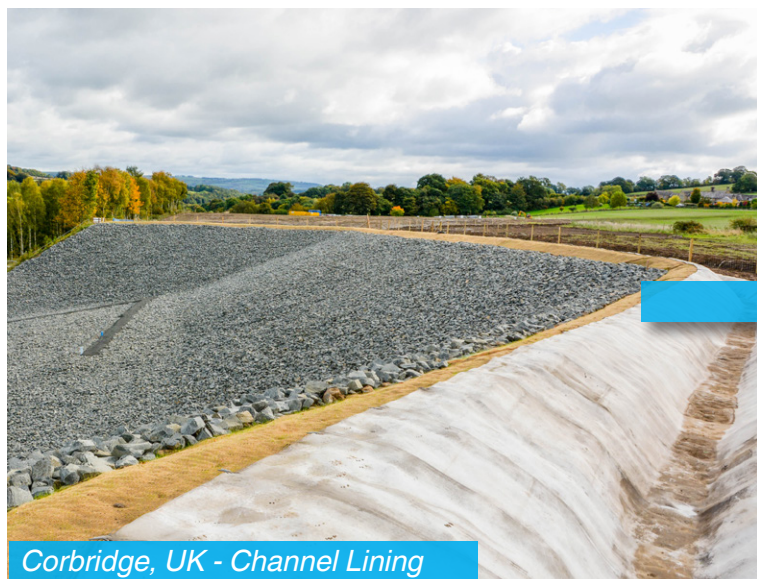
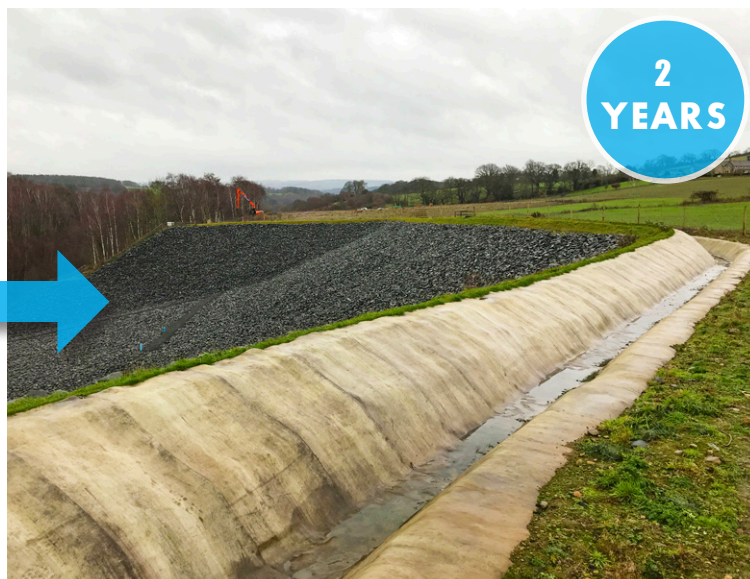
In January 2016, a steep slope overlooking part of the Newcastle to Carlisle line, between Corbridge and Riding Mill, suffered significant failure and caused a landslide, covering the tracks and closing the line. Following initial works to stabilise the slope and reopen the track, CC was specified to line a drainage channel at the crest. The channel was excavated at a greater depth than the original drainage system in order to ensure effective management of the water volumes flowing through it and reduce the risk of future ingress and slip.

Two years on, CC was found to be performing as designed and is beginning to 'green', with algae and moss growth establishing itself on the fibrous top surface of the material.

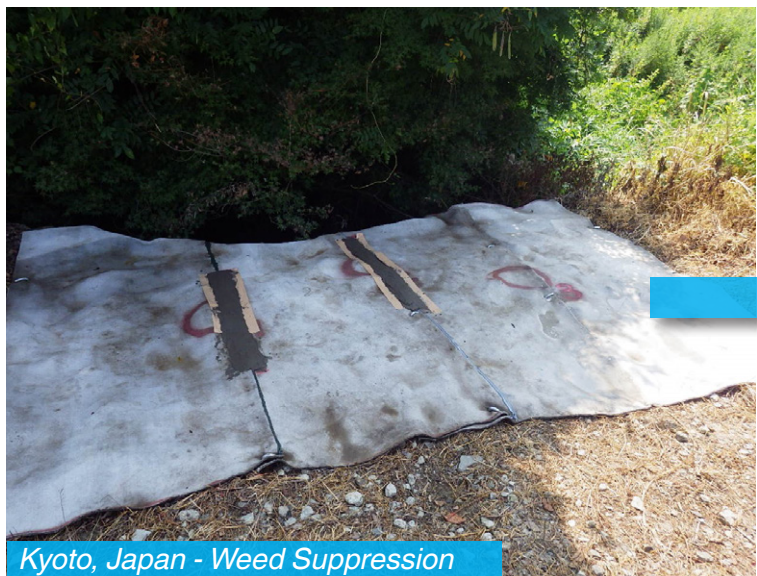
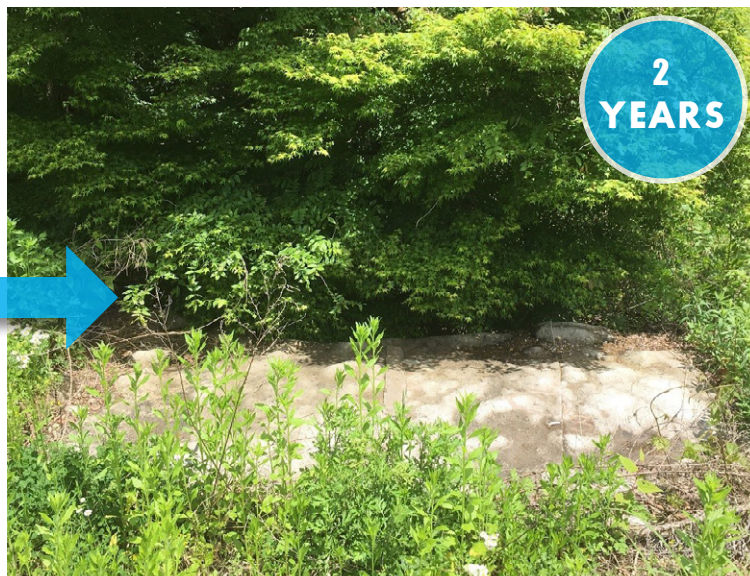
In July 2016, a trial was carried out on two sites in Kyoto Tamba-cho in Japan, to verify the strength of CC joints and establish CC's effectiveness as a vegetation control method for invasive plant species, including Japanese Knotweed.

The material joints were placed over sites where Japanese Knotweed shoots had been identified, and the sites monitored for knotweed shoot protrusions through the joints over the course of two years. CC was found to be an effective suppressant against knotweed, with no evidence of growth through the joints. The site was re-visited around six months after the end of the trial; CC was found to still be performing well, with no evidence of weed growth through the material despite a significant amount of growth around the installation and on the rest of the site.

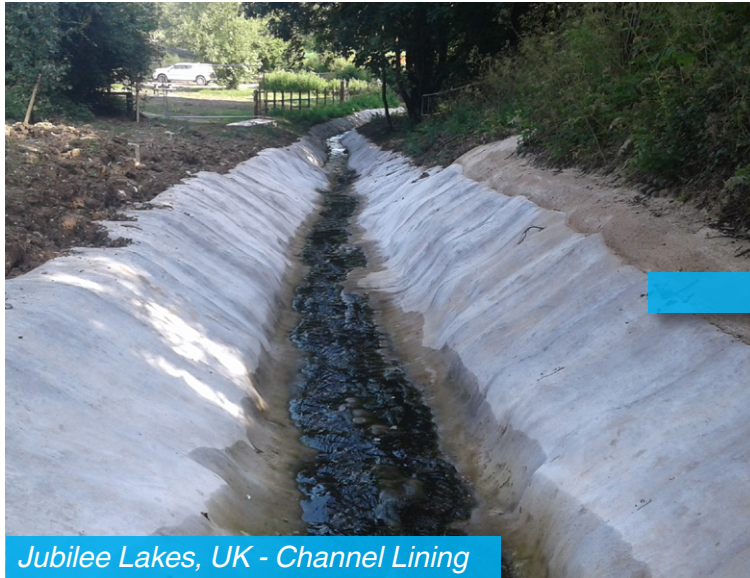
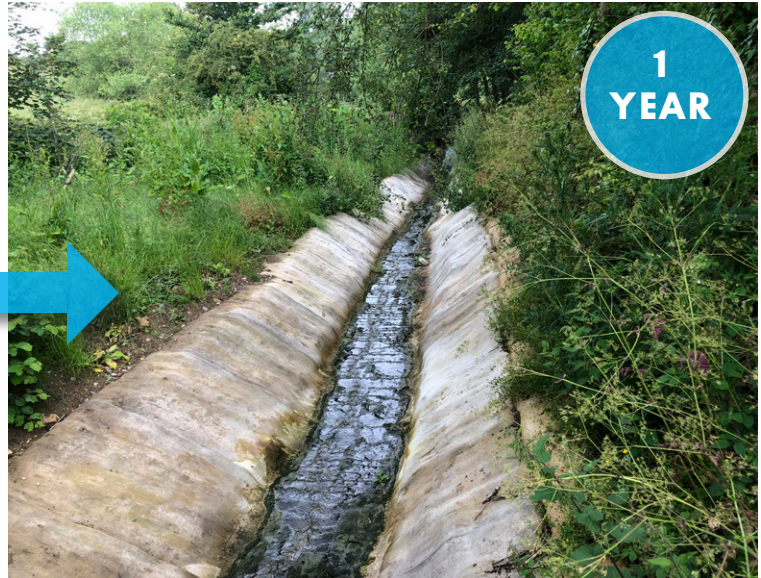
In January 2018, CC was installed as an erosion protection solution for a channel carrying water from an outfall pipe to a silt trap lagoon before entering the Jubilee Lake in Royal Wootton Bassett, Wiltshire, UK.

CC replaced a concrete block system which had eroded, leading to the formation of scour pockets. The full 75m long channel was lined and works completed within 3 weeks.

A year on, the CC had evidently bedded in quickly, with evidence of algae and moss growth on the material's fibrous top surface. This was particularly evident on the base of the channel due to typical low flows.

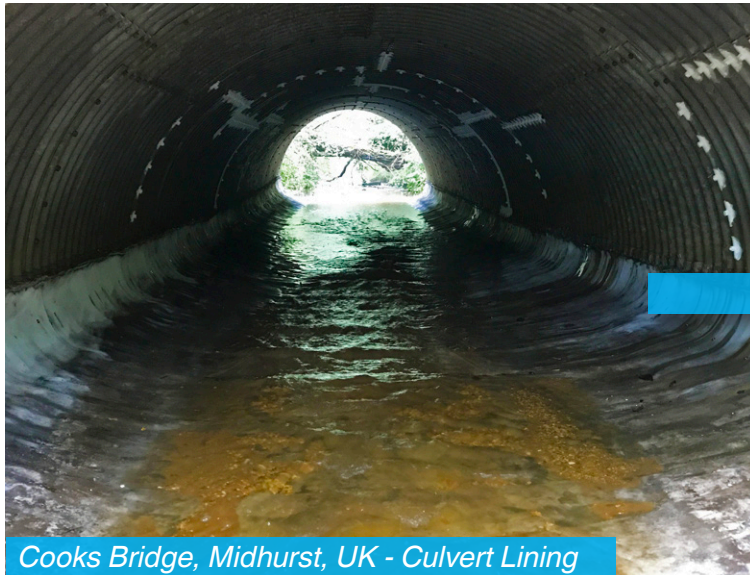
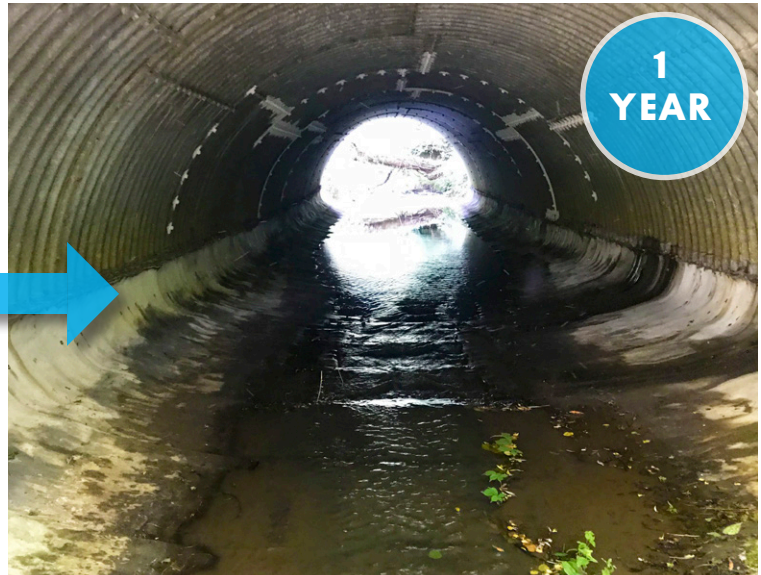
The Cooks Bridge culvert is situated below a highway, providing the only passage under the road for a stream. The existing corrugated steel culvert had corroded over time due to sediment and gravel transported through the structure in high flow conditions. The flow of water started to erode the soil beneath the structure, affecting the long-term performance of the culvert. CC13™ was specified to provide scour protection to the culvert and increase the structure's working life.

One year on, the material is successfully protecting the corrugated steel culvert. There is evidence of some build up of silt on the culvert floor, however the protection provided by CC means this will not cause any further damage to the structure.

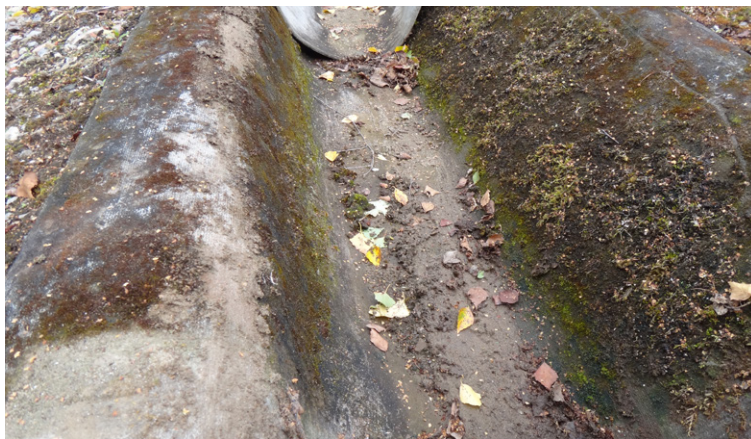
Fig. 1: Section of channel identified for testing

Samples of CC8™ material were removed from a section of channel which had been in place for 7 years in a UK climate. The section of channel identified was jet washed and labelled prior to cutting with a disc cutter. The channel sections removed were designated as being from the bottom (invert), sides or shoulders of the channel.

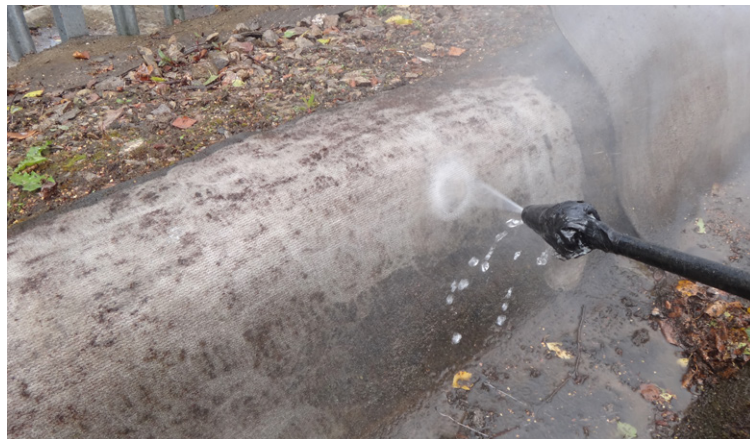
Fig. 2: Section of channel prior to cutting

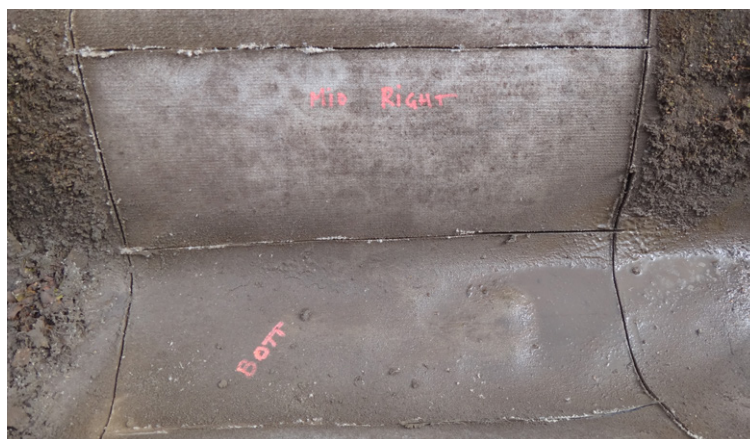
Fig. 4: Channel section after cutting

The section was cut into test bars and mechanically tested using a flexural bend test to ASTM D8058 and the 1<sup>st</sup> crack strength and ultimate bending strength recorded.
