CONCRETE CANVAS® Concrete on a Roll

AGRICULTURE CASE STUDIES

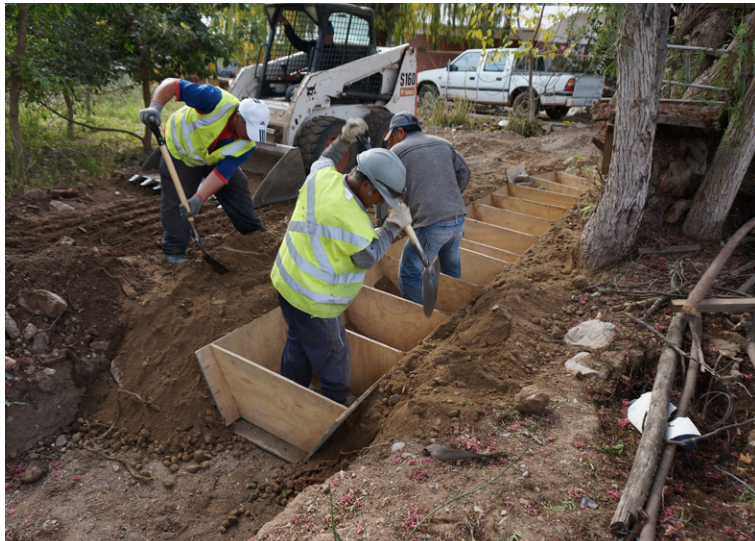
A wooden mold was used to compact the earth in preparation for installation

Vegetation, and debris were removed, and the ground excavated, levelled and compacted in preparation for installation. The CC was delivered to site in bulk rolls and mounted onto a spreader beam frame, cut to profile length to eliminate wastage and laid transversely. Overlaps of 100mm were screwed together at 200mm intervals, and the outside edges of the CC were captured in backfilled anchor trenches after being pinned using 250mm steel ground pegs. Hydration was then completed using a roadside 1000L water tank and motorised pump.

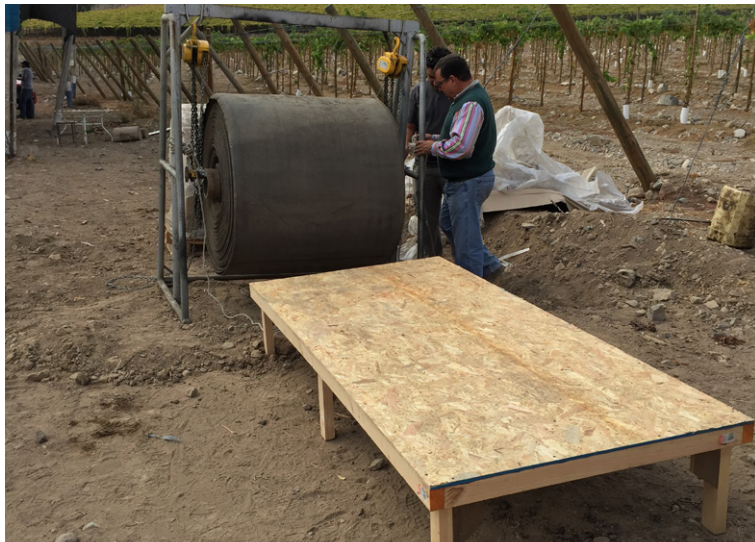
The CC was delivered to site in bulk rolls and cut to profile length using knives

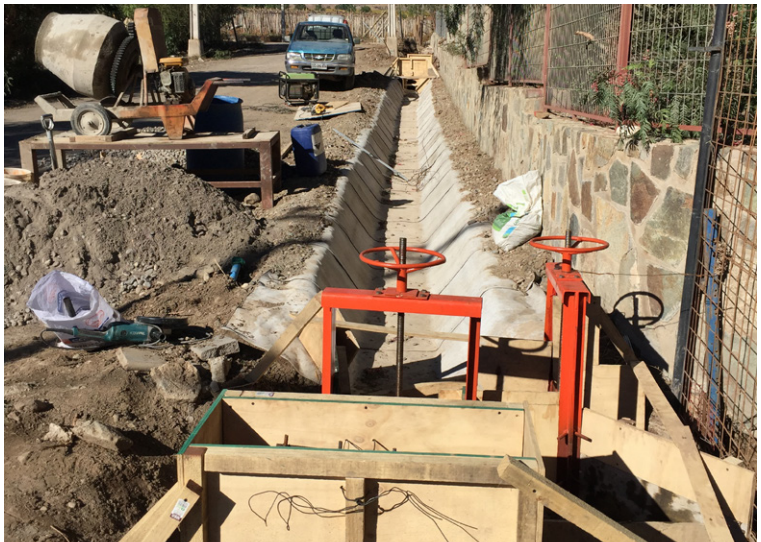
The CC was laid transversely across the channel

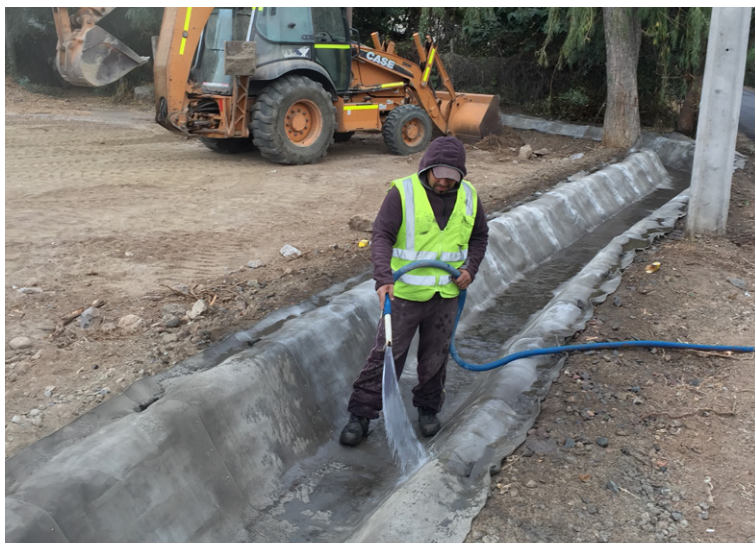
Hydration of the channel

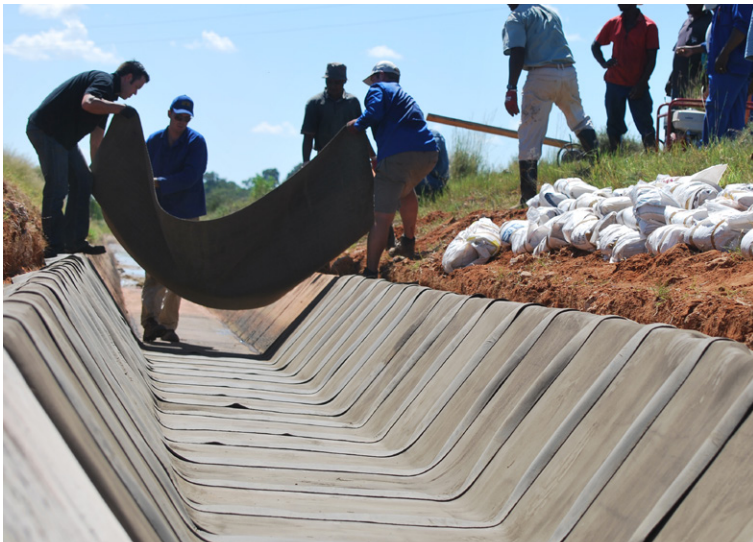
The CC was laid transversely

Prior to installation, any debris was removed from the existing concrete channel and the CC delivered to site in bulk rolls. The CC was cut to profile length and laid transversely across the canal, which measured approximately 2.9m wide. A surface-to-surface bonding technique was then used, where the CC was folded back on itself by 50mm so that the Canvas to Canvas contact was used for securing the joints with the overlap in the direction of water flow.

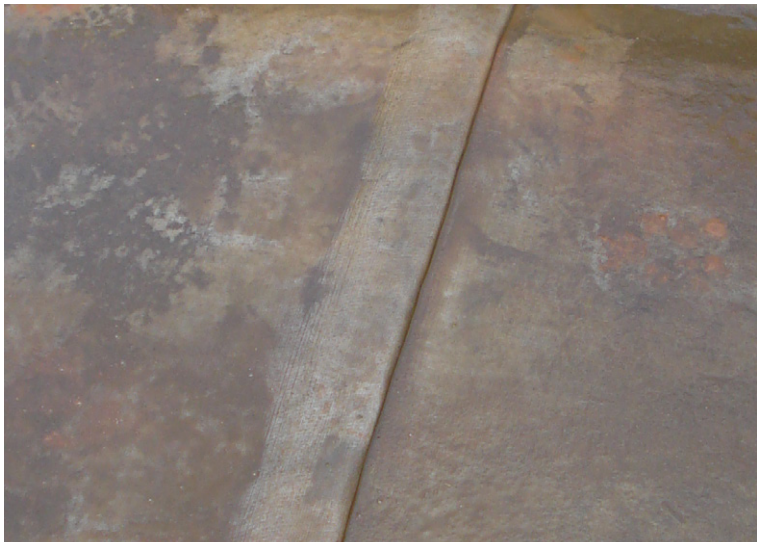
The CC overlaps were folded under by 50mm to create a water tight seal

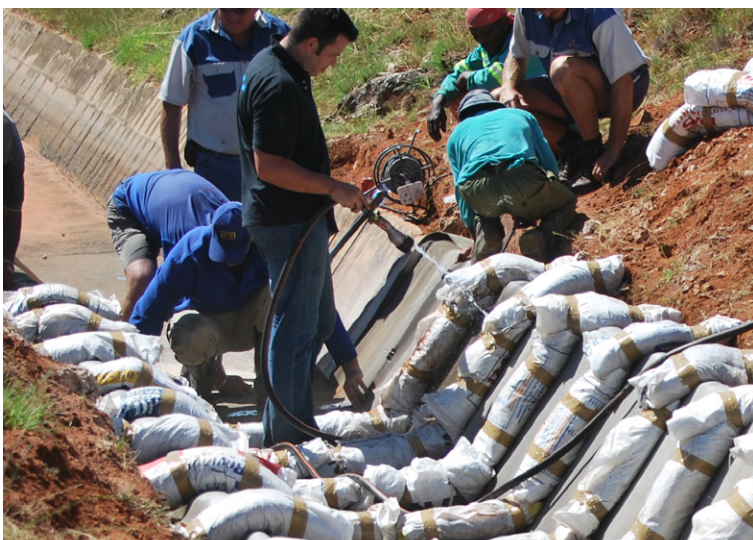
The CC was hydrated via hose

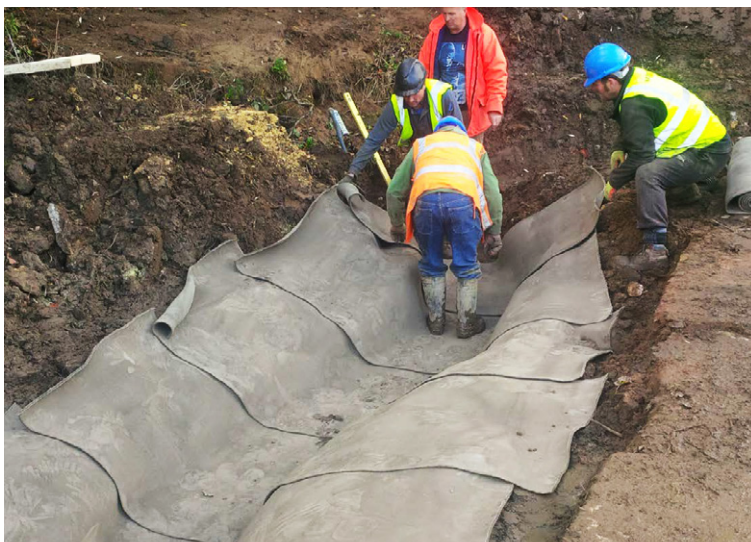
CC was laid transversely across the channel

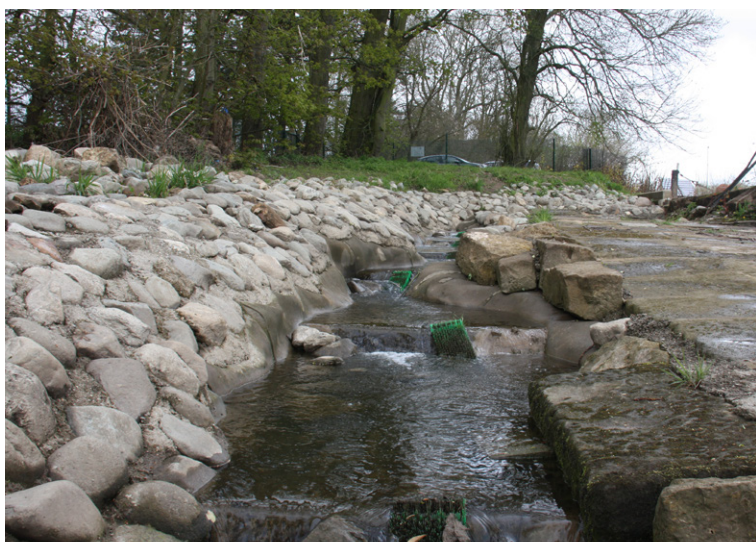
Completed installation and artificial assits for species migrating upstream

The project came with several challenges, including needing a constant trickle of water flow, an impermeable channel which could carry low-flows without leakage, a gradient that would allow pools with drops no greater than 100mm, and connections to the River Ouse both up- and downstream of the Weir. It was impossible to form a natural channel due to instability of the site, and so mass concrete and reinforced concrete channel forms were considered; however, the expense, high carbon impact and differential settlement made these options unsuitable. CC's lower carbon profile, natural looking properties and ability to promote algae and weed growth while still suppressing root growing vegetation meant it was chosen instead.

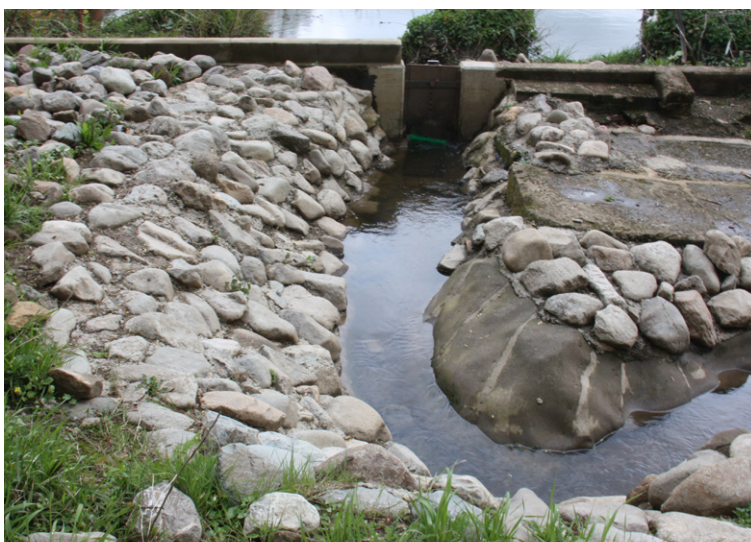
Sealed joint corner detail

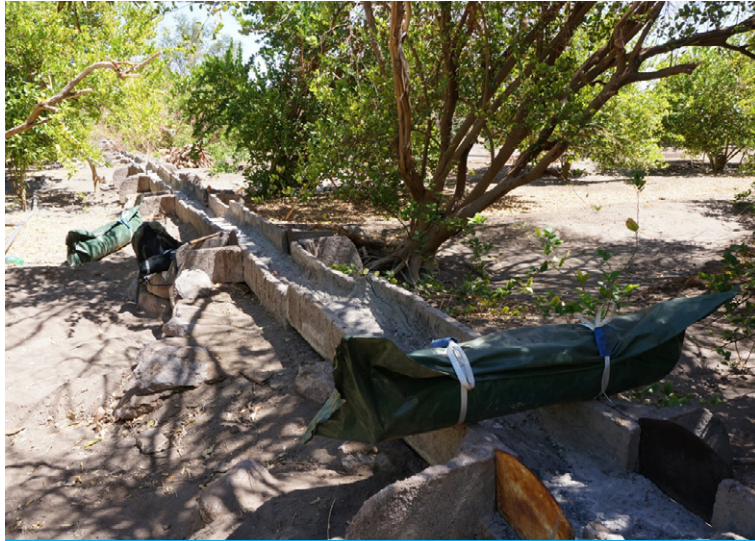
Damaged channel before repair

On the 1st of April 2014, an 8.2 magnitude earthquake struck off the coast of Chile. The force of the earthquake broke apart the farm's existing poured concrete irrigation ditch, cracking it in several places and making it unusable. This posed an immediate threat to the lemon trees and livelihood of the farmers. The works were carried out by INDAP (a government agency dedicated to help small farmers) and Pacifictek, who also funded the project as a joint venture.

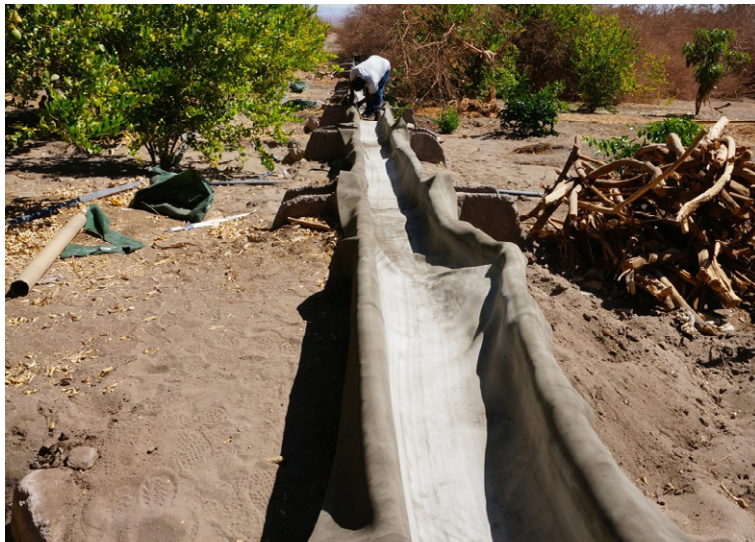
The CC was laid longitudinally down the channel and fixed down the sides

Man portable batched rolls of CC5™ were carried to site, as the proximity of the trees would not allow any kind of plant access. Debris was cleared from the channel, before CC was unrolled down its length and folded over the existing structure. The CC was fixed to the poured concrete form using masonry screws at 200mm intervals. Each layer was overlapped by 100mm in the direction of waterflow, screwed and grouted with an epoxy grout. Epoxy grout was also used on the joints created by the steel doors located on the sides of the channel, which are opened to allow irrigation.

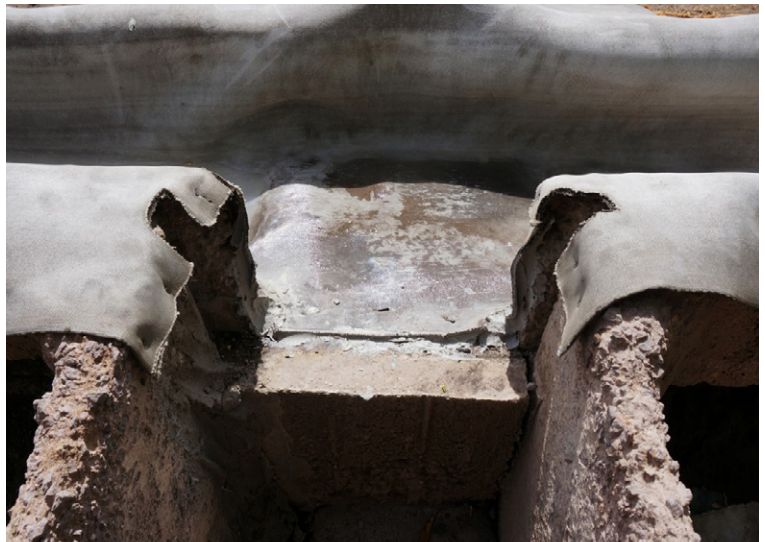
Screws were used to fix the CC in place

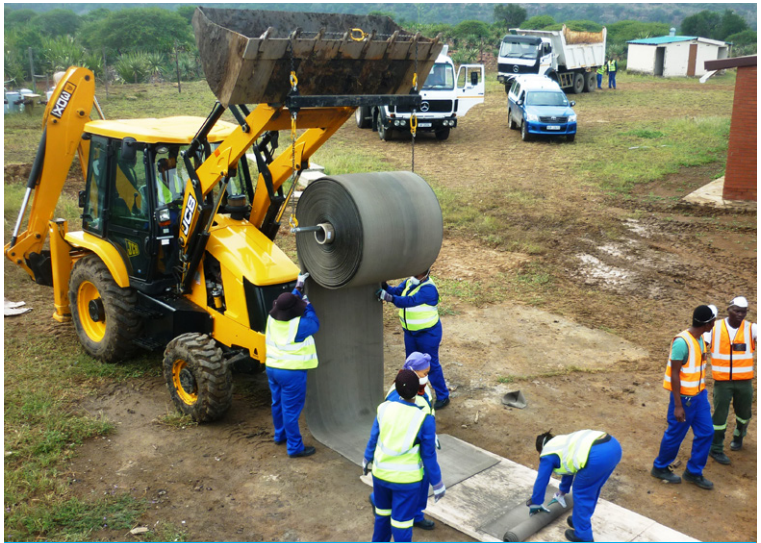
CC was delivered in bulk rolls and unrolled from a spreader beam

Due to the profile varying between 2m and 3m, a transverse layup was used to minimise wastage. The canal was cleared of any debris or vegetation and crumbling concrete was removed from cracks and voids before they were filled, and anchor trenches were excavated along the shoulders. The CC5™ was mounted onto a spreader beam hung from a JCB, and batched to specific profile length on site. The CC was unrolled across the channel, with layers overlapping by 100mm and the open edges placed into the anchor trenches. Hydration was given via 5000L water bowser and hose. 30 minutes later, knuckle joints were formed by folding the material back under itself, creating a 50mm wide knuckle. These joints were then hydrated again and compressed with sandbags. After setting, the anchor trenches were backfilled.

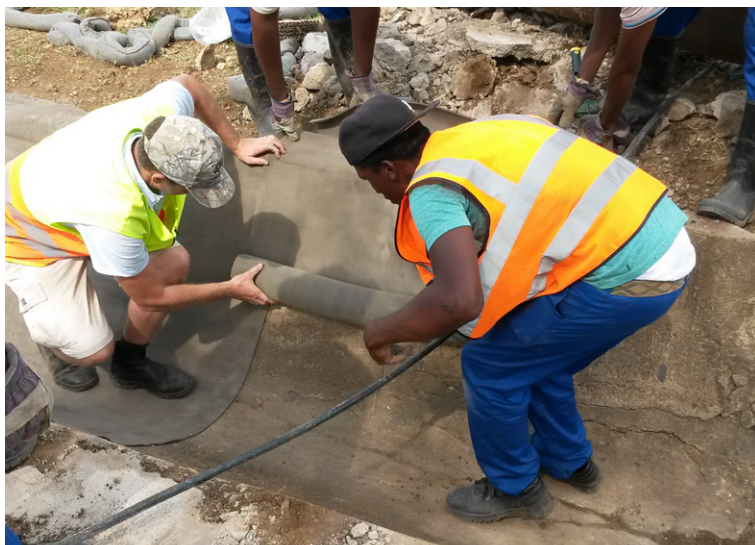
The CC was laid using a transverse layup

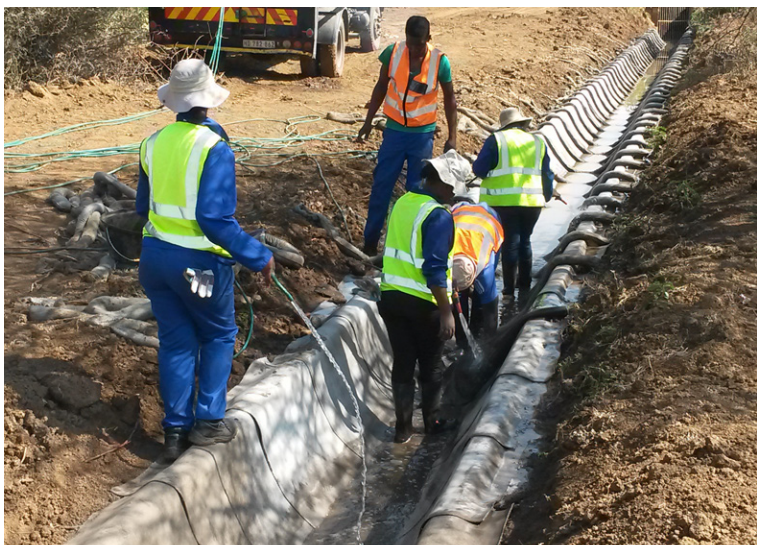
Joint overlaps and hydration via hose

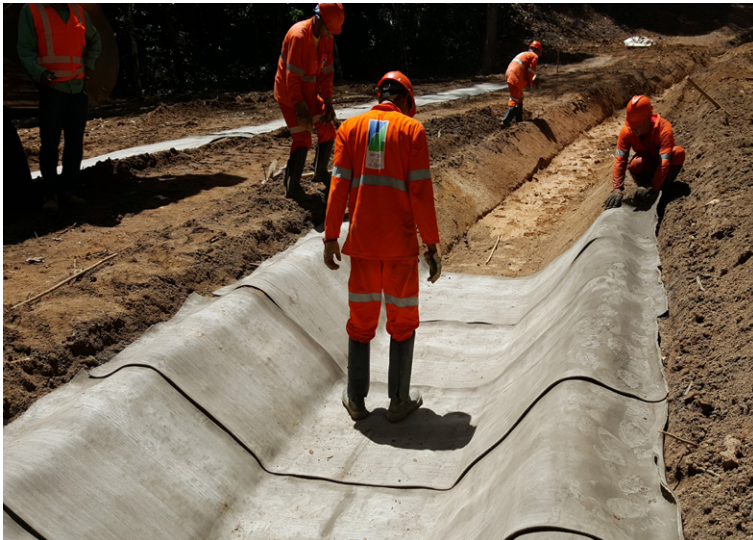
CC was laid transversely

In preparation for the installation, all existing vegetation from the site was removed as far as the tree line, which, due to environmental restrictions, could not be touched by installation the team. The drainage of the site was then considered before the channels and anchor trenches were dug. The CC was delivered to site in bulk rolls, and laid transversely across the channel profiles, fixed and then hydrated.

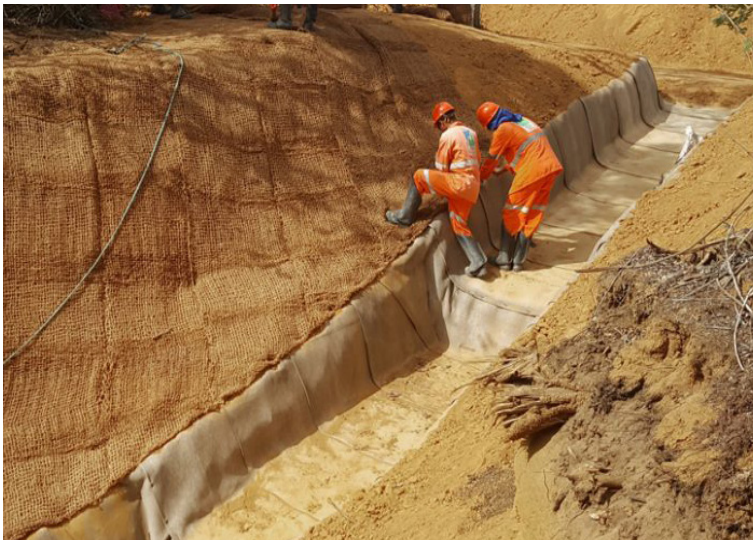
Coconut fibre was fixed to slopes around the channels after installation

1,125m² of CC8™ was installed over a period of ten days by a team of six people. A total of nine bulk rolls were installed for channel lining, and some CC was used for slope protection where required. The project spanned across three weeks as a geosynthetic material made of coconut fibre had to be laid down on top of the soil.

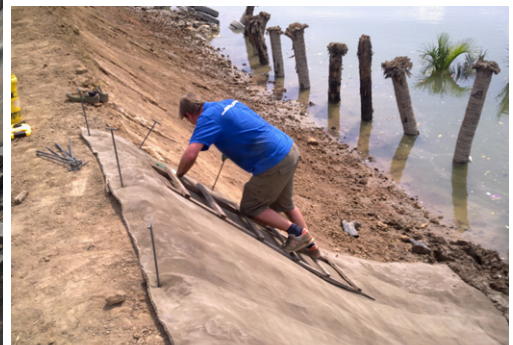
Pegging the pre-cut layers of CC to the substrate

The CC was delivered to site in batched rolls of CC8™, unrolled and cut to specific profile length and fixed to the slope using steel pegs. The edges of the CC were then buried in anchor trenches at the crest and toe of the slope and backfilled with soil. Hydration was then given using water from the lake below.

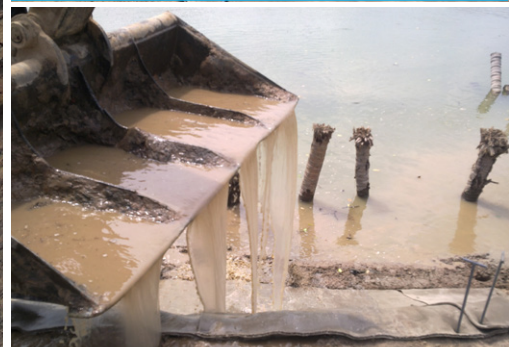
Hydration of the CC using plant site equipment

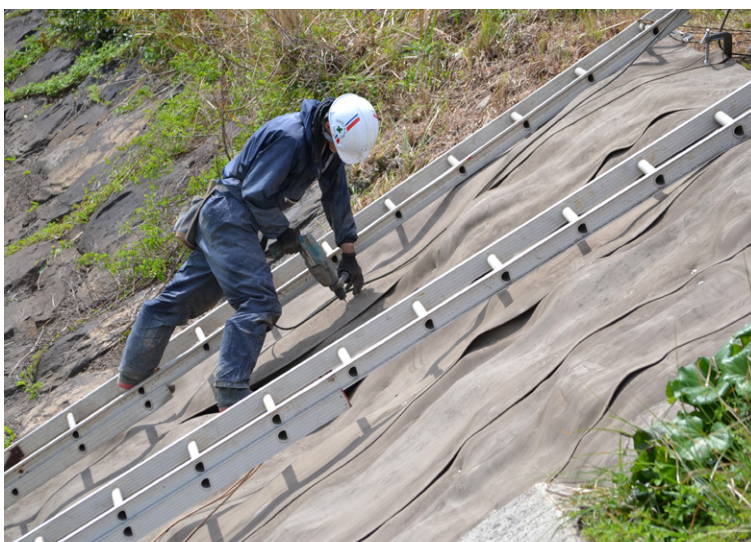
The CC was drilled, before being fixed with anchor bolts to the partial rock surface

Ground preparation for the installation consisted of the removal of all existing vegetation in the area, before the CC was laid and fixed using galvanised steel pegs, anchor bolts and sealant. The CC was then hydrated from the water below with the aid of a hose.

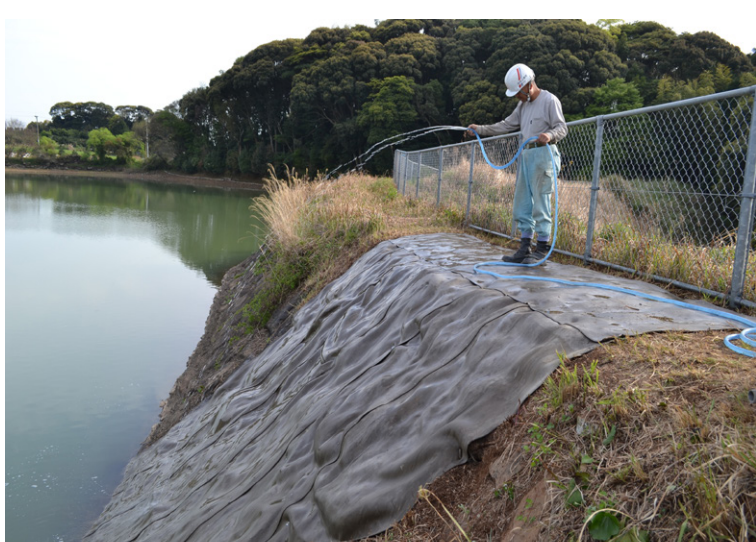
Water from the site was used for hydration
