**CONCRETE CANVAS®**  
Concrete on a Roll

CHANNEL LINING  
CASE STUDIES

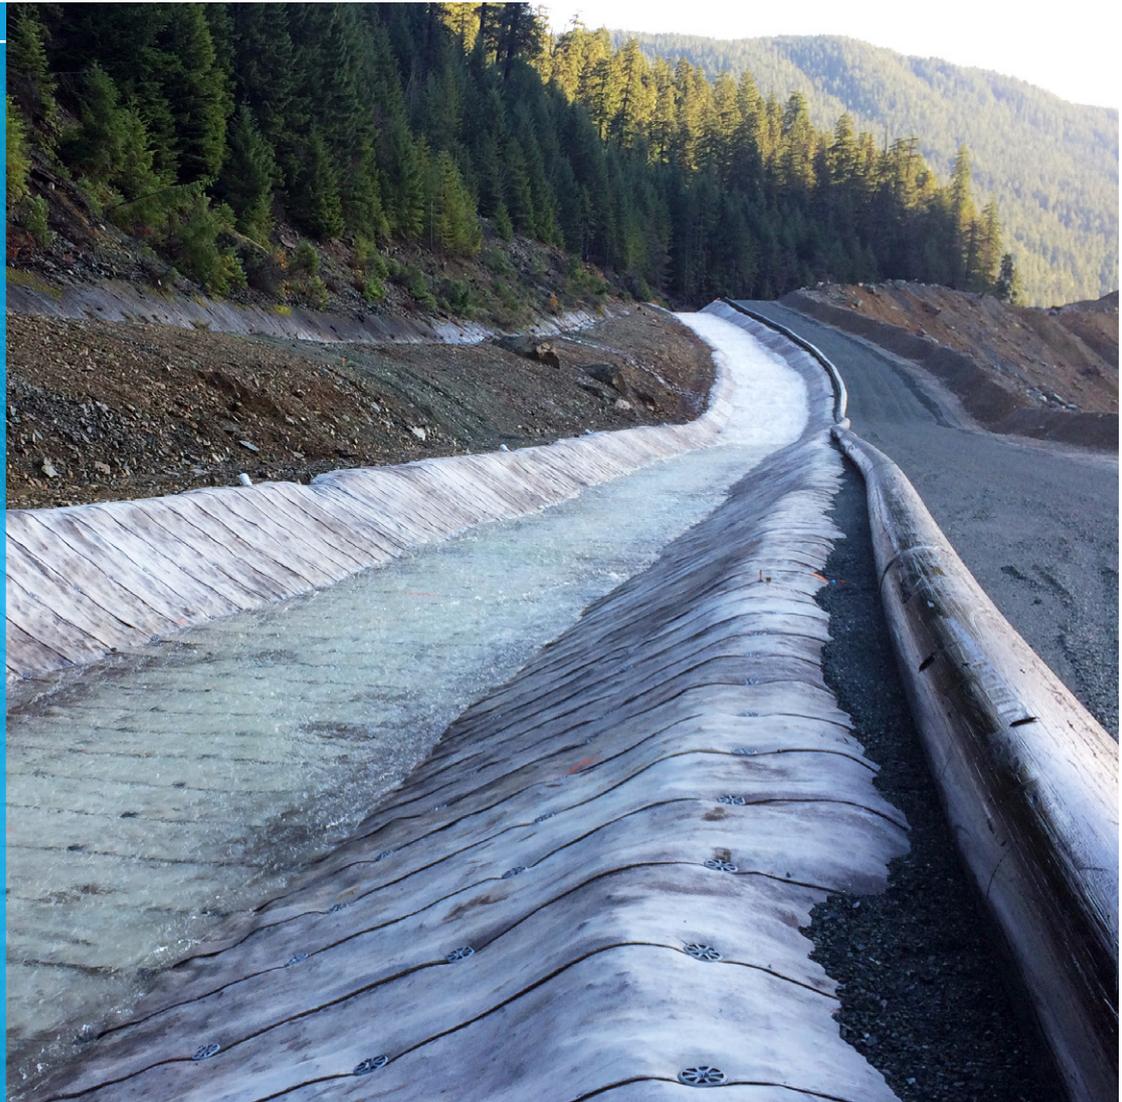
Completed CC lined channel with high flow 5 weeks after installation

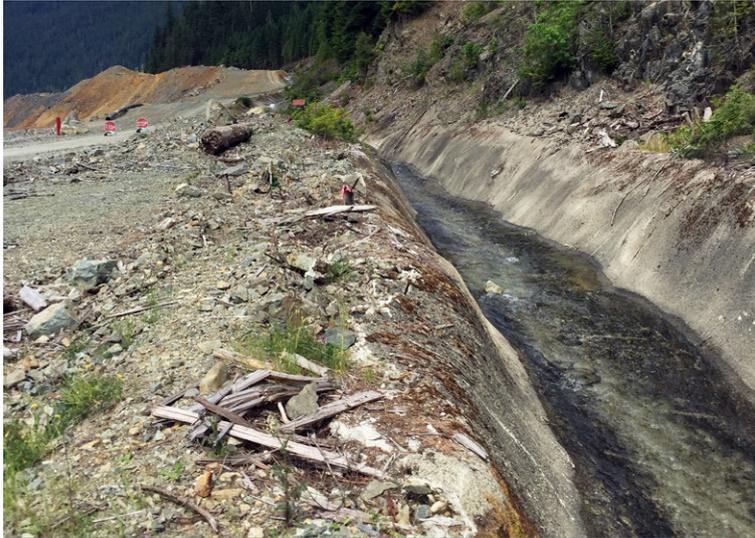
*Previous shotcrete lined channel showing signs of degradation*

The diversion channel, which conveys clean water from the hillside above to a lower creek, was originally lined with shotcrete but the material had begun to degrade over time. It was recommended that the diversion channel should be enlarged and realigned to effectively handle the high-water volume and velocities.

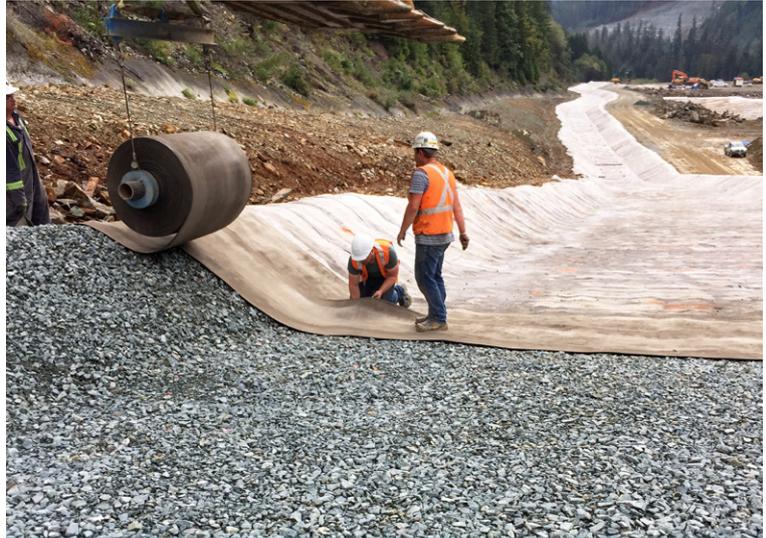
*Dispensing of bulk roll CC8™ via spreader beam mounted onto excavator*

To account for the variation in profile width, a transverse layup was specified and bulk rolls of CC8™ were deployed from a spreader beam mounted from an excavator to unroll the material across the width of the channel. Adjacent layers of CC8™ were overlapped by 100mm in the direction of water flow and secured using 1.5m earth percussion anchors with 3mm stainless steel cables every meter along the overlaps in conjunction with 8 stainless steel 1" screws at 150mm intervals. The CC was pinned into 300mm deep anchor trenches on either side of the channel using the 1.5m earth percussion anchors. The trenches were then backfilled with material to provide a neat termination and to prevent water ingress underneath. When fixing the CC to rock in some sections of the channel, Hilti rock anchors and 600mm rock bolts were used.

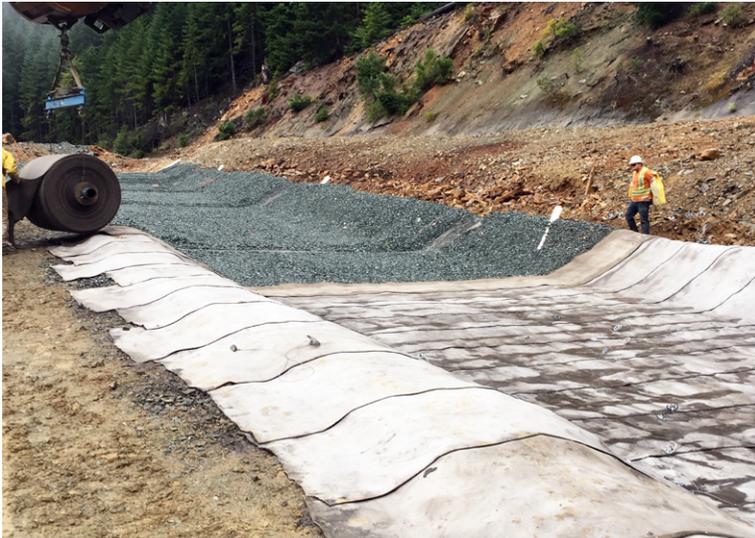
*Anchor trench prior to backfilling*

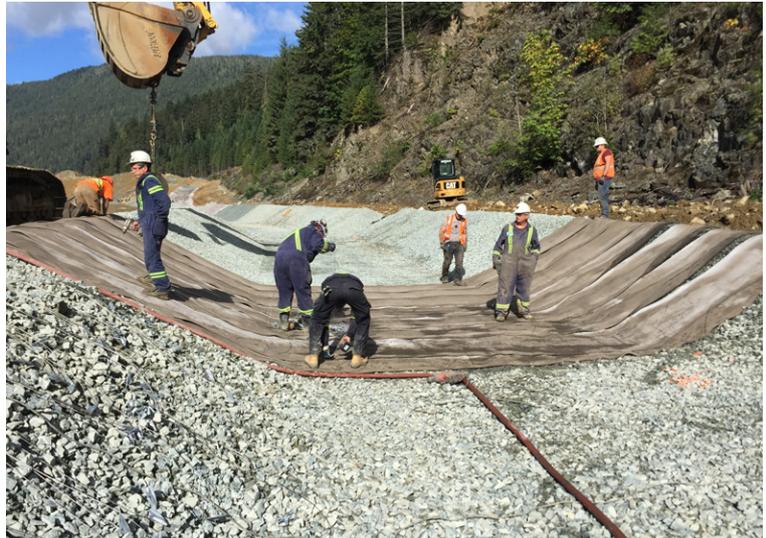
*Screwing overlapped joints at 150mm centres*

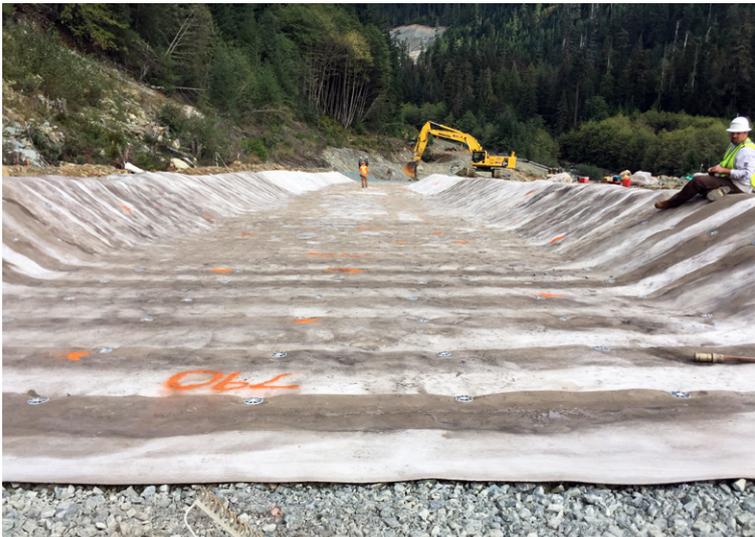
*Spacing of percussion anchors through overlapped CC8™ layers*

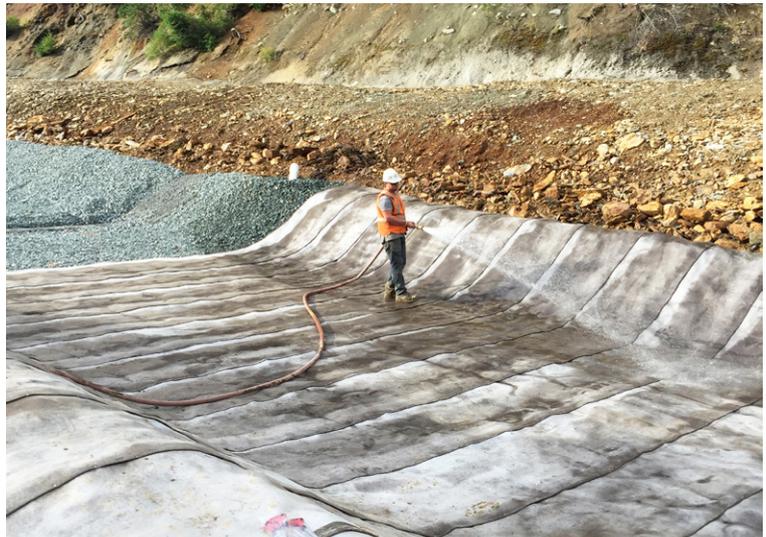
*Hydration of the CC layers*

The material was hydrated using a water truck and due to CC having a very low wash out rate and low alkaline reserve, treatment of the run off from installation was not required. CC has a working time of approximately two hours from hydration, meaning that work can continue even in very wet conditions. This can reduce programme disruption typically caused by bad weather when using traditional solutions.

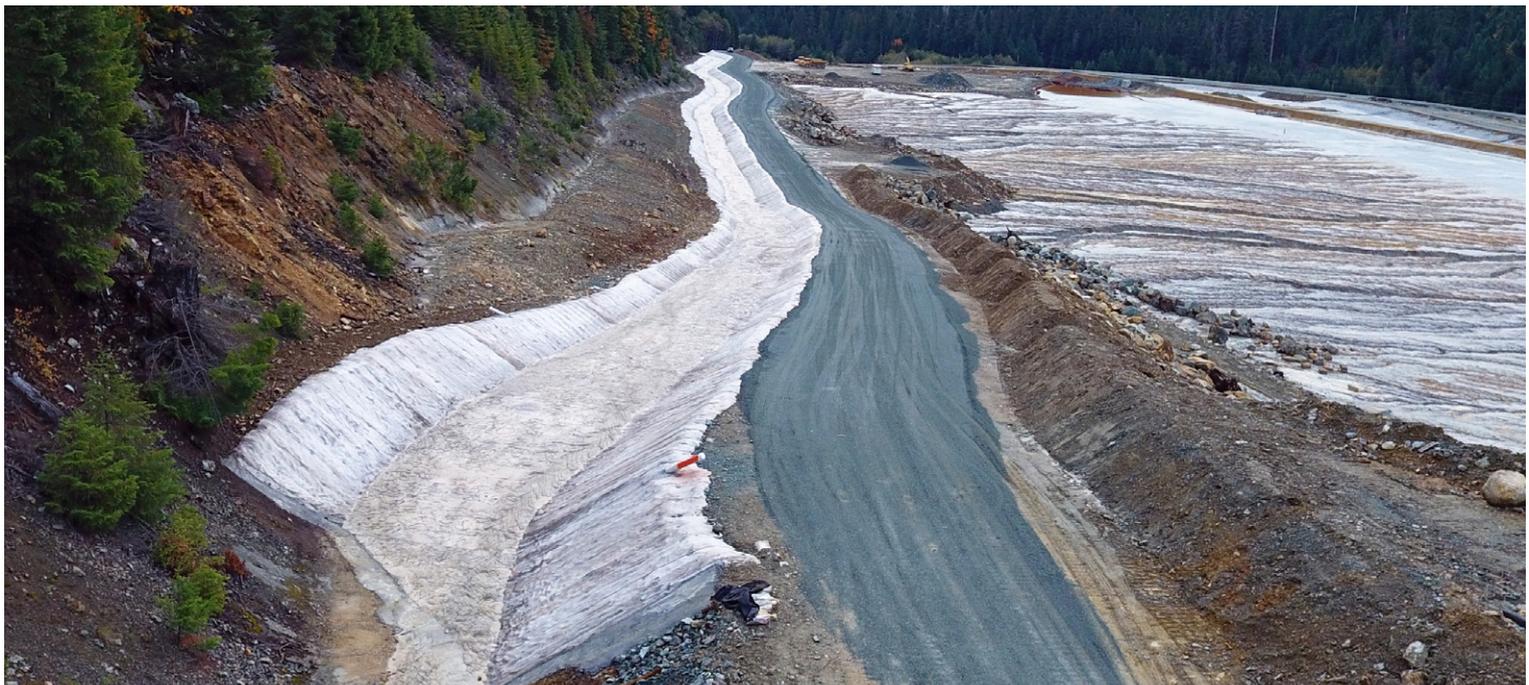
*Aerial view of the mouth of the channel showing transition anchor trench*

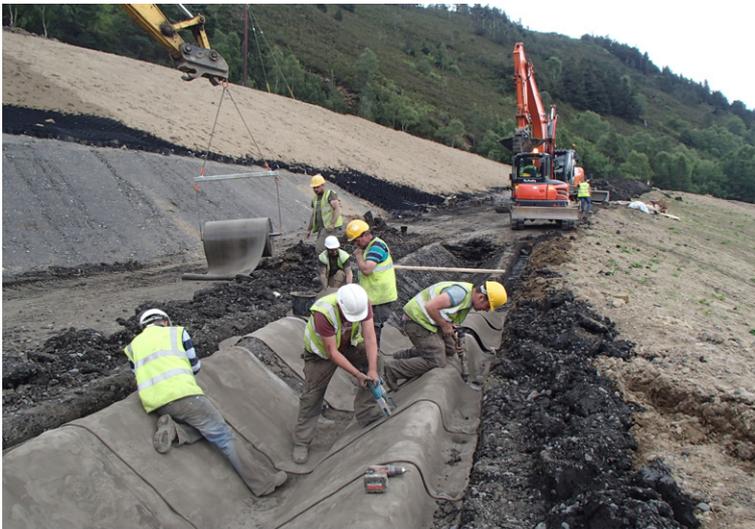
Sealing overlaps with Clearfix & securing with screws at 200mm intervals

The CC was laid transversely to accommodate profile variations, overlapping layers by 100mm in the direction of water flow. The overlaps were sealed using Everbuild Clearfix adhesive sealant, and screwed together at 200mm intervals. The edges were secured in the anchor trenches using ground pegs before the trenches were backfilled as an extra precaution against undermining. In some areas, concrete steps were installed and CC was laid over them to dissipate the water energy. The CC was pinned into the vertical interface of the steps using Hilti anchors. The CC material was hydrated after each day's work.

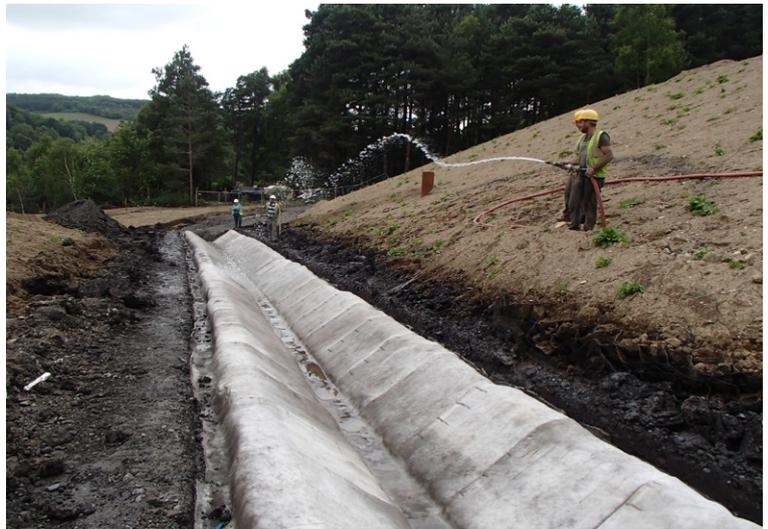
Hydrating the CC13™

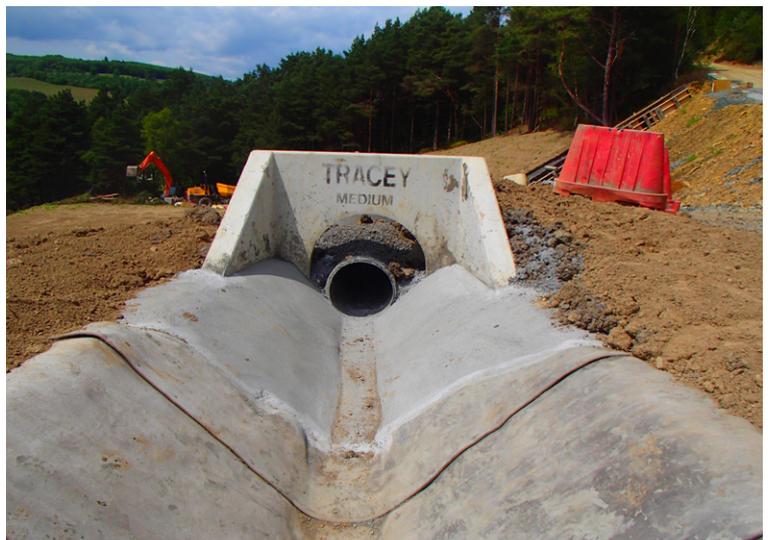
Headwall detail on upstream side

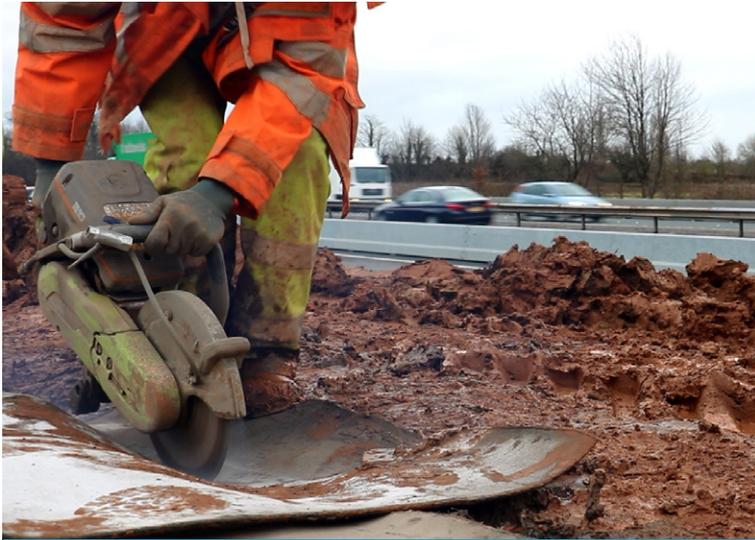
Hand power tools were used to cut the CC

The existing poured concrete channel was removed and the new section was excavated using plant and v-bucket. The base was then scattered with aggregate before the CC was laid across the width of the channel and cut to size using a petrol disc cutter. The CC was overlapped in the direction of water flow by 100mm, and screwed together at 200mm intervals. The outside edges of the CC were then pinned in anchor trenches using 200mm steel ground pegs and backfilled. Hydration was then given via a roadside bowser and pump.

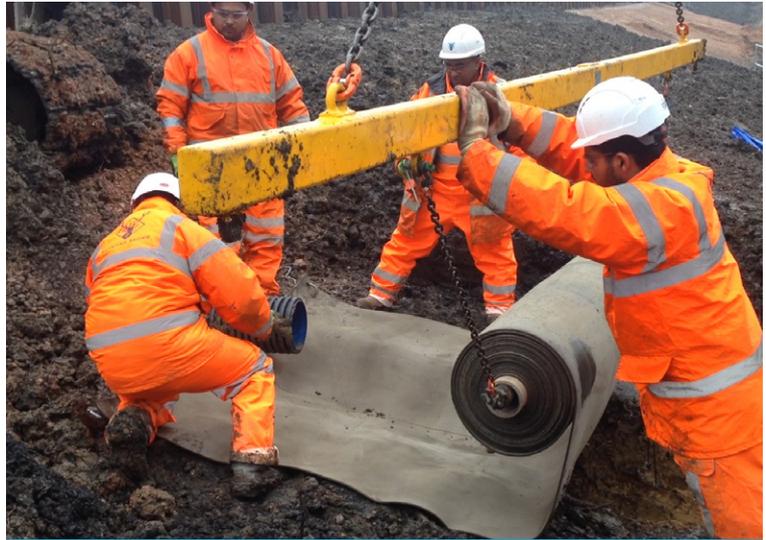
Steel pegs and screws were used to secure the CC

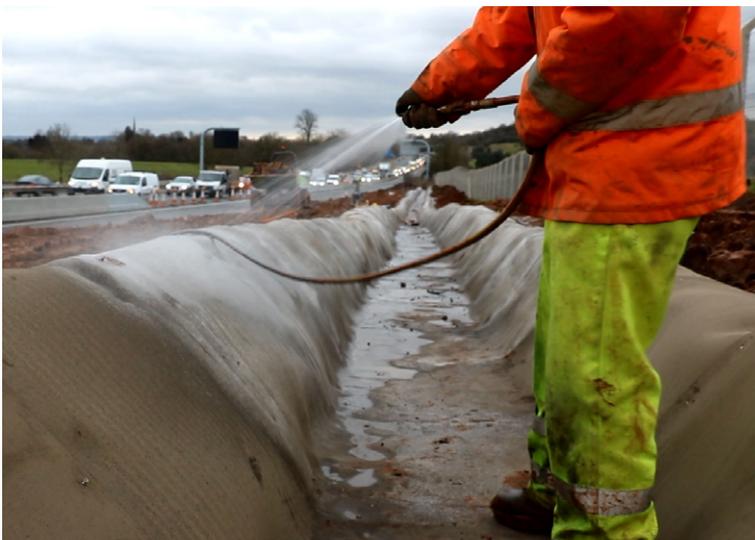
Hydration was given via hosepipe

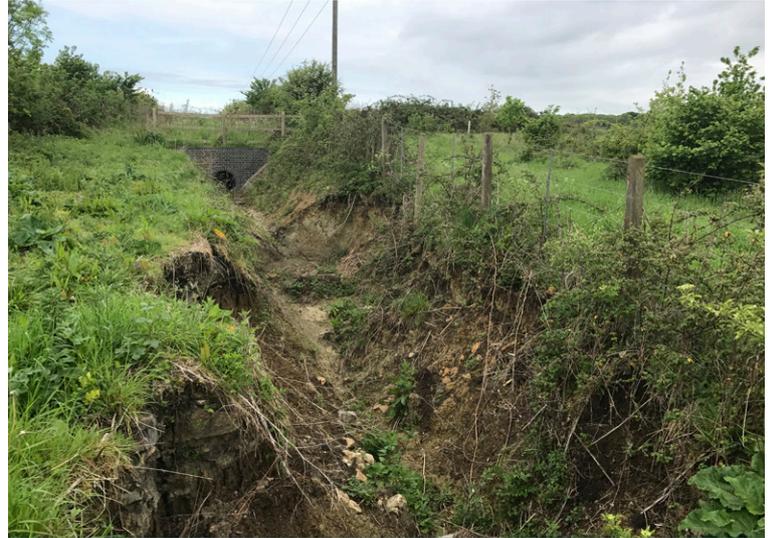
Unlined channel showing 3m deep scour and erosion

Since then, downstream of the original installation, an unlined section of the channel had eroded away, resulting in a 3m deep scour pocket occurring as water discharged from a headwall. The scour resulted in flooding of neighbouring fields and there was concern that future storm events could flood the nearby track. The works were carried out by BAM Nuttall for Network Rail, with consultation from Tony Gee and Partners LLP.

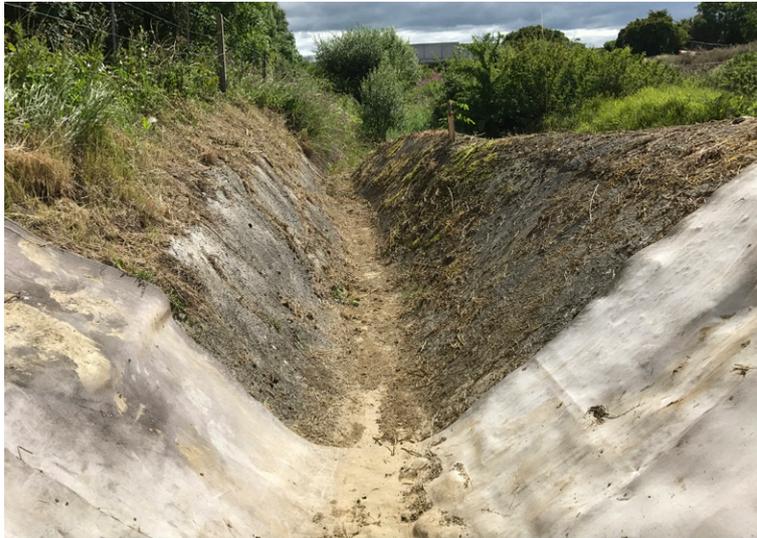
First layer of CC placed on existing concrete channel

The team began downstream at the existing concrete channel and worked upstream towards the headwall, overlapping adjacent layers of CC in the direction of water flow. Overlapped joints were screwed together to ensure intimate contact and prevent erosion between layers. To prevent water ingress beneath the material, the edges of the CC were terminated in an anchor trench, secured using ground pegs, and the anchor trench backfilled.

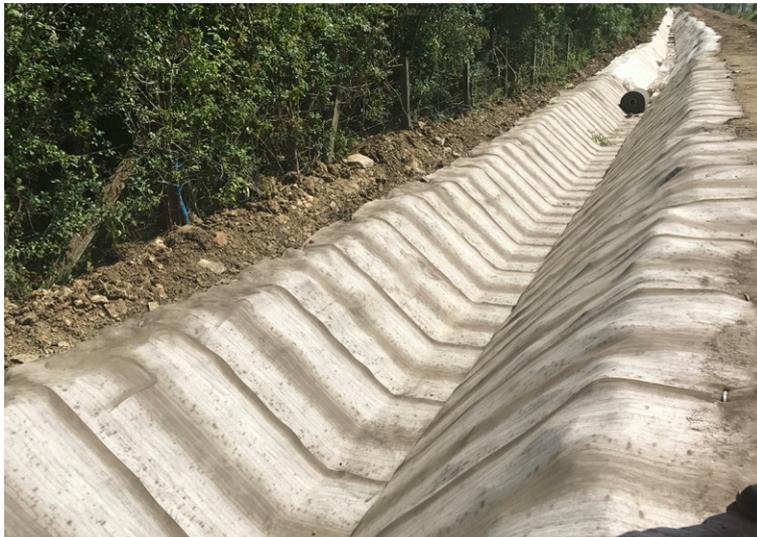
Installed CC prior to hydration and backfilling of anchor trench

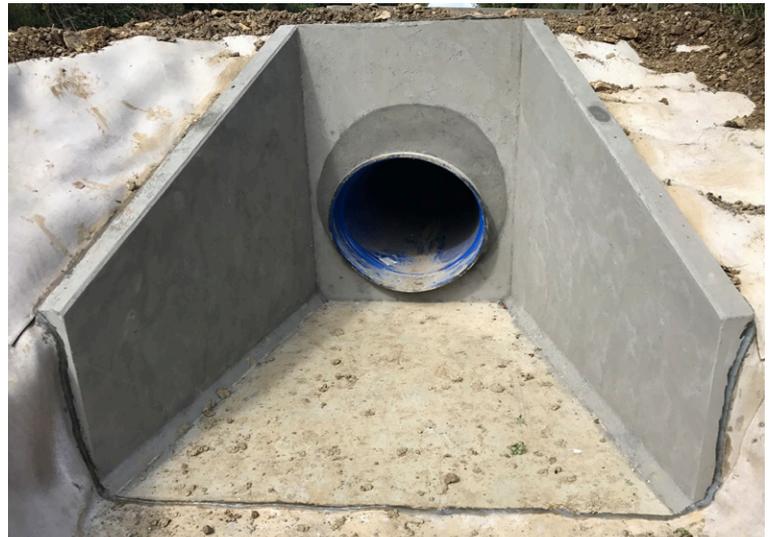
Headwall detail

At the headwall, the CC was laid underneath before being placed on top. The wingwalls to the headwall were backfilled to ensure the CC was tightly captured. All joints between the headwall and CC were finished with an adhesive sealant to prevent water ingress and potential scour.

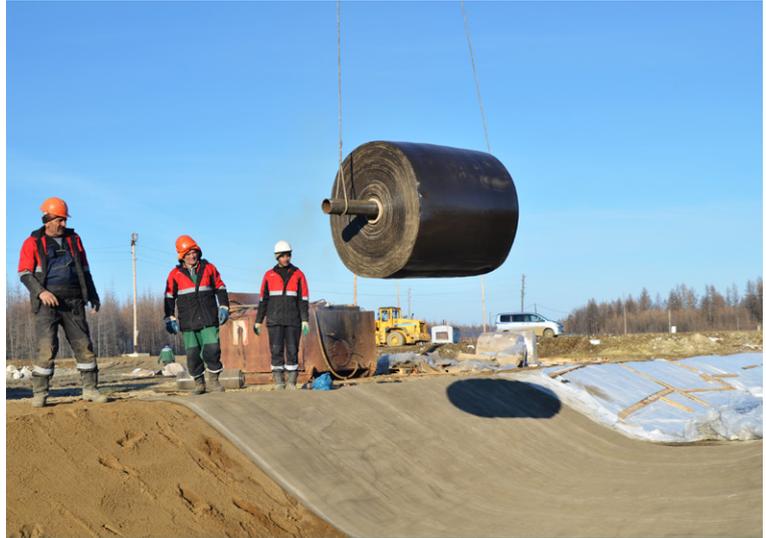
Bulk roll of CC13™ being lowered into position

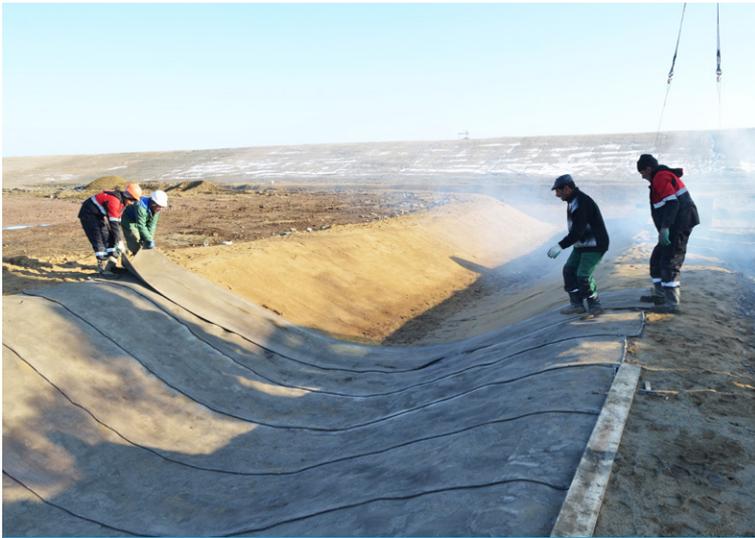
Overlapping the CC layers by 100mm

The CC was mounted onto a spreader beam and hung from a crane, unrolled across the channel before being cut to specific profile length with a utility knife, minimising wastage. The contractor laid the CC transversely, overlapping layers by 100mm in the direction of water flow. The overlaps were screwed at 200mm centres with 30mm screws. 400mm groundpegs were inserted through every overlap at the crest of the channel. One longitudinal layer of CC was used to cover the leading edge of the transverse layers and then buried into the anchor trench as an extra precaution against undermining. The CC was hydrated using a hose with spray nozzle attached and a 6000ltr water carrier. After hydration, the CC was protected with plastic sheeting due to the expected low overnight temperatures.

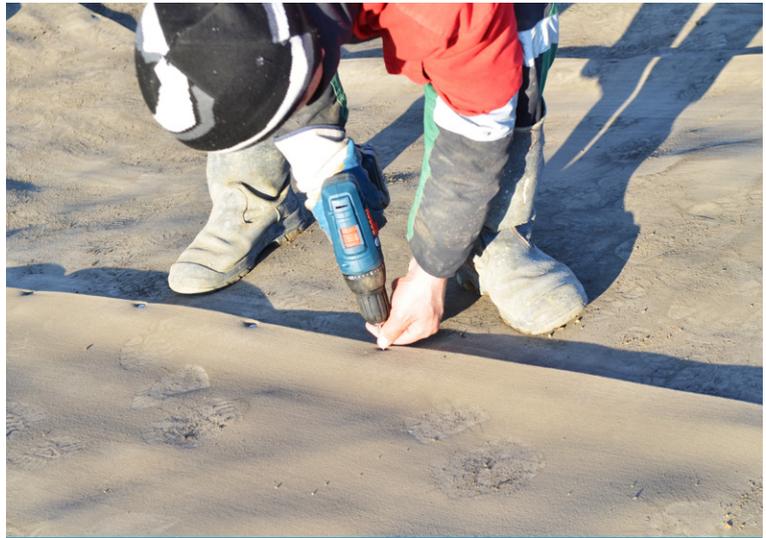
Joining the CC overlaps using screws

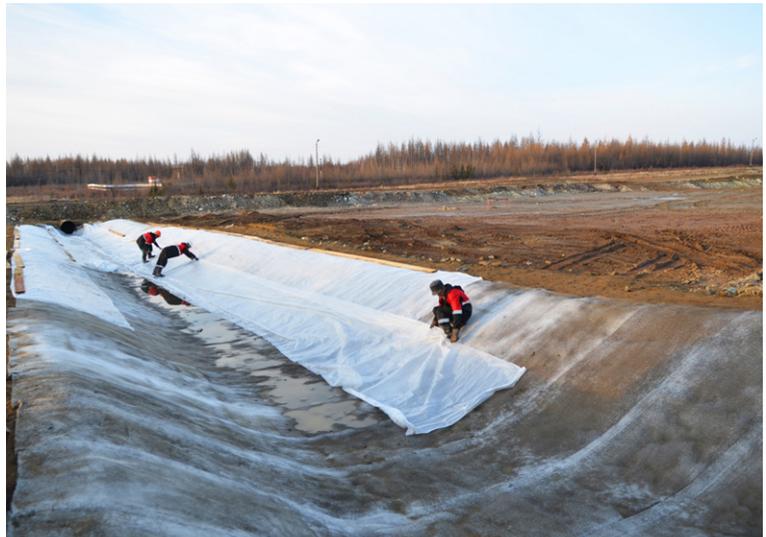
Protecting the CC with plastic sheeting
