CONCRETE CANVAS® Concrete on a Roll

CULVERT LINING CASE STUDIES

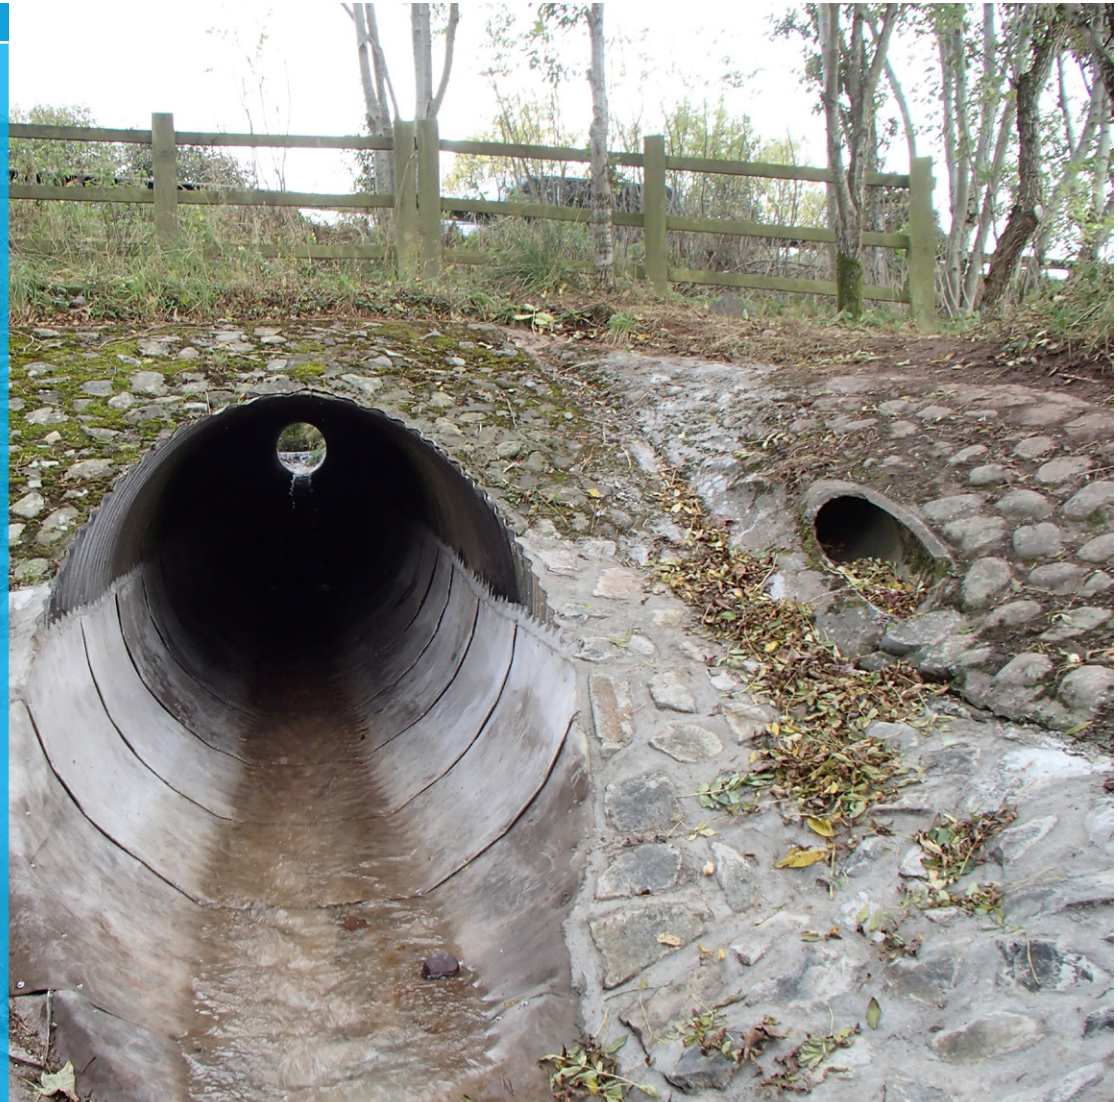
The completed culvert lining installation in Laurencekirk, Scotland.

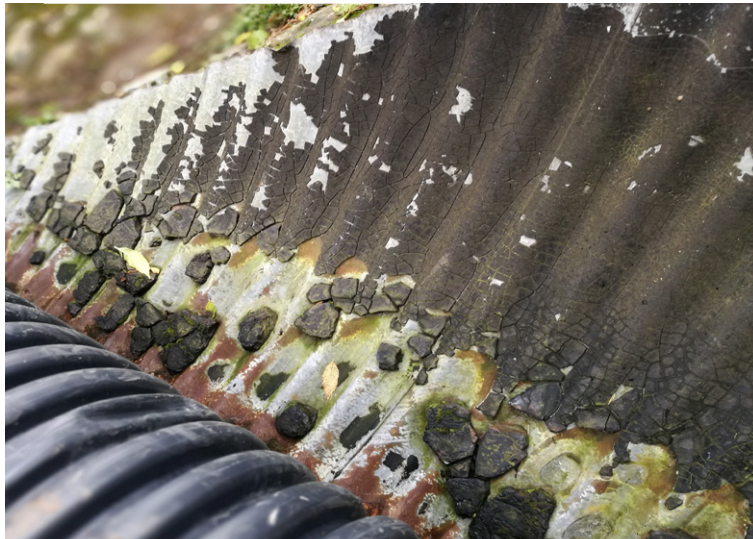
The original corrugated steel culvert, known as the Kirk Burn culvert, was 1.8m in diameter and had sustained significant degradation and erosion due to heavy water flows and abrasion. As a result, the existing 25mm bitumen coating inside the pipe had broken down through constant flow erosion and weathering.

Flow erosion had caused the existing bitumen lining to break down

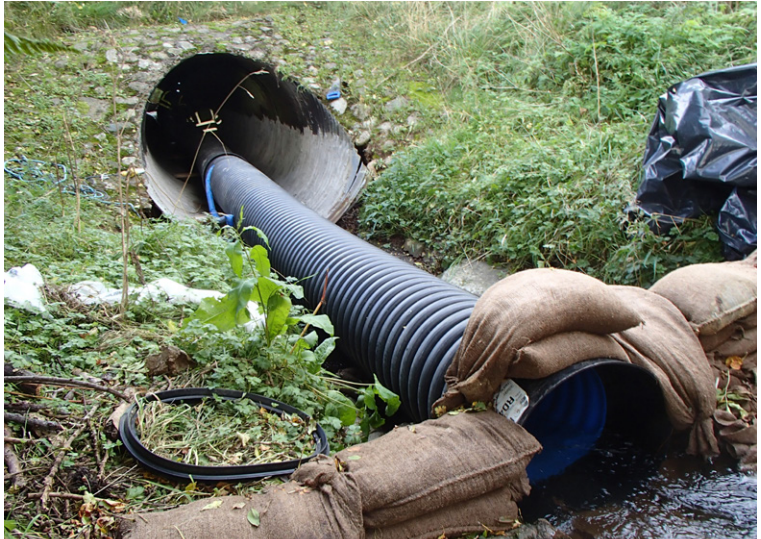
Water diverted into a 450mm HDPE Ridgidrain pipe

Prior to installation, the river was dammed using sandbags 10 meters upstream from the culvert and water was diverted into a 450mm HDPE Ridgidrain pipe which allowed fish to safely pass through the culvert for the project duration.

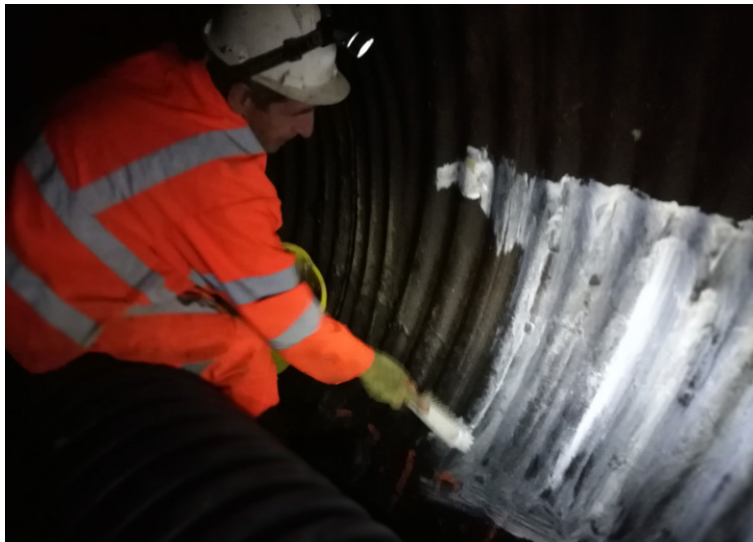
An Everbuild PVA adhesive & bonding agent was applied to crenulations

The contractor pressure washed the culvert to remove any sediment and debris, and removed any loose bitumen sections inside the culvert. An Everbuild Feb General Purpose PVA adhesive and bonding agent was then applied to the crenulations prior to filling them with a grout mix to provide a suitable fixing surface and to minimise void spaces underneath the CC.

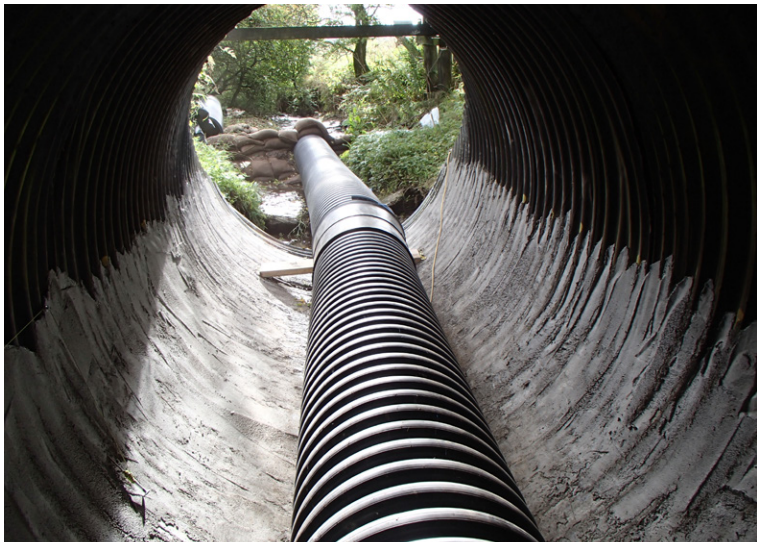
Semi-dry grout was applied to fill the corrugations

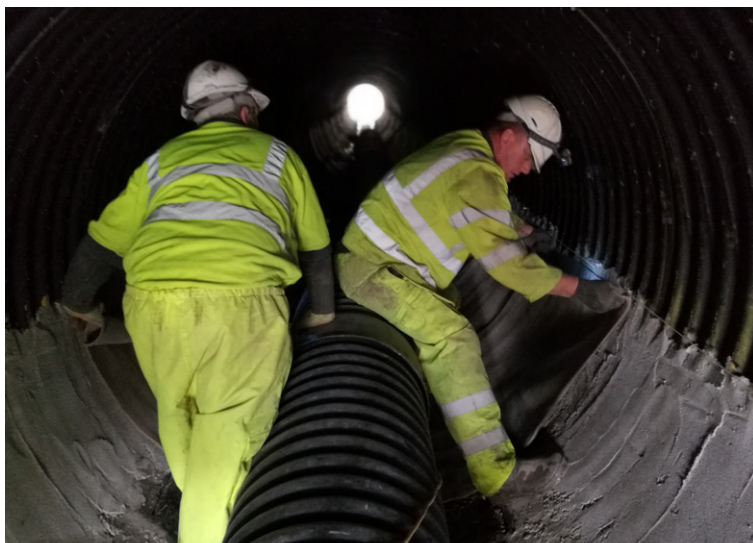
Batched rolls of CC8 were laid transversely across the width of the culvert

Due to restricted site access, batched rolls of CC8™ were delivered to site and unrolled by hand transversely across the width of the culvert. The adjacent CC layers were overlapped by 100mm and shingled in the direction of water flow. The CC overlaps were then screwed together and into the filled crenulations with 30mm stainless steel tech screws at 200mm centres and left unsealed, creating weep paths to prevent the build-up of any hydrostatic pressure behind the CC. The top edges of the CC were sealed with a line of grout to prevent water ingress behind the material. An anchor trench was dug on the upstream side to capture the CC edges and fixed with 300-500mm gabion stones before backfilling with material to prevent water ingress. The contractor used the water running in the HDPE pipe to hydrate the CC material with a hose pipe at the end of each day.

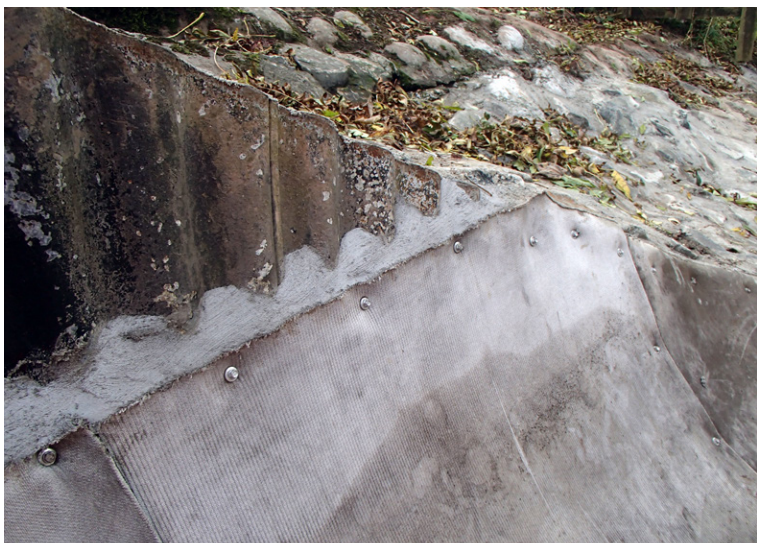
CC was fixed with tech screws & grout applied to prevent water ingress

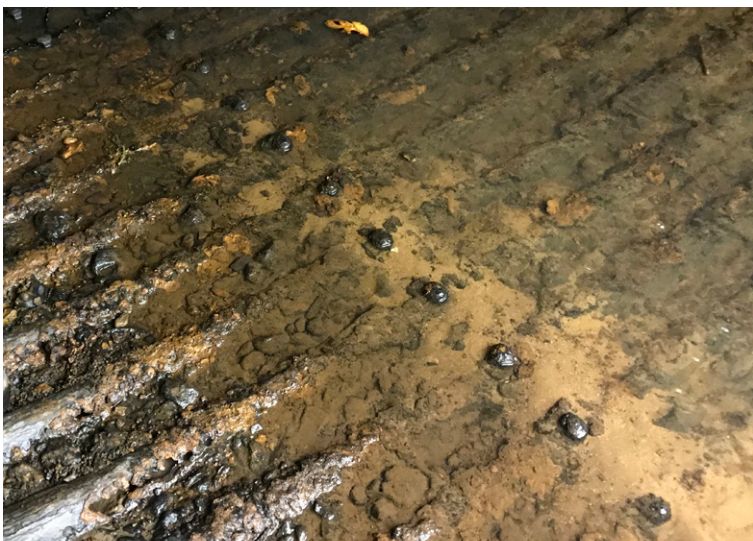
The culvert floor was corroded and heavily sedimented

To prepare the culvert, debris was removed from the corrugations and the culvert surface was cleaned to remove any sediment, some of which had solidified. The corrugation inverts were then filled with a rapid-set grout to ensure an even surface for the CC to be fixed to, as well as ensuring the material was flush to the culvert and to avoid any voids between the culvert and material. Grout was packed locally around protruding bolts and nuts to avoid potential puncture points.

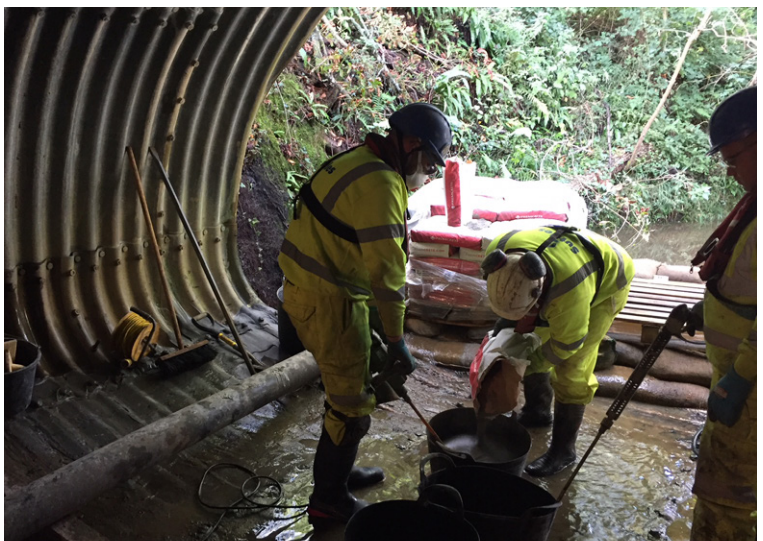
Quick-set grout was used to fill the voids in the corrugates

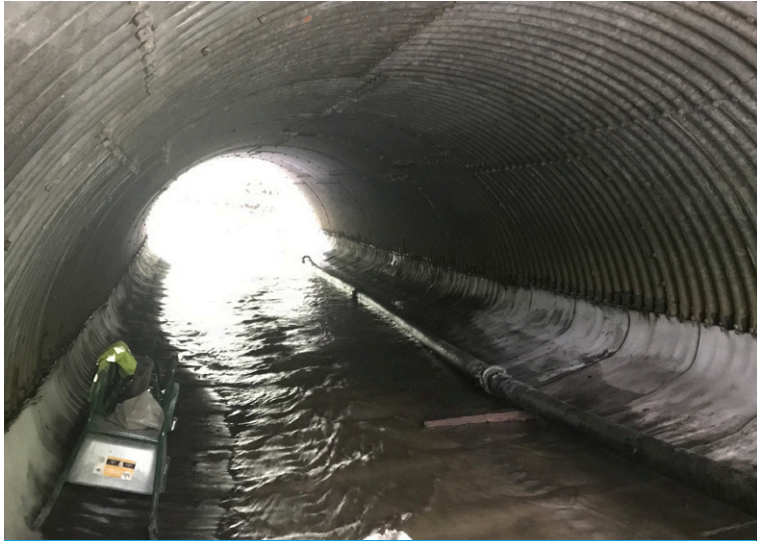
The CC was laid transversely across the culvert floor

The CC material was then laid by hand, transversely across the base of the 23m x 6m culvert. The material was fixed to the culvert by drilling holes through the steel and fixing in place using tech screws. The CC was fixed along its edge at roughly 150mm intervals. Additional fixings were then applied at 300-500mm intervals, to help the material fit to the curve of the culvert successfully. Each additional layer was laid in the direction of waterflow, with an overlap over 100mm, and jointed using Clearfix adhesive sealant for added impermeability. Sandbags were then placed on top of the joints to weigh them down while they dried. Once installation was completed, and the grout set, the CC was hydrated using water from the stream.

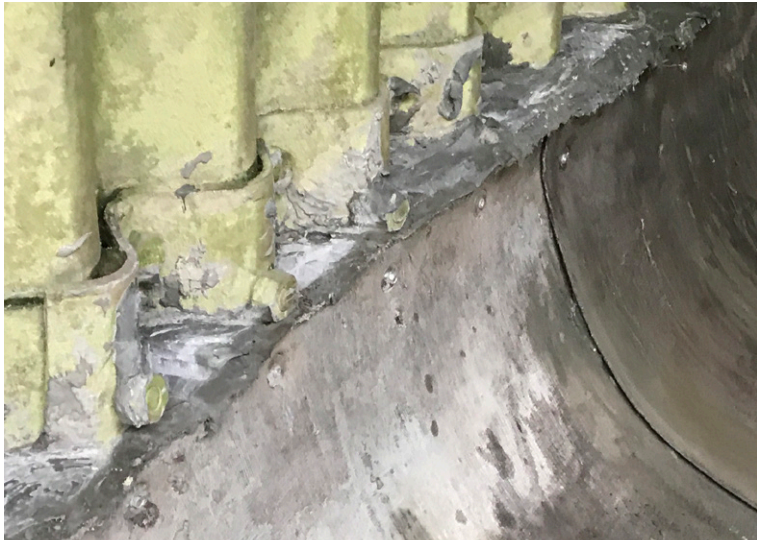
Voids behind the fixed CC were filled using more grout

Once set, the voids at the sides of the culvert and CC material were sealed by filling with poured grout to prevent ingress. At the start of the culvert, where there was a concrete apron, the CC was extended onto this and screwed in place, before a grout fillet was applied along the entire length to prevent water undermining. At the end, the CC was cut level with the headwall and another grout fillet applied and the edge buried with a larger stone.

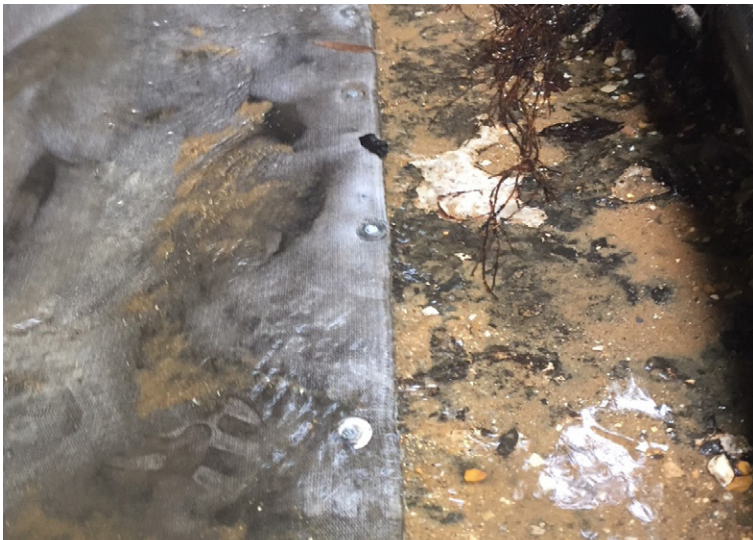
CC extending onto concrete apron, fixed using tech screws and grout

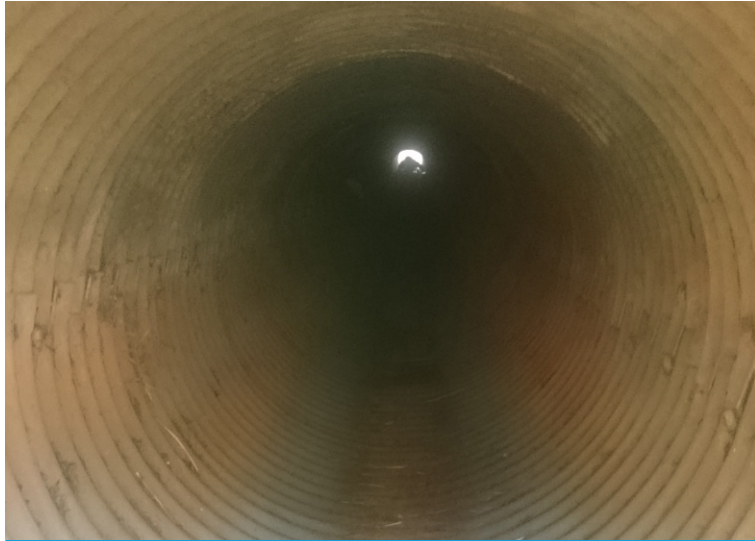
The culvert had previously been lined with corrugated steel, however abrasion had damaged the galvanised layer of the material, which had lead to the rapid deterioration of the steel itself, particularly where water was trapped in the corrugations.

Existing corrugated steel culvert

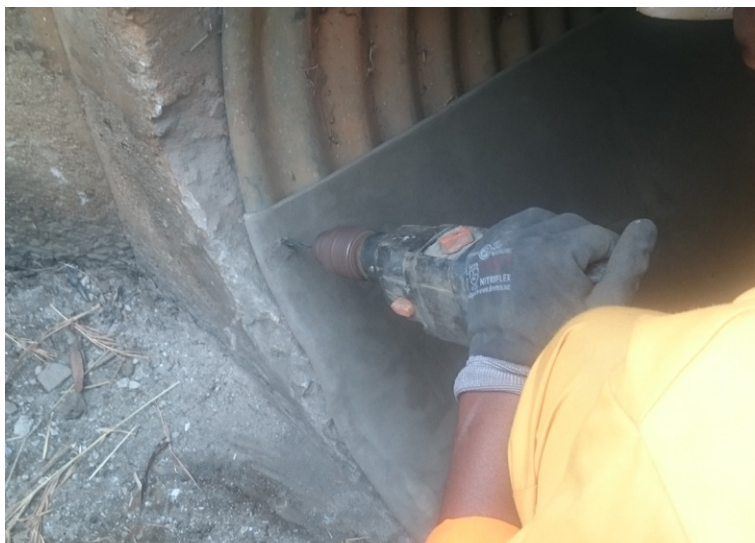
Fixing with pop rivets

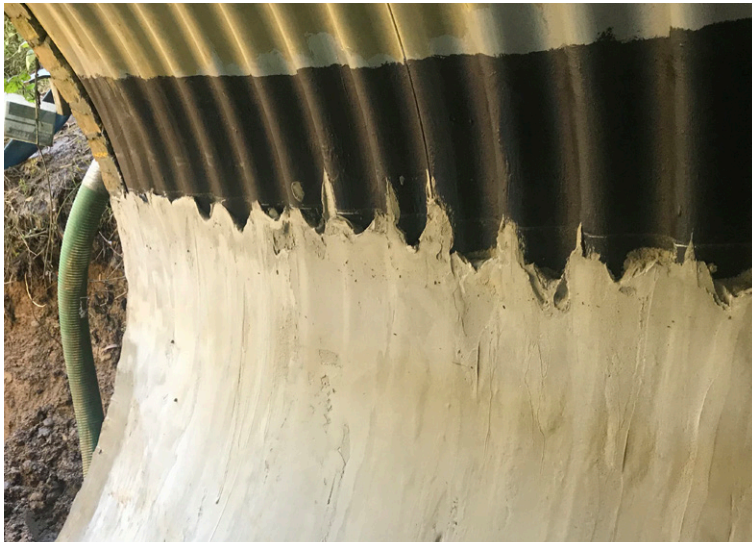
Inverts filled with concrete mortar following cleaning

Prior to the installation, the watercourse was dammed and over-pumped to divert water from the culvert. Approximately 600mm of stream bed material was removed, revealing its condition. The corrugations were then filled with a repair mortar before delivery and deployment of the specified CC8™ material. The installation started downstream, with the material laid transversely and layers overlapped in the direction of waterflow. The material was fixed to the culvert by drilling and fitting Hilti tech screws at 200mm intervals along joints, and 500mm intervals elsewhere. Once installation was completed, the dam was carefully lowered to allow water into the culvert before the water was brushed up the sides to ensure thorough hydration.

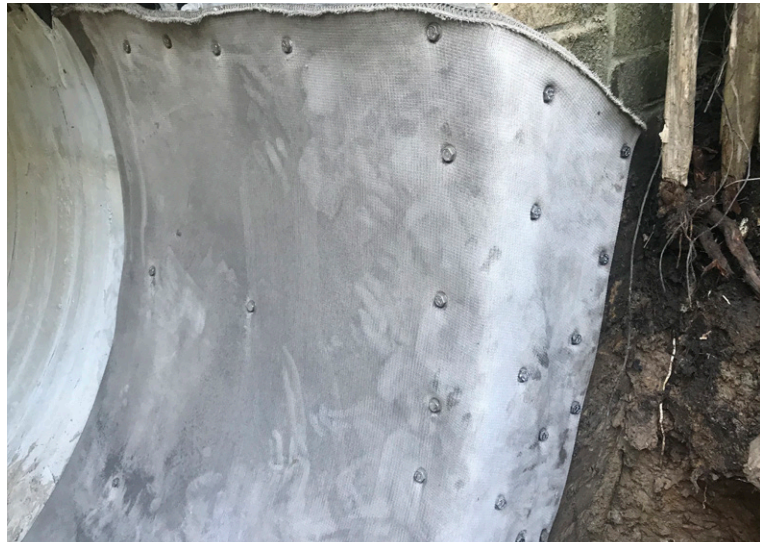
Fixing of first CC length to culvert and outside wall

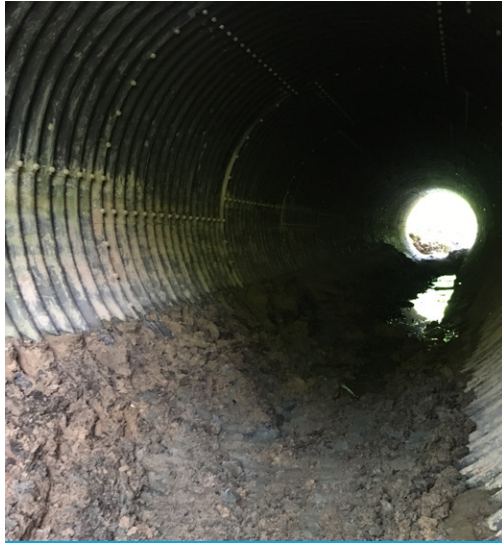
The culverts direct the river Rother under the A272 at Halfway Bridge, and were degrading due to sediment flow. One of the three was becoming increasingly affected, with a large amount of silt build up reducing its capacity.

Thick silt build up in culvert 1

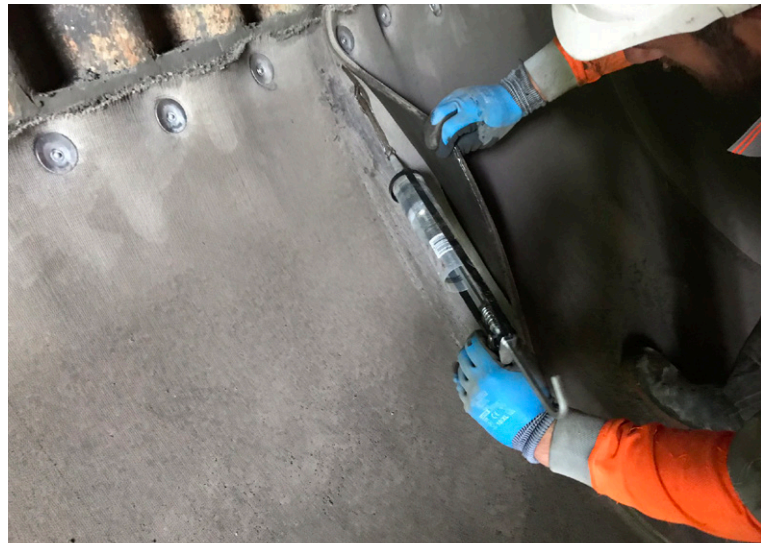
Hilti shot-fired nails used to fix CC to culvert before sealing joints

Following damming, silt build up was removed by hand, and the corrugations filled with grout. CC13™ bulk rolls were delivered and cut to required length on site. The CC was installed transversely and fixed to the culvert using Hilti shot-fired nails, while overlaps were jointed using adhesive sealant for increased impermeability. Once installation was completed, the dams were removed and water allowed to flow through it to hydrate the material. Water was then brushed up the sides of the culvert to hydrate the remaining material. In some cases, the water was hydrated using a hose and the river water.

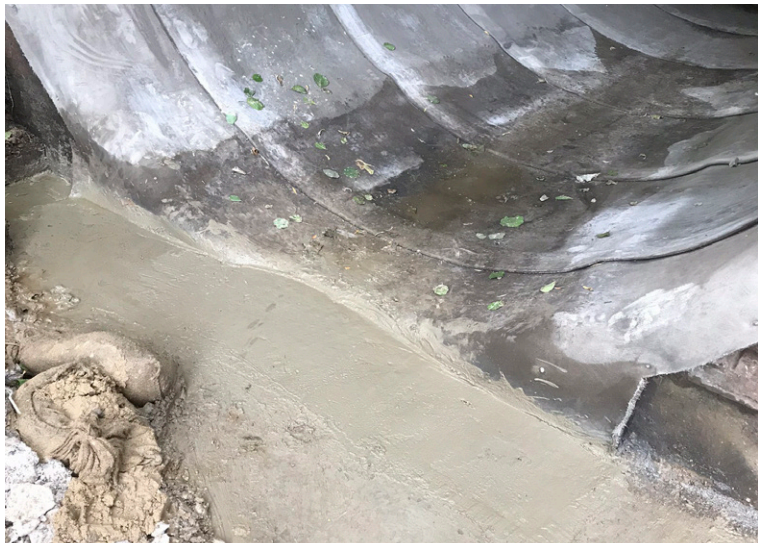
Edge of CC secured to archway and buried with poured concrete

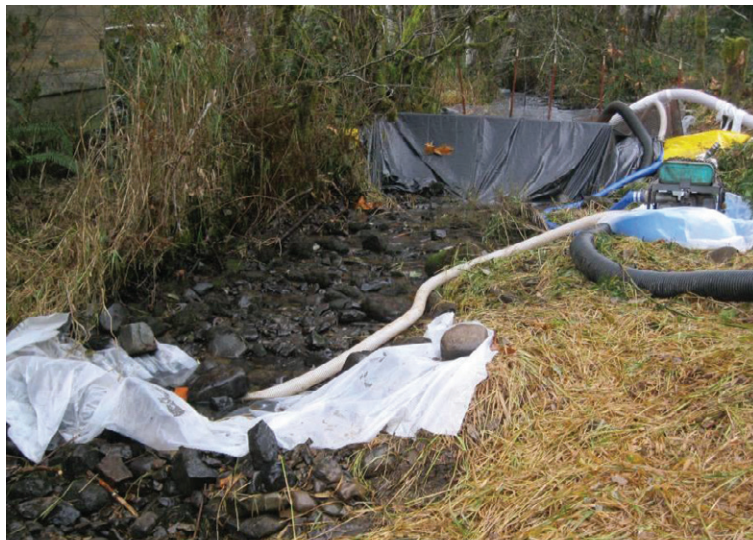
Isolating with cofferdams and de-watering the site

To facilitate installation, a stream bypass was installed to divert water around the work zone, which was then isolated with cofferdams while a fish rescue was performed and the site de-watered. Sediment laden water was pumped downstream to a grassy area where water was filtered prior to rejoining the stream channel.

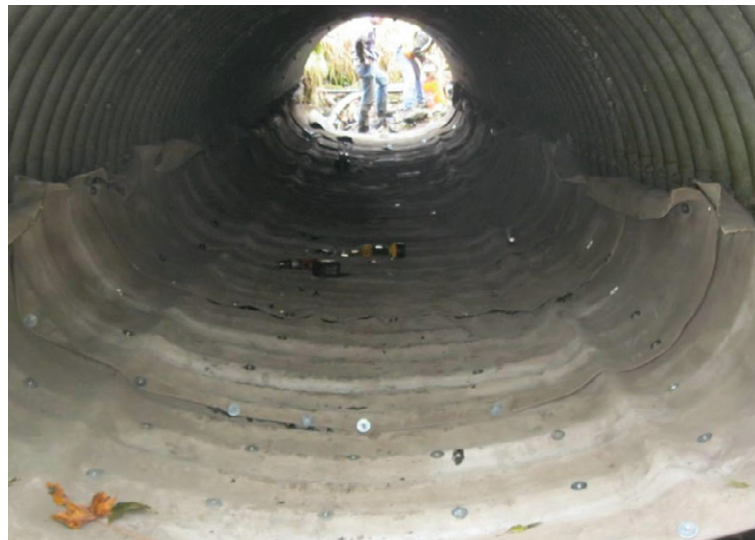
CC post-installation, prior to trimming and sealing of edges

The CC lining covered an area of approximately 10ft wide and 34ft long. A minimum overlap of 4 inches (approximately 100mm) was given between layers. Self-tapping stainless steel screws were used to fix the CC to the culvert, placed approximately every 4 inches (100mm) along the sides of the culvert, and every 18 inches (approximately 450mm) along the culvert floor. The use of the caulk to seal the CC edges prevented any ingress and protected the edges of the material, while offering an additional fixing method to secure the material in place. Tar was also applied over the edges to ensure a water tight seal. At the inlet and outlet of the culvert, CC was wrapped and fixed beneath the culvert pipe and substrate placed to fill existing voids.

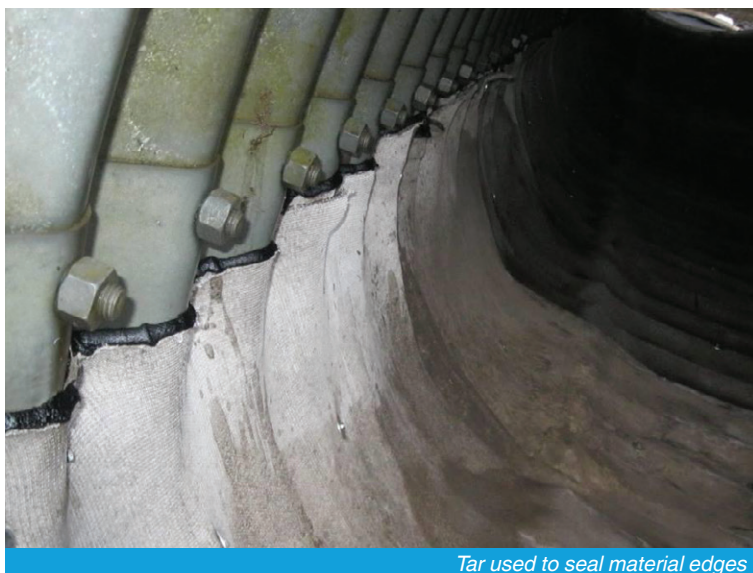
Tar used to seal material edges

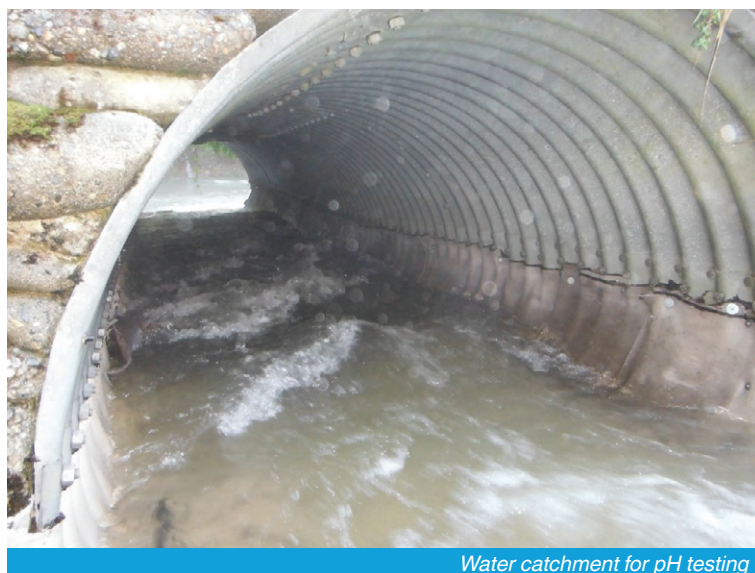
Water catchment for pH testing

Once installation was completed, pH monitoring was carried out as water was introduced to the material for hydration. Any excess water in the work zone was pumped to an upland where it would infiltrate. Once the CC had hardened, the water was pumped through the culvert, tested, and pumped to an upland until pH readings were within 0.5 units of the background readings between 6.5 and 8.5 units. Once was complete and pH readings met the required levels, the cofferdams were removed and the stream allowed to flow freely.

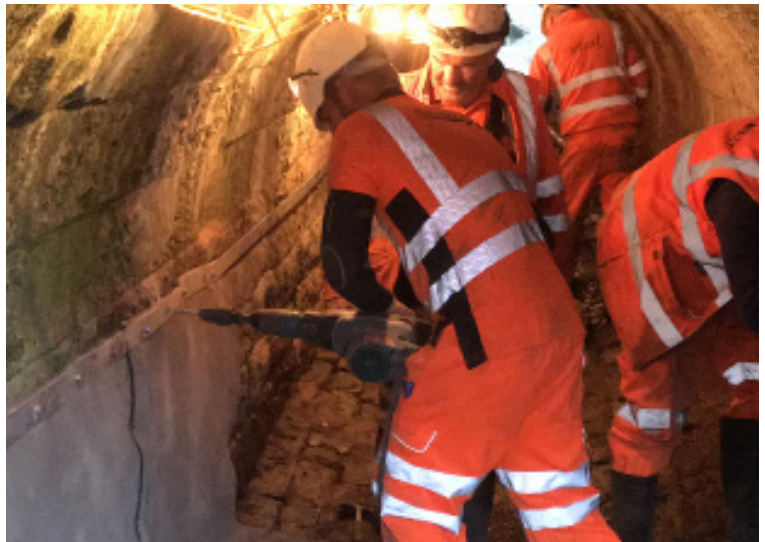
Fixing CC to masonry wall

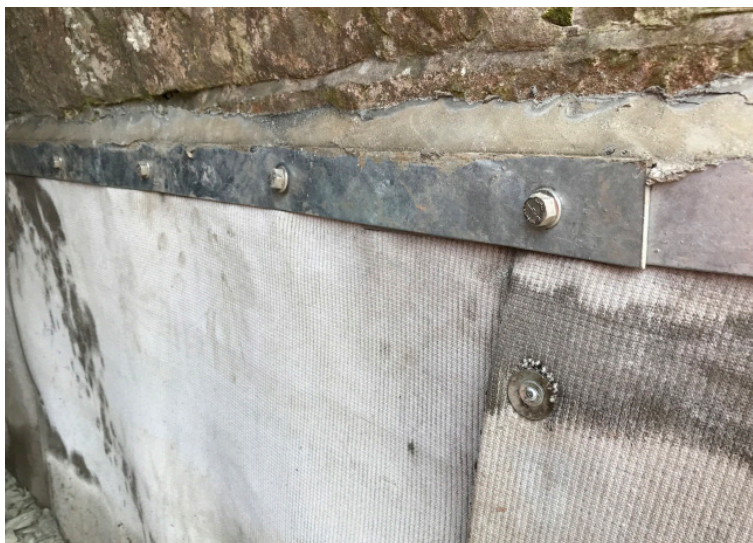
Shot-fired nails, steel bars and grout used for fixing and termination

The material was fixed to the masonry culvert with a mixture of shot fired nails and masonry bolts at 200mm centres on each overlap. The termination detail on the wall of the culvert was a galvanised steel strip securing the edge of the canvas to the wall and the galvanised strips were secured at 300mm centres. At the end of the installation a small bead of grout was then added to the top of the strip to neaten the edges and further prevent ingress of water.

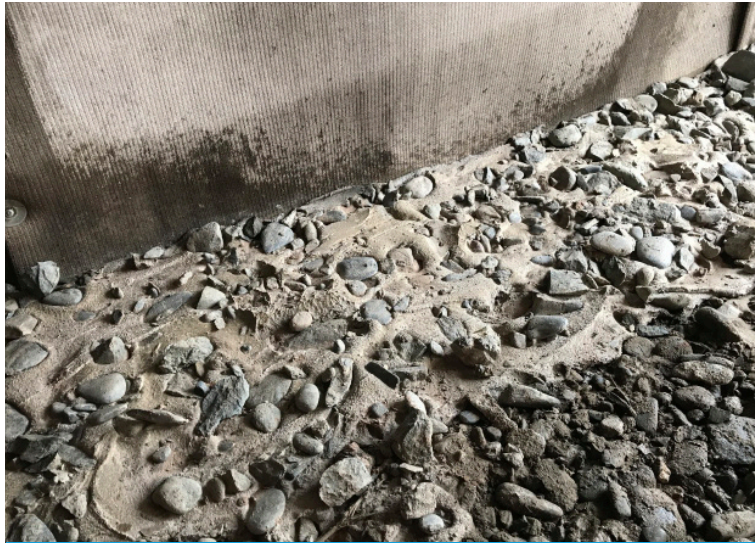
Grout & stones applied to CC floor to provide rocky surface for fish
