CONCRETE CANVAS® Concrete on a Roll

MINING CASE STUDIES

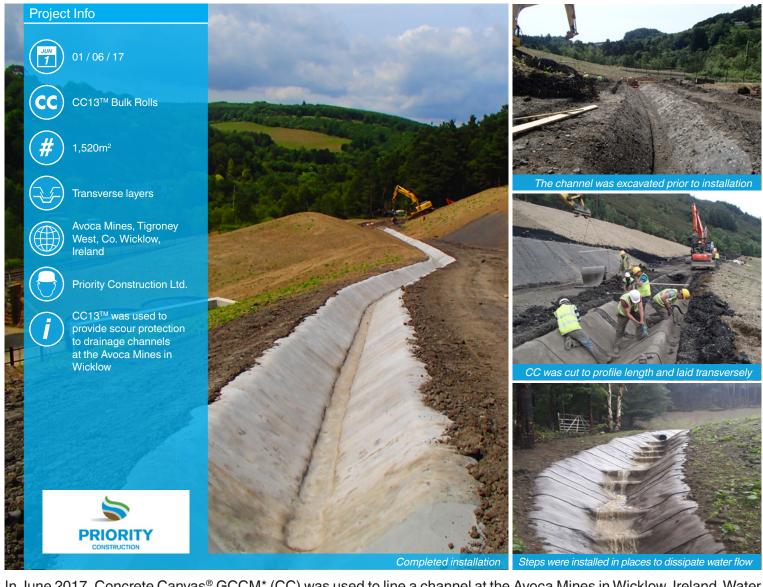
In June 2017, Concrete Canvas® GCCM* (CC) was used to line a channel at the Avoca Mines in Wicklow, Ireland. Water discharges from the old mines are acidic and metal laden, which impacts water quality of the Avoca River.

A combination of precast concrete channels and a HDPE liner/rip rap channel was originally considered, however, the steep, varying slopes around the site made this difficult. CC was specified as it allows concrete construction without the need for plant or mixing equipment on site. The work was carried out by contractor Priority Construction Ltd.

Prior to installation, bulk rolls of CC13™ were delivered to site, the channel was excavated and compacted, and a trench was created on either side to allow the CC's edges to be buried to prevent undermining. The CC was mounted onto a spreader beam and hung from an excavator, unrolled and cut to profile length to minimise wastage.

The CC was laid transversely, overlapping layers by 100mm in the direction of water flow. Overlaps were sealed with Everbuild Clearfix adhesive sealant and screwed at 200mm intervals. Steel ground pegs were then inserted through each overlap in the anchor trenches, which were backfilled. In some areas, concrete steps were installed and covered with CC to dissipate water energy. The CC was hydrated using a hose and a 6000L water carrier.

In total, 1,520m² of CC13[™] was installed within 2 weeks. CC is now being considered for multiple projects in the same region in both the public and private sectors.

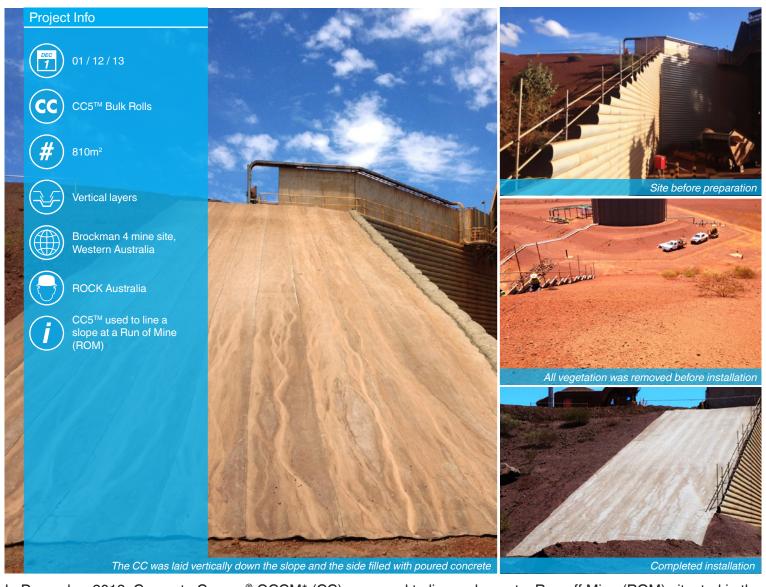
SLOPE LINING

In December 2013, Concrete Canvas® GCCM* (CC) was used to line a slope at a Run off Mine (ROM) situated in the Brockman 4 mine site, Western Australia.

The main objective for the project was to prevent surface water from penetrating the slope which causes instability. There was also a need for erosion control and weed suppression on the site. Alternatives such as shotcrete were considered, but CC was selected due to the speed and ease of installation as well as being the most cost-effective solution.

Large rocks, other debris and vegetation were removed from the slope before it was levelled in preparation for installation. CC5™ was delivered to site in bulk rolls and unrolled down the slope using a crane and spreader beam. The overlaps were then hydrated before being sealed and screwed. Ground pegs were then used to fix the CC to the substrate along one edge, and a grouted joint along the other, creating a water impermeable seal between the CC and retaining wall. At the crest of the slope, a transverse layer was used to overlap the vertical layers, before being anchor trenched and fixed with ground pegs. A water cart was used for hydration.

In total 810m² of CC5™ was installed in three days by a team of three people. The bulk rolls enabled a fast, easy and cost-effective install under very high temperatures of up to 43°C.

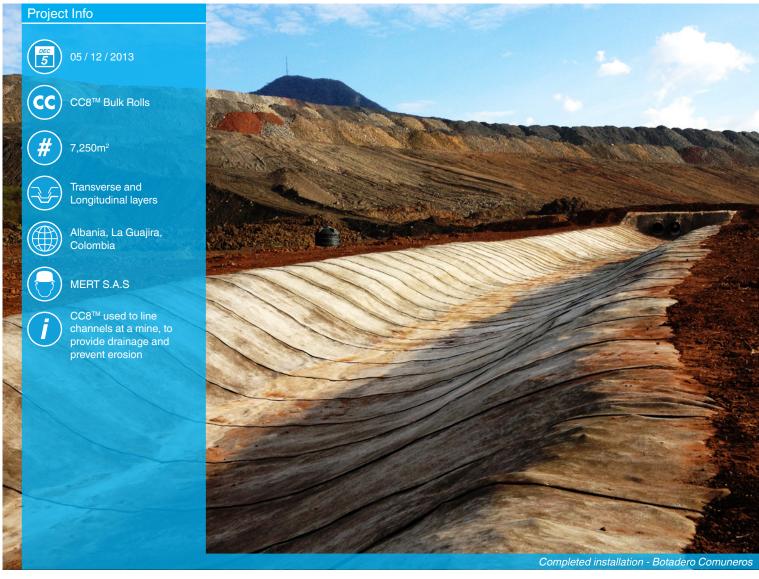
In December 2013, Concrete Canvas® GCCM* (CC) was used to line 12 drainage channels at a mine in Albania, Colombia. The channels dealt with rain water and man-made drainage caused by mining activity.

The original channels were carved from the substrate with no lining, and therefore suffered extreme erosion, causing damage to the local environment. As a result, The National Authority for Environmental Permits ordered urgent installation of lining to prevent further environmental damage. A geo-membrane and gabion combination was considered, but CC was specified due to speed of installation, which was key due to the possibility of penalties if drainage measures were not put in place by March 2014. CC can be installed ten times faster than conventional concrete, meaning the penalties could be avoided entirely. The work was carried out by MERT S.A.S.

Prior to installation, vegetation and debris were cleared to ensure intimate contact with the substrate. Bulk rolls of CC8™ were delivered to site and cut to length to reduce wastage, positioned and fixed using ground pegs. Layers were overlapped by 100mm in the direction of water flow and secured using screws at intervals of 200mm. For longitudinal layups, a spreader beam and plant were used to unroll bulk rolls of CC8™ along the length of the channels. These were then fixed using ground pegs every 1.5 metres and joined with screws at 200mm intervals. Both layups were sealed with an adhesive sealant along overlaps.

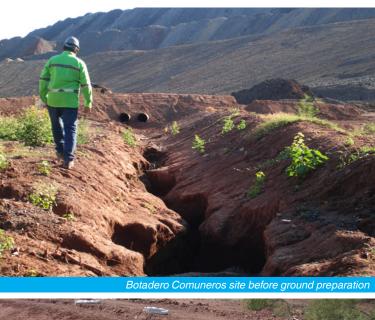
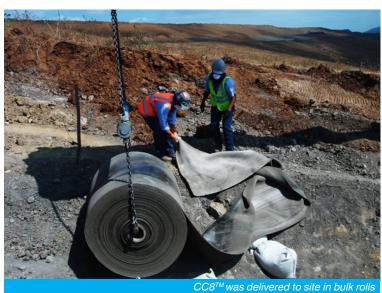
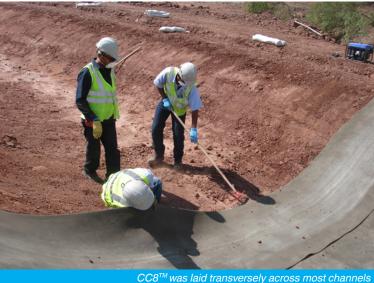
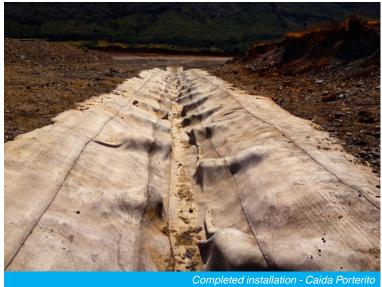
Baffling was needed in a steep channel known as 'Caida Poteito' to dissipate the water's energy and prevent fast flowing water undercutting the substrate at the bottom. The channel was graded to 45 degrees before pairs of sandbags were placed at 2m intervals on either side of the channel. CC8™ was then laid over them and fixed in place. The CC was then hydrated using a water truck.

The channel lining was installed consecutively by a team of six over a seven-week period in high temperatures of up to 34°C and under a tight deadline. The CC was able to accommodate the sharp bends, corners and existing pipework, among other complicated aspects of the installation. The client was very pleased with the results and the ANLA officials visited the site and gave their approval of the lining, which allowed mining works to continue without financial penalty.

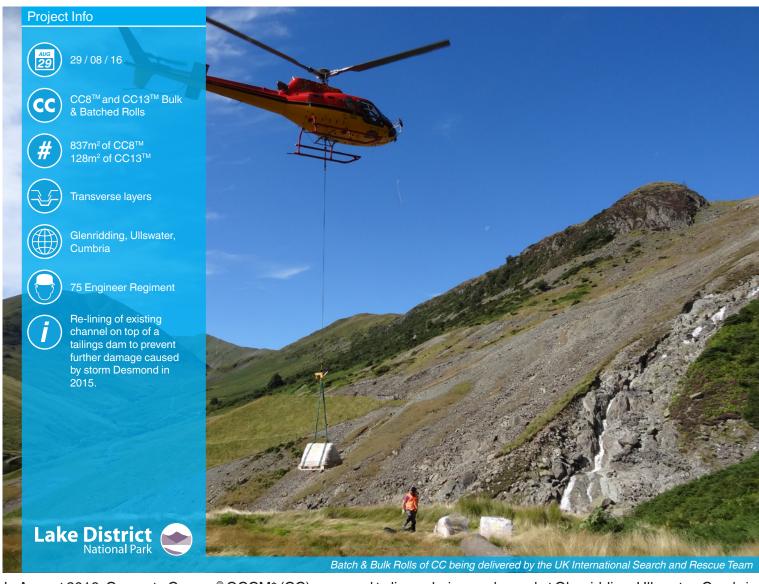
In August 2016, Concrete Canvas® GCCM* (CC) was used to line a drainage channel at Glenridding, Ullswater, Cumbria. The objective was to re-line an existing channel on top of a tailings dam to prevent further damage caused by storm Desmond in 2015. The site was an operational lead ore mine between 1825 and 1961, and is now a designated SSSI site.

Various other methods were considered, including dry stone walling and poured concrete. However, due to the limited site access, sensitivity of the site and several other factors, CC was chosen as the best solution. The works were carried out by multiple agencies, the 75 Engineer Regiment under 42 Brigade and the UK International Search and Rescue Team, with an additional aim to ensure materials and contaminants from the old mines did not affect the village below. The site is 2 miles up a remote track and there were a number of logistical issues for delivery so HIAB wagons and a UK International Search and Rescue Team helicopter had to assist.

Some of the dry stone walls and overburden on one side of the channel were removed prior to installation. The rolls of CC8[™] were batched to specific lengths to accommodate the varying width of the channel. The CC was trimmed using knifes and anchored to the ground using steel pegs and heavy rocks. The overlaps were jointed using screws at 200mm intervals. An army-issue, portable temporary 1000L reservoir was used for hydration.

A total of 965m² CC was installed over a ten-day period, in mostly clear weather, on a site with limited access.

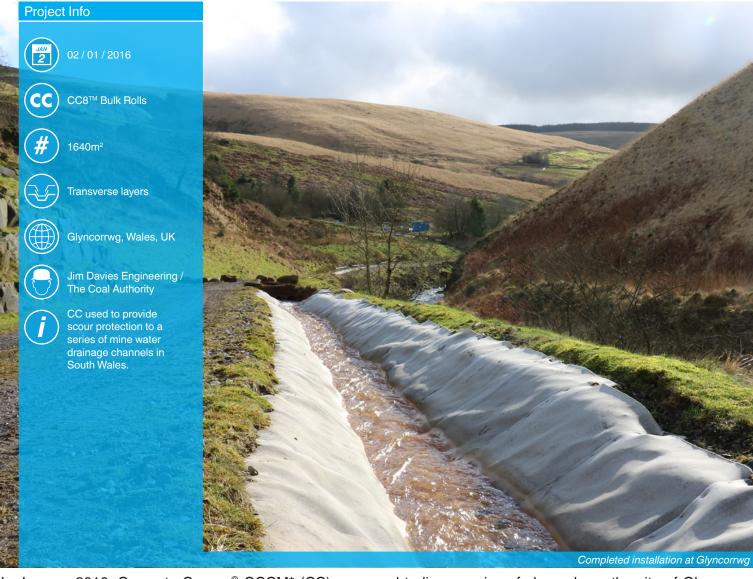
In January 2016, Concrete Canvas® GCCM* (CC) was used to line a series of channels on the site of Glyncorrwg Colliery, a disused mine which closed in the 1970s, in the Afan Valley, South Wales. The channels carried water down through the mine site, running parallel to the river Corrwg, and had become heavily contaminated with bright orange ochre deposition. The channels had previously been lined with an LLDPE liner protected by a nonwoven geotextile, however, this had severely degraded and would lead to further water contamination. Vegetation had also established and overgrown, risking overspill. As a result, CC was chosen as a channel lining and weed suppression solution due to its low maintenance properties and ease of install.

Sections of the drainage channels were dammed off with water flow directed further downstream, and anchor trenches were cut into the shoulders of the channels in preparation for installation. The channels were then cleared of debris and deteriorated sections of geotextile. The CC was unrolled and cut to profile length, and positioned with overlaps of 100mm. The CC was then fixed using steel ground pegs inserted in the anchor trenches which were backfilled, and the overlaps were jointed using stainless steel screws at 200mm intervals. Hydration was achieved using a bowser and hose.

A total of 1,640m² of CC8™ were installed over 4 weeks, in often severe weather and over poor ground conditions. Following the success of the installation similar schemes within the region are being considered by the Coal Authority for remediation using CC.

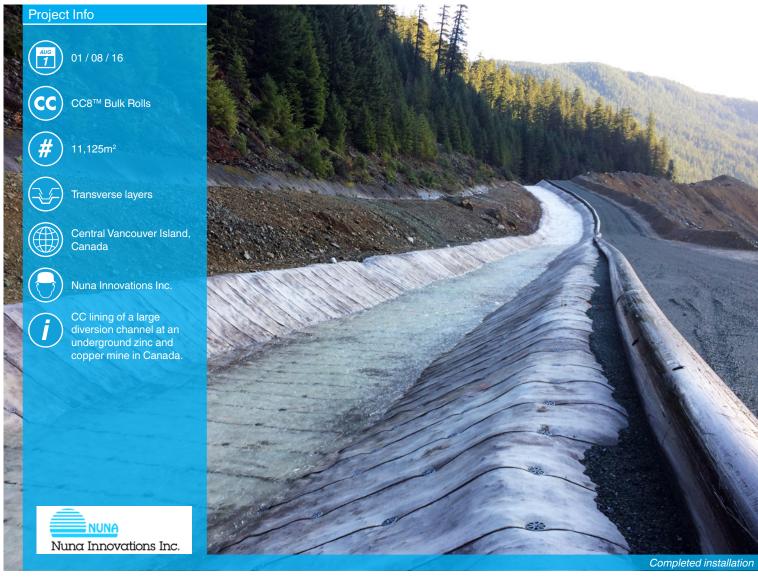
CHANNEL LINING

In August 2016, Concrete Canvas® (CC) GCCM* was used to line a channel at a zinc and copper mine on Central Vancouver Island, Canada. The channel, which transports clean water from the hillside to a lower creek, was originally lined with shotcrete which had begun to degrade. It was also in need of enlargement in order to manage fast water flow. Alternatives such as shotcrete were considered, but the demands of the project, and a need for the water to be diverted while works were underway, meant CC was chosen instead due to its quick installation times. The works were carried out by Nuna Innovations Inc. for an undisclosed client.

Prior to excavation of the new channel, all trees, brush and other vegetation in the area were removed, and standing water was drained away. A new, significantly wider channel was then created, measuring 735m in length, between 5-8.5m wide, with an average depth of 1.5m. CC8™ was delivered to site in bulk rolls which were positioned along the channel to save time during the installation. A transverse layup was used, allowing the CC8™ to be cut to size and minimising wastage. Layers of the CC were overlapped by 100mm in the direction of water flow and secured using 1.5m earth percussion anchors with 3mm stainless steel cables every metre and eight one-inch screws at 150mm intervals. The CC was then pinned into anchor trenches, which were backfilled prior to hydration.

A total of 11,125m² of CC8[™] was installed in 6 weeks by a team of six in temperatures of up to 34°C. The client was impressed with the product, ease of install and lack of need for specialist training or equipment.

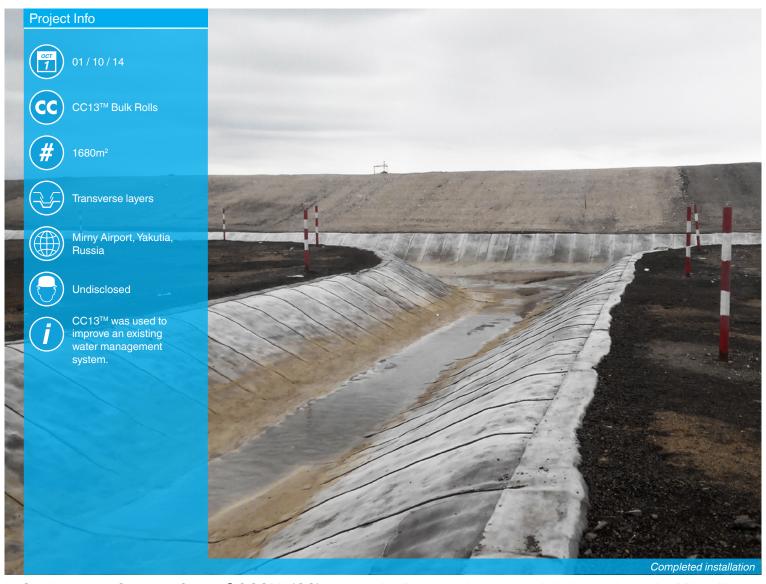
In October 2014, Concrete Canvas® GCCM* (CC) was used to line a newly excavated drainage channel at Mirny Airport, Yakutia, Russia. The airport is the main means of transport for Mirna Diamond Mine. Due to the small window of dry weather conditions in the area, speed of install was vital. The area is also very cold during that time of year, which would have brought work to a halt with traditional concreting methods, however, CC has been successfully tested against freeze-thaw weathering cycles, making it the only option.

24 bulk rolls of CC13™ were delivered to site and transported using a forklift. The channel was excavated using a 20T excavator, and an anchor trench were created at the crest of the channel to allow the CC to be buried to prevent undermining. The CC was mounted onto a spreader beam, hung from a crane and unrolled across the channel before being cut to profile length with hand tools to minimise wastage. The CC was laid transversely, with layers overlapped by 100mm in the direction of water flow and screwed at 200mm intervals with 30mm screws. The CC was further fixed with 400mm ground pegs at the crest before an additional longitudinal layer was laid along the edge of the anchor trench before being secured and backfilled as an extra undermining precaution.

1,680m² of CC13™ was installed in 3 days, making it 10-times faster to install than traditional methods. Installation was carried out in temperatures of 5°C with night temperatures reaching -4°C. The client was satisfied with the product and is considering placing another order the next construction period.

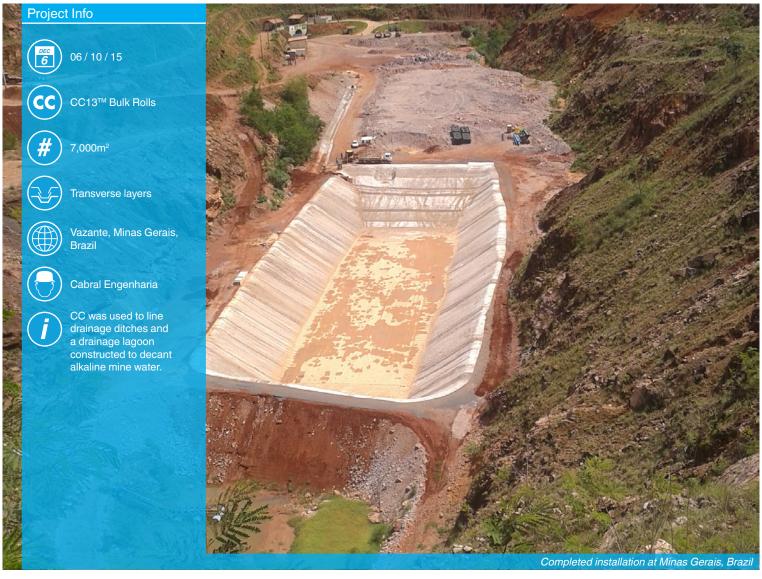
LAGOON LINING

In October 2015, Concrete Canvas® GCCM* (CC) was used to line a newly constructed drainage lagoon at Votorantim Metais Zinco mine in Vazante, Minas Gerais, Brazil. Alkaline mine water would be transported to the lagoon via a series of drainage ditches, also lined with CC, to be decanted and treated. Installation was carried out during the rainy season, which would have led to disruption had shotcrete been used. However, CC can be installed during inclement weather allowing for fast and easy installation. The material was supplied by SPI Engenharia e Representações.

Vegetation was removed from the area and the lagoon slopes graded and compacted in preparation for the installation. Bulk rolls of CC13[™] were delivered to site and mounted onto a spreader beam, unrolled down the lagoon faces and cut to profile length. Layers were overlapped by 100mm and pegs inserted through overlaps at the crest. Everbuild Clearfix adhesive sealant was then used to join the overlaps and joints were compressed. Hydration was then achieved using a water truck and hose. 7000m² of CC13™ were installed in two months in inclement weather and temperatures of up to 42°C. The client was impressed with the CC and its ease of install.
