# PETROCHEMICAL CASE STUDIES

## CHANNEL LINING

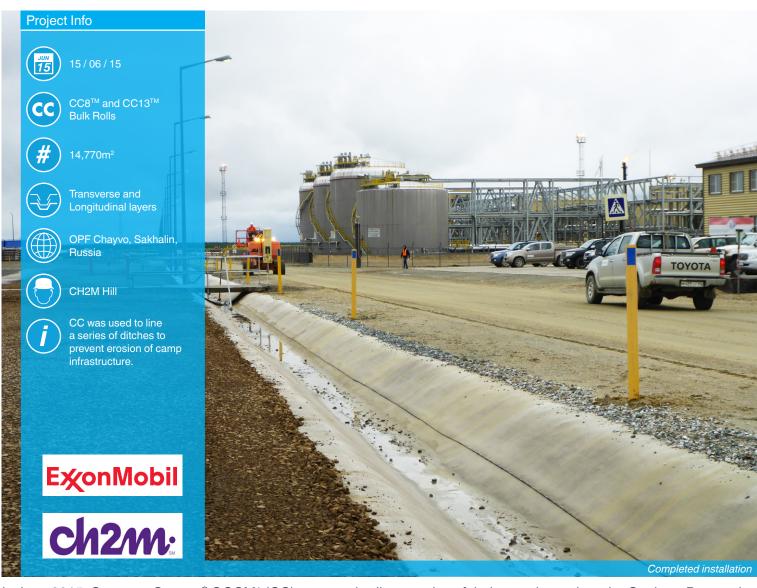
In June 2015, Concrete Canvas® GCCM\* (CC) was used to line a series of drainage channels at the Onshore Processing Facility (OPF) in Chayvo, Sakhalin, Russia. The camp is built on a class C sand substrate and is exposed to harsh weather conditions and temperatures as low as -40°C. A trial channel installed the previous year proved CC could cope with these conditions, leading to this much larger installation. CC is the only viable solution for this site. The works were carried out by CH2M Hill for Exxon Neftgas Ltd., a subsidiary of ExxonMobil.

The channels were excavated and compacted using a vibrating plate, with anchor trenches dug along each shoulder. Bulk rolls of CC8<sup>™</sup> and CC13<sup>™</sup> were mounted onto a spreader beam hung from a tele-handler and unrolled longitudinally or transversely depending on the channel profile. The CC was overlapped by 100mm, specifically in the direction of water flow for transverse layups. Pegs were inserted into the anchor trench through every overlap for transverse layups and every 2m for longitudinal layups. The overlaps were sealed with an adhesive sealant and jointed with screws placed at 200mm centres. Hydration was achieved using a 7000L water truck and hose with spray nozzle attached.

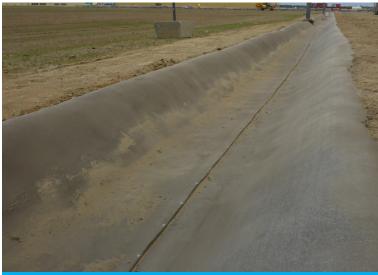
Both longitudinal and transverse layups were used

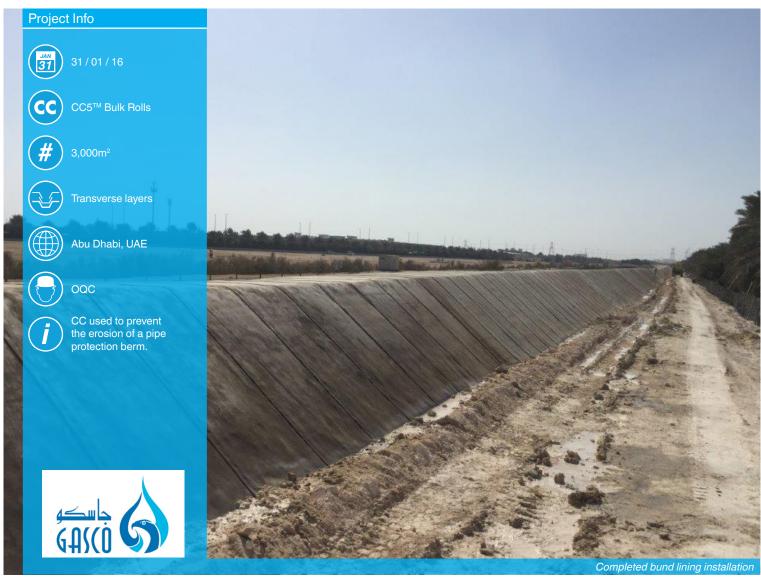
In January 2016, Concrete Canvas® GCCM\* (CC) was trialled as an erosion prevention method on a pipe protection berm for a gas pipeline in Abu Dhabi. The bund was at risk of weathering erosion which could have led to the exposure of the gas transport pipe beneath, risking infrastructure and environmental damage. Other conventional methods, such as Bitumen, can quickly degrade under high levels of UV exposure and can have a huge environmental impact. In addition, there is risk of wildlife damage to the bund, to which CC would be much more resistant. The works were carried out by OQC for GASCO.

The bund was compacted using the bucket of an excavator before bulk rolls of CC5™ were delivered to site. The rolls were mounted onto a spreader beam and hung from plant equipment before being deployed transversely across the berm, with each layer overlapping the previous by 100mm. Sealant was used to increase the impermeability of the overlap and screws were inserted at 100mm intervals. A 3000-gallon water truck was used to hydrate the material. Due to the high temperatures and arid climate, hydration was undertaken hourly to ensure sufficient hydration.

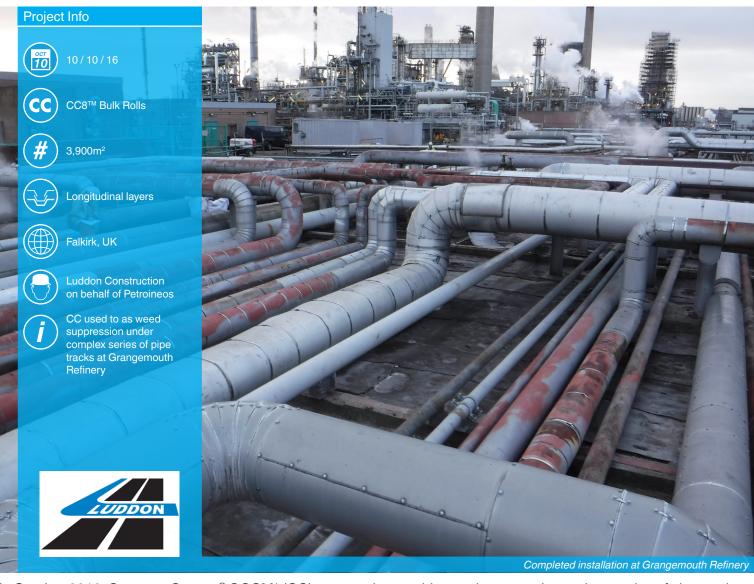
In October 2016, Concrete Canvas® GCCM\* (CC) was used to provide weed suppression under a series of pipe tracks at Grangemouth Refinery, operated by Petroineos in Falkirk, UK. Since buying the site from BP in 2005, Ineos have heavily invested in infrastructure and, as part of the Refinery Integrity Improvement Project, identified a section of pipework as in need of remediation.

Prior to installation, the pipe track area was graded, evened out and vegetation removed. Due to the restricted access caused by low pipes and little clearance between the pipes and track floor, the CC was deployed using a modified light weight spreader beam. Layers were laid perpendicular to the pipe track to accommodate the majority of pipe upstands and minimise length and subsequent weight of each layer. Layers were overlapped by 100mm and screwed together at 200mm intervals. CC was then fixed to the substrate using a combination of steel and plastic ground pegs, depending on the ground condition at specific points. Hydration was given using onsite water mains.

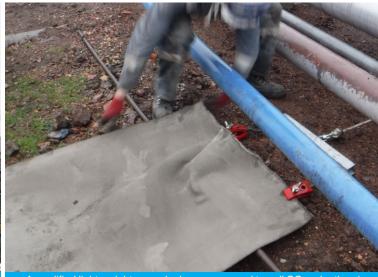
CC was delivered to site in bulk rolls and unrolled from

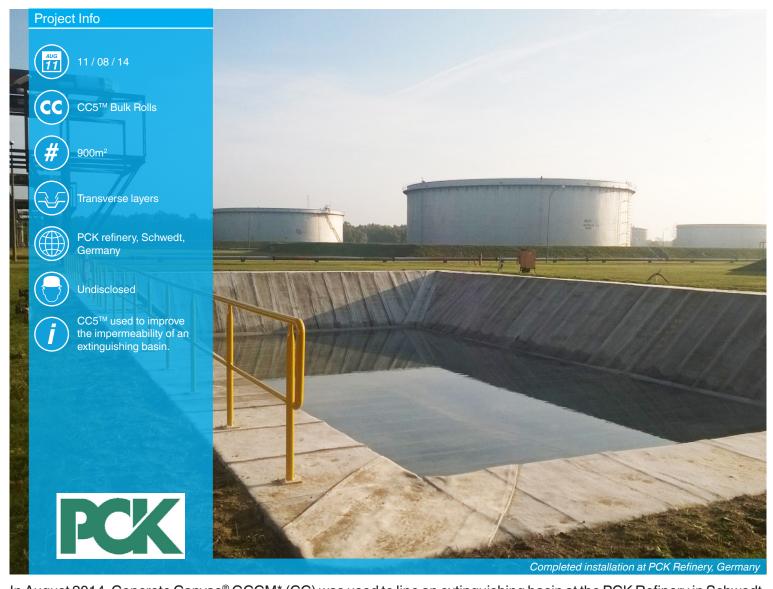
In August 2014, Concrete Canvas® GCCM\* (CC) was used to line an extinguishing basin at the PCK Refinery in Schwedt, Germany. The original poured concrete had cracked and spalled, resulting in excessive water loss. Removing the basin and re-building it using poured concrete was considered, however this would have been more time consuming, taking the basin out of operation for an extended period of time. As a result, CC was chosen. The works were carried out by an approved contractor, who had no prior experience of installing CC, for PCK in a joint venture between BP, Rosneft, Shell, Eni and Total.

The existing concrete was cleaned and mortar applied to large cracks to eliminate voids under the CC. An anchor trench was then created on the shoulder to prevent ingress and provide neat termination. Bulk rolls of CC5™ were delivered to site, mounted onto a spreader beam and hung from a Zoom Boom for easy unrolling. The project was completed in sections with the two shorter sides of the basin completed first. The CC was unrolled on the flat, cut to profile length and positioned in the basin by hand with alternating perpendicular overlaps at the corners. This allowed the CC to be unrolled across the width of the basin for the remaining sections, starting at each end and working towards the middle. The CC was fixed to the concrete using 40mm wedge anchors at 2m intervals, with overlaps of 100mm hydrated and then sealed. Hydration was then achieved across the rest of the installation via extinguishing hose.

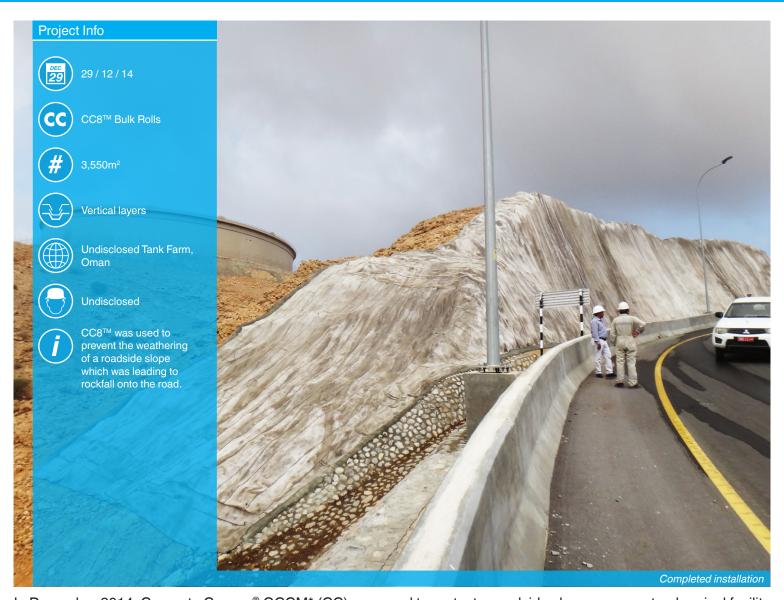
In December 2014, Concrete Canvas® GCCM\* (CC) was used to protect a roadside slope near a petrochemical facility in Oman. The slope was suffering from weathering erosion which was causing rocks to fall onto the road below. CC was installed in a trial, with shotcrete simultaneously installed on a different part of the slope to establish which was the better method for this application.

Loose rock was removed from the slope face to ensure intimate contact with the CC. Bulk rolls of CC8™ were delivered to site and mounted onto a spreader beam and hung from a crane. The rolls were lifted to the top of the slope and the leading edge placed in an anchor trench and pegged in place. The CC was then unrolled down the slope and cut to length, to avoid wastage. Layers were overlapped by 100mm and then sealed with an adhesive sealant and screwed at 100mm intervals. Pegs were also inserted where needed, and mortar used to seal the CC to the concrete substrate and to the pipes installed to allow the egress of water. Hydration was achieved using a 200-gallon tanker at the crest of the slope and a bowser at the base. Due to high temperatures, a second hydration was given an hour later.

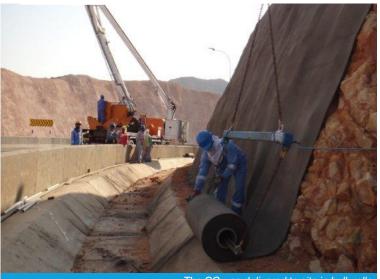
The CC was delivered to site in bulk rolls

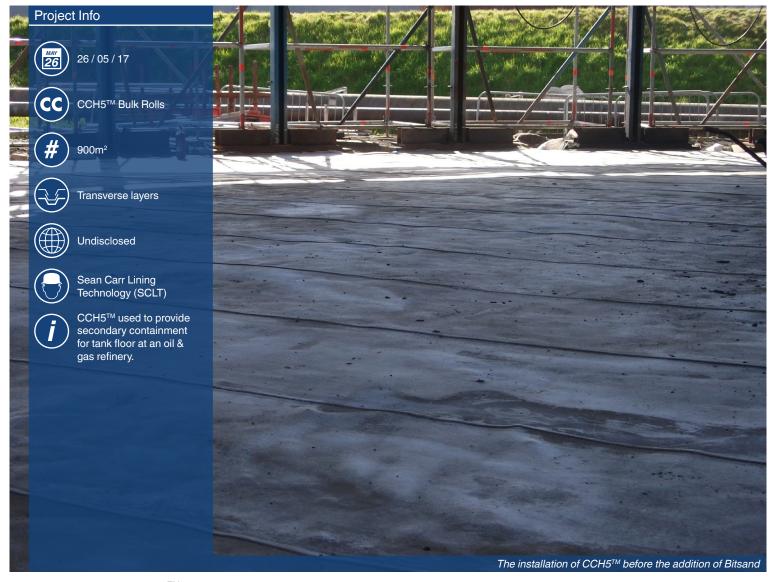
In May 2017, CC Hydro™ (CCH) GCCB\* was used to provide a retrofit below-tank liner for a tank overhaul project at a refinery in the UK. CCH5™ was specified by a consulting agency with 20 years of Oil & Gas and Petrochemical experience. Work was carried out by Sean Carr Lining Technology (SCLT) on behalf of the client.

The tank was jacked up by 2m around the perimeter in order to allow the ground underneath to be prepared for the installation of the CCH. The CCH was then laid with 100mm overlaps, which were thermally welded to create impermeable joints, then hydrated using a hose. The CCH was then allowed to dry and totally harden before the tank was lowered back into place.

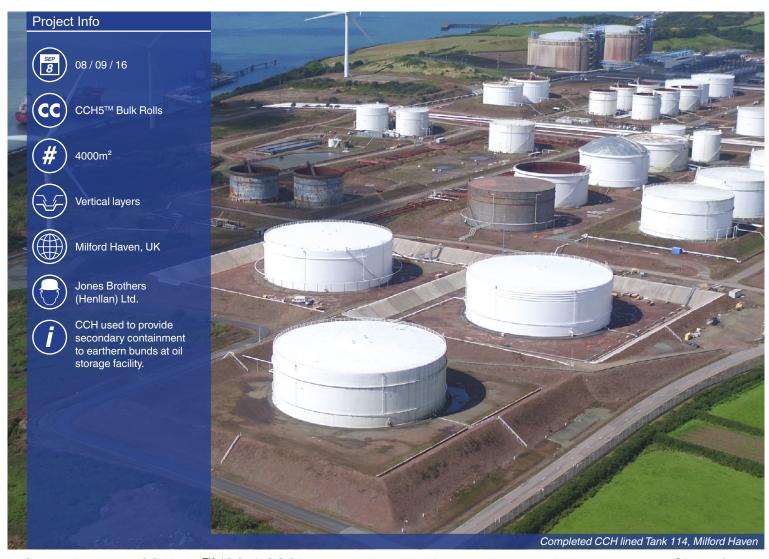
In September 2016, CC Hydro™ (CCH) GCCB\* was used to provide secondary containment to a 5000m² berm face at an oil storage facility in west Wales operated by SemLogistics Ltd.

There are 52 tanks of various sizes within the site that are used to store different petrochemical products: gasoline, gasoline blendstocks, naphtha, jet fuel, gas oil and diesel, as well as crude oil. Each tank sits within a bunded area formed with granular fill during the original construction of the site. As part of ongoing improvements, the company embarked on a programme to install secondary containment around two of the site's most critical storage tanks.
