CONCRETE CANVAS® Concrete on a Roll

PUBLIC WORKS CASE STUDIES

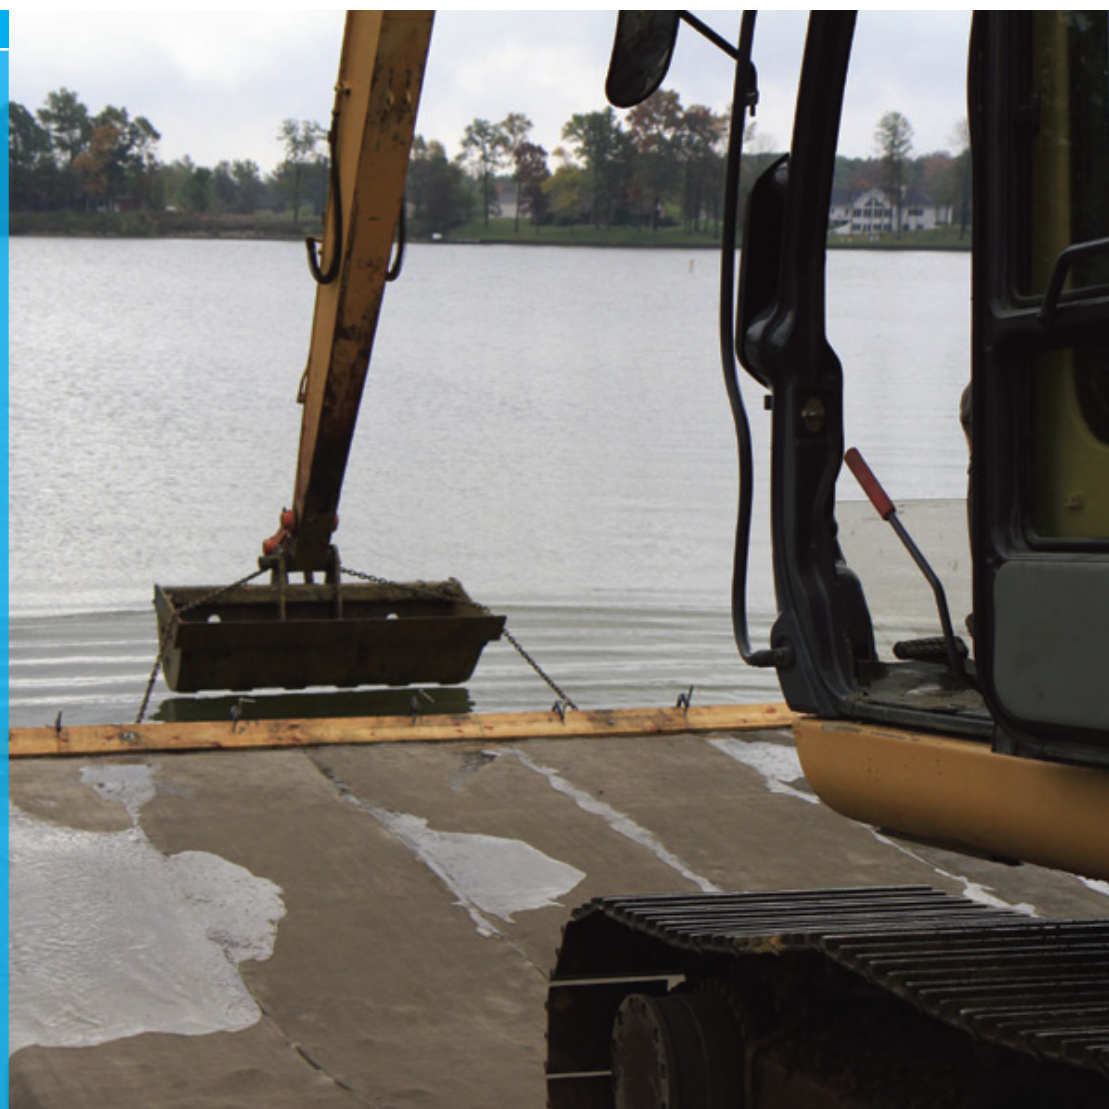
Installation underway at East Fork Lake, Illinois

In Autumn 2011, Concrete Canvas® GCCM* (CC) was used to extend a boat ramp at a lake in Olney, Illinois, USA. The East Fork Lake in the City of Olney, IL, is a significant recreational draw for boating and fishing enthusiasts. The lake has only one public access boat ramp, built in the 70s, to accommodate small fishing boats and recreational watercraft. However, the ramp is now not long enough to accommodate longer boat trailers, especially when water levels have dropped.

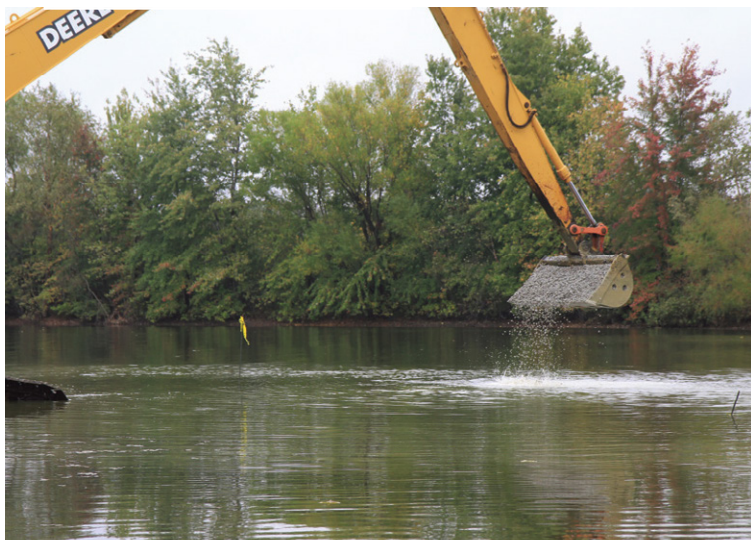
Removal of old gravel ramp extension

Prior to installation, the excavation contractor used a backhoe with 20m reach to remove the existing gravel and some subsurface mud/soil to provide a consistent base for the new gravel under layer. The contractor then prepared a bed of new stone to 45cm depth, graded to extend the angle of the existing concrete ramp. The dimensions of the area to be added were the full ramp width of 10m and length extension of approximately 6m.

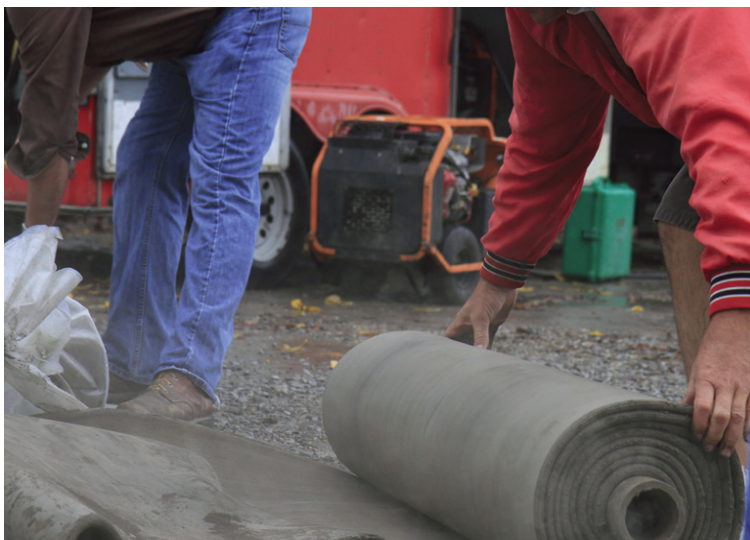
Unrolling the CC

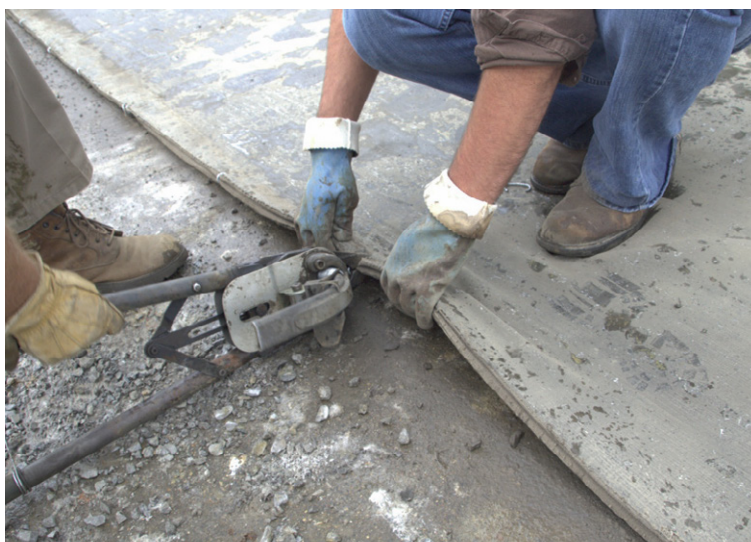
Connecting the CC panels with hog rings

The project then began with the underwater contractor (diver) surveying and guiding the excavation contractor. The diver made adjustments to the gravel surface to ensure it was level, and the excavation contractor then created two large panels of CC from two pre-cut widths of CC13™ connected by hog rings. The panels were pulled into place using the backhoe, with the diver guiding installation. A final layer of CC was placed perpendicular to, and under, the panels at the interface between the concrete slab and the gravel bed to provide additional stability. The panels were secured to the concrete slab using a 70mm wide steel hold-down bar across the width of the ramp, and anchoring to the slab using screws inserted through the bar and CC layers into the slab.

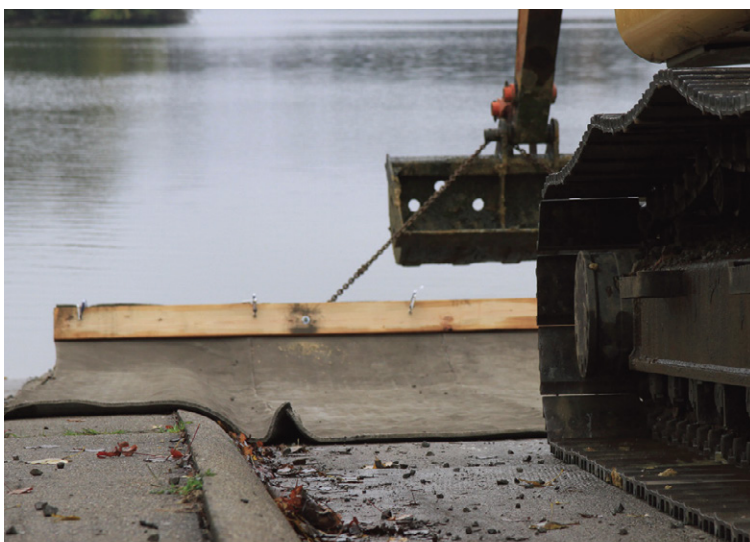
Deploying the CC into the lake

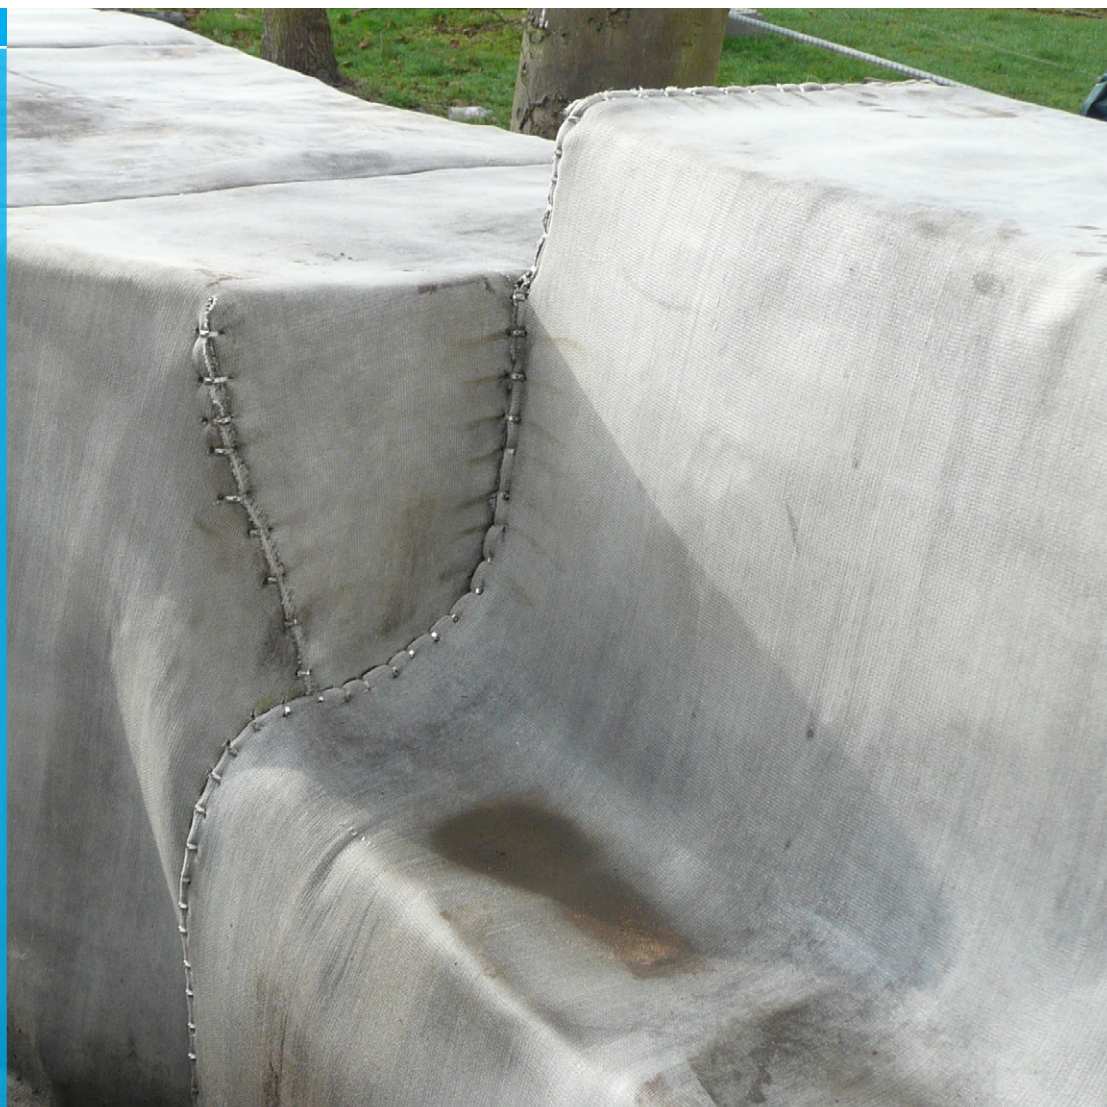
CC13™ was used to repair and protect gabions which provided flood defence to a residential area in Derby, UK.

Completed installation

Prior to installation, the CC was delivered to site in bulk rolls, which were batched into shorter lengths on site to match the variable gabion profiles. A spreader beam and plant were then used to lift and place the batched CC lengths onto the gabions. CC layers were overlapped and hog ringed along the edges. The layers were fixed to the gabion structure using re-bar staples. This was repeated along the full length of the gabions, with additional staples used at corners and intersections of adjoining gabions for additional security. The CC was then fully hydrated.

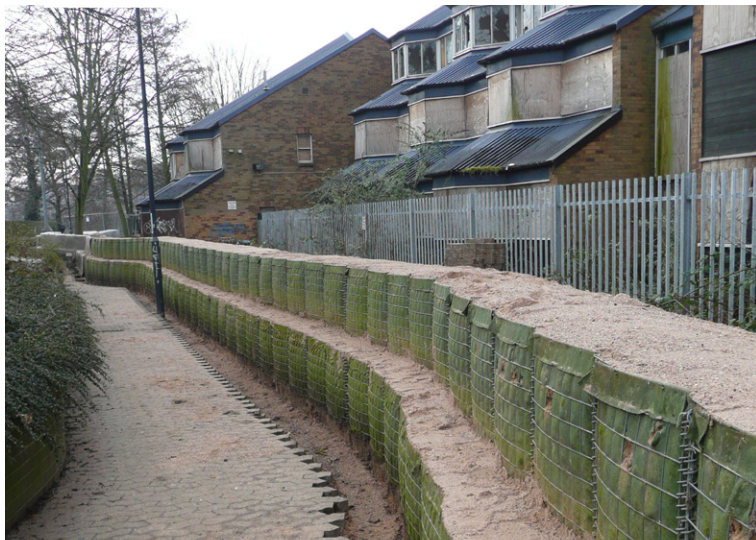
Section of gabion prior to installation

In March 2012, Concrete Canvas® GCCM* (CC) was used to repair a gabion wall structure in Derby, UK. The gabion wall, which provided flood defences to a residential area, had become damaged and unstable as a result of vandalism and weathering erosion.

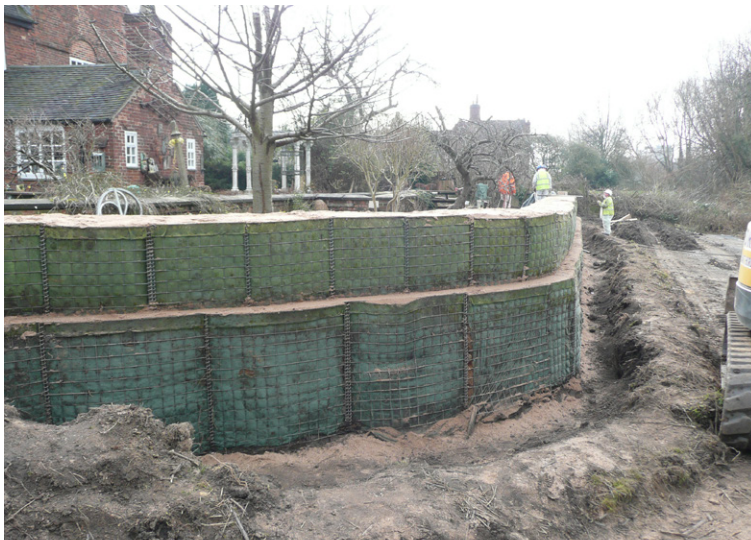
Site prior to installation

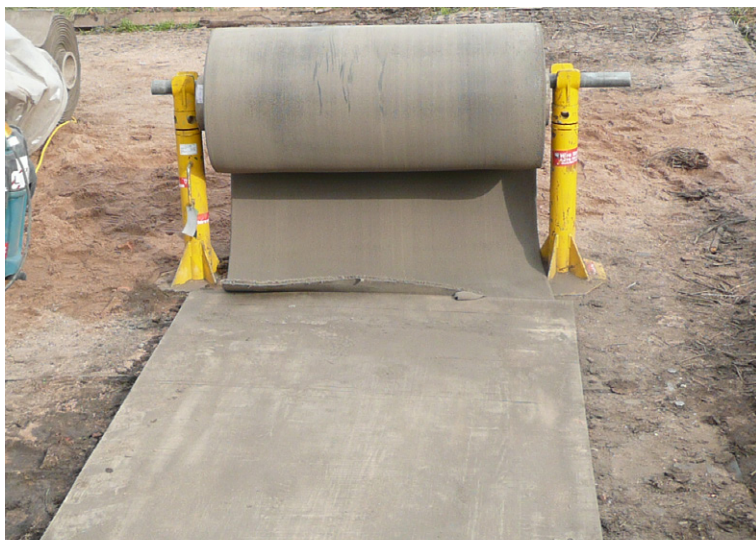
CC was delivered to site in bulk rolls and batched to length on site

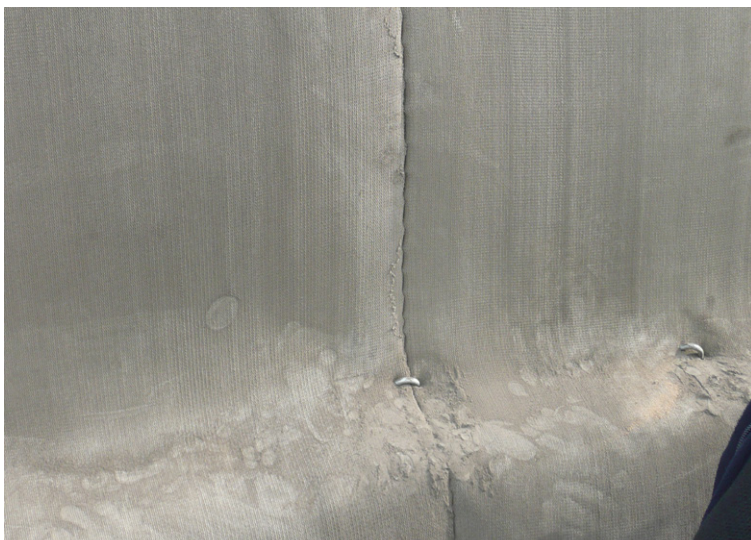
The CC was secured with hog rings and staples

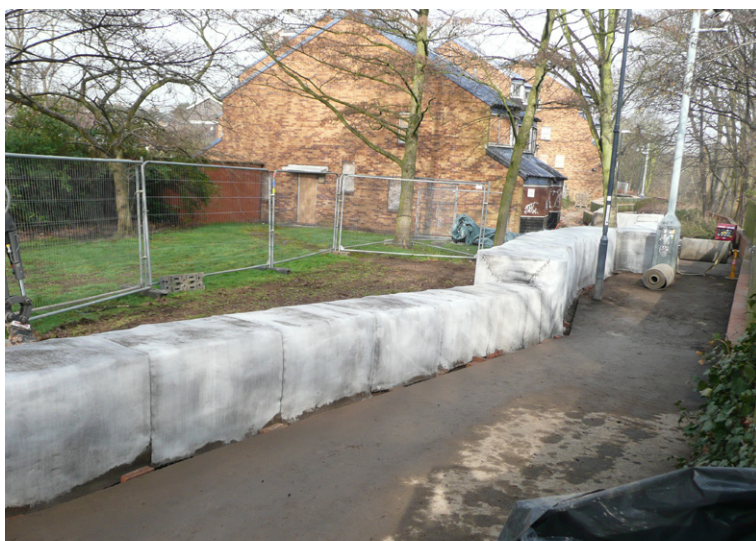
Completed installation

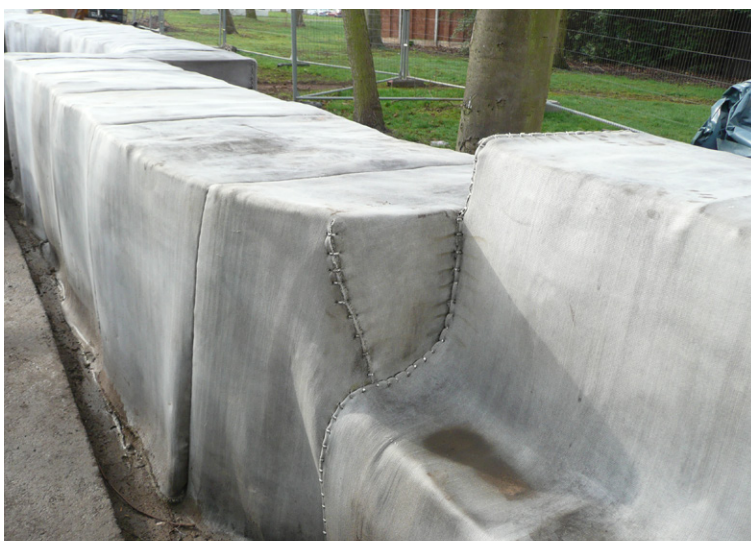
Completed corner detail

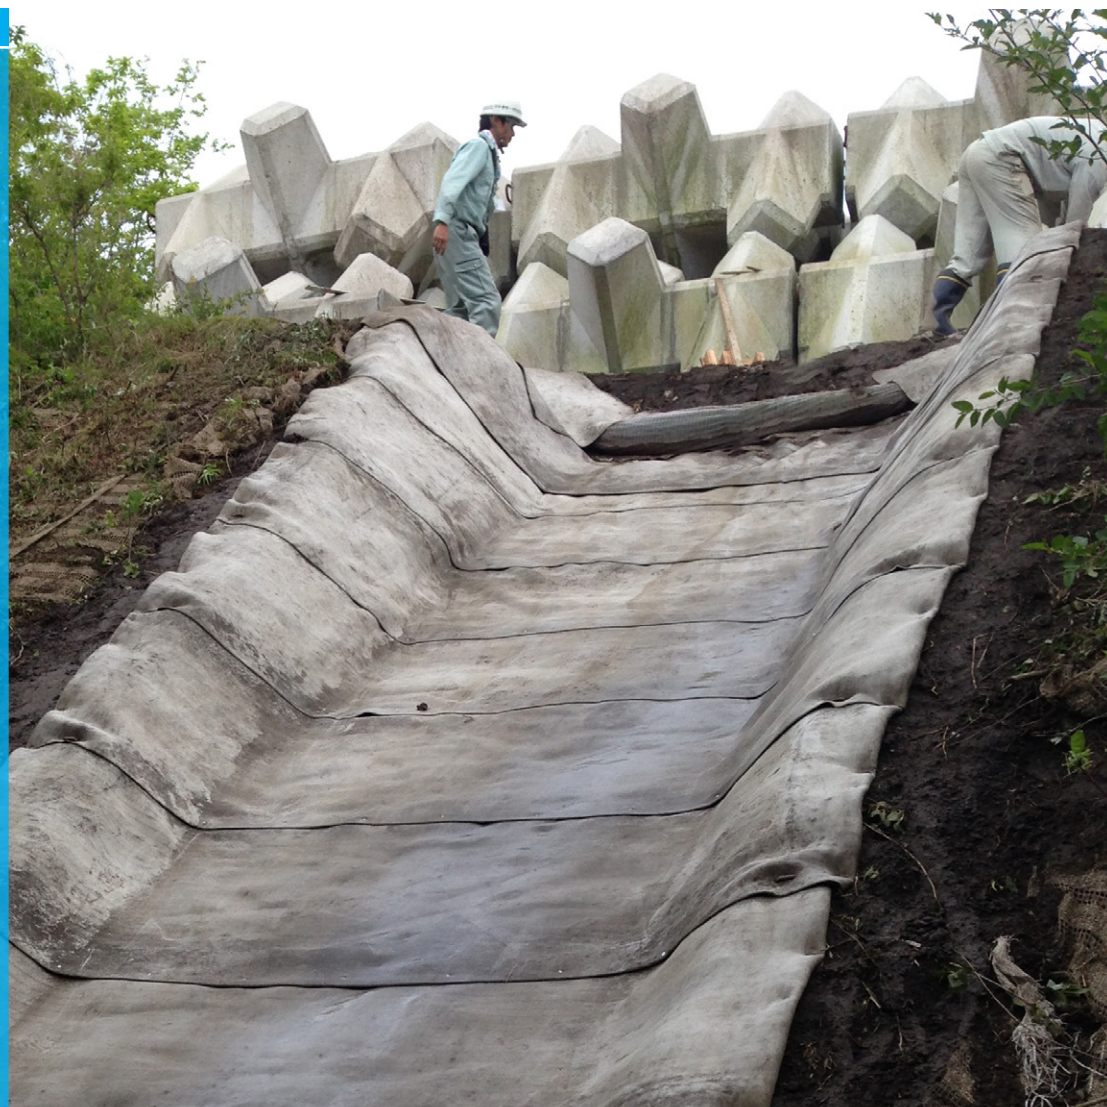
CC5™ used to line an outfall to prevent erosion.

Completed installation at Mt Asama, Japan

Prior to installation, the ground was compacted and any areas of deep erosion were filled to prevent any voids under the CC. The outfall was then profiled by hand and batched rolls of CC5™ were delivered to site. The CC layers were manoeuvred into place and overlapped by 100mm. Each CC layer was fixed to the substrate and overlapped layers were jointed using SS screws at 200mm intervals. The edge of each layer was folded back underneath itself to provide neat termination.

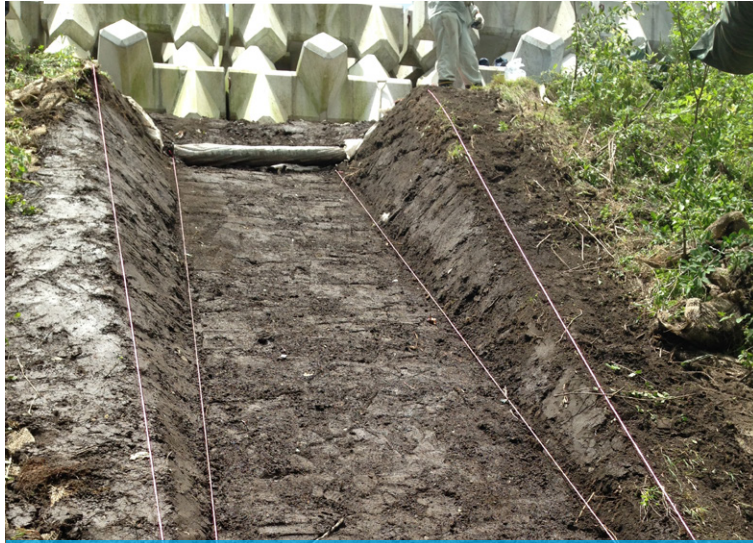
Installation site after ground preparation

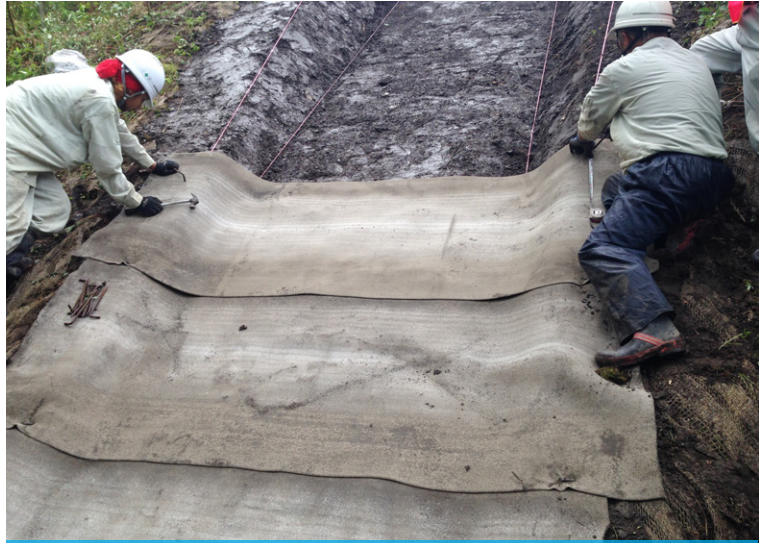
The CC was laid horizontally down the slope

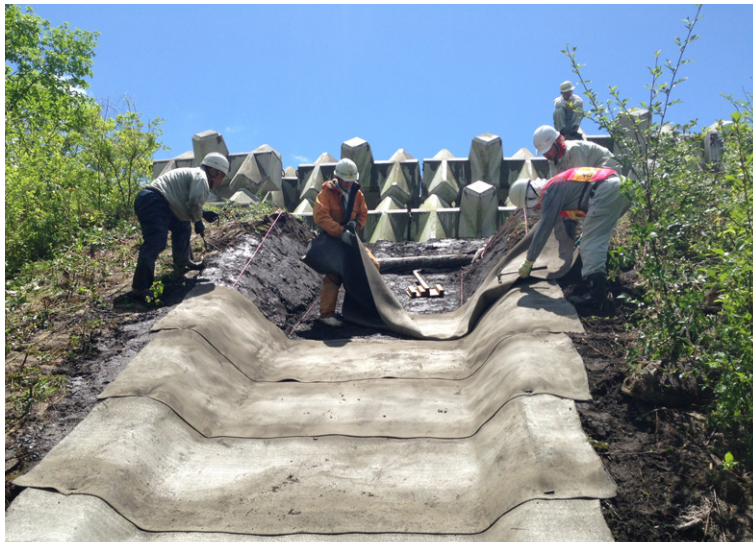
Installation progress

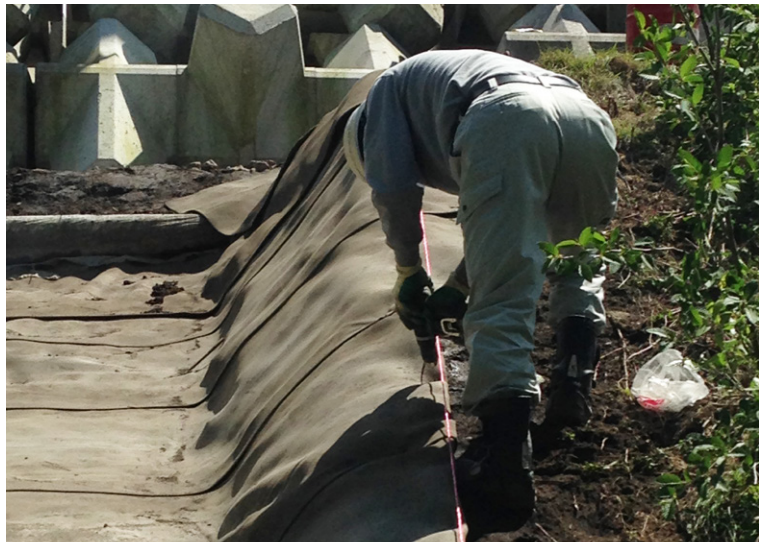
The CC edges were folded beneath themselves for neat termination

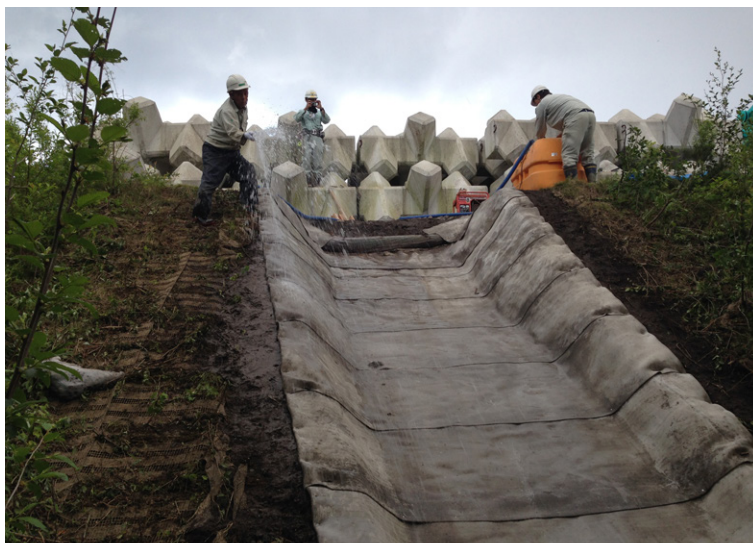
Hydration of the completed installation

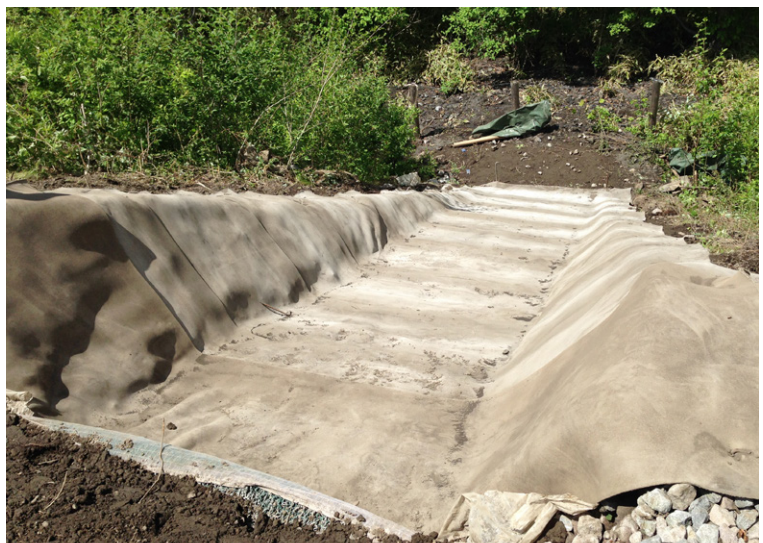
Completed installation

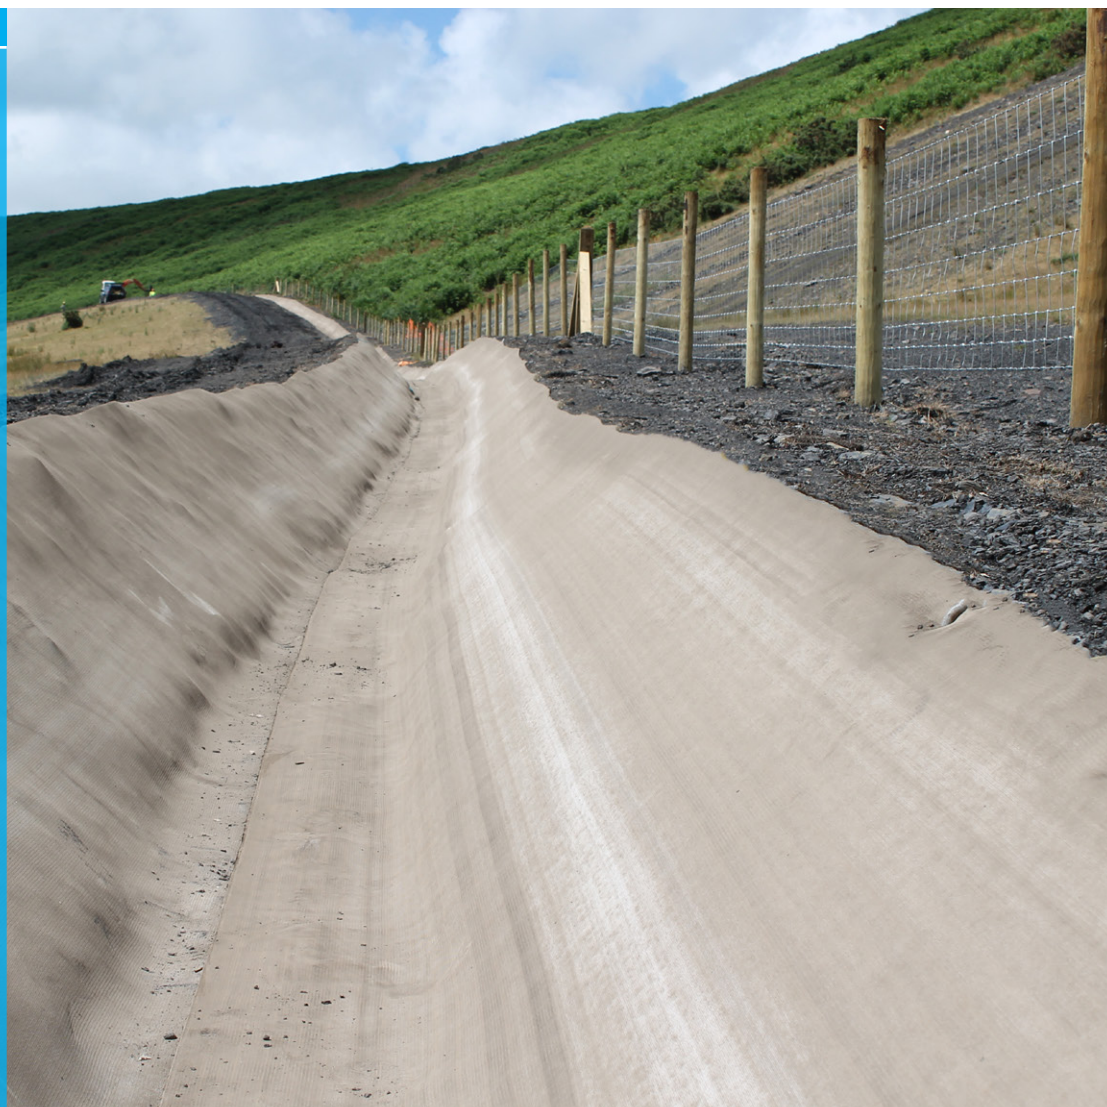
CC8™ used to line
a channel in an
environmentally sensitive
area to help redirect
surface run-off from a
nearby slope causing
surface erosion and slip.

Completed installation at Pontardullais site

Prior to installation the channel profile was excavated and cleared of any vegetation and debris before bulk rolls of CC8™ were delivered to site. Spreader beam equipment and heavy plant was used to dispense the CC along the length of the channel in two longitudinal, overlapping layers. The overlaps were screwed together at 200mm intervals, and the CC fixed to the crest of the channel with steel ground pegs. The material was then hydrated using on-site equipment.

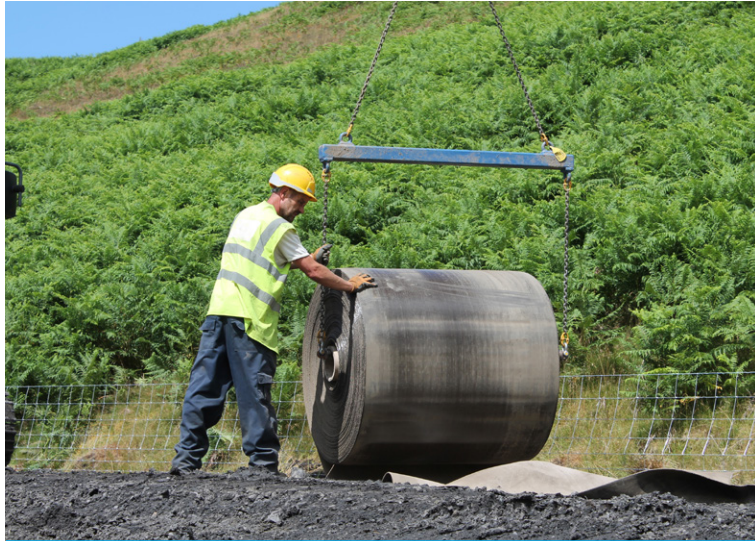
CC was delivered to site in bulk rolls

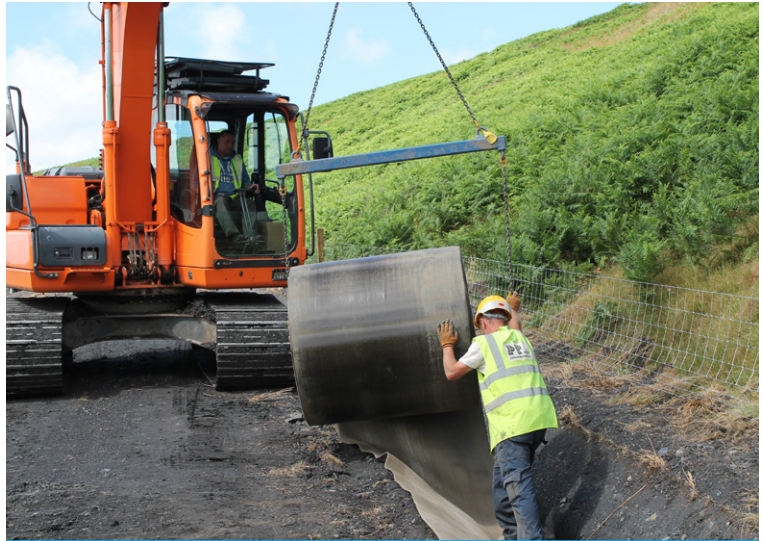
A spreader beam and heavy plant were used to deploy and lay the CC

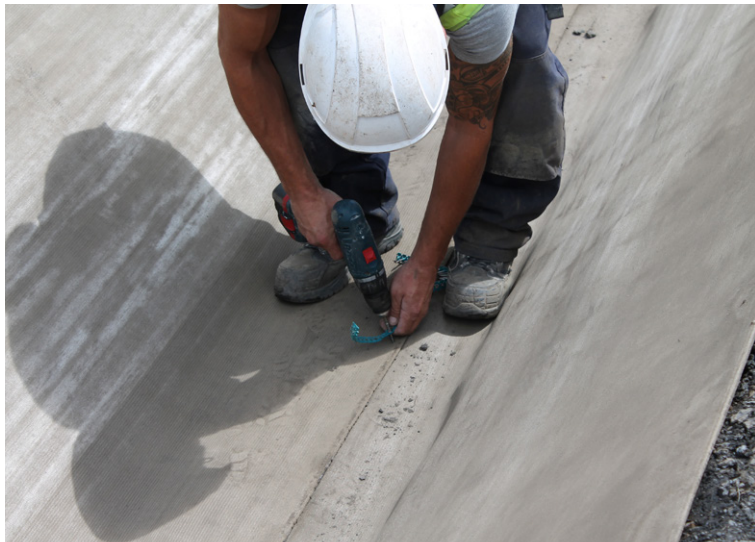
Screws were used to joint the CC at the overlaps

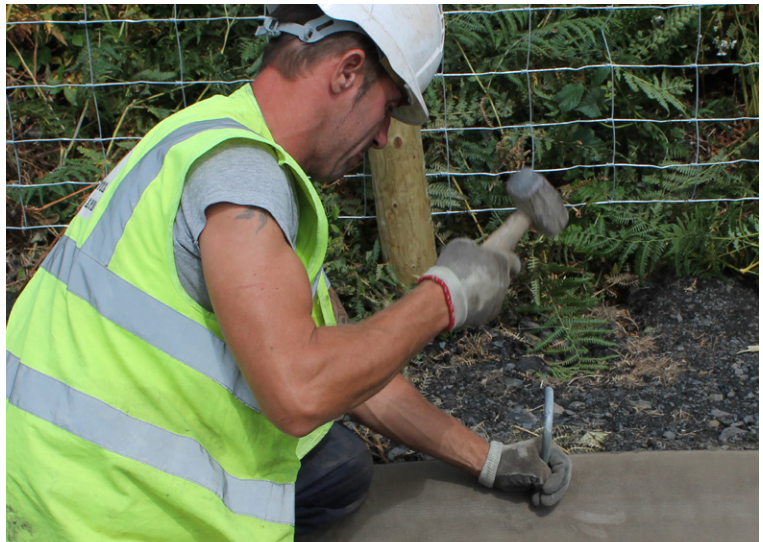
The CC was fixed to the ground at the edges using ground pegs

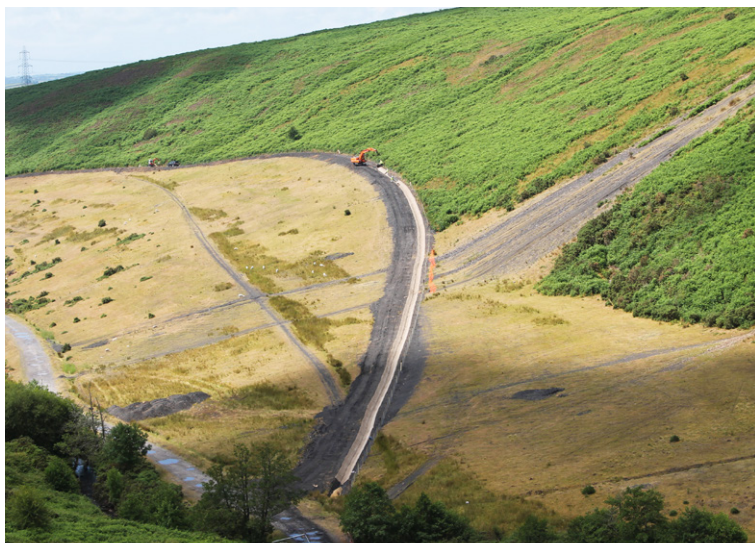
Completed installation

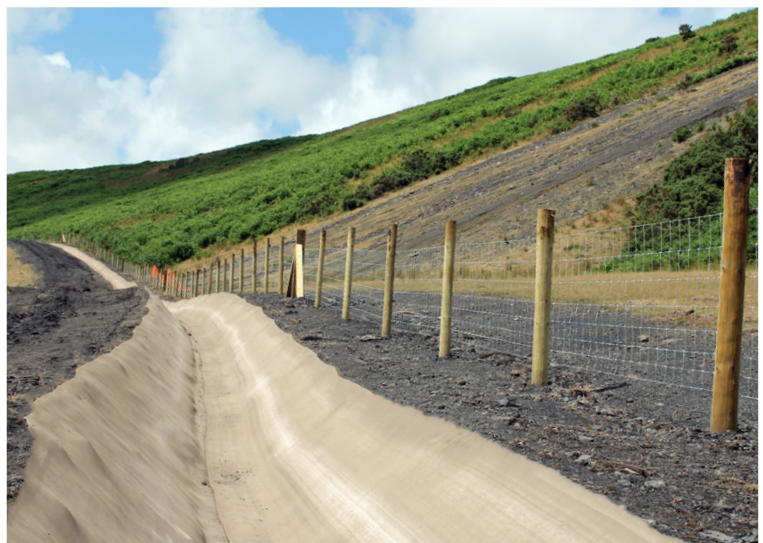
Completed installation - downstream view

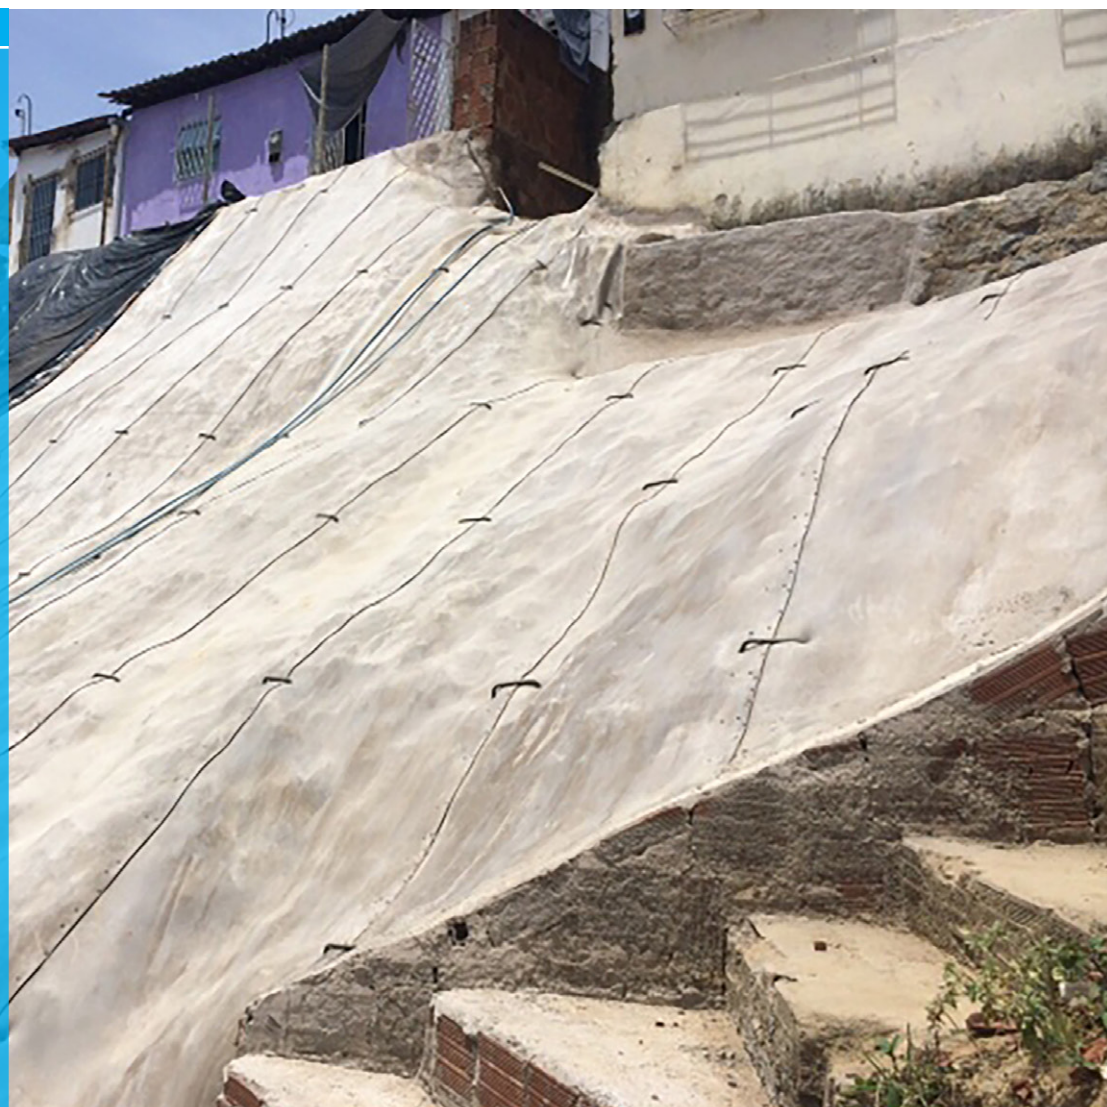
CC8™ was used to
protect a residential
slope facing severe
erosion issues.

Completed installation

In February 2015, Concrete Canvas® GCCM* (CC) was used to protect a slope in Recife, Brazil. The slope was facing severe erosion problems that had already led to a house at the crest of the slope collapsing. The works were carried out by SPI Brasil for Defesa Civil Recife (Civil Defense Recife Municipality).

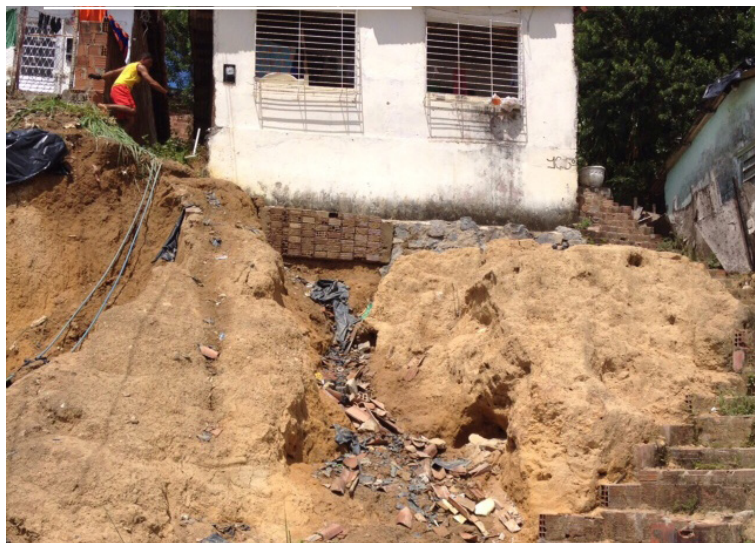
Slope prior to installation works

The slope ranged from 5m to 12m in height and was surrounded by housing. Debris was removed and the surface re-graded. The CC was delivered to site in bulk rolls, mounted onto a spreader beam and hung from a crane for easy deployment. For the smaller lengths, the CC was unrolled on the flat, cut to length and positioned by hand. For the rest, the CC roll was positioned at the top of the slope and spooled down and cut to length, reducing manual handling. All layers were overlapped by 100mm.

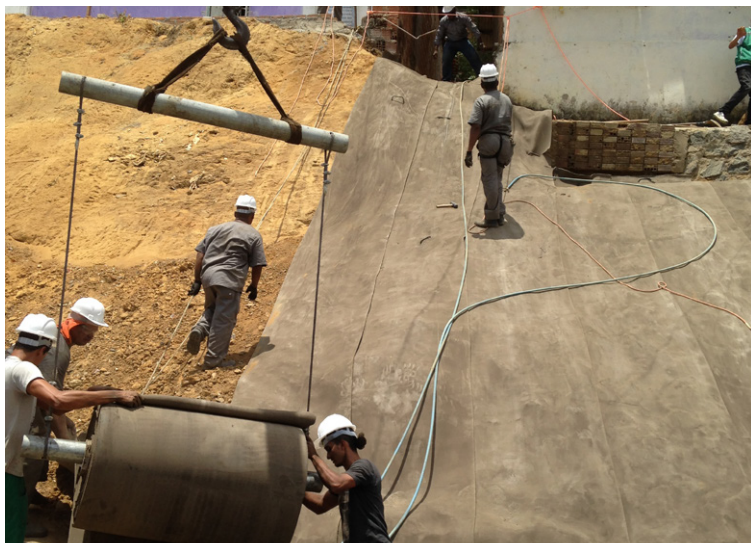
Deployment of CC

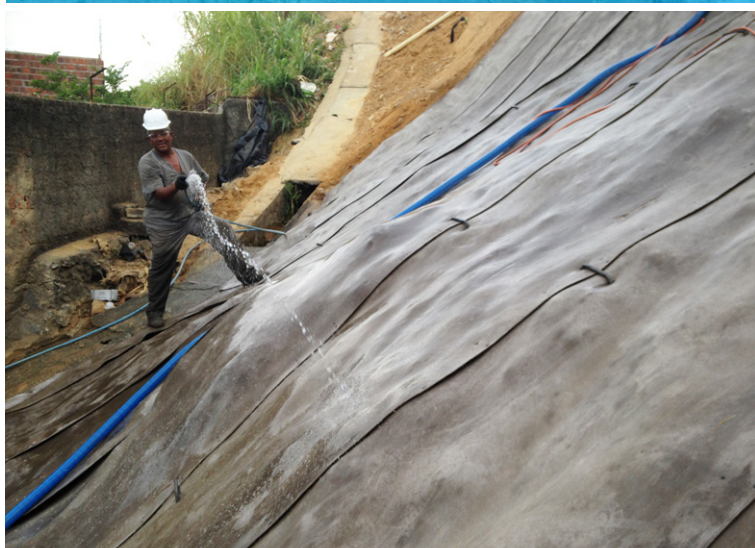
Hydrating the CC

The CC was initially fixed at the top to allow hydration under the overlaps before fixing the CC to the slope with 400mm ground pegs at 2m intervals. A double row of screws were then applied at 200mm intervals, and hydration was completed using an 8000L bowser and hose. Concrete mortar was then used where the CC terminated onto masonry, and the CC was painted once set to match its surroundings.

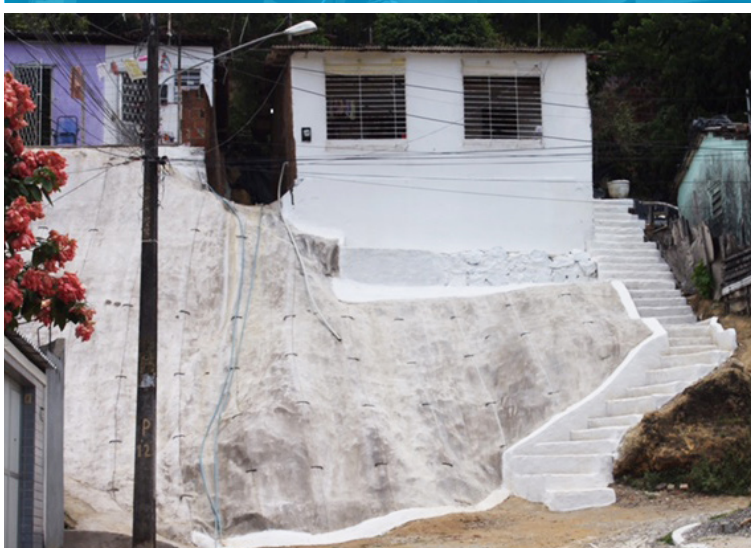
Completed, painted installation

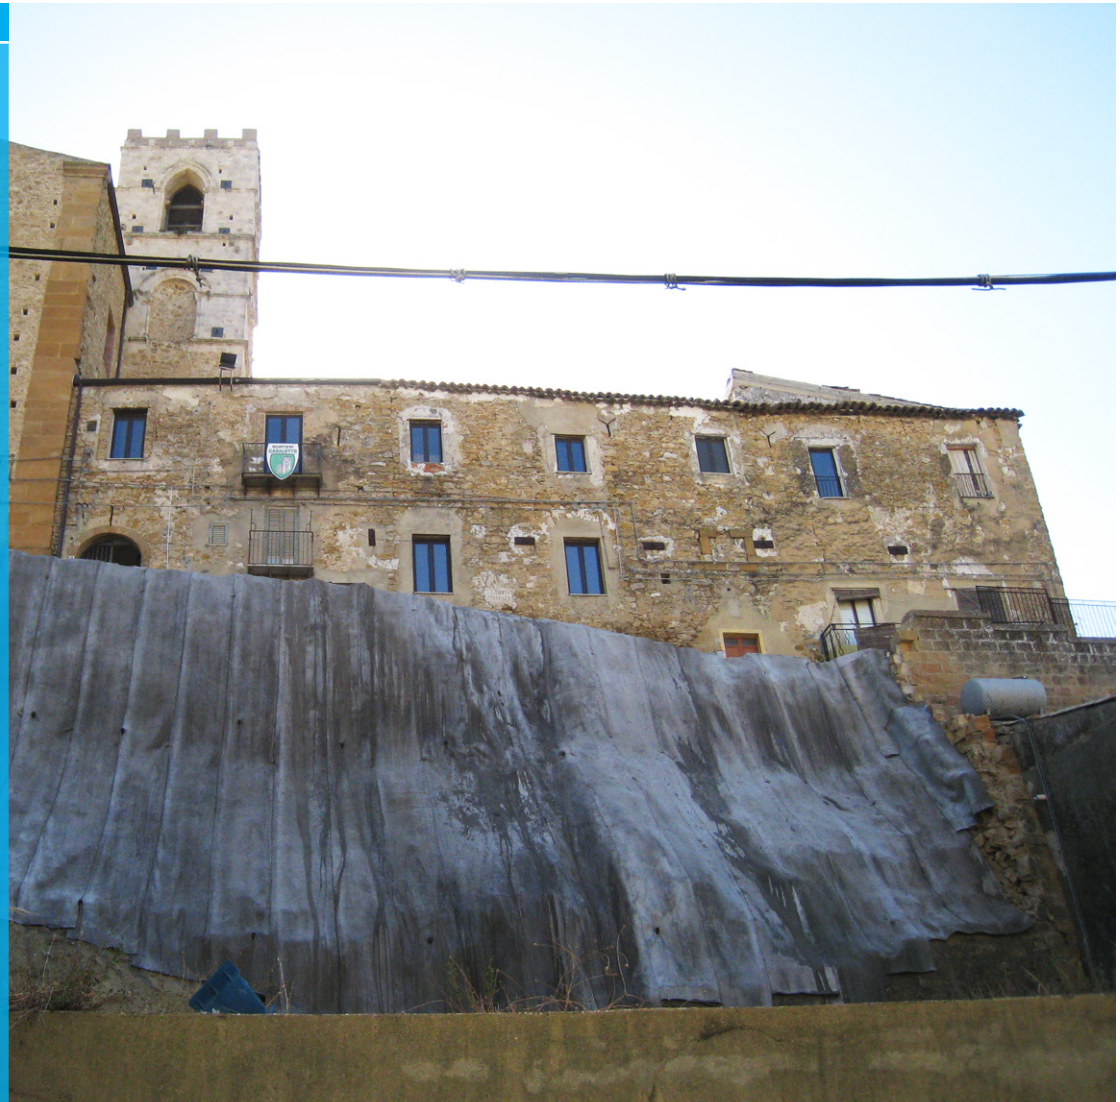
CC5™ was used to
cover a slope 281m
in length, and 14m
in height in Piazza
Armerina, Sicily

Completed installation in Enna, Sicily

In August 2015, Concrete Canvas® GCCM* (CC) was used to protect a steep slope in the Piazza Armerina in the Enna Province, Sicily. The slope was 281 metres in length, and 14 metres high, and had been exposed after a historical wall, built in the 1900s, collapsed. The slope was in need of temporary protection to prevent further collapse and damage to the area.

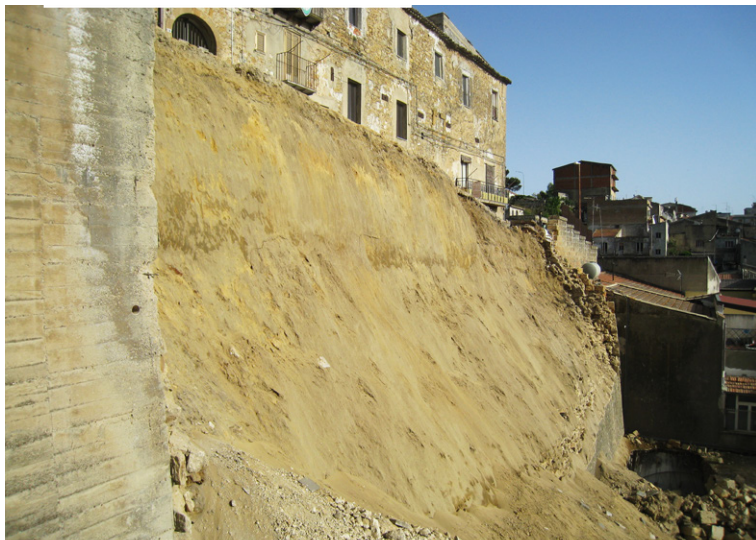
Slope before installation

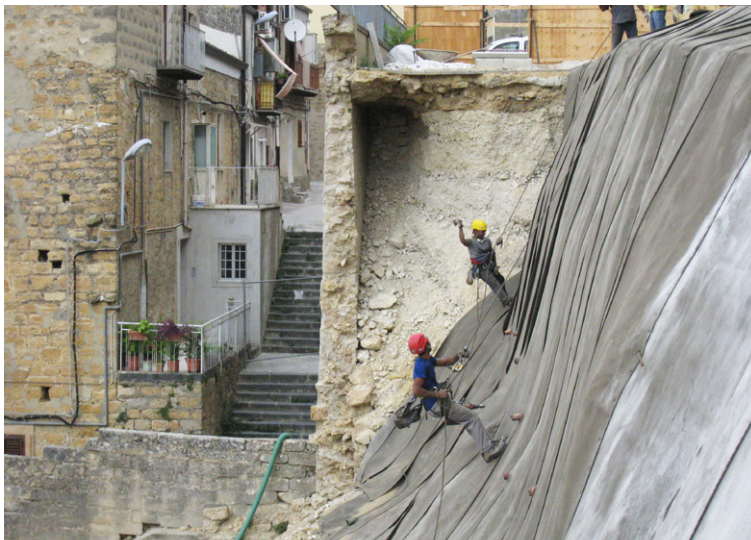
Two rock climbers assisted with the installation

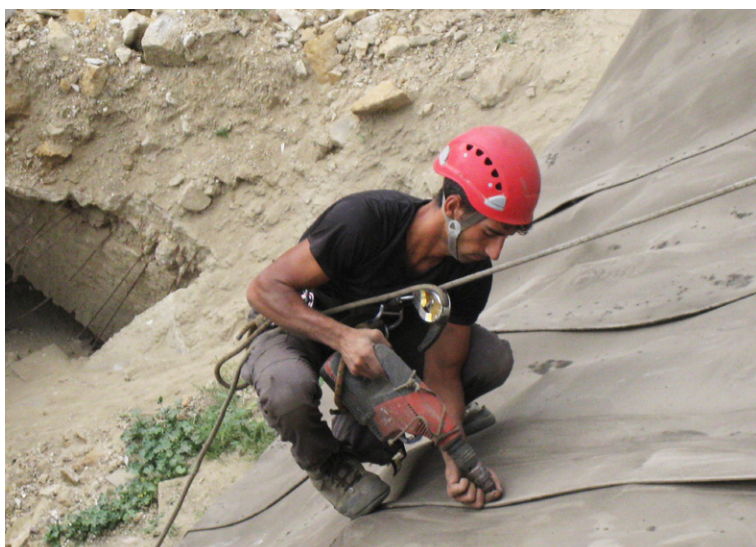
Screws were used to fix and join the layers of CC

Prior to installation, debris was removed from the slope and an anchor trench dug at the crest. The CC was delivered to site in bulk rolls, cut to profile length and deployed down the slope, jointed with screws at intervals of 200mm, and then ground pegs every 1m in the anchor trench along the top of the slope, before being hydrated.

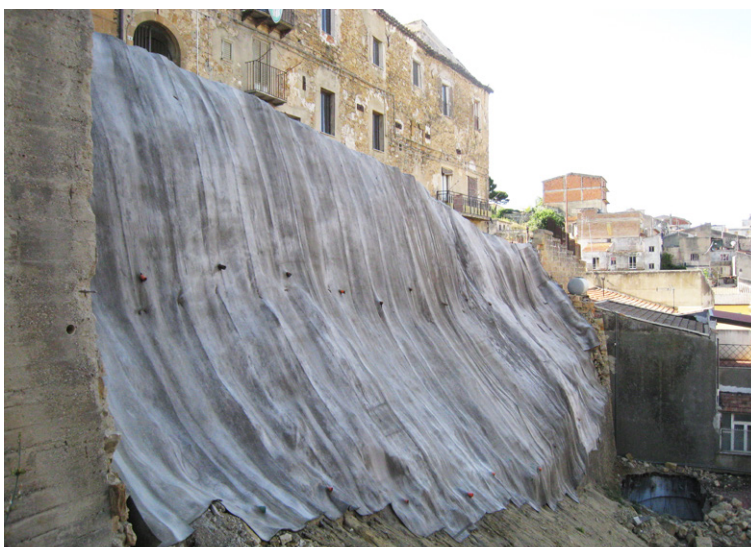
Completed installation

“After 2 years the CC5™ protection is still there, the original request was for a temporary protection, until the municipality could find the money to rebuild the collapsed wall, but until now the funds to rebuild have not materialised and the situation has not changed, and will in all likelihood not do so for another 2 years.”
