CONCRETE CANVAS® Concrete on a Roll

PUBLIC WORKS CASE STUDIES

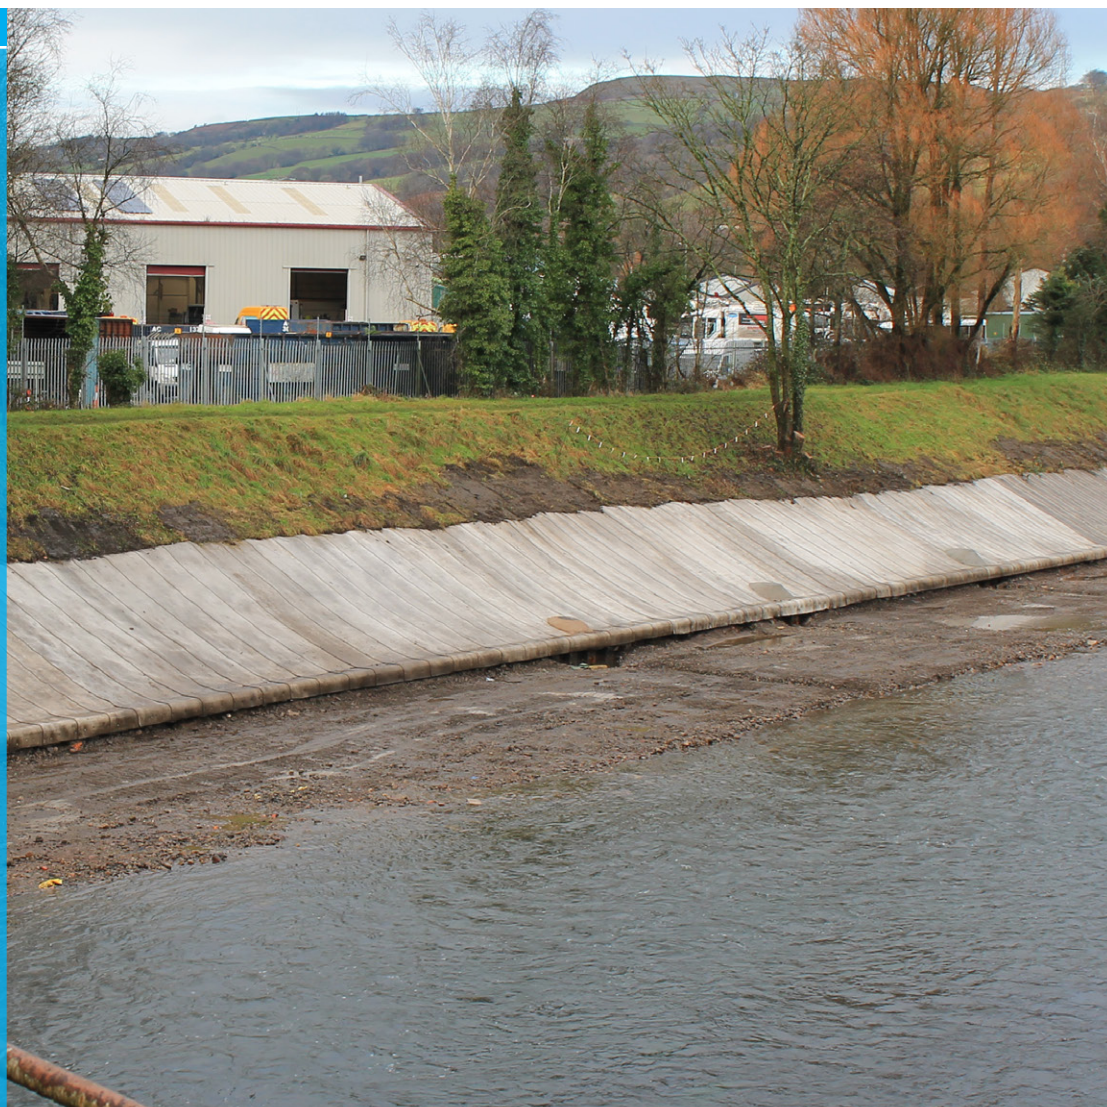
Completed installation

In November 2016, Concrete Canvas® (CC) GCCM* was used to line sections of embankments of the River Taff in Pontypridd, South Wales. A particular section of the river, within the Treforest Industrial Estate, was showing signs of degradation; the existing concrete riprap was heavily cracked, spalled and showing established vegetation growth. Remediation was required to provide an effective erosion protective layer to prevent further scour.

The CC was laid over the geotextile, with layers overlapped by 100mm in the direction of waterflow, and screwed together through the overlap at 150mm intervals. The lack of sealant used in this installation and the use of the geotextile below the CC would allow the release of any build-up of hydrostatic pressure within the embankment, as well as creating a natural water transition between the substrate and CC.

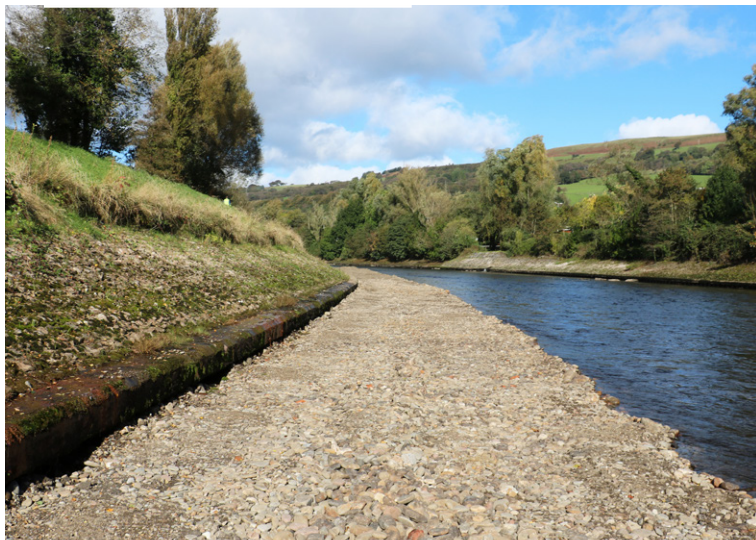
The site prior to installation

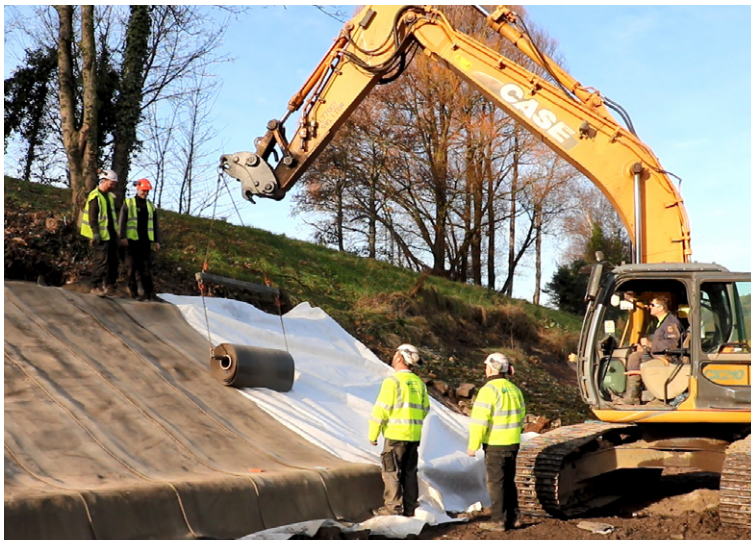
Deployment of the CC

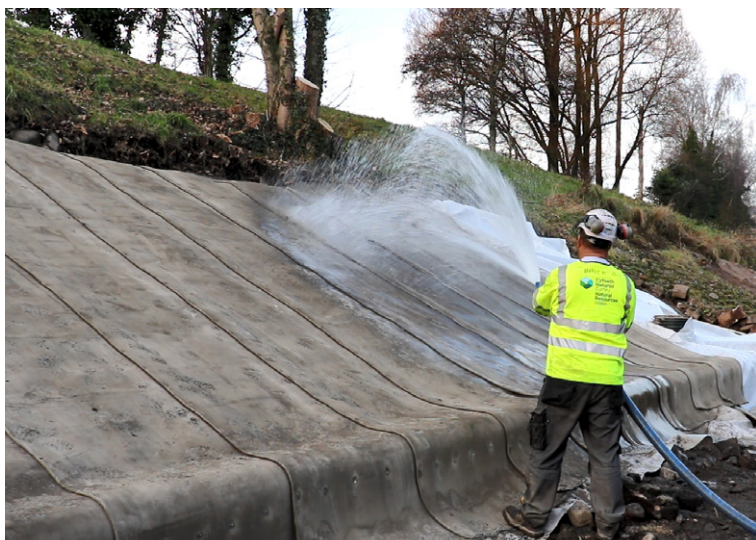
Hydration directly from the river

At the crest, the edges of the CC were captured and pinned using steel pegs within an anchor trench, which was then backfilled. The concrete kerb at the toe of the slope allowed the CC to be fixed using masonry anchors. The side edges of the CC were also anchor trenched within concrete poured backfill to prevent ingress. A series of drainage chambers were installed along the length of the embankment. Hydration was given via hose using water from the river.

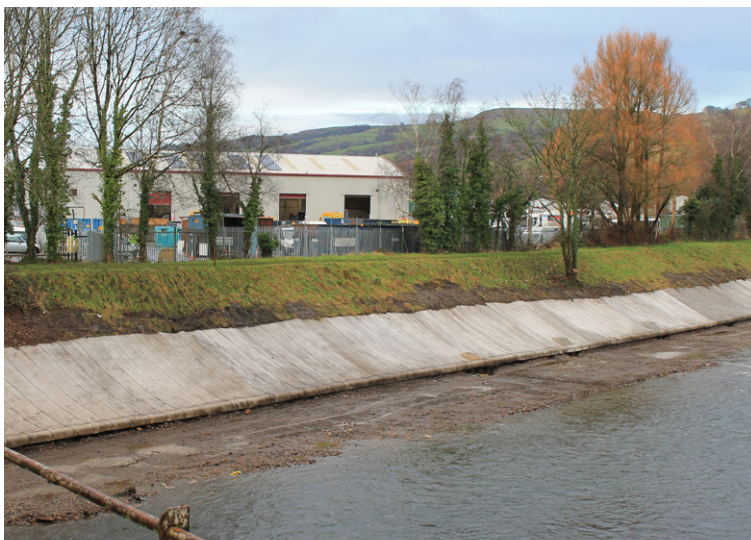
Completed installation
