**CONCRETE CANVAS®**
Concrete on a Roll

RAIL CASE STUDIES

Concrete Canvas® is part of a revolutionary new class of construction materials called GCCMs. It is a flexible, concrete filled geosynthetic that hardens on hydration to form a thin, durable and water proof concrete layer. The material is predominantly used for erosion control applications such as channel lining and slope protection, offering a faster, lower carbon alternative to conventional concrete.

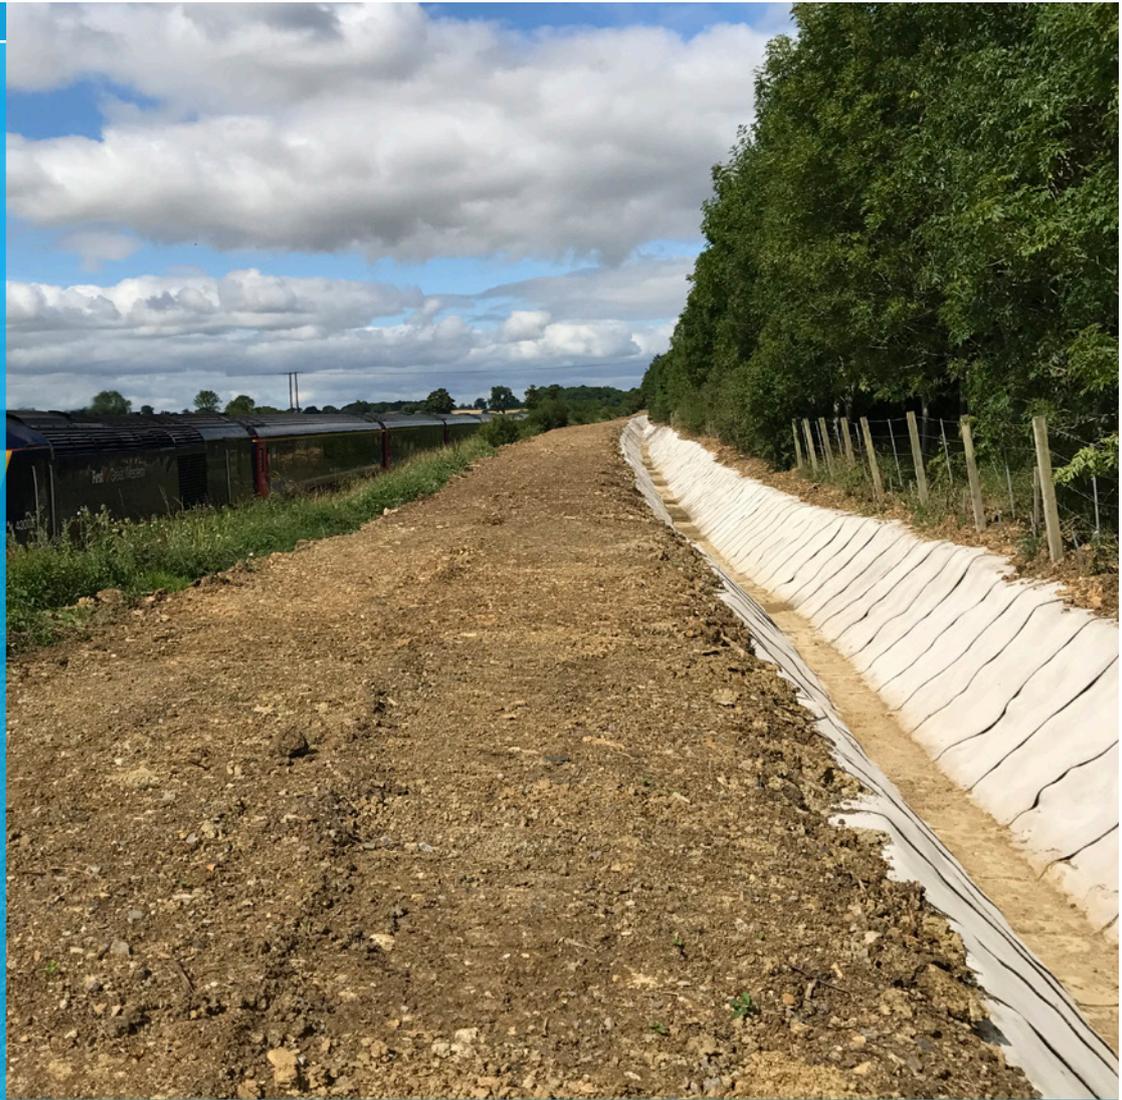
Completed second channel section in Sherston, Wiltshire

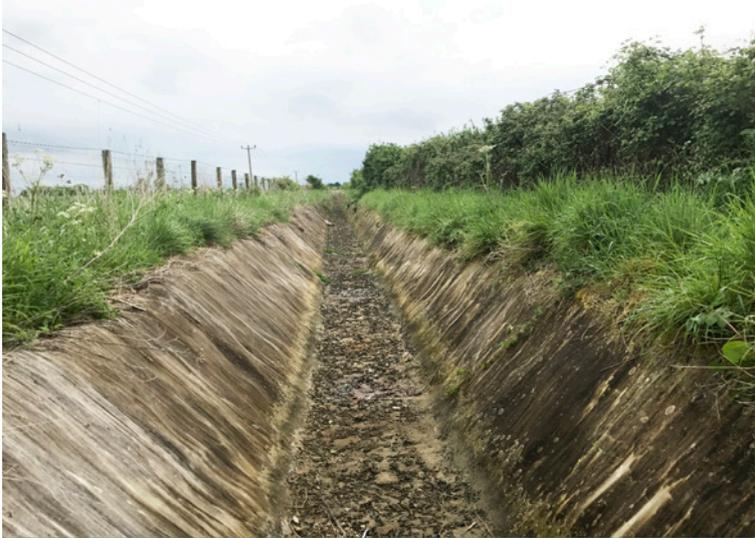
Original CC lined channel installation three years after completion

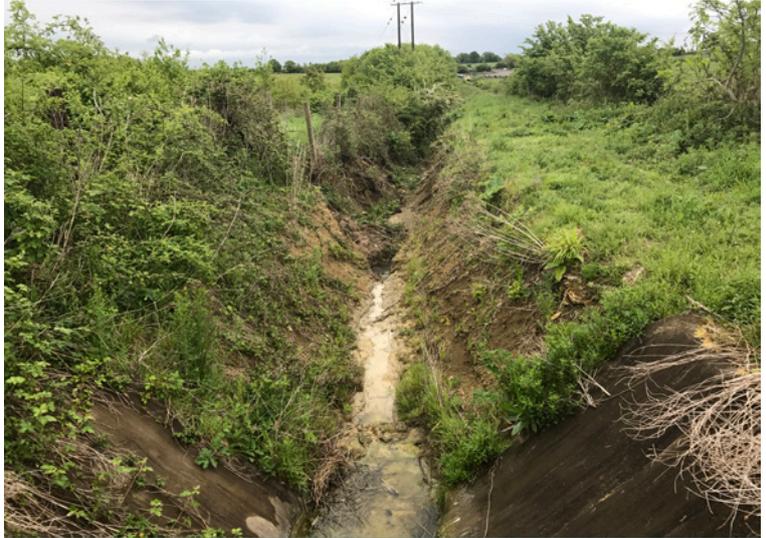
Unlined channel showing 3m deep scour and erosion

The section of CC lined in 2017 was situated downstream of the original CC installation and beyond a culverted section of drainage, which had eroded away and created a 3m deep scour pocket occurring as water discharged from a headwall into the unlined channel. The scour resulted in flooding of neighbouring fields and concern that future storm events could also flood the track.

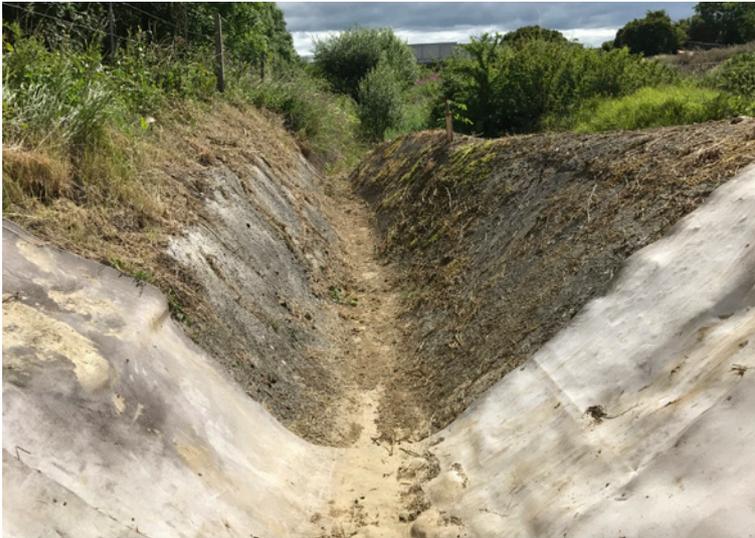
First layer of CC placed on existing concrete channel

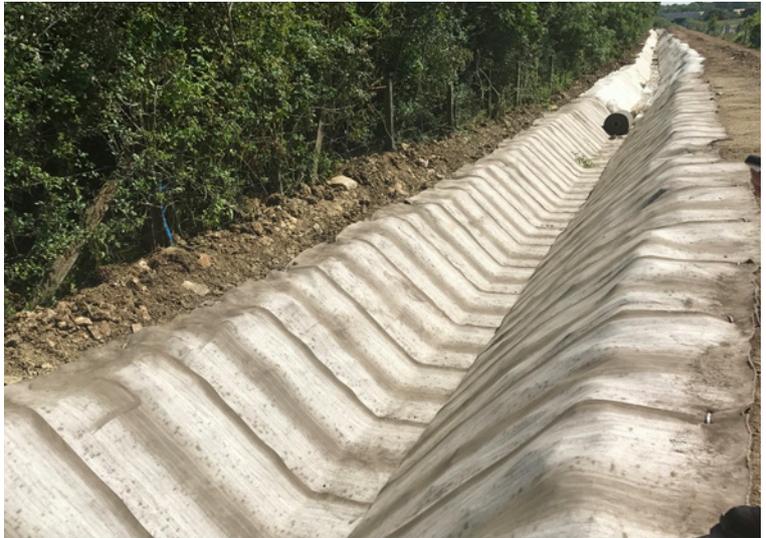
Installed CC prior to hydration and backfilling of anchor trench

The 750mm diameter culvert was extended for 80m before a new headwall was formed. The open channel was regraded and lined with CC8™ material, continuing for 350m before terminating into an existing sprayed concrete channel. Due to the restricted access and a need for end on working, the contractor's team excavated 30m sections of the channel using a ditching bucket, then installed the CC in a transverse layup. The team began downstream at the existing concrete channel, working upstream towards the headwall, lapping adjacent layers of CC so that they were shingled in the direction of water flow. Overlap joints were screwed together to prevent erosion between layers. To prevent water ingress beneath the material, the edges of the CC were pinned in an anchor trench which was backfilled.

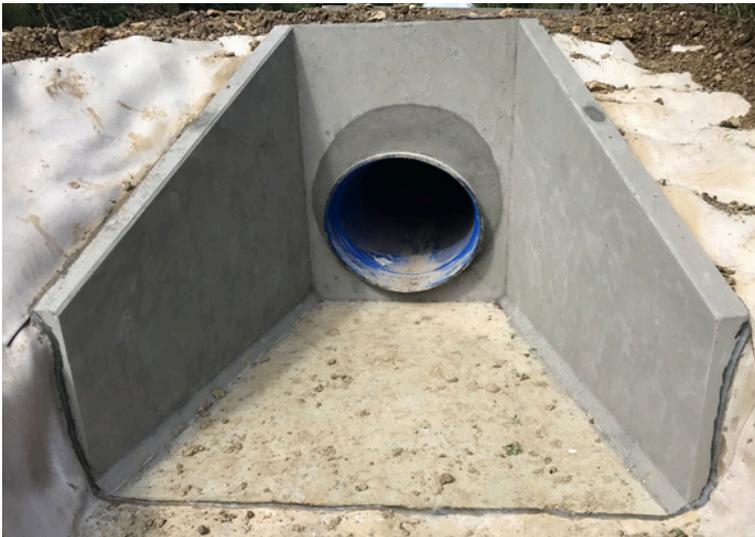
Headwall detail

The CC material was laid underneath the headwall before it was placed on top. The wing walls to the headwall were backfilled to ensure the CC tightly captured between the soil and concrete wingwall. All joints between the headwall and Concrete Canvas were finished with an adhesive sealant to prevent water ingress and potential scour. At times the installation was carried out in 30 degree heat and to ensure adequate hydration was achieved, more than 6 litres of water was used for every m² of CC installed. Even with restricted access and by end on working, 1950m² of CC8™ was installed in 3 weeks by a team of three.

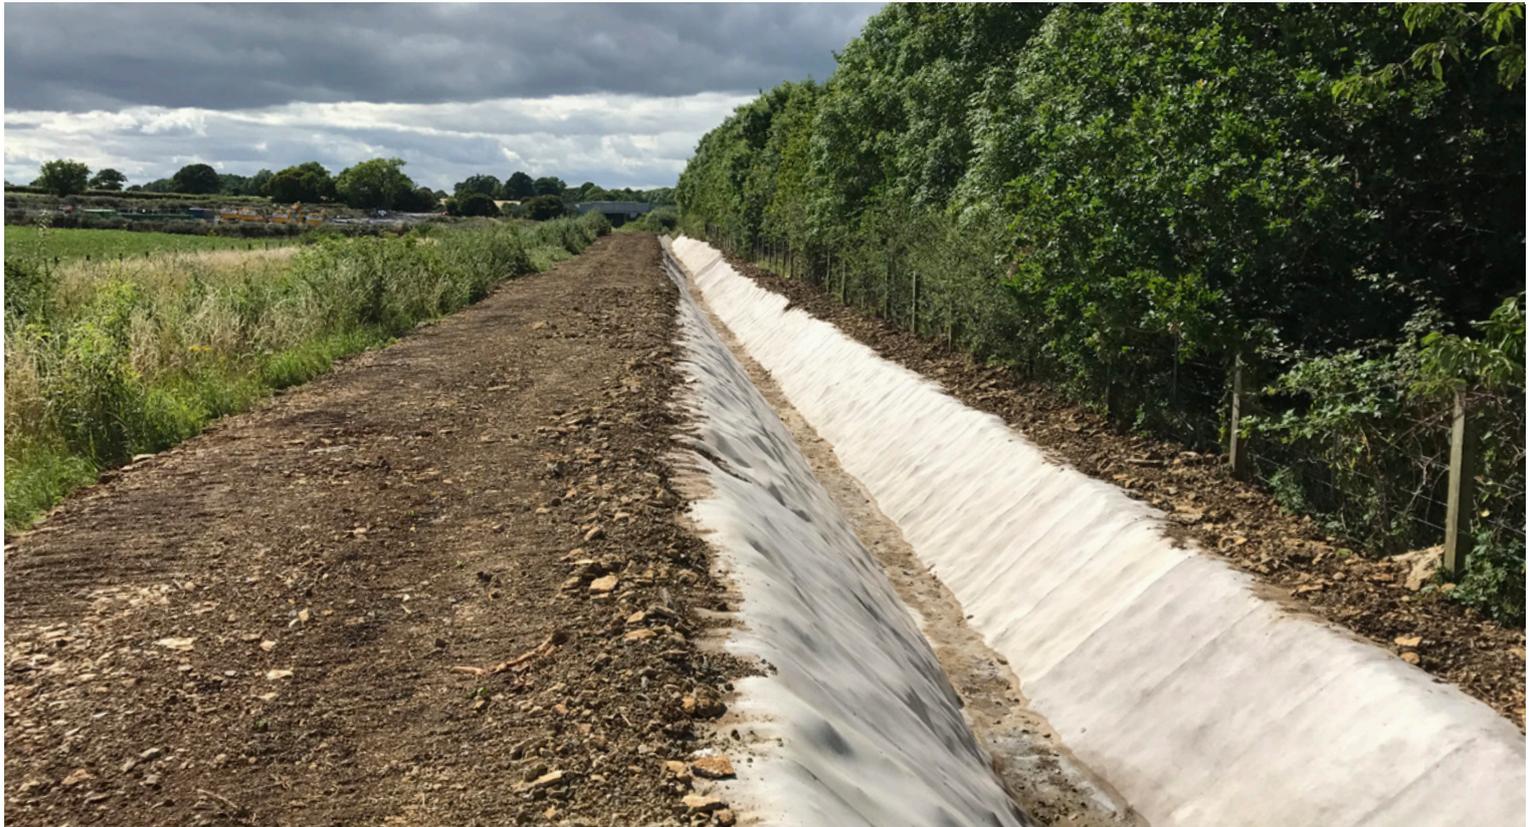
Completed second CC lined channel section in 2017 in Sherston, Wiltshire

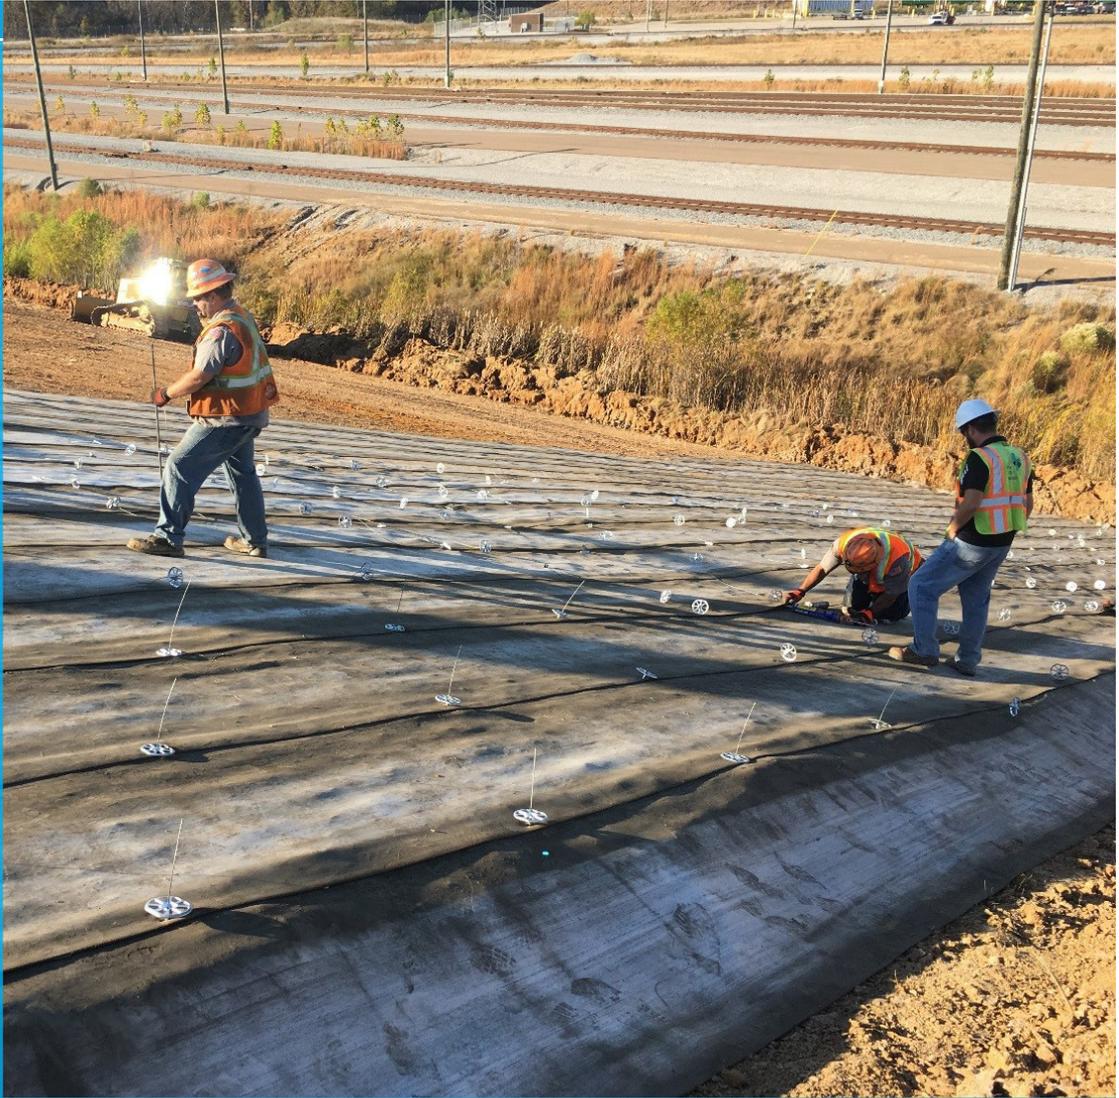
Installation of CC5 on a slope in Rossville, Tennessee

CC5 was specified for the project and was delivered to the site in bulk rolls. The material was laid longitudinally down the slope, from crest to toe. Subsequent layers of CC were overlapped by 100mm and jointed using percussion earth anchors, which were also used to fix the material edges. The edges were then captured in anchor trenches prior to backfilling.

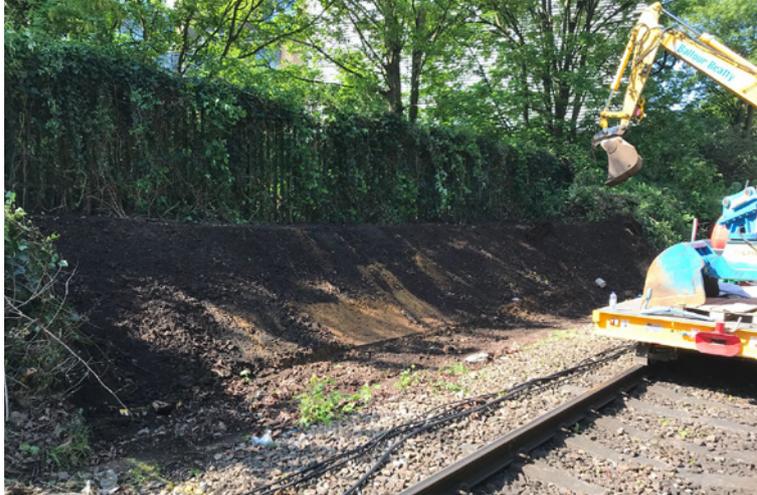
Ground works prior to installation

Six slope sections required lining, but first had to be cleared of vegetation and the slope profiles graded. The CC5™ material was delivered in bespoke-length bulk rolls to minimise wastage, transported via rail trolleys and dispensed using a spreader beam hung from a track-mounted excavator.

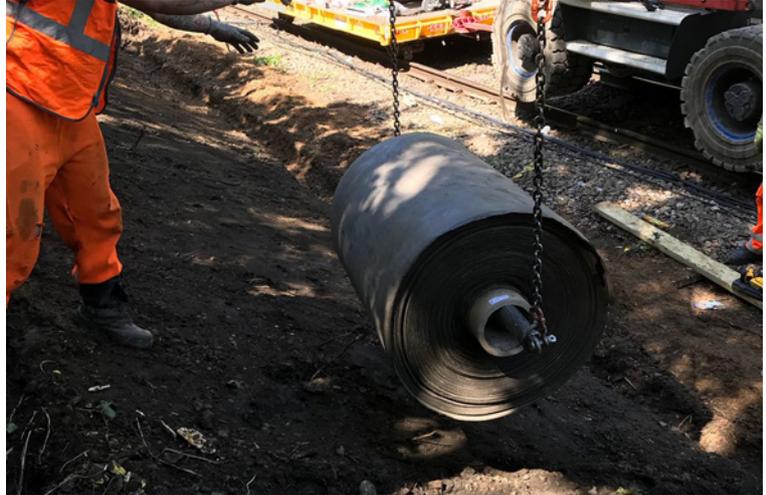
Deploying first length of CC

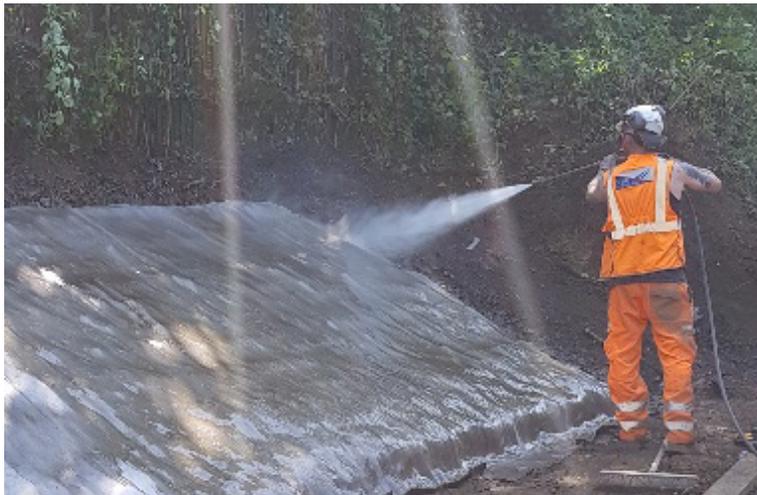
Hydration

The material was laid vertically, with edges pinned at 1m intervals in perimeter anchor trenches for a flush finish around formwork and overlapped layers jointed using stainless steel screws. Where the material had to be fitted around folding post signal structures, formwork was created around the post which was later filled with poured concrete. Following installation, the material was hydrated via bowser.

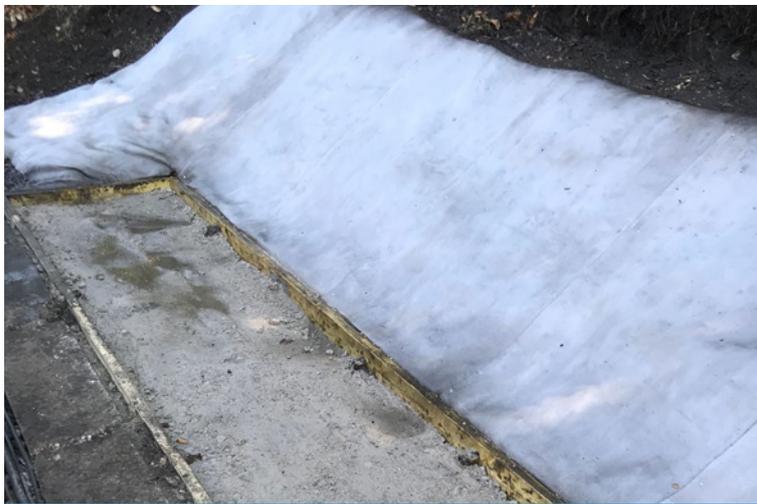
CC installed around framework

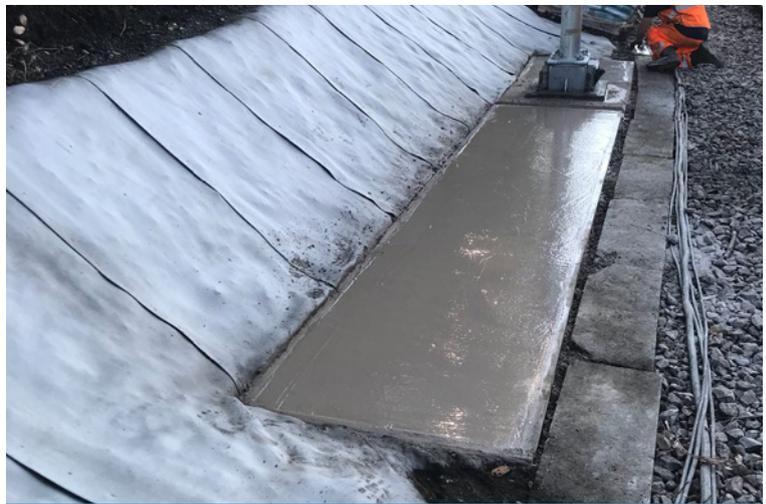
Poured concrete installation completed

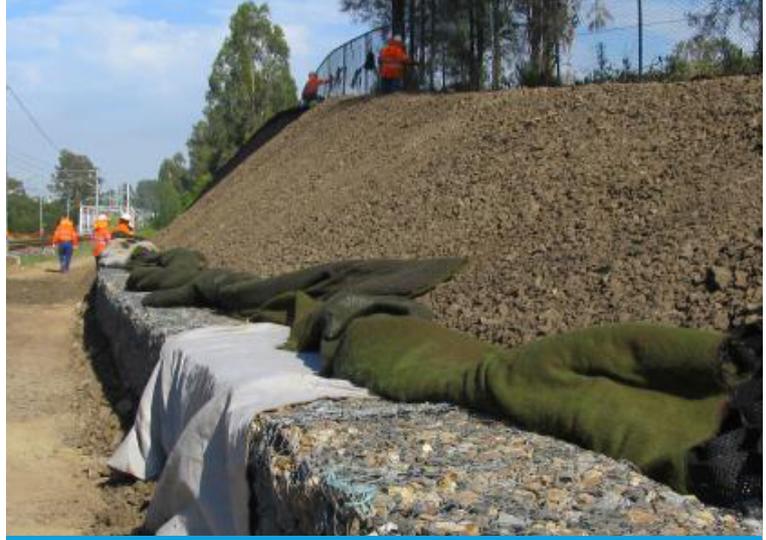
Slope following re-grading and gabion placement

After clearing the bank of vegetation, a single course of Gabions was installed along the length of the embankment to form a permanent toe from which the slope could be re-graded, while ensuring underground services were protected and accessible. The slope was then protected using a three-layer system of the non-woven geotextile, the geoweb system, which was then filled with ballast materials, and the erosion control matting. A 'V' drain was created at the crest, shaped and lined with CC material which was secured using ground pegs at the edges, which were then buried in an anchor trench. Overlaps were jointed using screws and sealant.

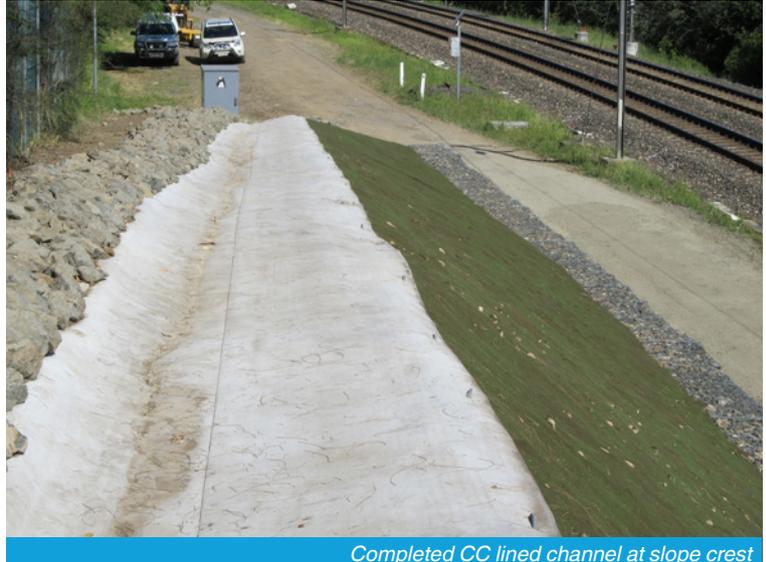
Completed CC lined channel at slope crest

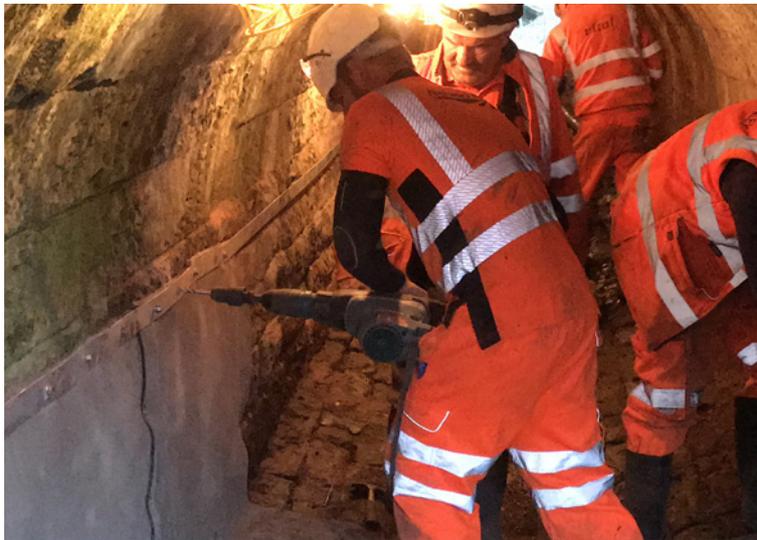
Joining overlaps using shot-fired nails

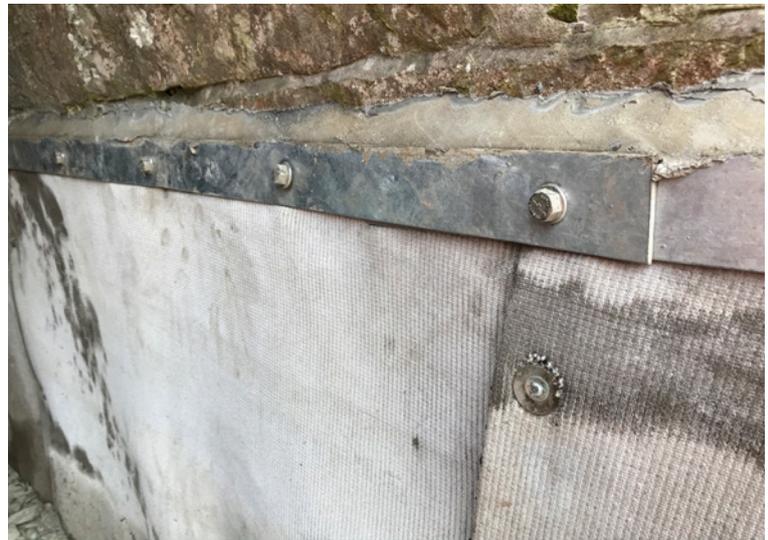
Termination of CC edges using steel bars and grout

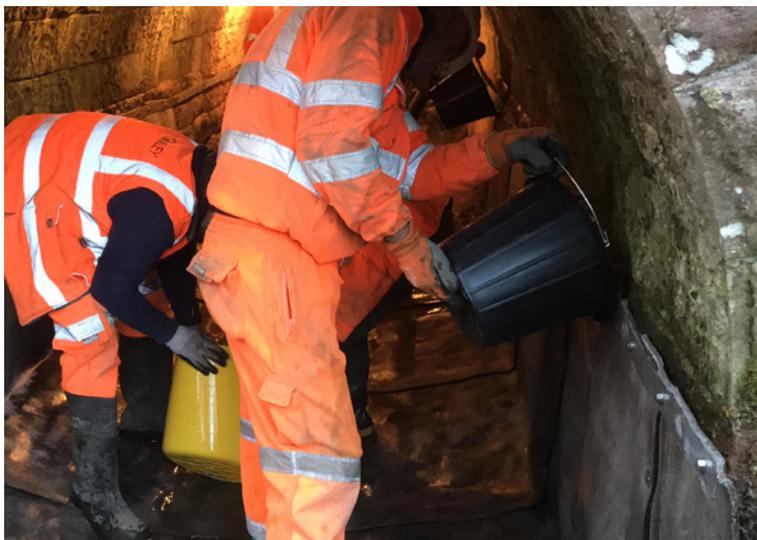
Hydration of CC on culvert walls

Prior to installation, large voids were filled to prevent water ingress below the material. Vegetation was removed, and repairs and repointing were carried out where required. The batched rolls were cut to 3.5 linear metre lengths which covered the invert of the culvert and the walls above the high-water line. Batching the material to the exact required lengths minimised wastage and made the material easier to handle in the culvert. The CC was fixed with a mixture of shot-fired nails and masonry bolts at 200mm centres on each overlap. The termination detail on the culvert wall consisted of a galvanised steel strip securing the edge of the CC; the strips were secured at 300mm centres. Following installation, grout was added to the top of the strip to neaten edges and further prevent ingress. Water from the upstream side of the culvert was used with a sump pump to hydrate the material, with buckets used to hydrate CC on the culvert walls. The installation was carried out over 5 days by a team of five.

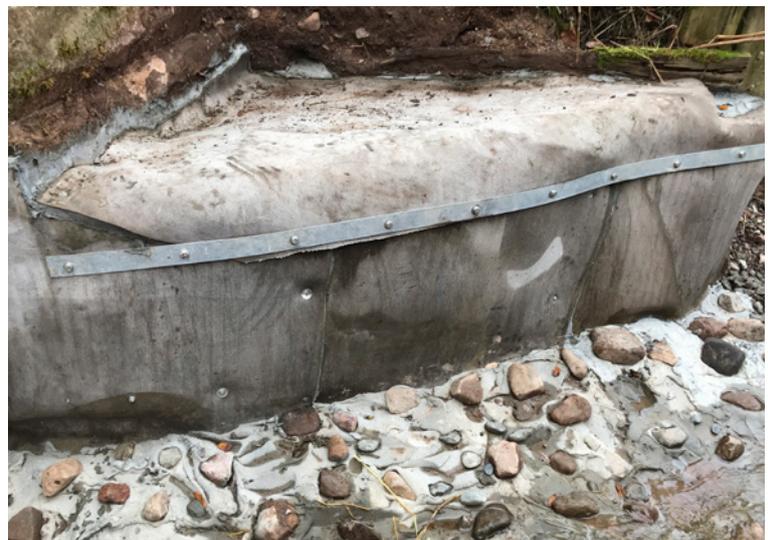
Termination details on wall outside culvert

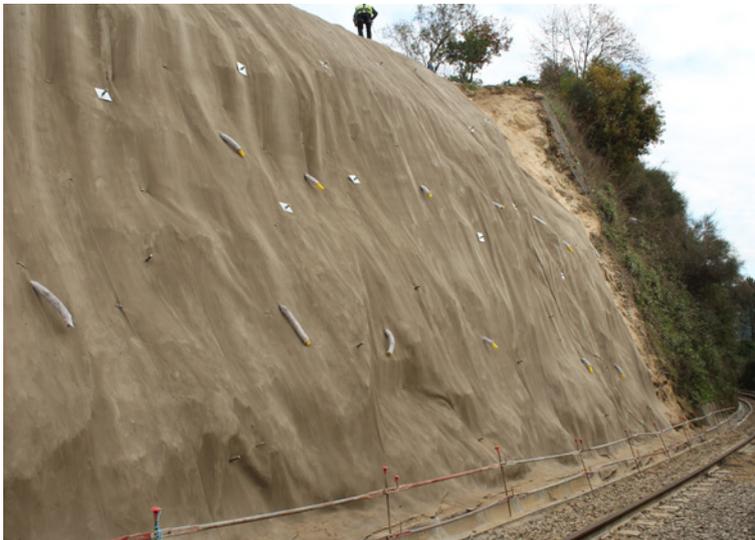
The CC was cut to fit around the pre-fitted weep holes

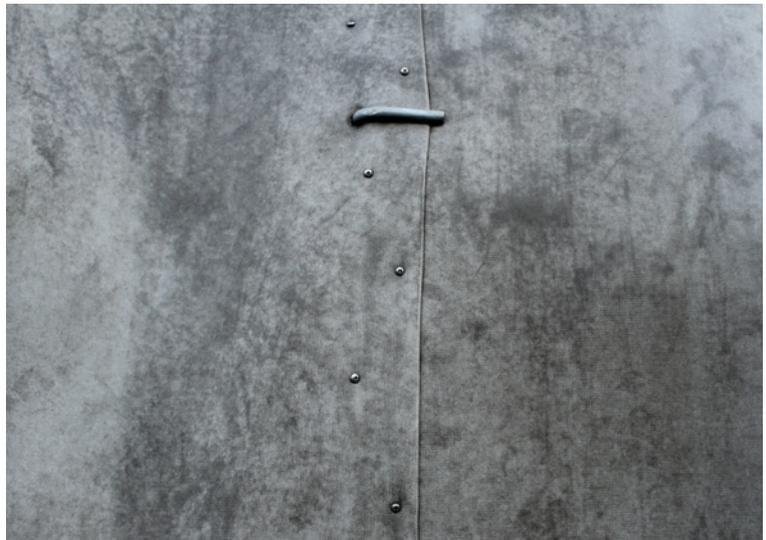
Screws were inserted in a triangular shape for greater ingress prevention

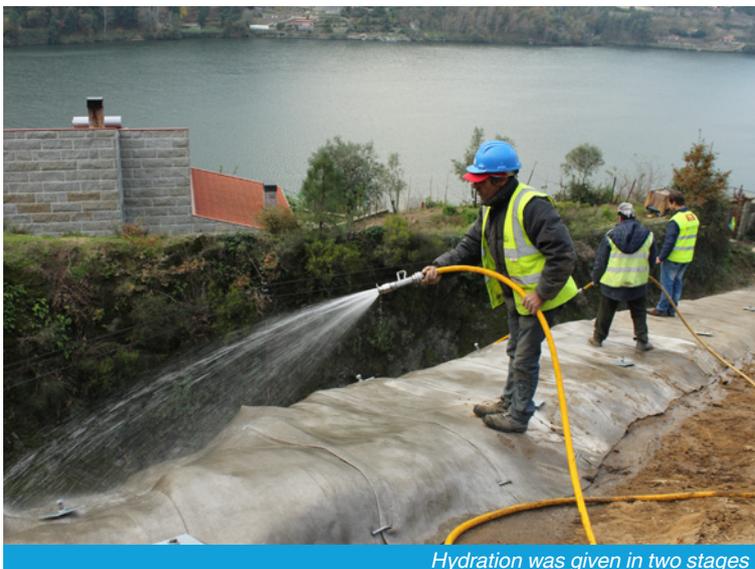
Hydration was given in two stages

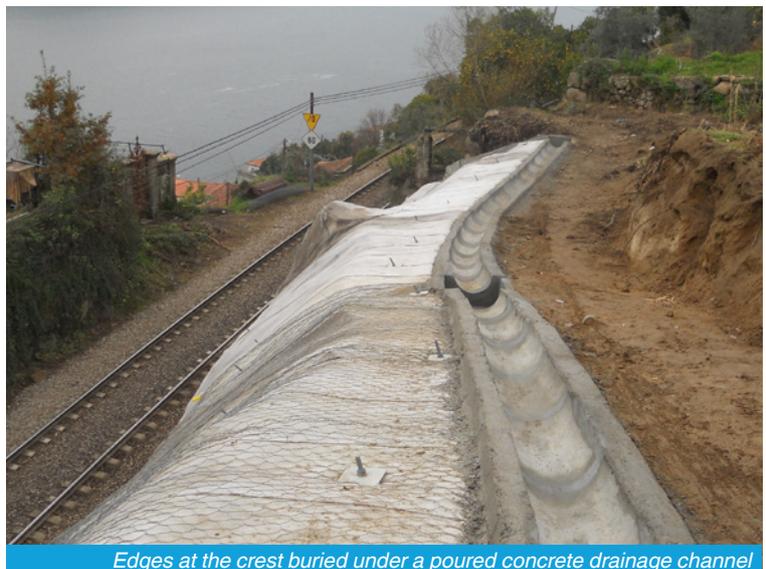
Edges at the crest buried under a poured concrete drainage channel

In preparation for the installation, vegetation, large rocks and other debris were removed from the slope, and bulk rolls of CC5™ delivered to site. The CC was mounted onto a spreader beam and suspended from an excavator for easy deployment. It was then unrolled down the slope and cut to length, with ground anchors and ground pegs used to fix the CC to the substrate at the crest and down the face of the slope, eliminating voids beneath the material. Layers were overlapped by 100mm and jointed using screws in a triangular pattern to help prevent ingress. Masonry screws were used where the CC met an existing stone wall. The CC was hydrated twice, with an hour rest period in between. Following installation, a poured concrete drainage channel was installed along the crest of the slope, running down the side and along the toe. This was created to direct rainwater away from the tracks.

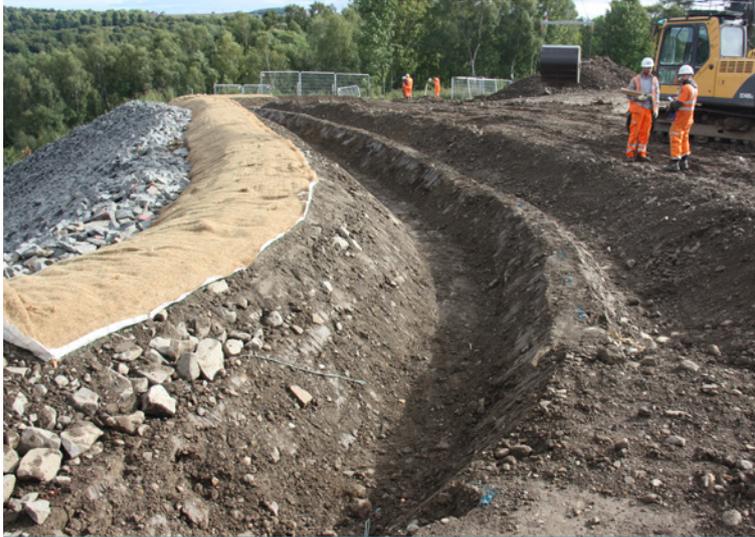
A V bucket was used to dig the channel

CC was specified to direct and control drainage and reduce the risk of future water ingress and failure. The channel was re-excavated to ensure it was able to manage the volume of water flowing through it. The CC was deployed from a spreader beam and plant and laid transversely across the channel. The material was cut using hand tools to reduce waste, and layers overlapped by 100mm. The CC was hydrated below the overlaps, jointed using stainless steel screws and fixed to the substrate using ground pegs within pre-dug anchor trenches, which were backfilled following hydration.

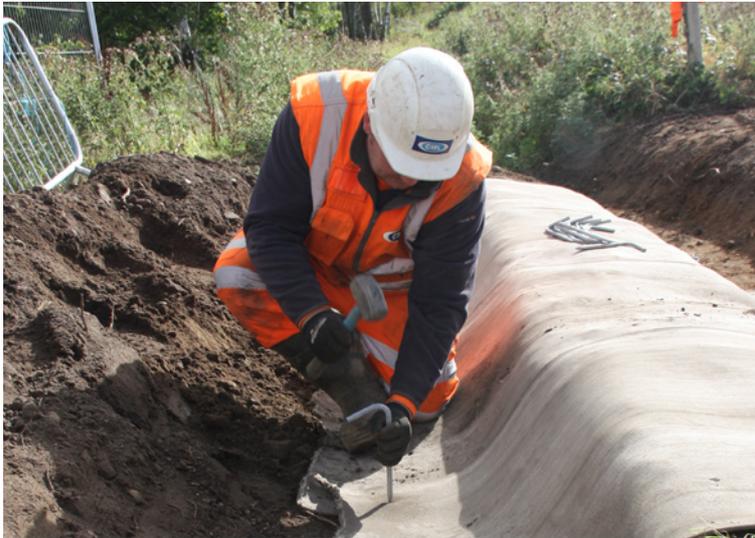
Laying the CC8™

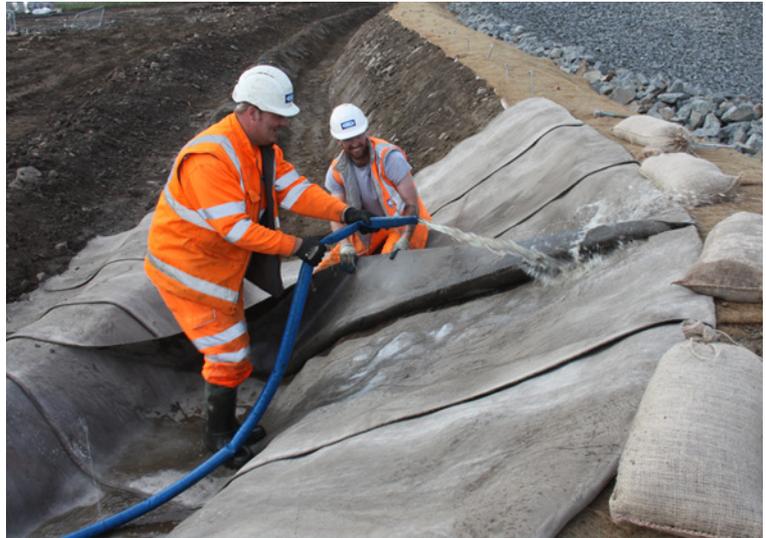
Ground pegs were used to secure the CC in the anchor trenches

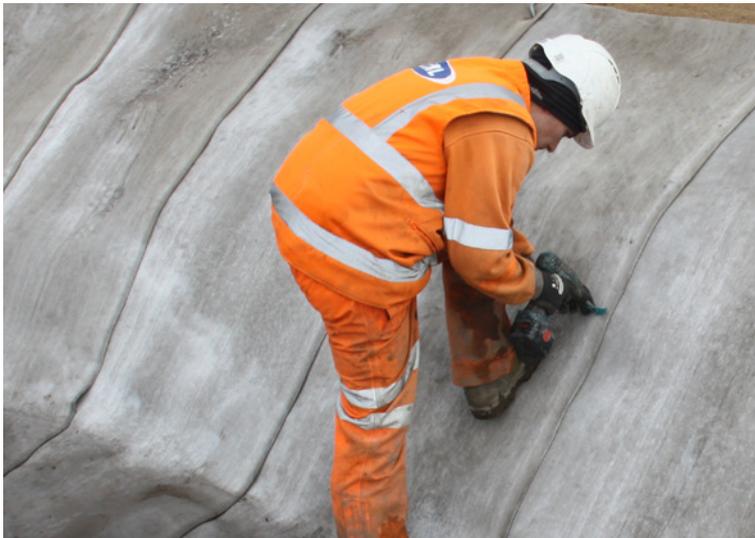
CC under the overlaps were hydrated before fixing

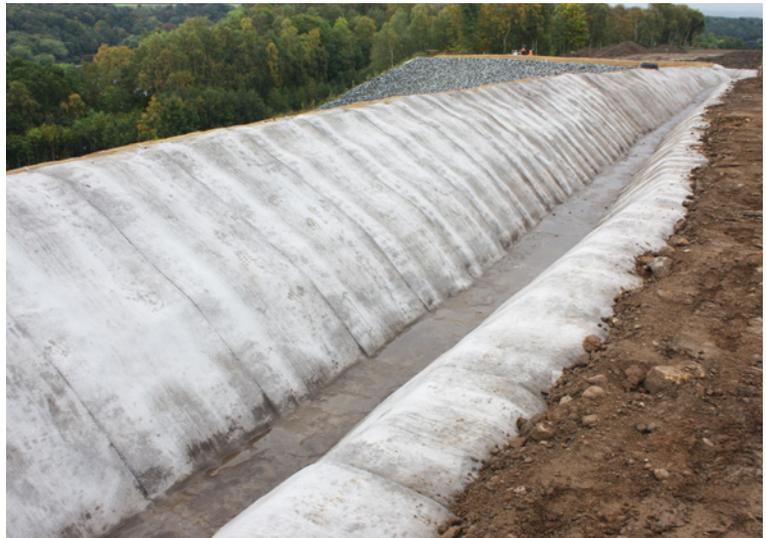
Layers of CC were fixed using stainless steel screws
