CONCRETE CANVAS® Concrete on a Roll

REMEDIATION CASE STUDIES

Muck Burn Flume,
Dumfries & Galloway,
Scotland, UK

CC8™ was used to
remediate a dilapidated
concrete flume forming
part of a hydro-electric
system.

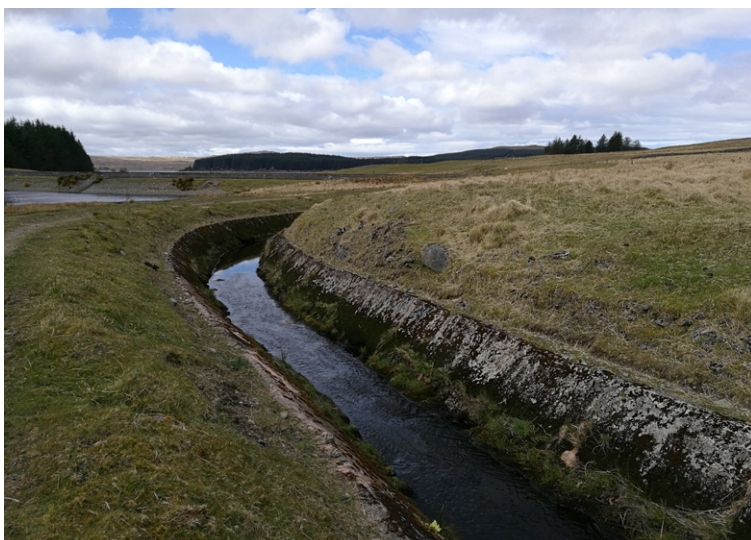
Algae, moss & vegetation growth within the flume channel

Prior to installation, the flume was pressure washed to remove vegetation and minor repairs were carried out using a semi-dry grout mix to fill any voids in the concrete to ensure intimate contact between the CC and the concrete substrate. The water flow was then diverted into a nearby channel by building an earthen dam and using sandbags. Bulk rolls of CC8™ were then delivered to site in staggered deliveries to reduce onsite storage and accommodate the speed of the installation crew. The bulk rolls were then mounted on a spreader beam, which was hung from a Komatsu PC210LC-7 Hydraulic Excavator.

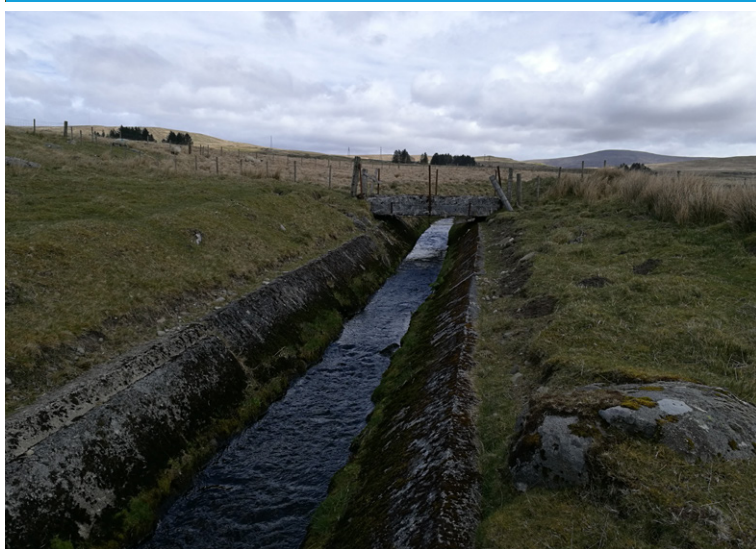
A civil general inspection undertaken in June 2014 noted that the condition of the flume was poor in significant areas, and some localised repairs were carried out in 2015. The deterioration to the structure is consistent with erosion and frost damage. Rather than using conventional concreting techniques, CC was proposed to significantly mitigate the need for costly periodic repairs.

360m dilapidated concrete slabbed flume prior to installation

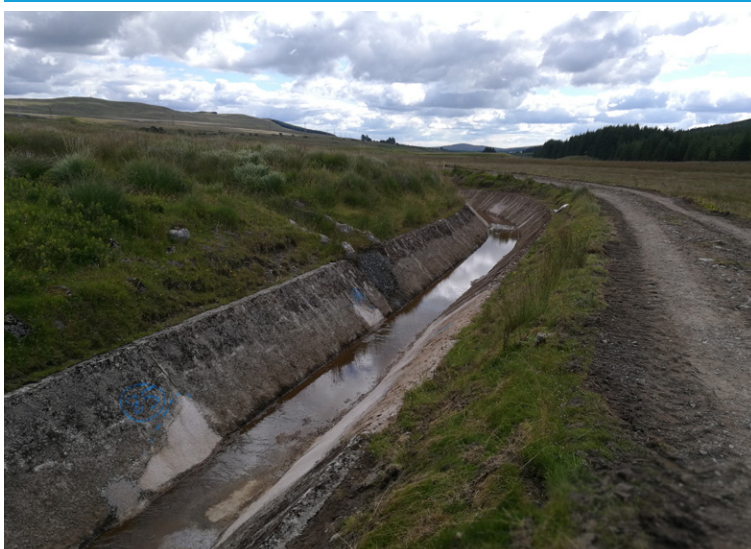
Vegetation & algae removed and water diverted out of the flume

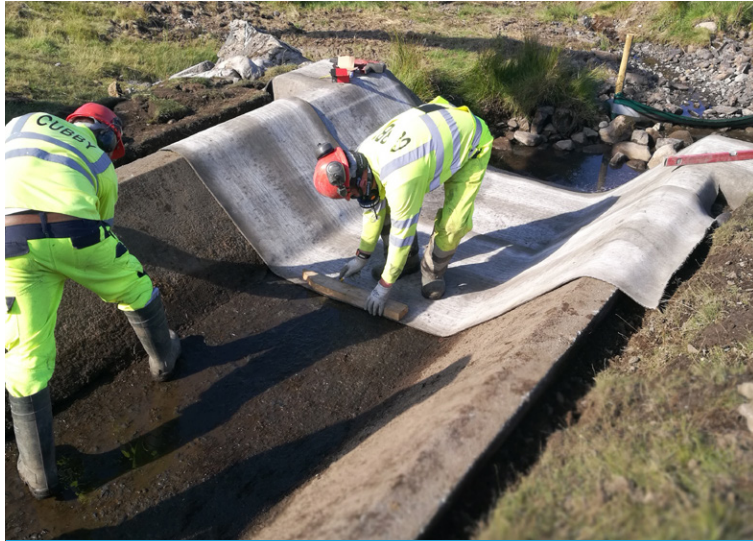
First layers of CC being laid into anchor trench & overlaps marked

The CC was then rolled across the width of the flume before being cut to specific profile length with an angle grinder. Each length of CC was laid transversely, with adjacent layers overlapped by 100mm in the direction of water flow, and fixed in place using 34mm Hilti nails with 25mm diameter washers shot fired at centres not exceeding 600mm. Cubby Construction were extremely diligent in preparation and ensured the 100mm overlaps and 600mm Hilti spacing intervals were clearly marked in chalk prior to fastening to ensure the correct interval spacing.

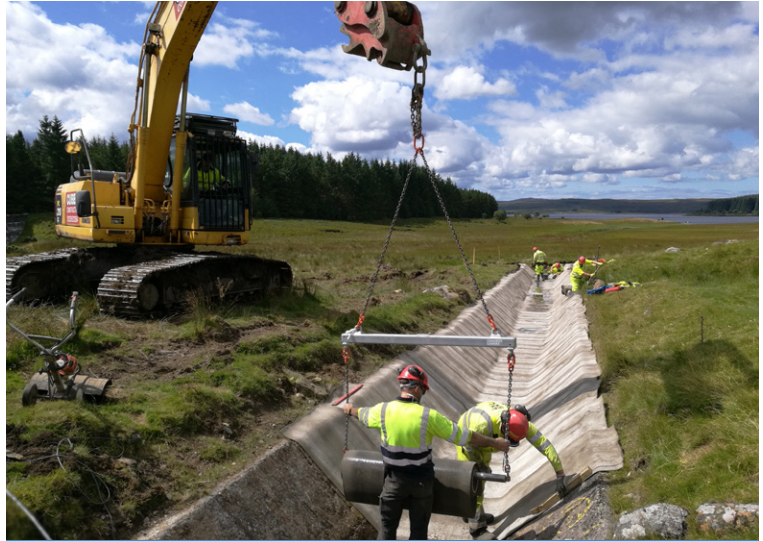
CC dispensed with a spreader beam & cut to length

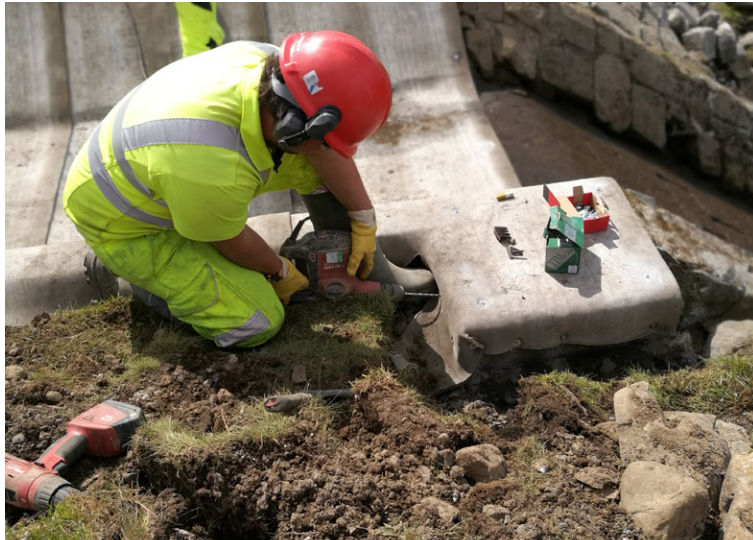
Installing 34mm Hilti nails with 25mm washers

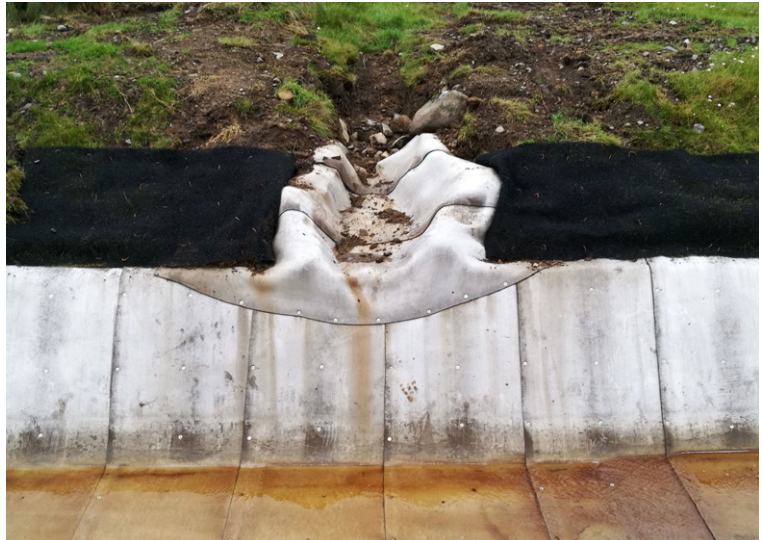
Inlet ditches lined with CC to direct bank runoff into flume

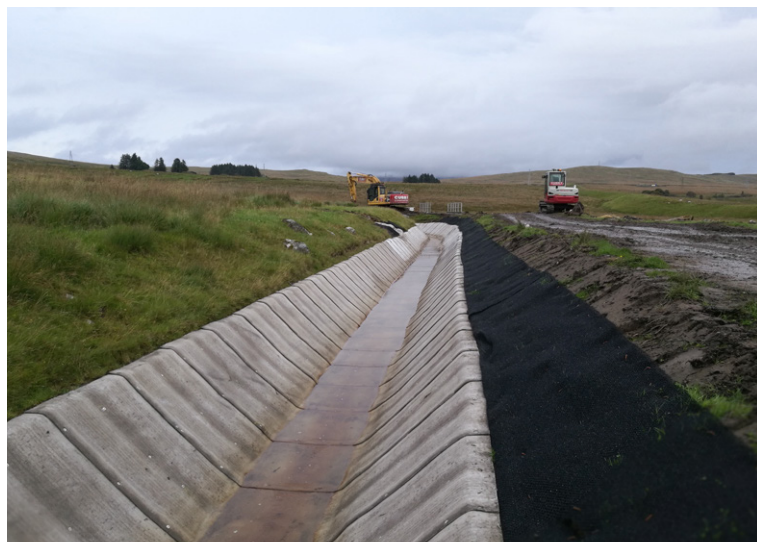
CC layers overlapped in the direction of water flow providing natural weep paths

In order to prevent any build-up of hydrostatic pressure between the original concrete slabs and the CC, the joints were left unsealed and free draining. These free draining joints create natural weep paths to allow water ingress into the flume. The end sections of CC were cut with an angle grinder post-set to provide a neat termination and any inlet areas with direct bank water runoff were either lined with CC or buried into an anchor trench. The CC material was hydrated after each day's work using a hose with spray nozzle attachment and a 6000L water carrier.

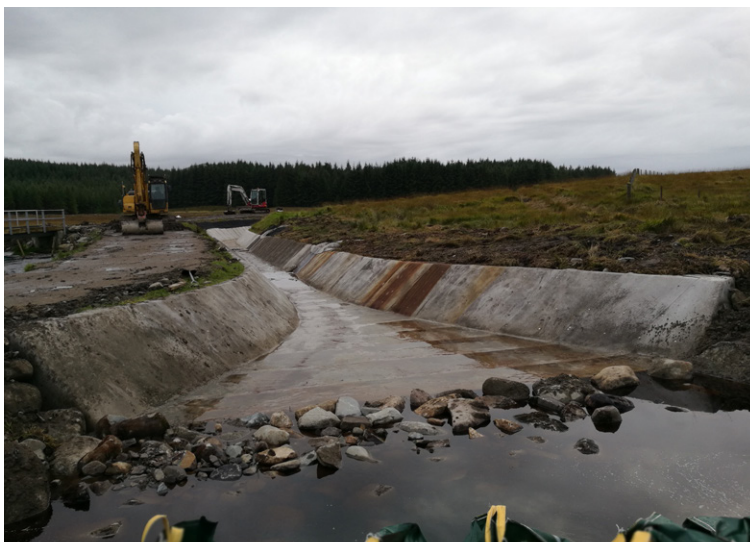
Flume inlet with an anchor trench running across the width of the channel

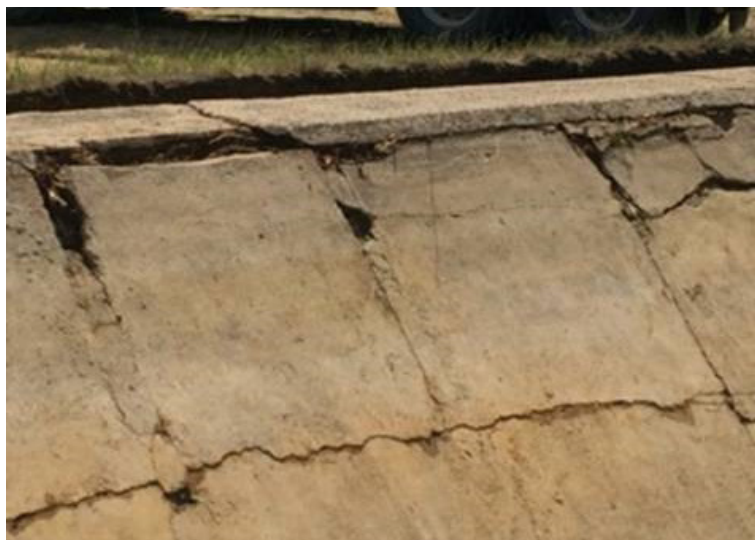
In August 2014, Concrete Canvas® GCCM* (CC) was used to line an extinguishing lake in Schwedt, Germany, to improve impermeability. The original poured concrete structure had cracked and spalled, resulting in excessive water loss. Removing the basin and re-building it using poured concrete and form work was considered, however this would have been more time-consuming, taking the basin out of operation for an extended period. The works were carried out by an approved contractor for PCK (a joint venture between BP, Rosneft, Shell, Eni and Total).

Site before works

The failing concrete was cleaned and mortar applied to any larger cracks to eliminate voids under the CC. An anchor trench was created on the shoulder of the basin to prevent water ingress and provide a neat termination. Bulk rolls of CC5™ were delivered to site and mounted onto a spreader beam hung from a Zoom Boom. The two shorter sections of the basin were completed first. The CC was unrolled on the flat, batched to profile length and positioned basin by hand with alternating perpendicular overlaps created at the corners. This allowed the CC to be laid transversely across the width of the basin for the remaining two sections, starting at each end and ending at a drainage sump in the middle. For each section, the leading edge of CC was fixed to the concrete substrate using 40mm wedge anchors at 2m intervals, each subsequent layer was then overlapped by 100mm and sealed. Once the installation was completed, the CC was hydrated.

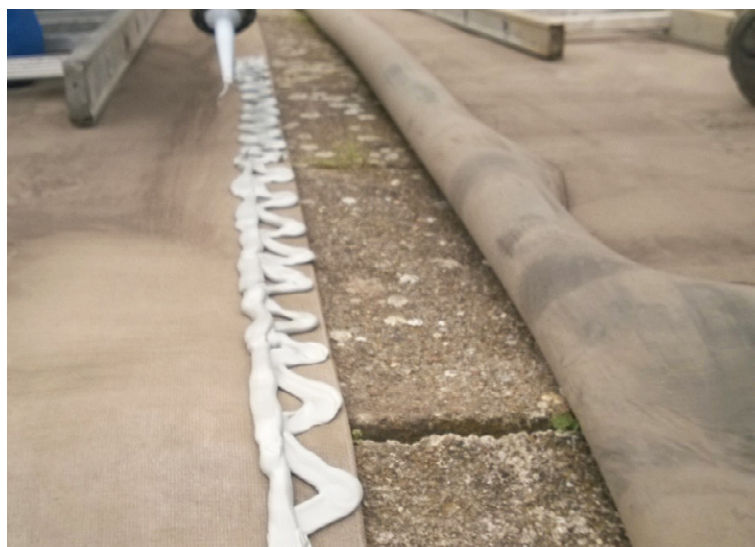
Sealing under the overlap

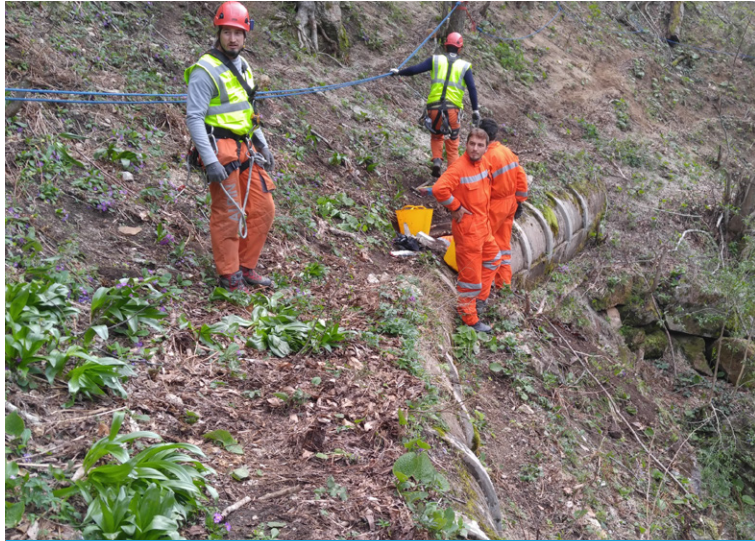
The outside of the pipeline was overgrown with vegetation

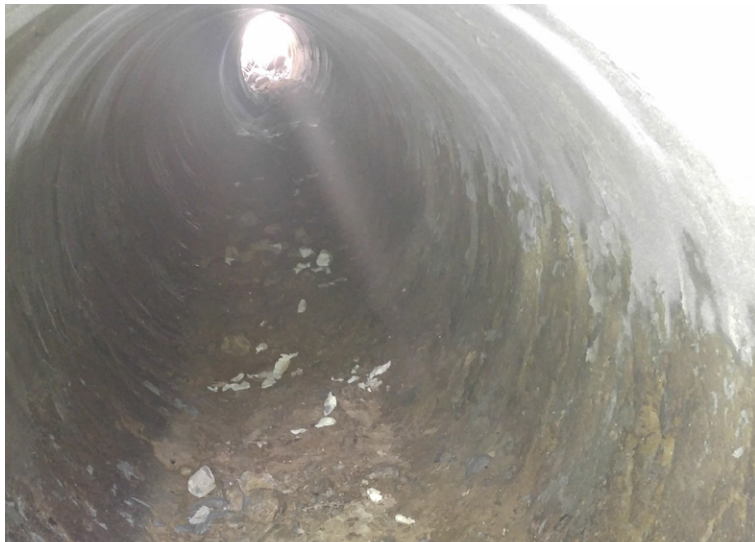
The inside of the pipe had to be cleared of rocks and debris prior to works

Prior to installation, the concrete was cleaned, vegetation removed and cracks and holes were repaired using high performance mortar. The material was passed into the pipeline in manageable sections through access holes along the top of the pipe. There was limited space to work, with an inner circumference of 900mm. The material was laid longitudinally and fixed using screws at 200mm intervals and along overlaps. Where material met the pipe wall, CT1 sealant and grout mortar was applied to prevent ingress. Once the installation was complete, a hose was fed into the pipeline and the CC material was hydrated.

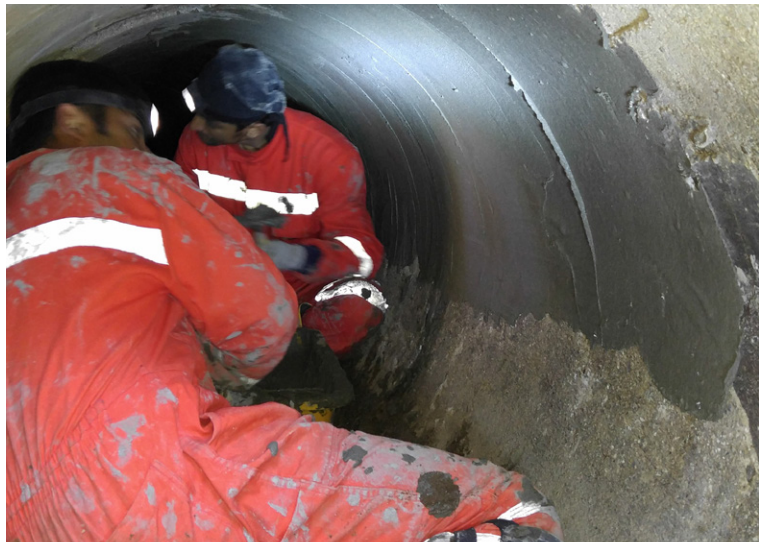
Repair works were carried out with mortar prior to installation

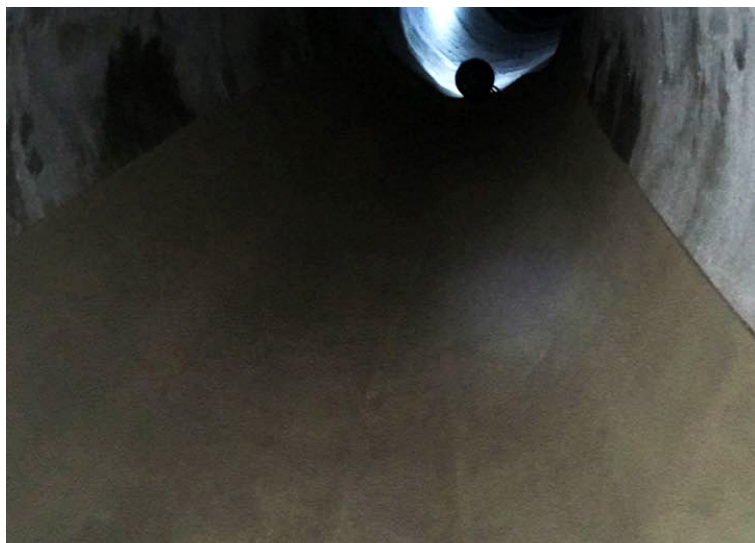
The CC was laid longitudinally and fixed with screws

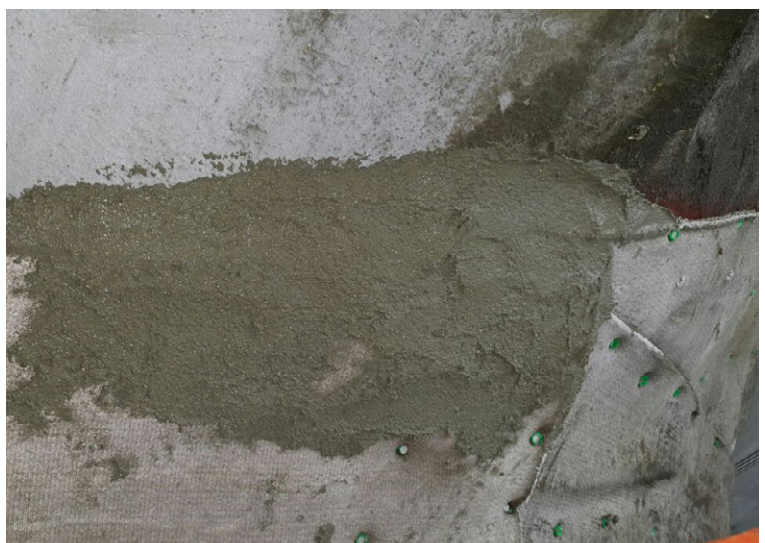
Mortar and sealant was used to prevent ingress at the edges of the CC

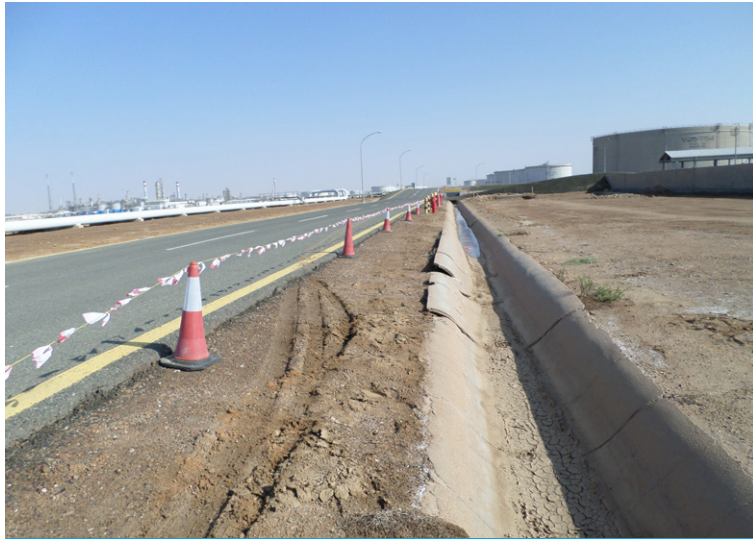
In December 2016, Concrete Canvas® GCCM* (CC) was used to remediate a channel at the Yanbu Refinery, owned by Saudi Aramco. The channel, previously lined with curved concrete blocks, had cracked in several places, becoming a risk for weed protrusion, further erosion and damage. Fixing the cracks with, and laying fresh conventional concrete had been considered, but as the site was privately owned there was limited access and time on site. As CC would significantly reduce the time and cost of the job, this was chosen instead. The entire 90m long by 2.5m wide channel was fitted with CC. The works were carried out by FOQSCO for Saudia Aramco.

Channel prior to installation

The cracks and gaps between existing concrete blocks were repaired and filled, and anchor trenches were excavated ahead of the installation. The CC was laid longitudinally using a spreader beam and crane, and cut using basic hand tools. The CC8™ was laid longitudinally down the middle of the channel, with CC5™ laid on either side. Overlapping layers of CC were sealed using a hot air gun, and CC was secured along the edges into the anchor trenches, using ground pegs. Once laid and fixed, the anchor trenches were backfilled with marlstone. Due to very dry weather conditions, the CC was hydrated for one hour, and re-hydrated following a period of two hours. This was repeated the following day.

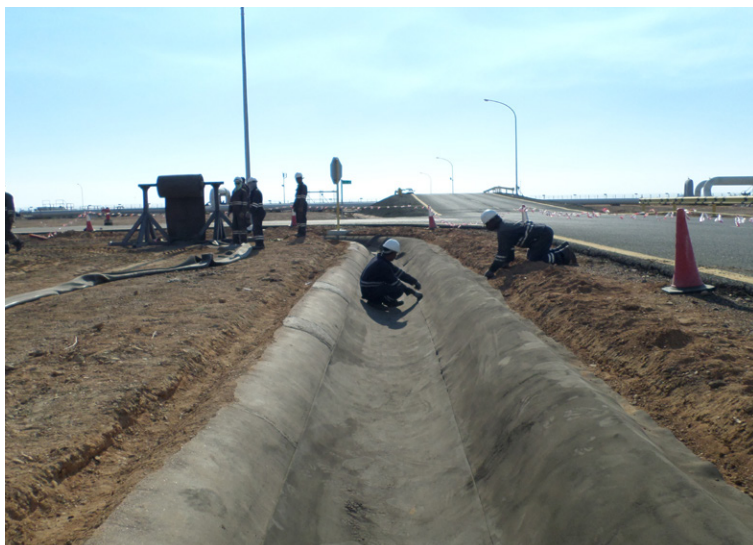
CC5 was laid down the middle, with CC8 laid either side

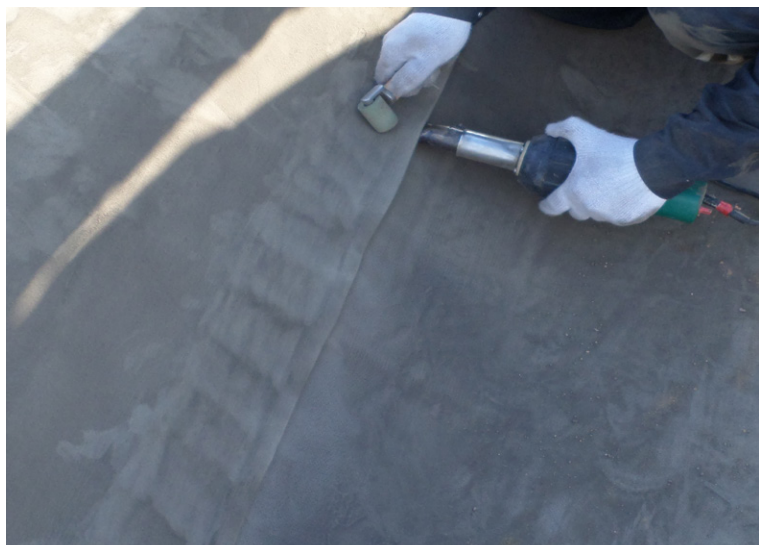
CC was sealed with a hot air gun before fixings were applied

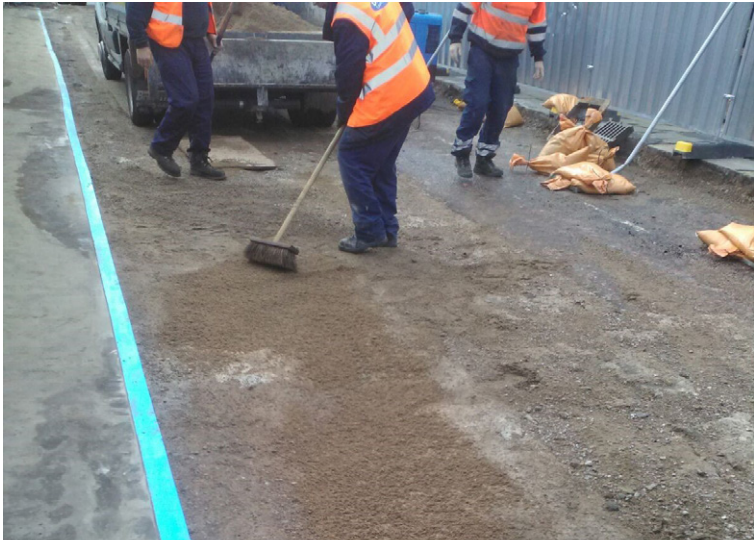
The substrate was flattened before installation

In preparation for the installation, the top flag stones were removed along with some of the substrate and the ground compacted using a whacker plate in order to provide a smooth surface for the CCH to be laid on. Bulk rolls of CCH8™ were then delivered to DCC's warehouse and then delivered to the site when required. The bulk rolls were then mounted onto a spreader beam and unrolled longitudinally along the length of the bridge. Adjacent layers of CCH were laid and then thermally welded using a Leister Twinny T or Leister Triac and roller. Once laid and thermally welded, each section was hydrated and re-covered using the removed substrate, leaving the leading edge of the CCH uncovered to weld to the adjacent layer of the next section.

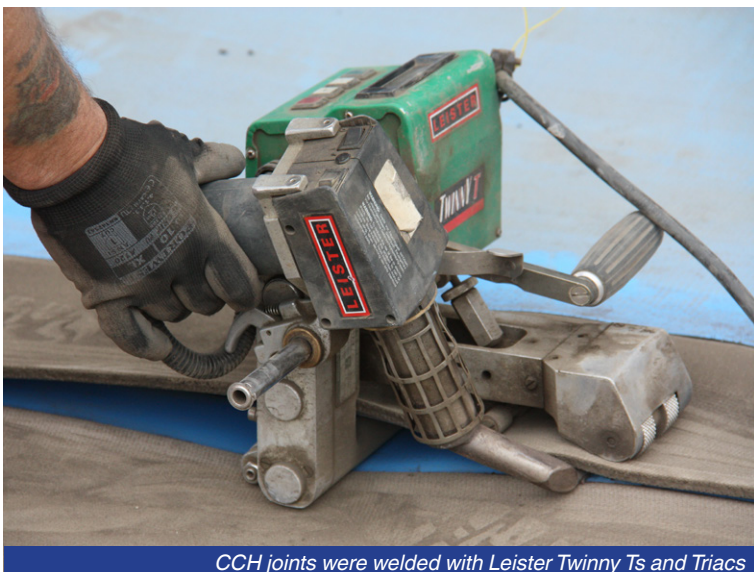
CCH joints were welded with Leister Twinny Ts and Triacs

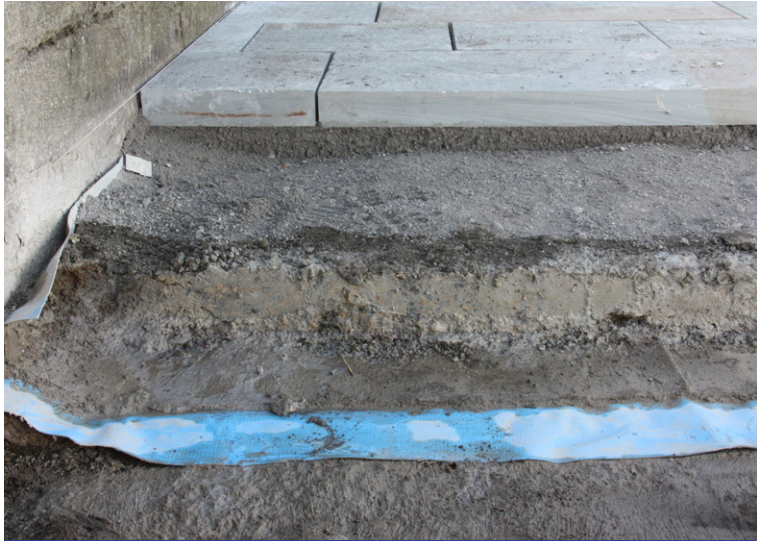
CCH layer underneath re-laid substrate and flagstones

Following the installation of the CCH across all sections of the bridge, the flag stones were re-laid on top of the water-proof CCH layer.
