CONCRETE CANVAS® Concrete on a Roll

UTILITIES CASE STUDIES

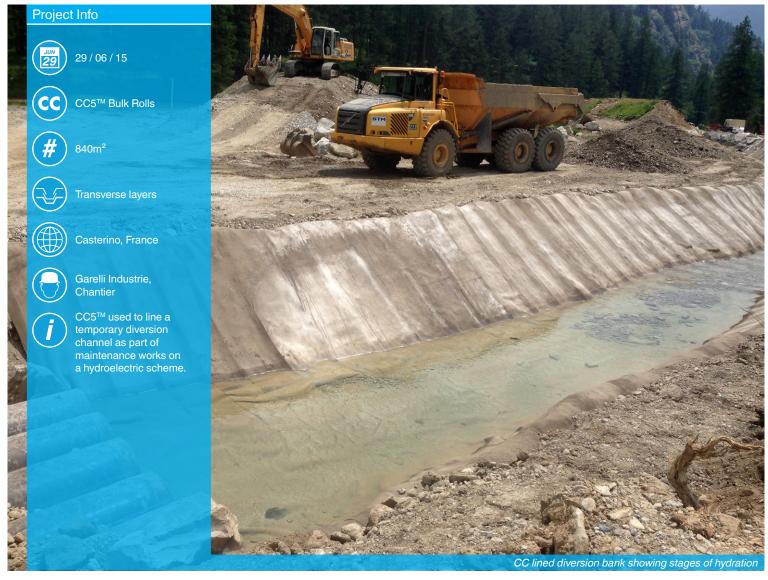
In June 2015, Concrete Canvas® GCCM* (CC) was used to line a temporary diversion channel at a construction site in Casterino, France. Intended to be in operation for two months, the lined channel was designed to re-direct flow from an existing hydroelectric scheme whilst critical maintenance works were being conducted. The work was carried out by GARELLI I.E.S (Industrial & Environmental Services) with input from French distributor, Point P Travaux Publics.

Prior to installation, any loose material and rocks were removed, the channel graded and anchor trenches excavated. The CC was delivered to site in bulk rolls, and cut to profile length using hand tools. The CC was laid transversely across the channel, with layers overlapping by approx. 100mm, and fixed to the substrate using steel pegs. The overlaps were then joined using screws at 200mm intervals. Following installation, hydration was given via water tank and hose.

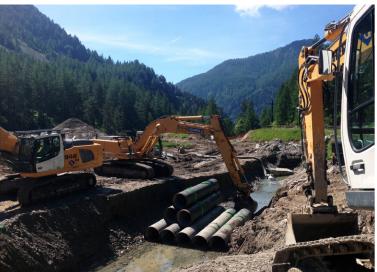
In total, 840m² of CC5[™] was installed over three days, by a team of four. The customer was very satisfied with the end result and particularly impressed by the rapid installation times.

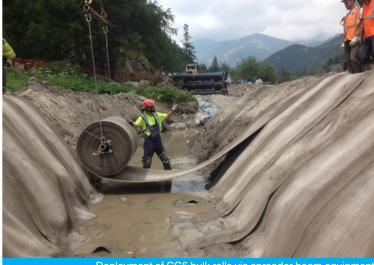
Deployment of CC5 bulk rolls via spreader beam equipment

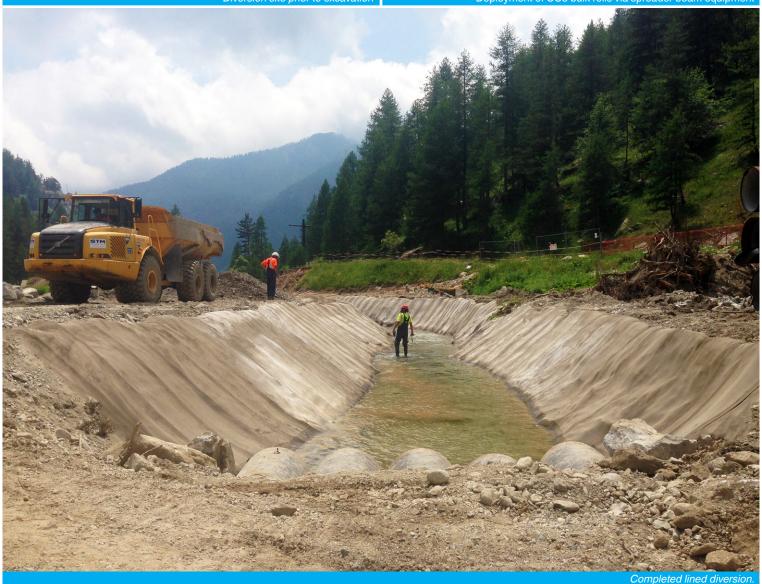
In September 2016, Concrete Canvas® GCCM* (CC) was used to line a channel at Dawes Lane, Scunthorpe. The objective was to provide a rapid method of offering a protective cover to a National Grid key gas main that had been identified to have a shallow cover, therefore falling outside of the required specifications. The works were carried out by TK Gallagher Ltd for, and in conjunction with National Grid.

The CC was unrolled, cut to profile width to minimise waste using a petrol disc cutter, and laid transversely across the channel with layers overlapping by 100mm. The CC was then fixed to the ground using ground pegs through the overlaps and within the anchor trenches. The overlaps were also jointed using stainless steel screws at 200mm intervals, before hydration of the Concrete Canvas. Following hydration, the anchor trenches were backfilled to prevent future ingress of water between the CC and the substrate.

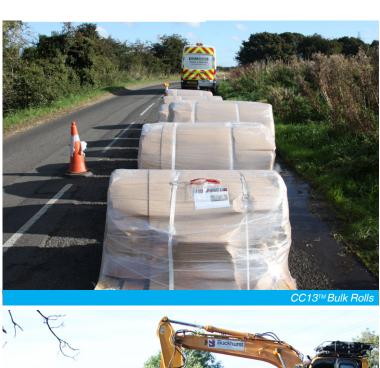
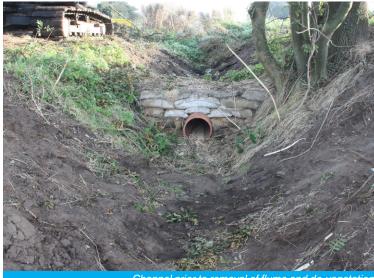
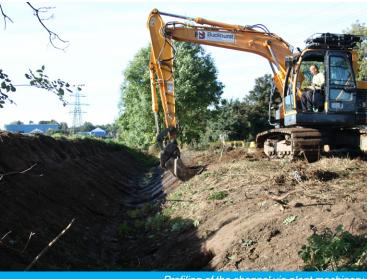
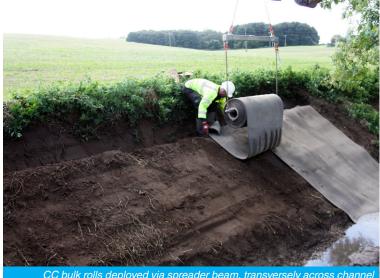
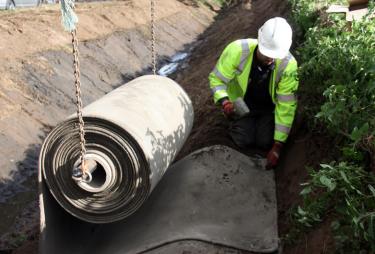
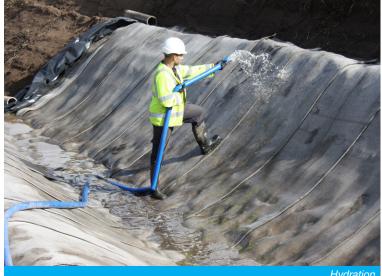
Prior to installation, the site had to be cleared of all vegetation, including a large tree which had to be cut back substantially. An existing flume and debris also had to be cleared; the ground was then graded with a digger bucket to give a smoother surface ready for installation. Anchor trenches were cut into the shoulders of the channels ready to receive the CC13™ Concrete Canvas material which was delivered to site in bulk rolls.

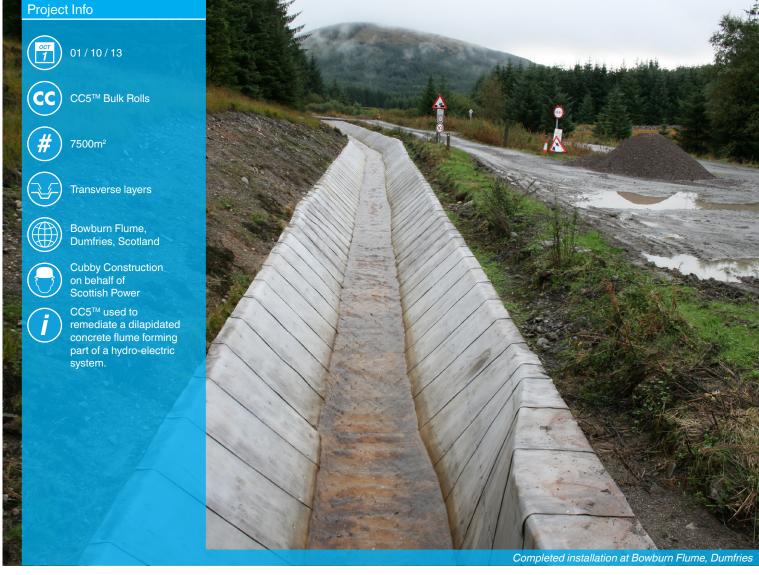
REMEDIATION

In October 2013, Concrete Canvas® GCCM* (CC) was used to remediate a 1.5km concrete flume, forming part of a hydro-electric scheme operated by Scottish Power, in Dumfries and Galloway, Scotland. The works were carried out by Cubby Construction with design consultancy provided by A. L. Daines and Partners.

Prior to installation, the flume was pressure washed to remove vegetation and minor repairs were carried out using a semi-dry grout mix to fill any large voids in the existing concrete. Bulk rolls of CC5™ were delivered to site and cut to specific profile lengths. Each length was laid transversely and fixed in place using 34mm Hilti nails with 25mm diameter washers shot fired at intervals of 600mm. Layers were overlapped by 100mm in the direction of water flow. Once hydration was given, the ends of the CC were cut with an angle grinder post-set to provide a neat finish.

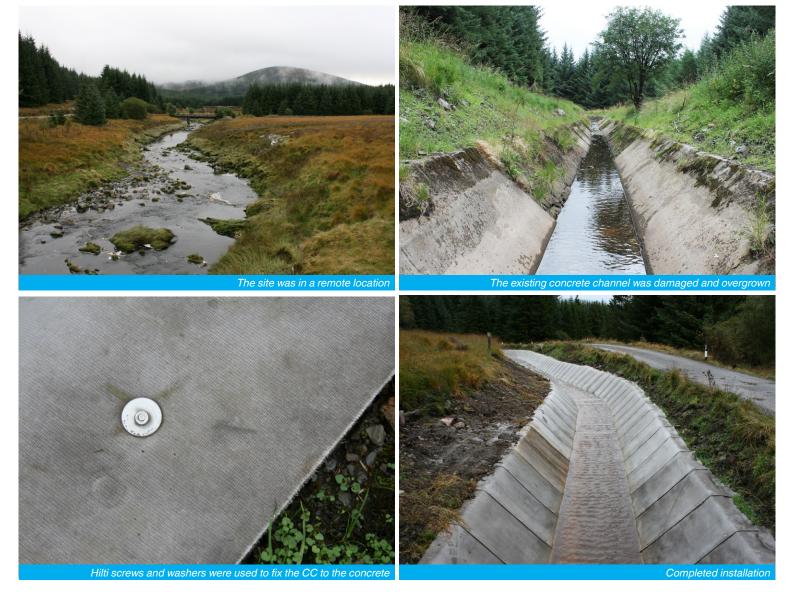
Inspections of the flume found that there were several areas in real need of refurbishment, while the whole length had algae, moss and grass growth covering the top surface. There was also a substantial build-up of gravel and detritus at certain locations and the condition of the concrete panels were variable. Traditional options previously used had included sprayed concrete and the removal and replacement of existing concrete sections. However, CC was proposed to significantly mitigate the need for costly periodic repairs and maintenance.

The CC was installed over a 6-week period at a rate of up to 600m2 per day in inclement weather and in a remote location. The performance of the CC will be reviewed by half-yearly inspections of the flume in relation to abrasive nature of the water on the CC. The use of CC allowed Scottish Power to line the entire length (1500m) of the flume encasing all the concrete defects, thus negating the requirement to carry out concrete repairs every 2 years.

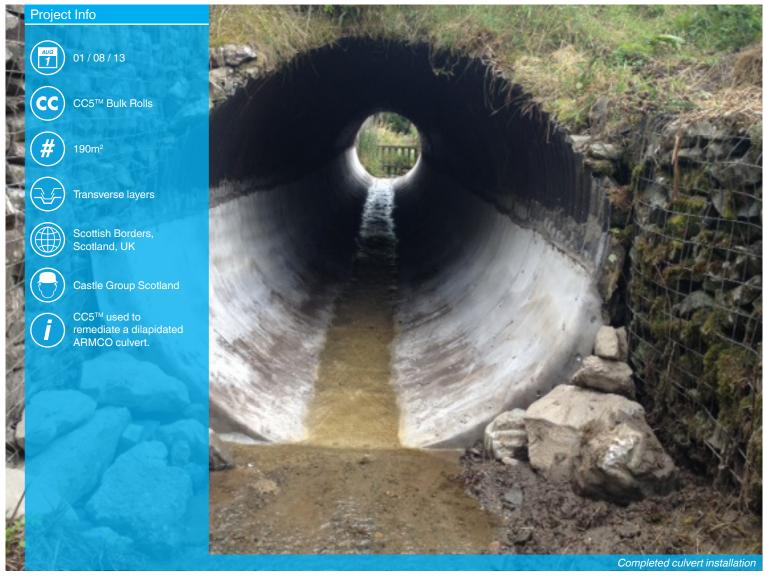
CULVERT LINING

In August 2013, Concrete Canvas® GCCM* (CC) was used to reline an ARMCO steel corrugated pipe which formed part of a culvert on the Scottish borders.

Prior to installation, the ARMCO pipe was cleared of any silt and other debris and the damaged bitumen lining removed using a pressure washer. A semi-dry grout mix was then applied to fill in the corrugations before bulk rolls of CC5™ were delivered and cut to length on site, ensuring minimal wastage. The CC was laid transversely, overlapped by 100mm in the direction of water flow and fixed at 200mm intervals using stainless steel screws before being hydrated.

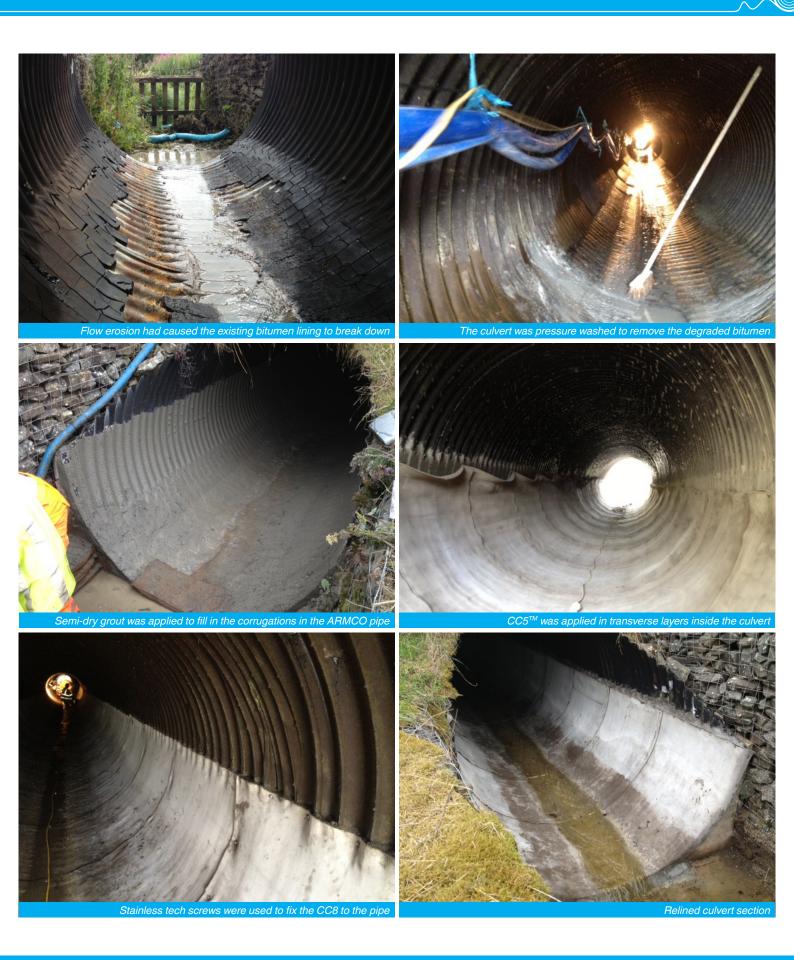
CULVERT LINING

The existing 1-2mm bitumen coating had degraded due to erosion and weathering, resulting in an increase in silt, debris and vegetation growth within the culvert. Installing a new culvert would be costly and would involve temporary lane closures of the nearby A7 trunk road, while re-spraying culverts with bitumen is now generally prohibited by the Scottish Environment Protection Agency (SEPA) due to the potential for environmental damage, and any remediation solution would need SEPA approval. Glass Reinforced Plastic (GRP) was also considered, but this would have to be specially made, leading to increased cost and lead time. CC was chosen due to its speed of installation, its ability to easily accommodate changes in culvert profile and its minimal environmental impact.

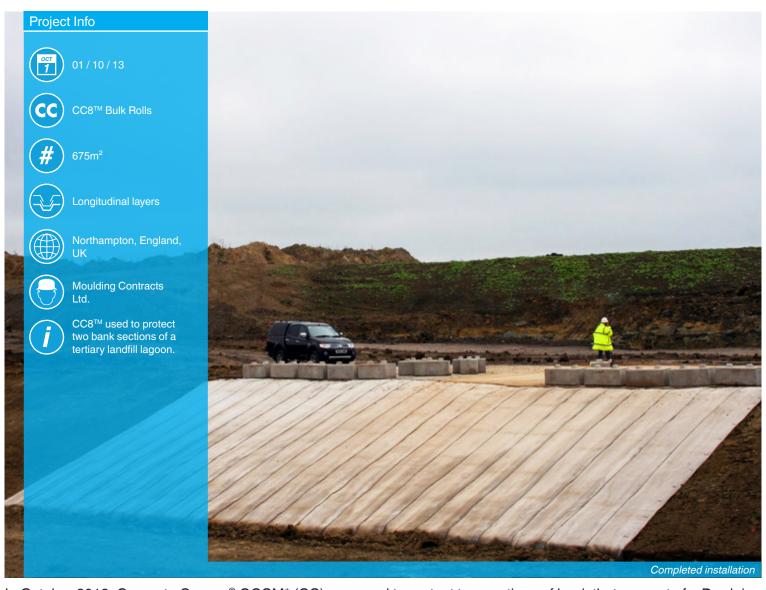
LAGOON LINING

In October 2013, Concrete Canvas® GCCM* (CC) was used to protect two sections of bank that are part of a Dredging Waste Temporary Storage Area (DWTSA) at a landfill site in Northampton.

Prior to installation, the clay substrate was excavated across an area of approx. 41m by 76m at ground level to a depth of approx. 4.5m, providing a holding capacity of around 5000m³. CC8™ was then installed on the southern section, and part of the eastern section of the lagoon slopes, as filling and emptying will only be carried out from these areas. The CC was laid vertically down the slopes, anchor trenched at the toe and mortar joined at the crest to a concrete loading platform. Metal peg fixings were used at regular intervals to fix the CC along its length. Once fixed, the CC was hydrated.

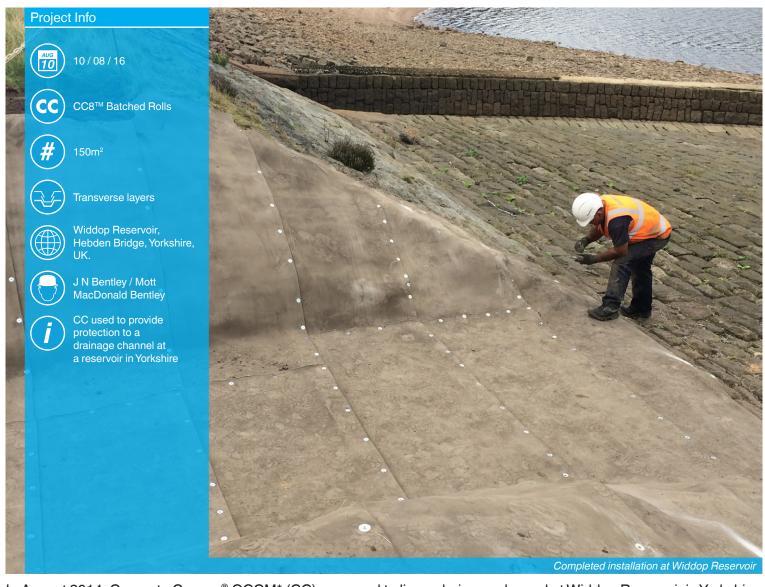
In August 2014, Concrete Canvas® GCCM* (CC) was used to line a drainage channel at Widdop Reservoir in Yorkshire, UK. CC provided cost savings compared to conventional concrete solutions given the speed of installation in a remote, limited access location. The works were carried out by Contractors J. N. Bentley on behalf of the consultant Mott MacDonald Bentley for Yorkshire Water.

Prior to installation, a temporary flume was built to enable a digger to access the other side of the drainage channel. The wall of the channel was left in place while it was excavated, but was then removed and the stones were marked and kept ready for rebuilding the wall following installation. The CC was laid transversely across the channel with layers overlapped by 100mm and fixed with screws and washers. The edges of the CC were then buried in pre-dug anchor trenches which were then backfilled. Hydration was given via sump pump using water from the temporary dam.

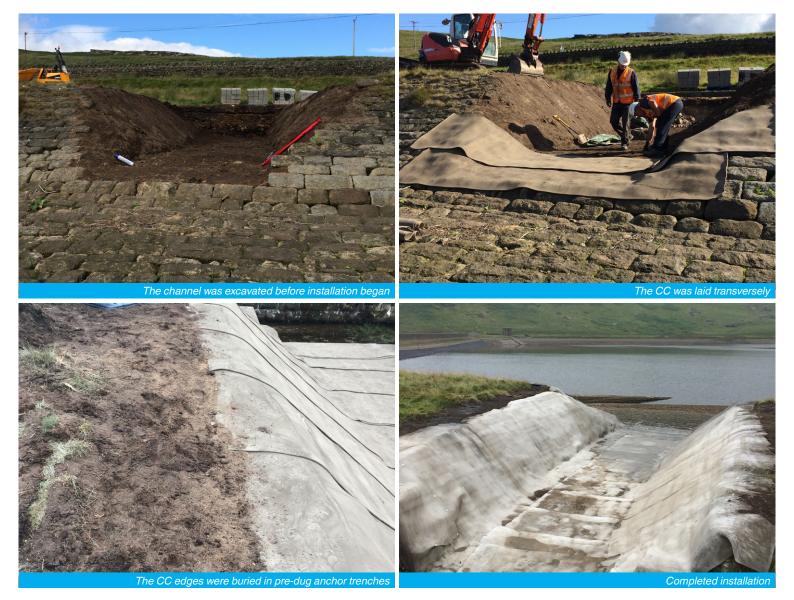
CHANNEL UNING

In total, 150m² of CC8™ was installed in clear, sunny weather in just one day. The use of CC meant a 67% reduction in labour costs, utilising 28% of staff that would ordinarily be required when using a conventional alternative.

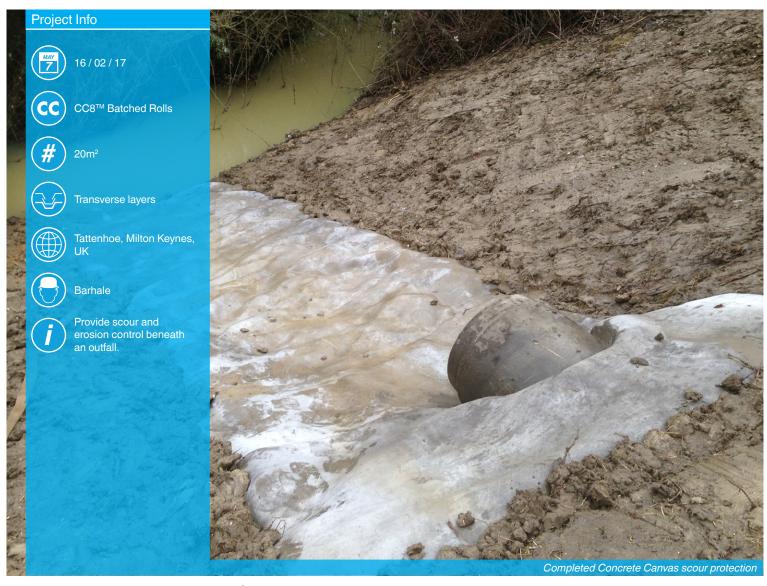
In February 2017, Concrete Canvas® GCCM* (CC) was used to provide scour and erosion control beneath an outfall near a housing development at Tattenhoe, Milton Keynes, UK. An existing headwall had collapsed into the river due to scour erosion caused by storm flows from an outfall pipe. Heavy rainwater flows eroded the vegetated bank further which caused the final section of pipe to collapse into the channel. The solution was to regrade the existing slope and install a robust erosion control solution to prevent scour of the reinstated area. CC was specified as the ideal choice due to the speed and ease of install on a steep slope. The works were carried out by Barhale as part of Anglian Water's IOS Alliance.

The installation took place in dry weather, but the ground was very damp and muddy, making working conditions more difficult. Prior to installation, vegetation was removed from the slope with an excavator, then re-graded, and anchor trenches dug by hand. The CC was laid horizontally, fixed with 250mm steel pegs at 1m intervals, jointed with stainless screws at 200mm centres and grouted around the existing pipe. The edges of the CC were then captured in the anchor trenches, which were backfilled by hand. The CC material was hydrated using water pumped directly from the stream.

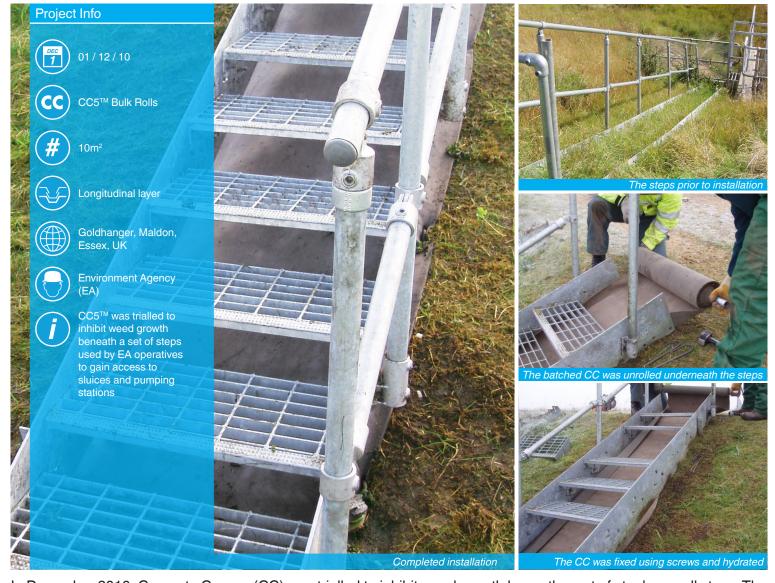
WEED SUPPRESSION

In December 2010, Concrete Canvas (CC) was trialled to inhibit weed growth beneath a set of steel seawall steps. The steps provide Environment Agency (EA) operatives safe access up/down their seawall embankments to structures such as sluices and pumping stations.

The steps have an open tread mesh which allowed grass to grow up from beneath, meaning that additional maintenance was required to keep them clear from obstructions. The grass and vegetation below the steps could not be removed using strimming equipment and herbicides were discounted as many of the seawalls that the stairs gave access to were environmentally designated sites (SSSI, RAMSAR, SPA, SAC etc.) and had nearby water. The decision was reached that the best way to prevent grass growth was to suppress the area beneath the stair access. A layer of geotextile or filter canvas was considered but it was thought that this would degrade in UV and wouldn't provide a long term solution. CC5™ was chosen instead for its durability and protection from weathering and UV degradation. The CC was installed quickly, by removing several of the step treads, slotting the edge of a batched roll below the steps and unrolling it down the embankment. This was advantageous as the steps did not have to be fully removed, which saved on time and did not require plant equipment. The CC was then fixed using screws, and the EA were also able to take advantage of the borrow dyke channel behind the seawall to collect water for hydrating the CC.
