CC8™ Bulk Rolls

Bullockstone Road,
Herne Bay, Kent, UK

Steadline for Amey

CC8™ used to provide protection to a culvert invert to prevent further degradation.

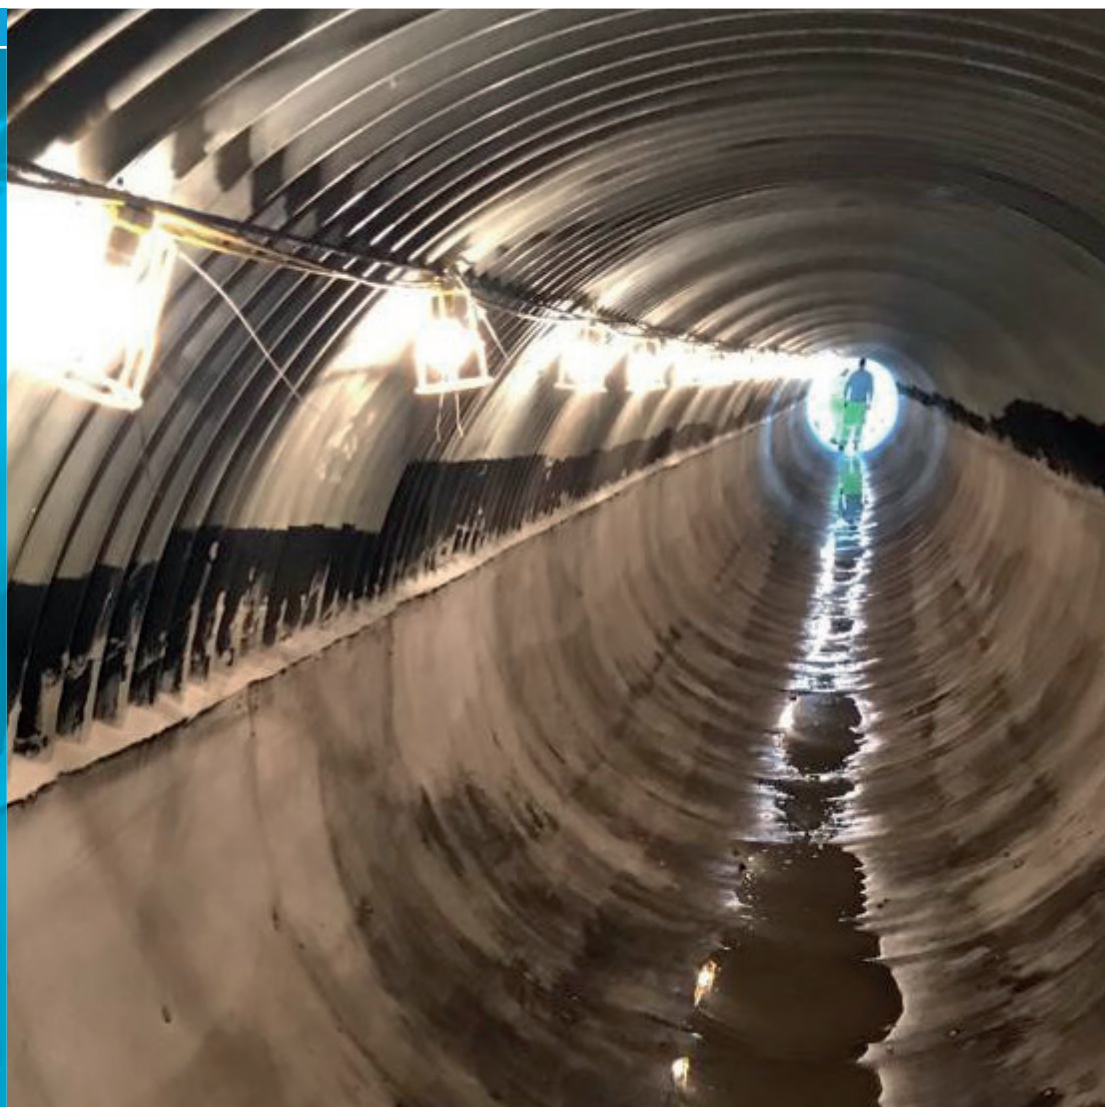
Completed installation

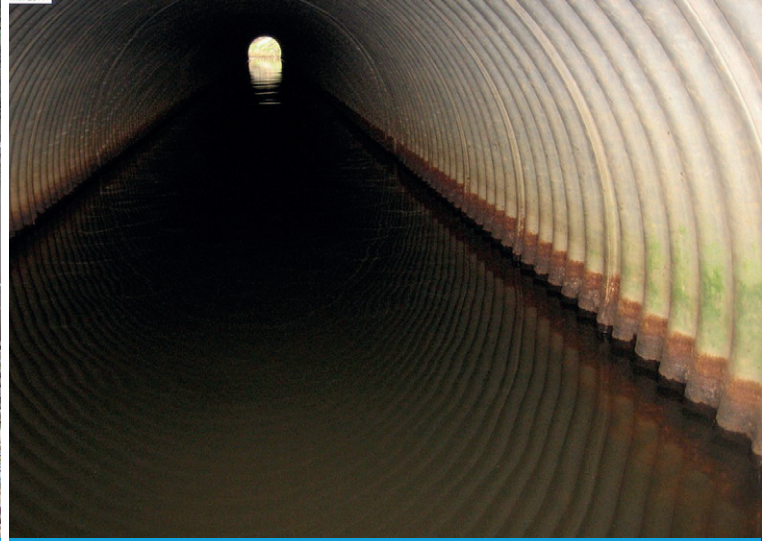
Culvert prior to works

Prior to the installation, the watercourse was dammed and over-pumped to divert water from the culvert. There was approximately 600mm of stream bed material in the culvert that required removal to expose the condition of the culvert invert. The corrugations were then filled with a repair mortar before delivery and deployment of the specified CC8™ material.

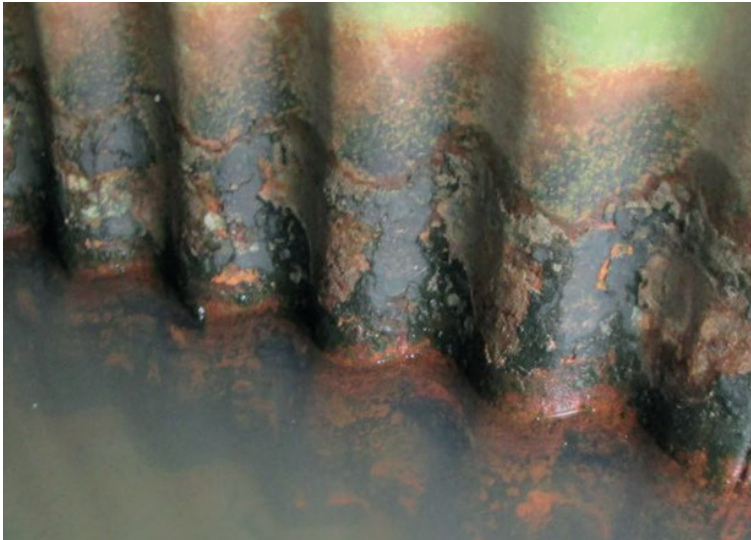
Silt build up and corrosion of culvert floor

In September 2018, Concrete Canvas® (CC) GCCM* was specified to remediate a culvert located on Bullockstone Road in Herne Bay, Kent. The invert had begun to corrode as a result of constant water immersion and sediment flow within it, and a solution was required to protect the structure from further degradation.

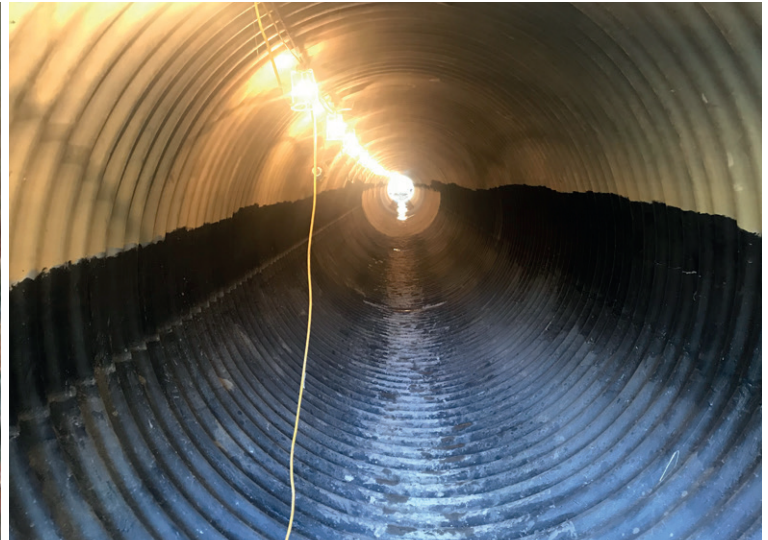
Culvert floor following cleaning

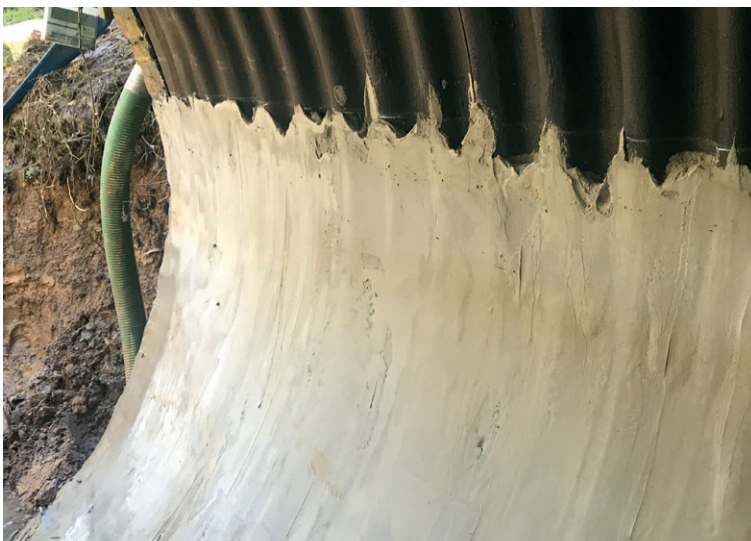
Inverts filled with concrete mortar

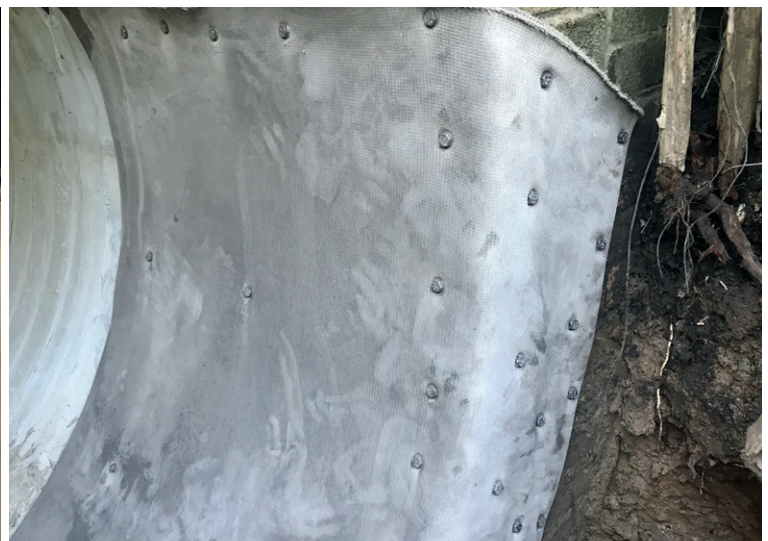
Fixing of first CC length to culvert and outside wall

The installation started downstream, with the material laid transversely and layers overlapped in the direction of waterflow. The material was fixed to the culvert by drilling and fitting Hilti tech screws at 200mm intervals along joints, and 500mm intervals elsewhere.

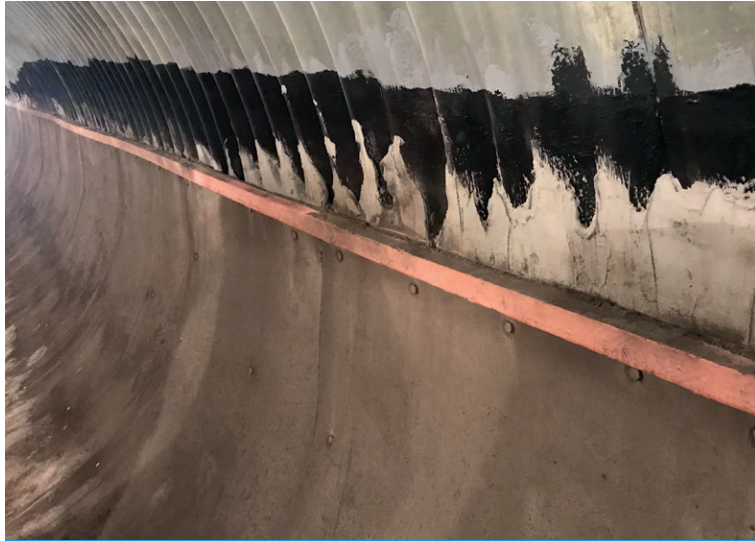
Wood bar fitted to secure CC edges and provide cutting guide for termination

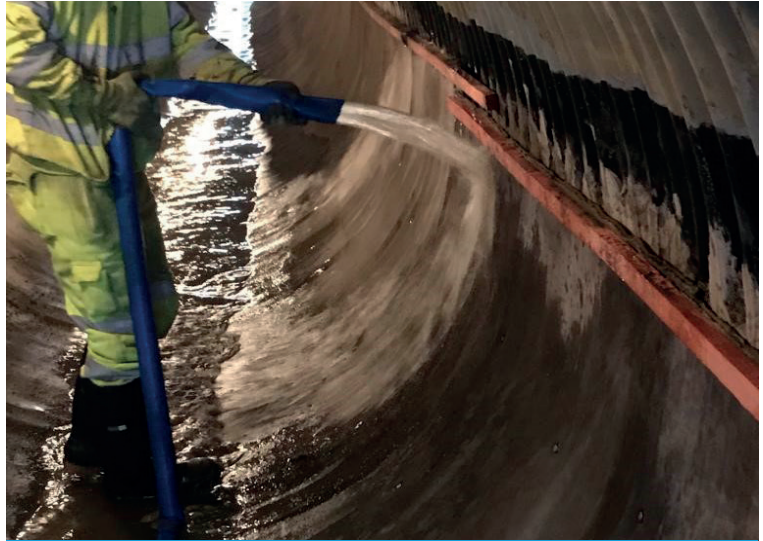
Hydration

Once installation was completed along the length of the culvert floor, the dam was carefully lowered to allow water into the culvert. The water was then brushed up the sides to allow for thorough hydration of the material.

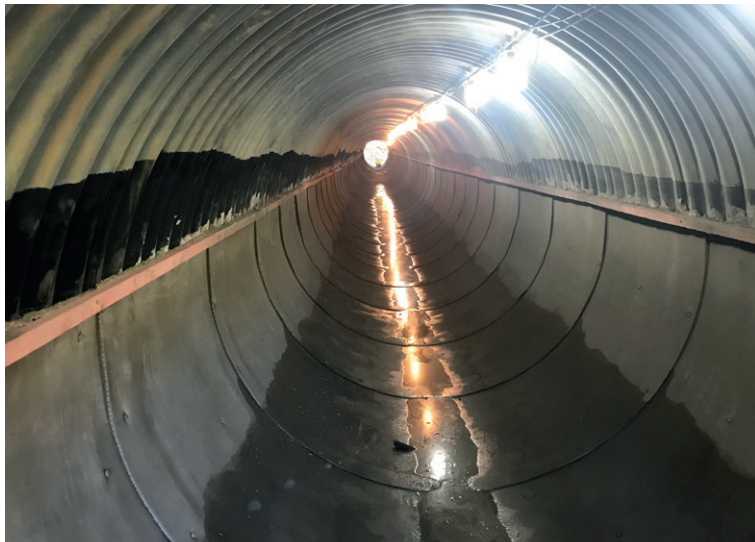
Completed installation

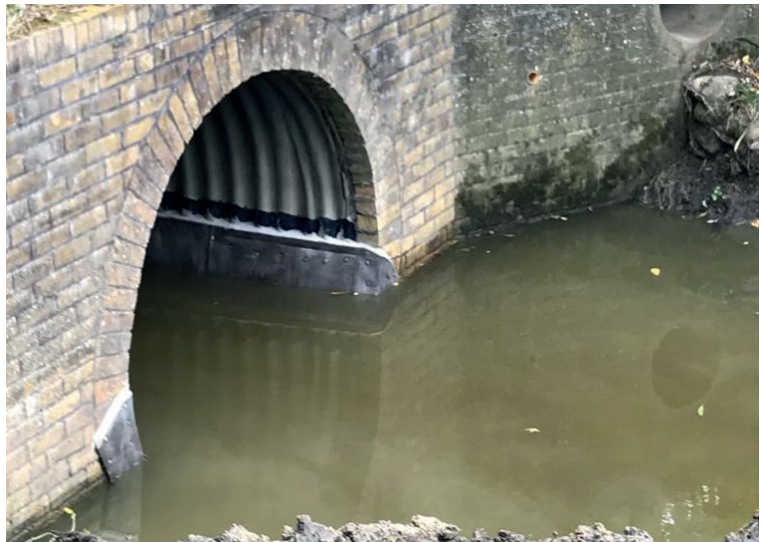
Completed culvert back in use
