CC13™ Bulk Rolls

Cooks Bridge, Midhurst,  
West Sussex

CC13™ was used to provide scour protection and increase the working life of a culvert in West Sussex.

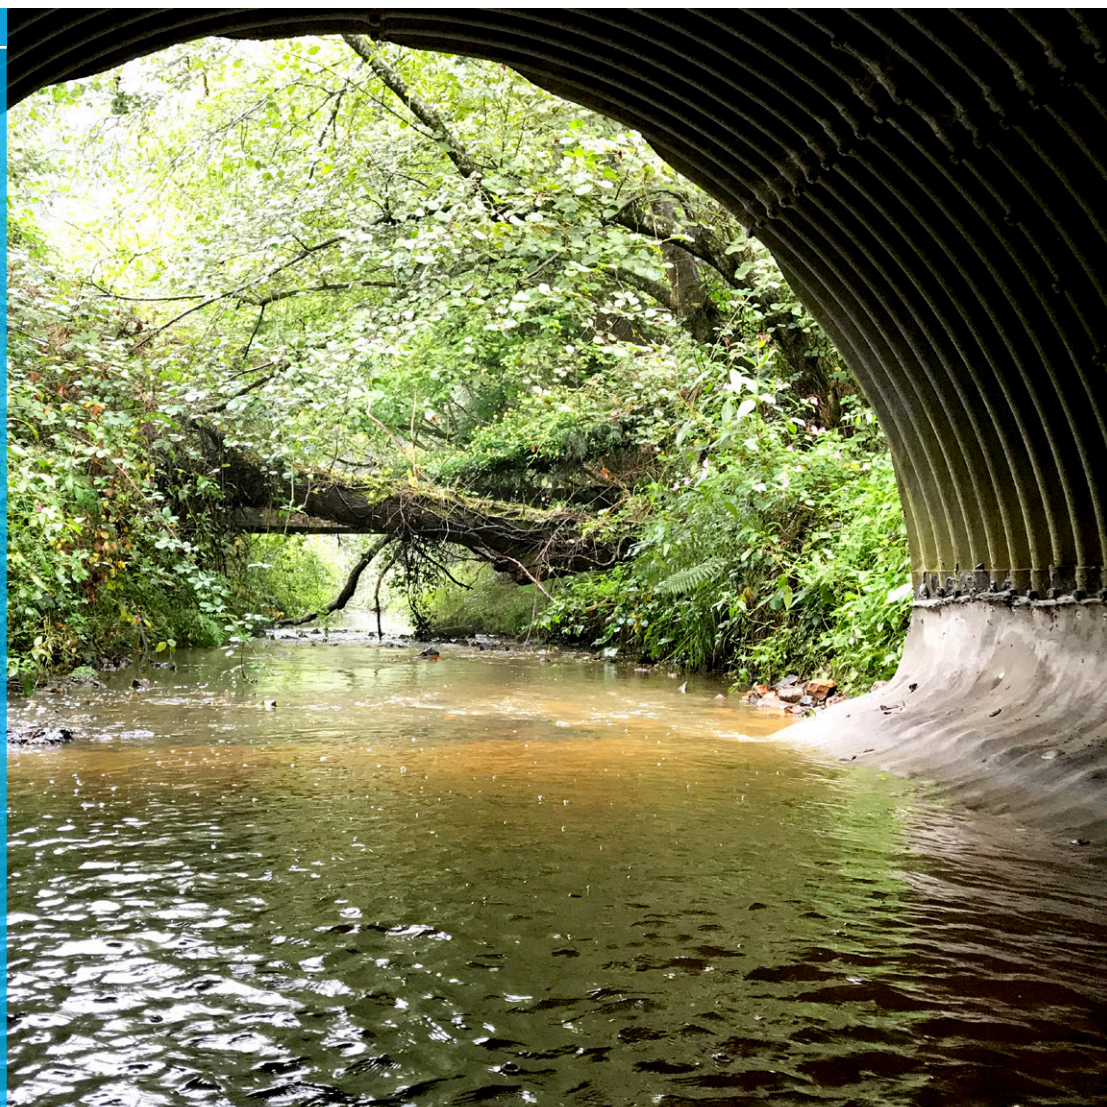
Completed culvert in use

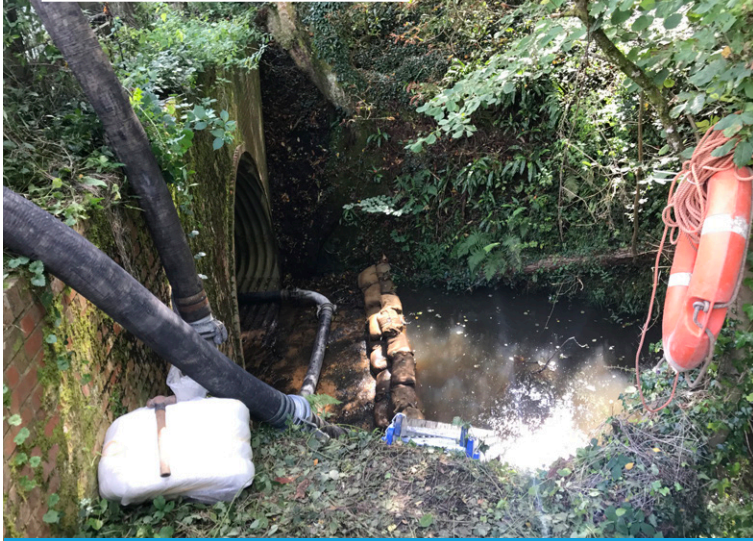
*Site access was very restricted*

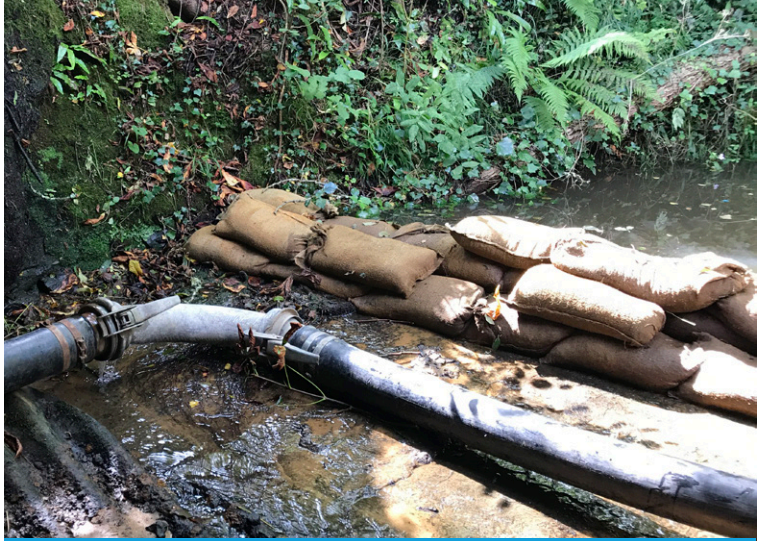
*The waterflow was restricted for the works using sandbags*

Bulk rolls of CC13™ were delivered to site ahead of installation and mounted on a spreader beam to lift the material for batching on the side of the highway above, before the batched lengths were lowered and transported by hand into the culvert. Water was diverted away from the culvert during works using sandbags and overpumping to avoid high water levels in the culvert and the CC being hydrated too quickly, allowing plenty of time to work with the material, as it has a 2-hour workable period following initial hydration before it begins to harden.

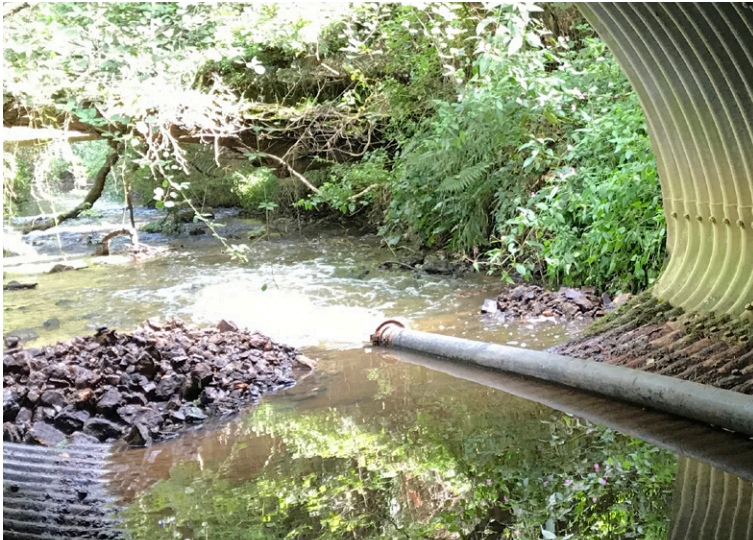
*And water redirected using overpumping*

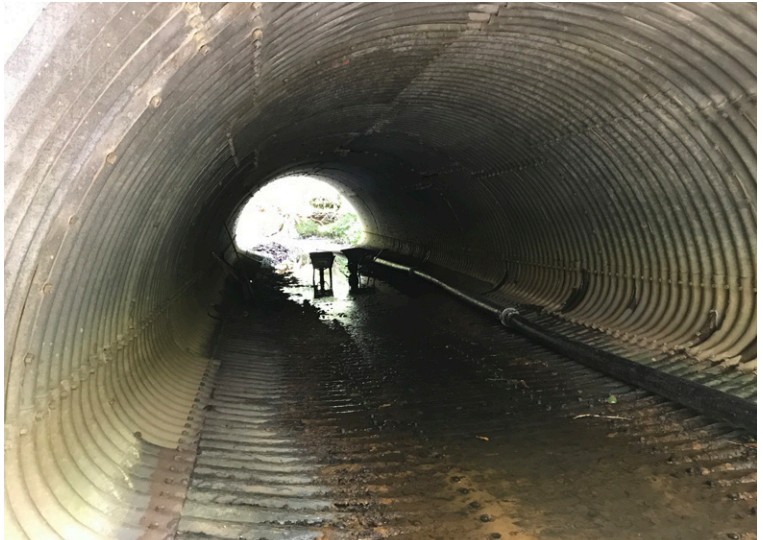
*The culvert prior to prep and installation*

In September 2017, Concrete Canvas® GCCM\* (CC) was used to line a culvert in Cooks Bridge, Midhurst, West Sussex. The culvert was situated under a highway, and provides the only passage under the road for the stream; however, the existing corrugated steel culvert had corroded over time, in part due to the abrasion from sediment and gravel transported along the channel in high flow conditions. The flow of water started to erode the soil beneath the structure, affecting the long-term performance of the culvert. CC was specified to provide scour protection to the culvert and increase the working life of the structure. The works were carried out by Suttle Projects for Igroup/Balfour Beatty Living Places/West Sussex County Council.

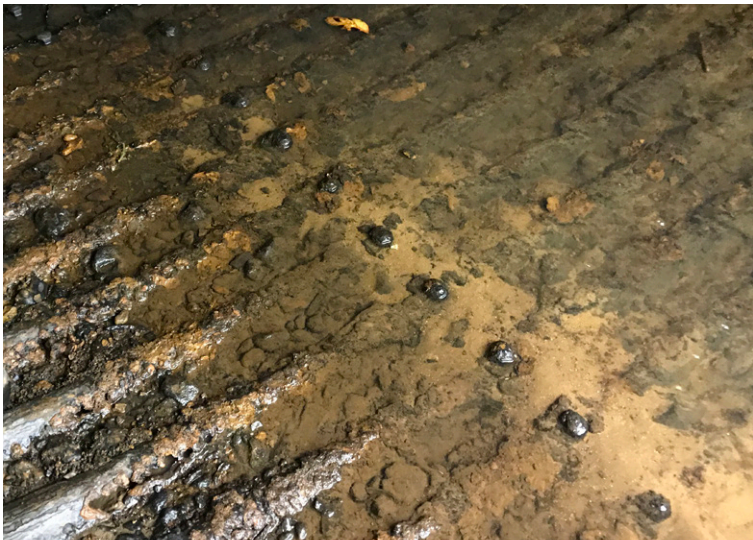
*The culvert floor was corroded and heavily sedimented*

To prepare the culvert, debris was removed from the corrugations and the culvert surface was cleaned to remove any sediment, some of which had solidified. The corrugation inverts were then filled with a rapid-set grout to ensure an even surface for the CC to be fixed to, as well as ensuring the material was flush to the culvert and to avoid any voids between the culvert and material. Grout was packed locally around protruding bolts and nuts to avoid potential puncture points.

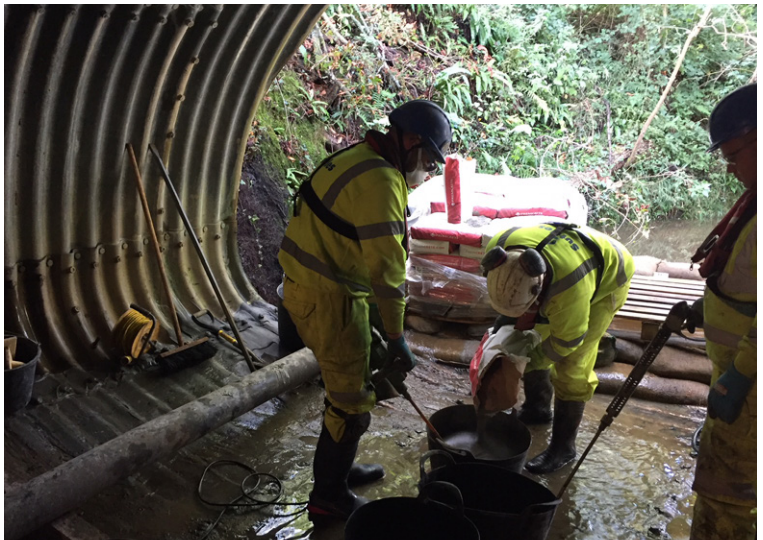
*Quick-set grout was used to fill the voids in the corrugates*

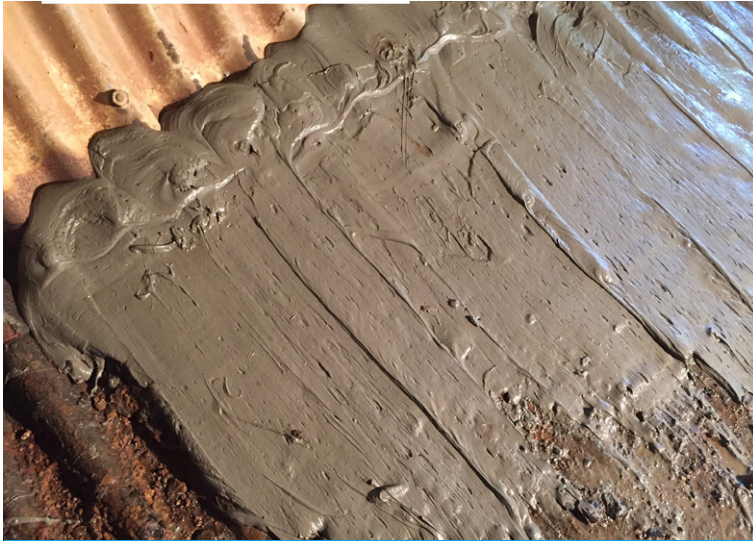
*The grout provided a flat surface to lay the CC on top of*

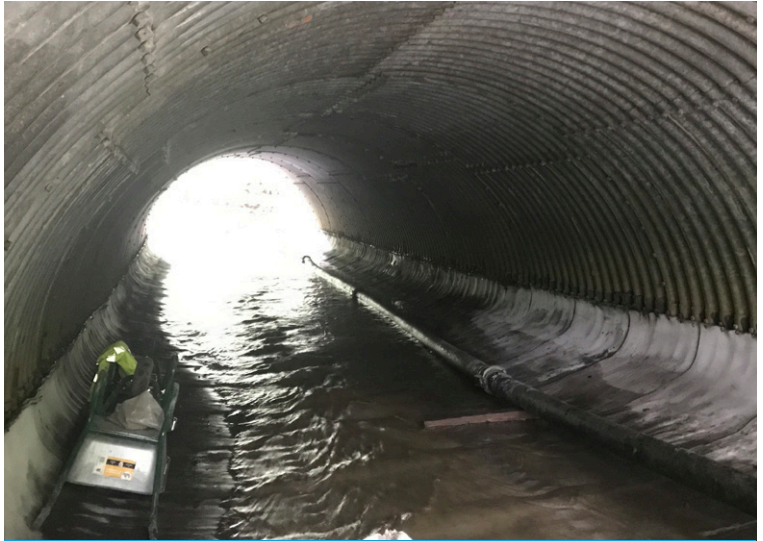
*The CC was laid transversely across the culvert floor*

The CC material was then laid by hand, transversely across the base of the 23m x 6m culvert. The material was fixed to the culvert by drilling holes through the steel and fixing in place using tech screws. The CC was fixed along its edge at roughly 150mm intervals. Additional fixings were then applied at 300-500mm intervals, to help the material fit to the curve of the culvert successfully. Each additional layer was laid in the direction of waterflow, with an overlap over 100mm, and jointed using Clearfix adhesive sealant for added impermeability. Sandbags were then placed on top of the joints to weigh them down while they dried. Once installation was completed, and the grout set, the CC was hydrated using water from the stream.

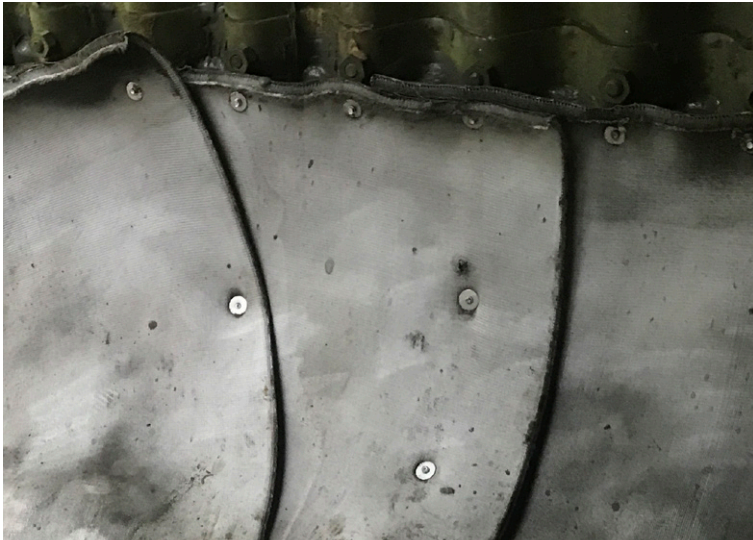
*CC was fixed to the culvert using tech screws*

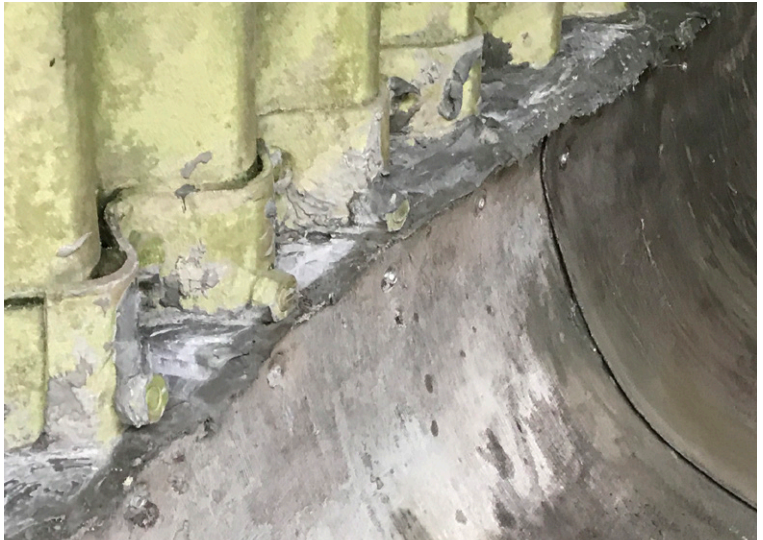
*Voids behind the fixed CC were filled using more grout*

Once set, the voids at the sides of the culvert and CC material were sealed by filling with poured grout to prevent ingress. At the start of the culvert, where there was a concrete apron, the CC was extended onto this and screwed in place, before a grout fillet was applied along the entire length to prevent water undermining. At the end, the CC was cut level with the headwall and another grout fillet applied and the edge buried with a larger stone.

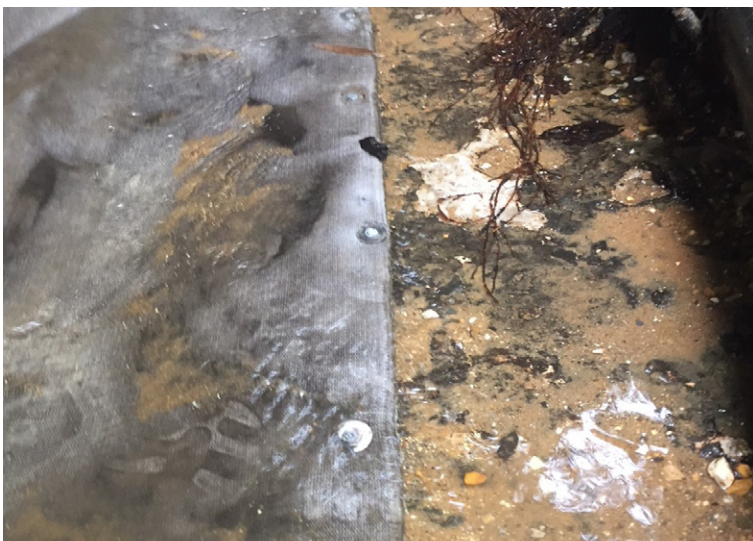
*CC extending onto concrete apron, fixed using tech screws and grout*

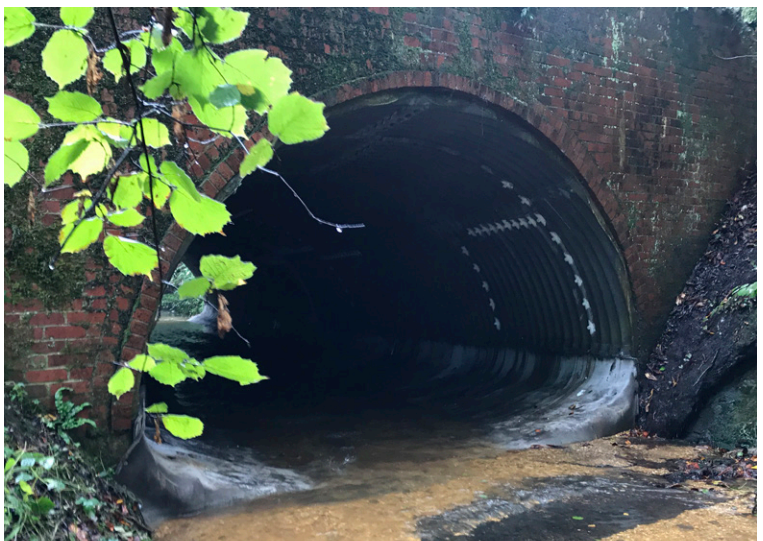
*CC aprons at the start of the culvert*

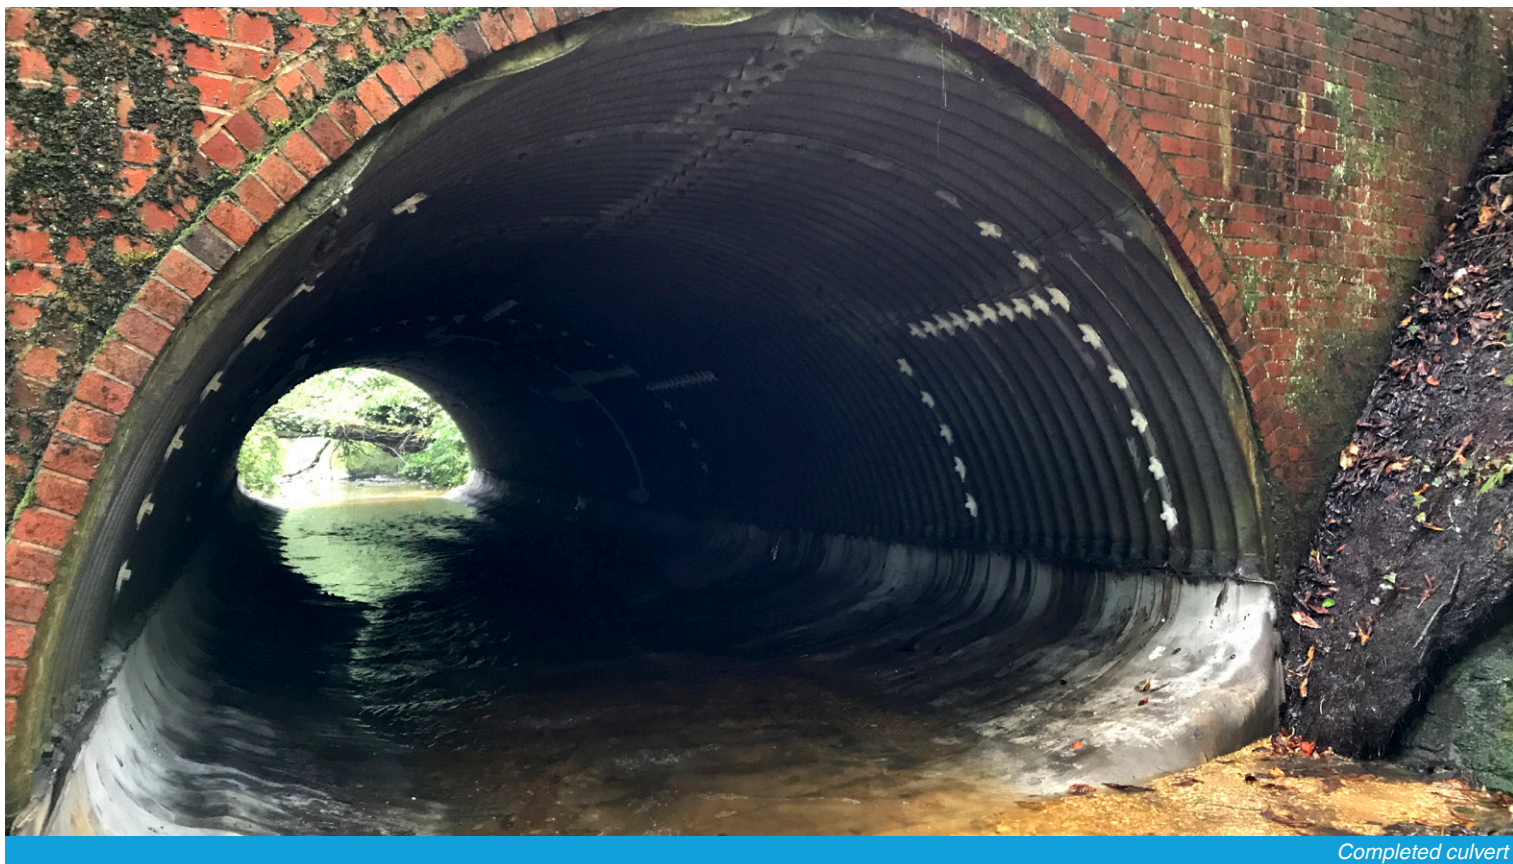
Completed culvert

The project as a whole took 11 days to complete, including mobilisation and preparation work. A total of 160m<sup>2</sup> of CC13™ were installed, fixed and hydrated in 3 days by a team of 4 people (with the majority of the installation time spent fixing the CC to the culvert with tech screws), on a site with limited access and material transported into position by hand.
