CULVERT LINING

In September 2014, Concrete Canvas® GCCM* (CC) was used to line a culvert in Earlston, Scotland. The culvert was failing and previous lining/remediation attempts had been unsuccessful. Shotcrete was considered as an alternative, however this would have resulted in a much lengthier installation, as well as requiring much more complex logistics as access to the full length of the culvert was limited. Additionally there was concern over the environmental implications of installing shotcrete in this location.

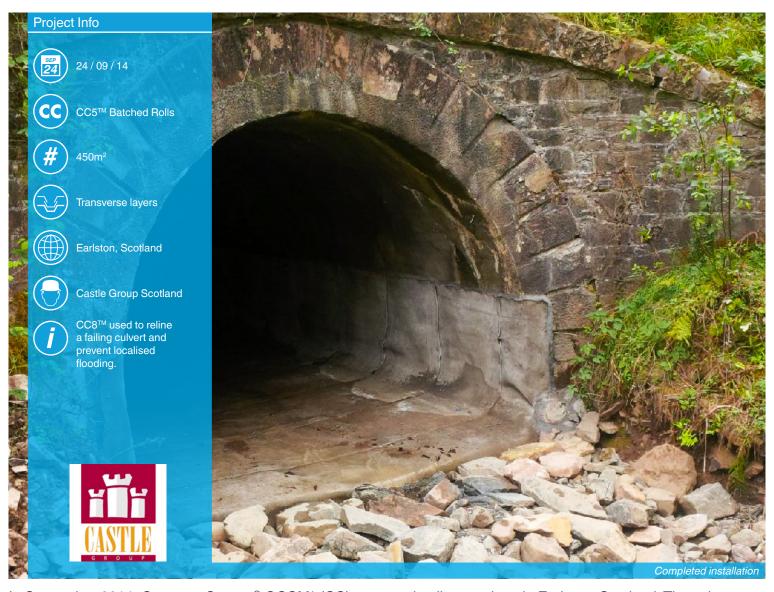
Installation was carried out by Castle Group Scotland for Bear Scotland. To prepare the culvert the existing failed coatings were removed from the corrugated section and replaced with a semi dry mortar mix to provide a flat profile. Further down the culvert is of masonry construction, and the entirety of the culvert floor is poured concrete. Batched rolls of 5mm thick CC (CC5™) were delivered to site and unrolled by hand across the width of the culvert, with an overlap of 100mm created between adjacent layers. The overlaps were screwed with 30mm stainless steel screws at 200mm centres but were left unsealed, creating weep paths to prevent the build up of hydrostatic pressure behind the CC. The top edges of the CC were sealed with a line of grout to prevent water ingress behind the material. Water was pumped from the nearby water course for hydration.

450sgm of CC5™ were installed by 4 people in 4 days in a live water course. The client was very impressed with the installation and CC is likely to be used on further culvert projects.
