CC8™ Batched Rolls

Kent, England, UK

CC8™ used to provide a remedial lining solution to a culvert located below a main road in Kent

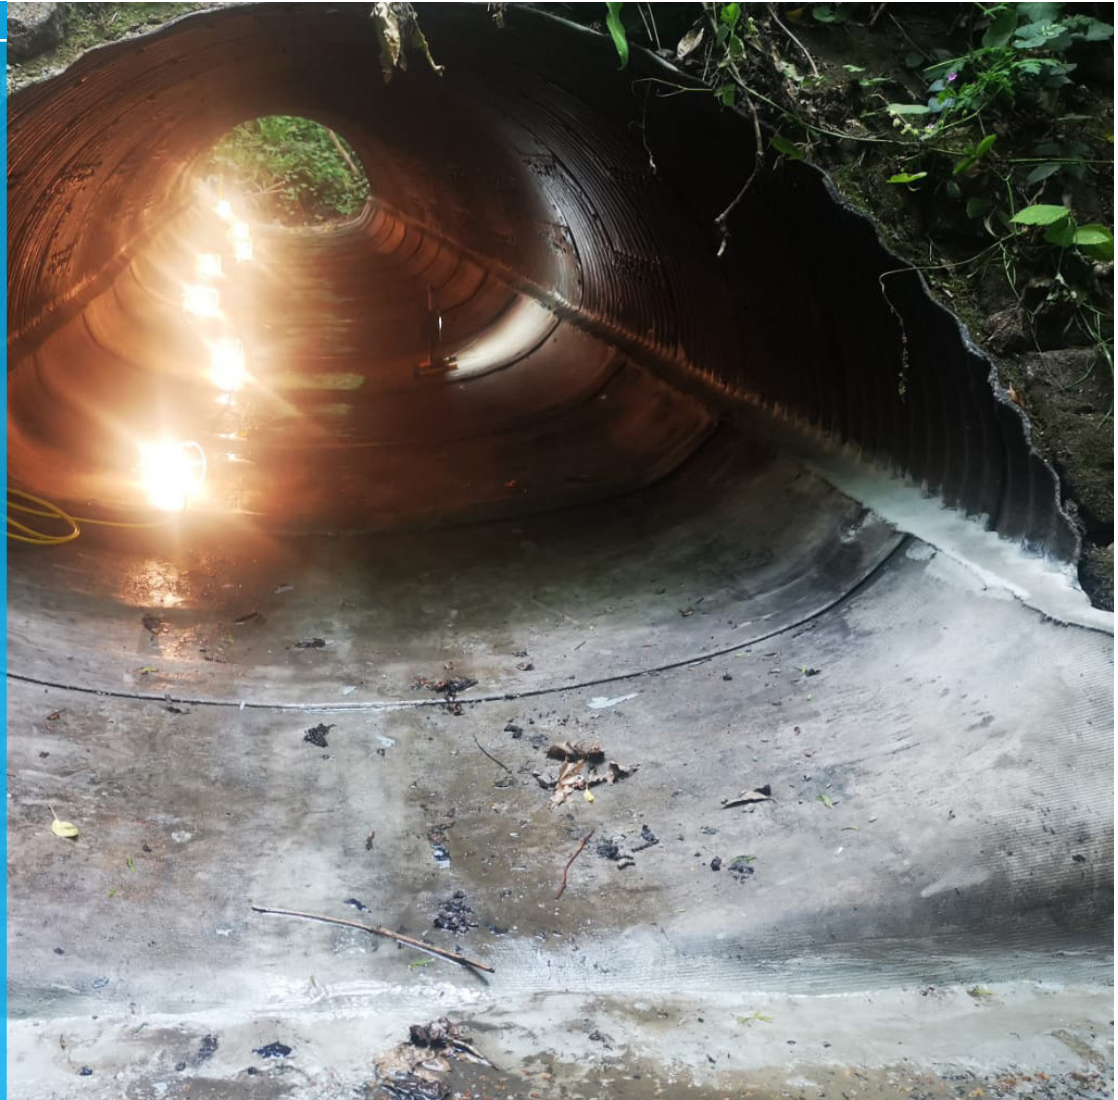
Completed culvert lining installation in Kent, England

A total of 45m² of CC8™ material was installed by a team of four from T Body Jnr Plant Hire Ltd. The project was a success. The client was happy with the outcome, especially with the speed and ease of installation despite the limited site access and restrictions within the culvert.

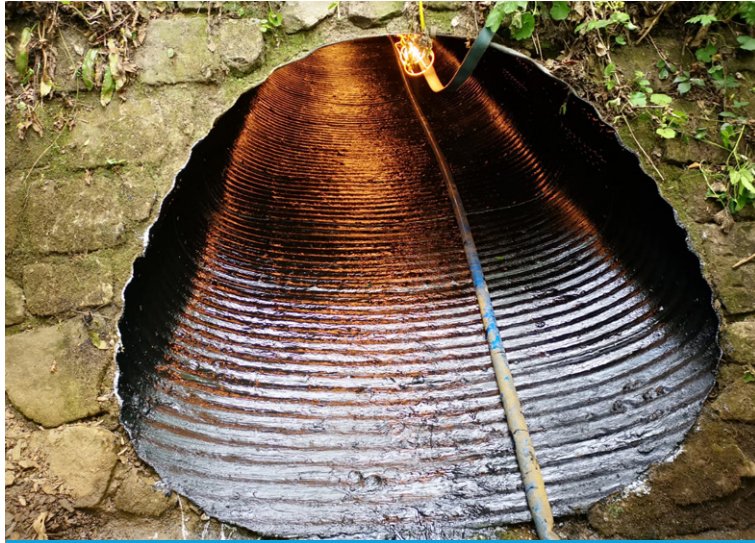
In May 2020, Concrete Canvas® (CC) GCCM* was chosen as a culvert lining solution. An existing culvert located below a main road in Kent had degraded over time as a result of erosion caused by the stream which runs through it. As a result, significant rusting and perforations were seen in the corrugated steel structure and a solution was required to remediate the floor of the culvert.

Culvert prior to works

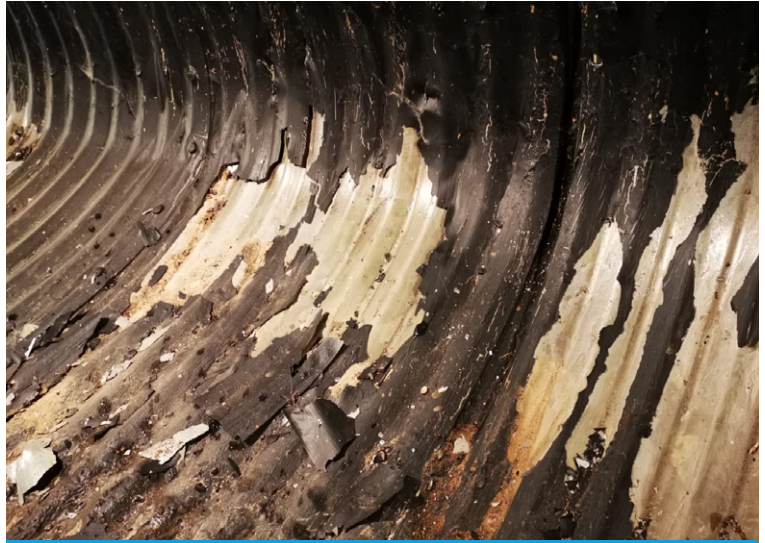
Signs of degradation, rust and flaking of the bitumen coating

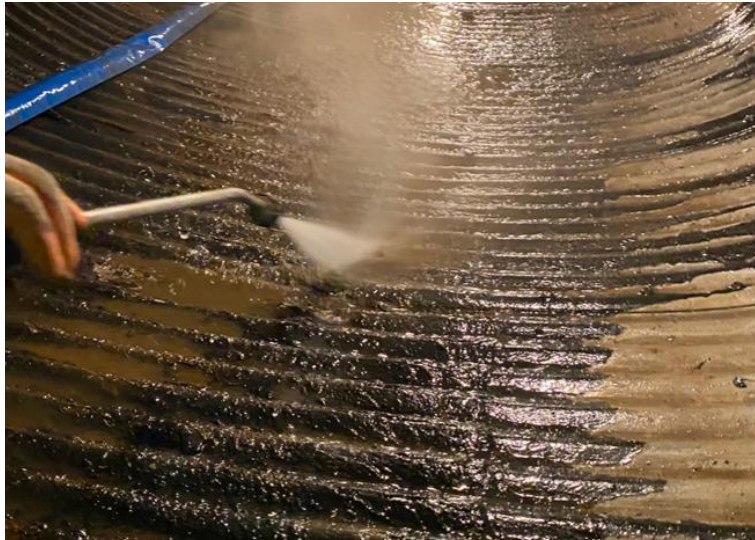
Power hose used to remove bitumen coating, sediment and surface rust

Prior to installation, the culvert was cleaned and a preparation layer installed. All corrugation inverts were then filled with a fast setting grout to provide an even surface, eliminating any voids beneath the material and ensure a successful installation. Wooden batons were then fixed to the culvert at the termination point on each side.

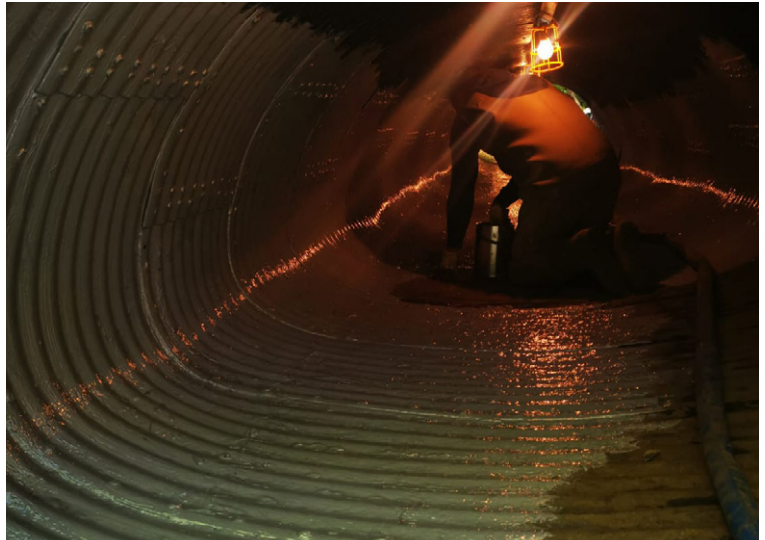
Application of grout to culvert floor and walls

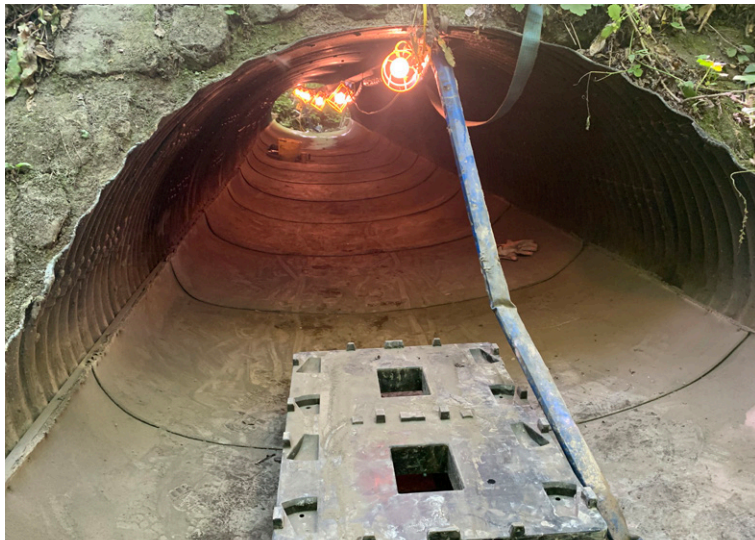
Batched rolls of CC were transported through the culvert on a trolley

Starting at the downstream end of the culvert, each pre-cut length of CC was transported into the culvert using trolleys, unrolled transversely across the culvert floor and the ends fixed to the wooden batons using stainless steel screws. Subsequent layers of CC were shingled so as to overlap the previous layer by 100mm. The material beneath the overlaps was hydrated before a bead of adhesive sealant was applied. 30mm stainless steel screws were then used to reinforce the overlaps. Following installation, the material was hydrated using a bowser and hose attachment.

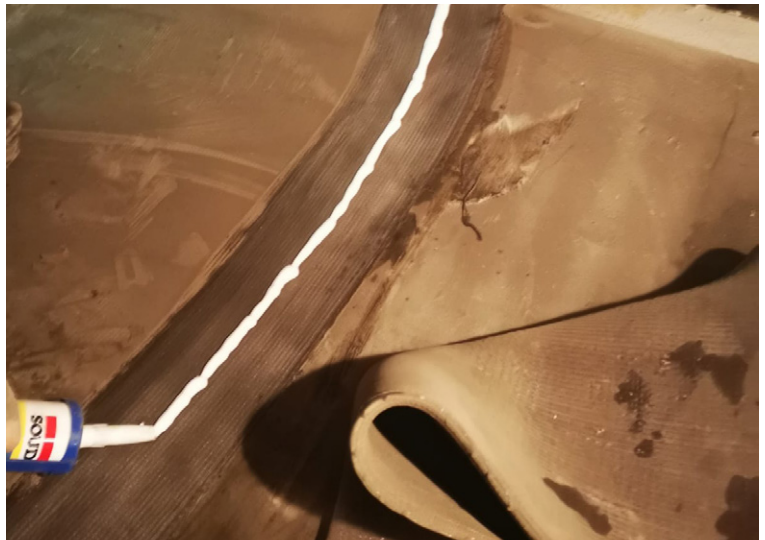
Sealant used to reduce permeability of joints

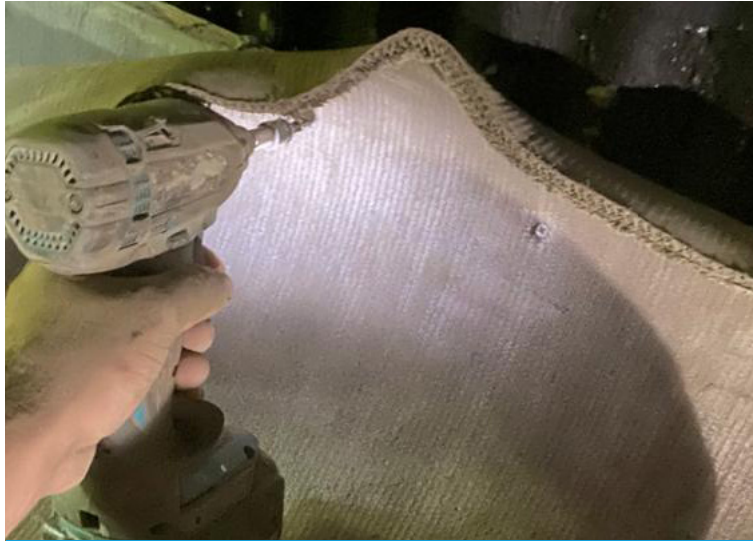
CC attached to wooden battons using stainless steel screws

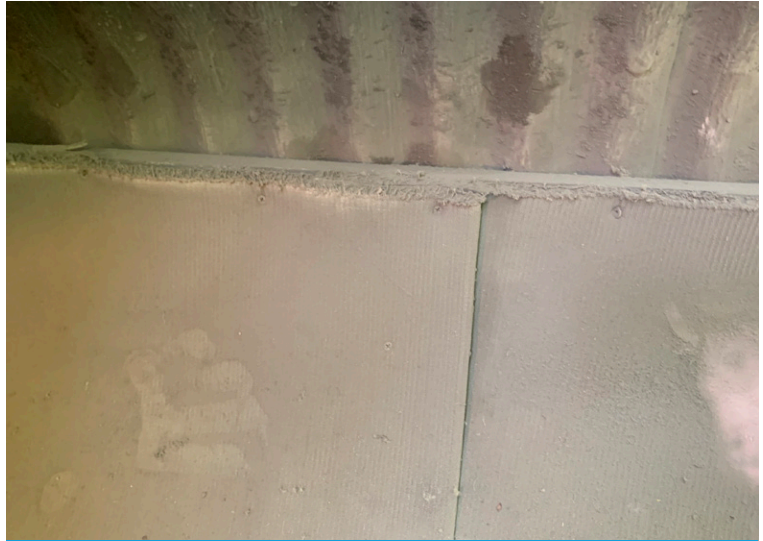
CC edges cut level with wooden batton for neat termination

Once the material had set, grout was applied to the raw edges of the material and over the wooden batons to prevent water ingress below the material and provide a neat termination detail. At the entrance and exit of the culvert, CC aprons were created and secured to the masonry using anchor bolts and further grout applied to the material edges.

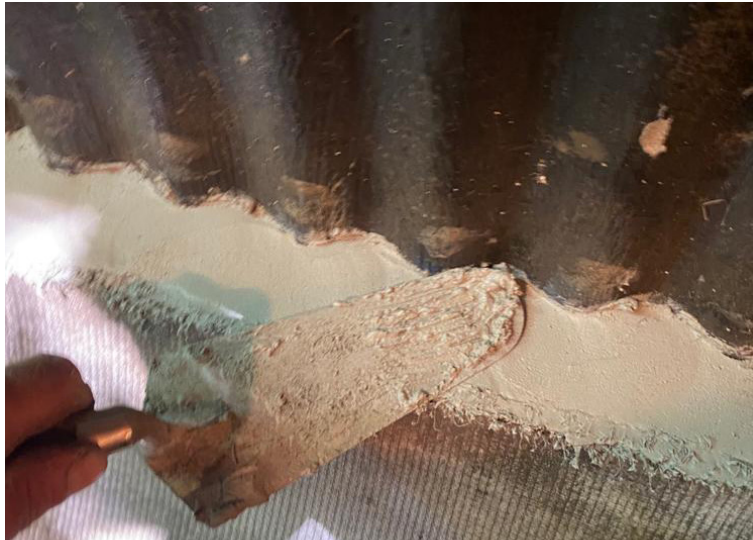
Grout applied around edges to prevent ingress post-hydration

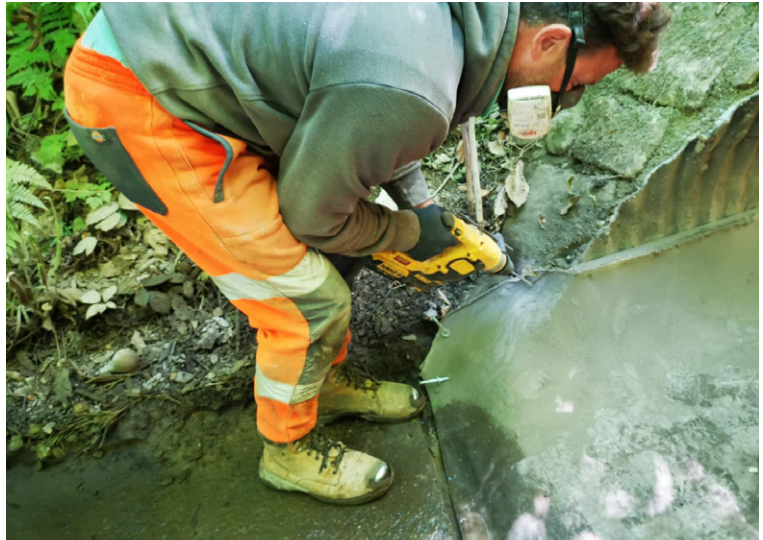
CC attached to masonry exterior using shot-fired nails

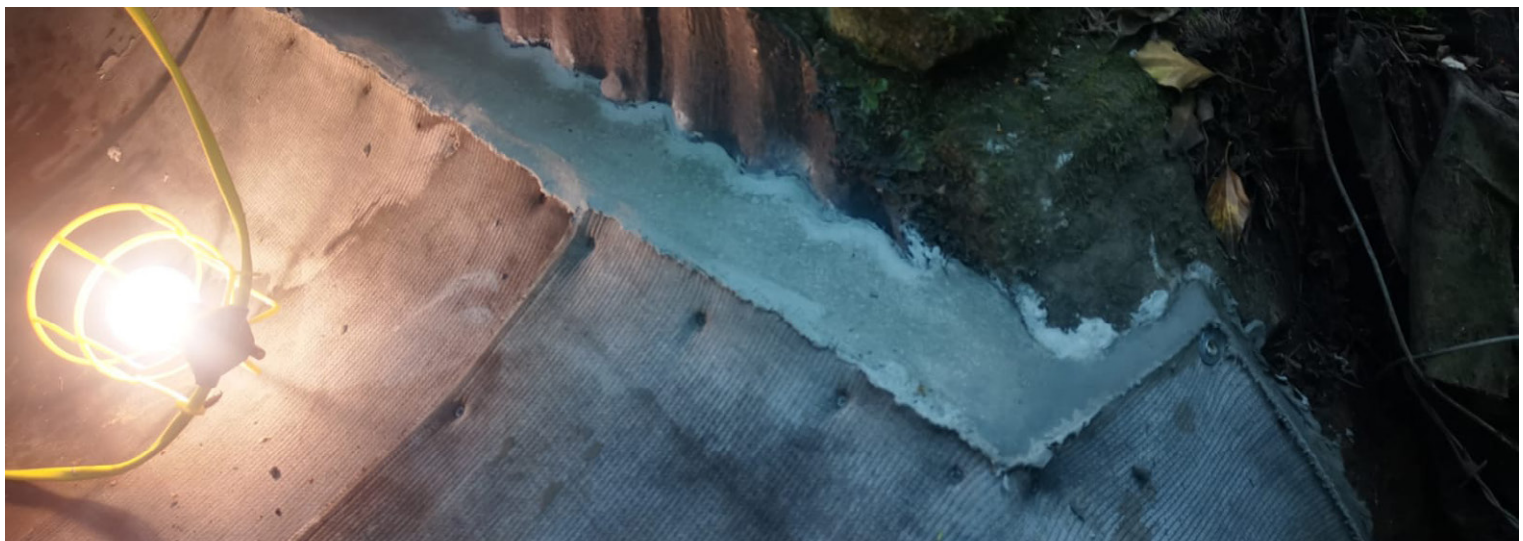
Termination detail outside culvert

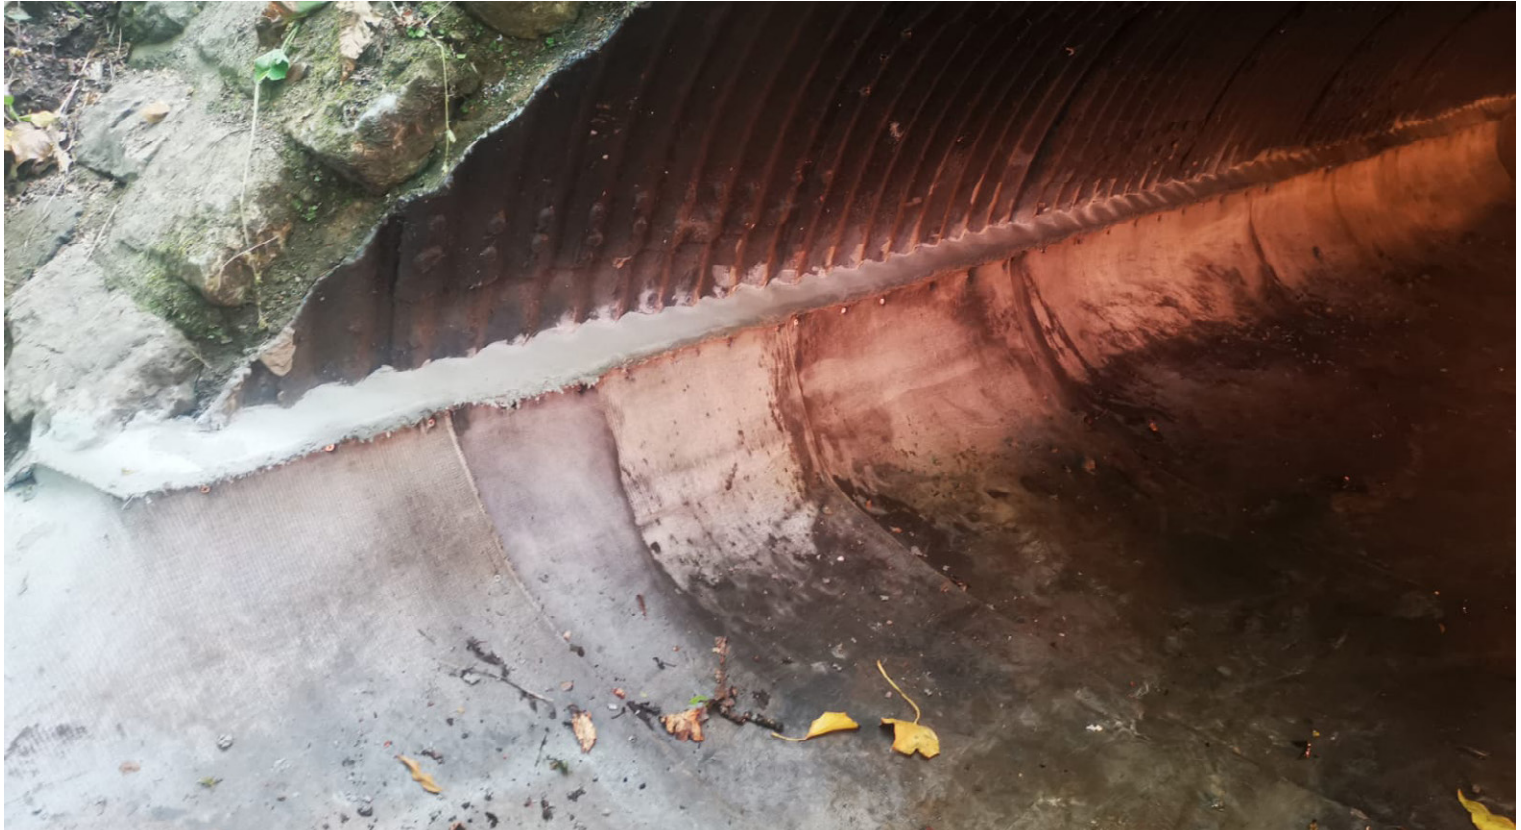
Completed culvert lining installation
