CC8™ Batched Rolls

Kirk Burn culvert,
Laurencekirk, Scotland

Briggs Building Ltd.
with BEAR Scotland

CC8™ was used to
remediate a dilapidated
culvert and prevent
erosion caused by high
water flow rates.

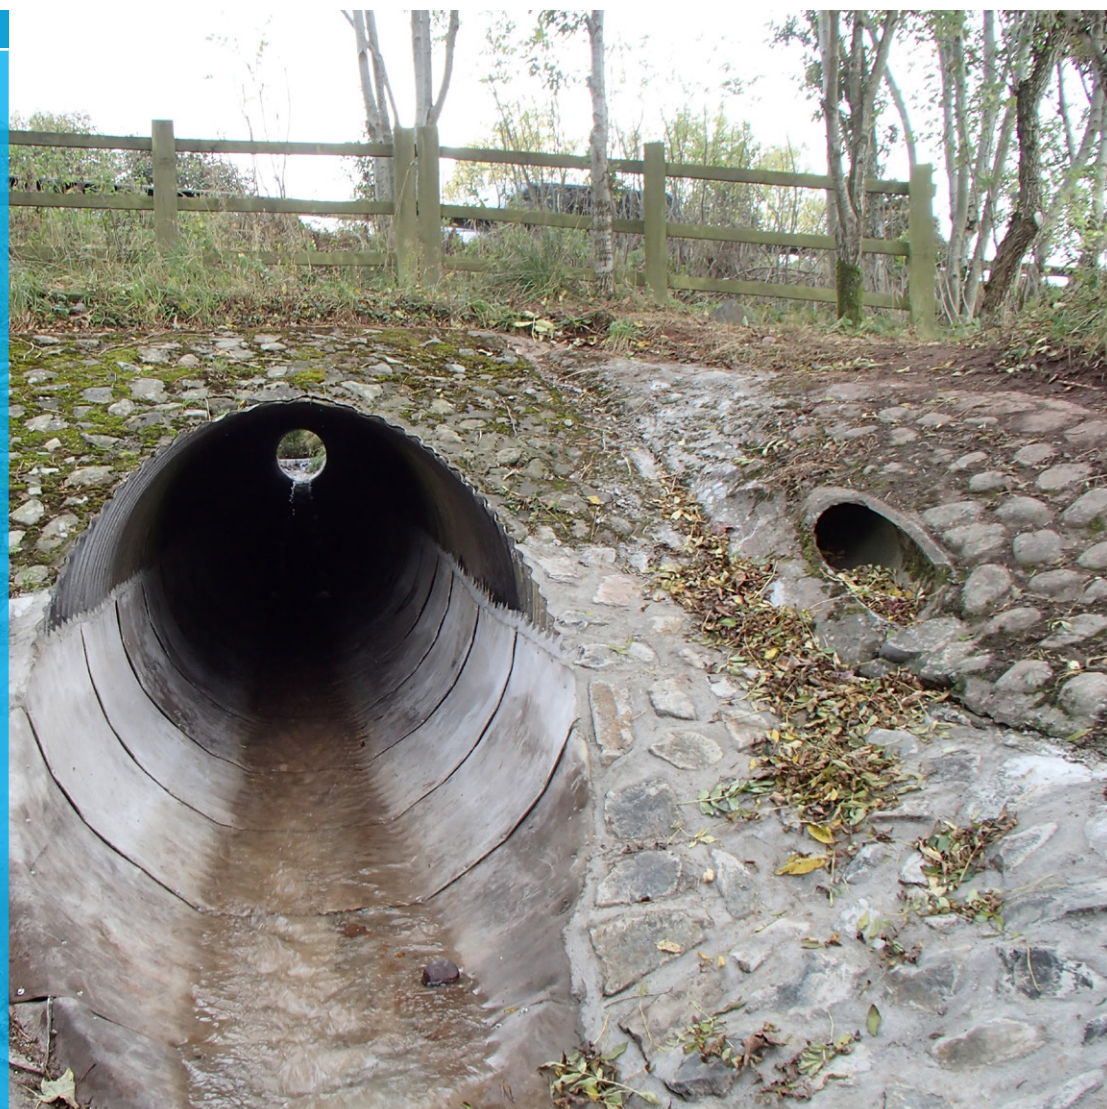
The completed culvert lining installation in Laurencekirk, Scotland.

In total, 170m² of CC8™ were installed in 5 days by a crew of 4 people. The client was impressed with the ease and speed with which CC was installed, along with its minimal environmental impact and increased lifespan compared to bitumen.

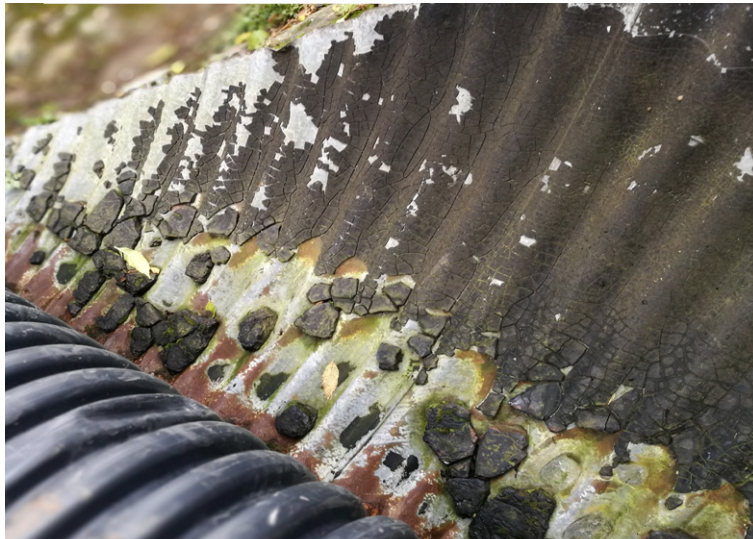
The original corrugated steel culvert, known as the Kirk Burn culvert, was 1.8m in diameter and had sustained significant degradation and erosion due to heavy water flows and abrasion. As a result, the existing 25mm bitumen coating inside the pipe had broken down through constant flow erosion and weathering.

Flow erosion had caused the existing bitumen lining to break down

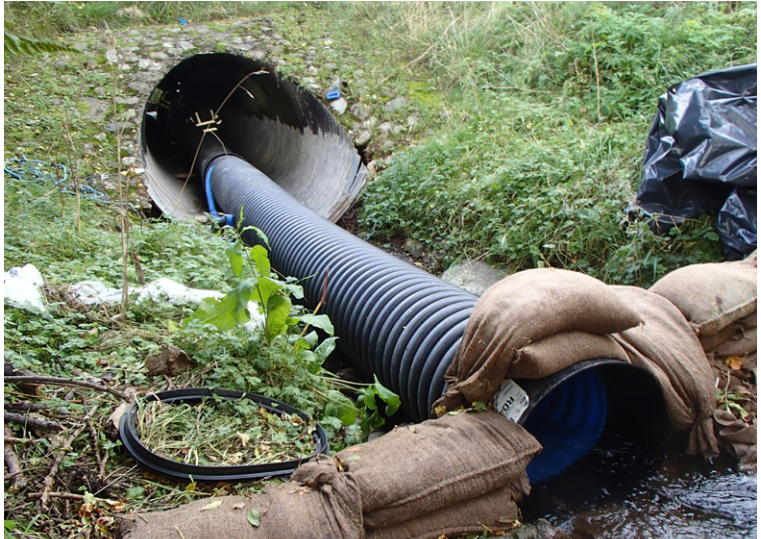
Water diverted into a 450mm HDPE Ridgidrain pipe

Prior to installation, the river was dammed using sandbags 10 meters upstream from the culvert and water was diverted into a 450mm HDPE Ridgidrain pipe which allowed fish to safely pass through the culvert for the project duration.

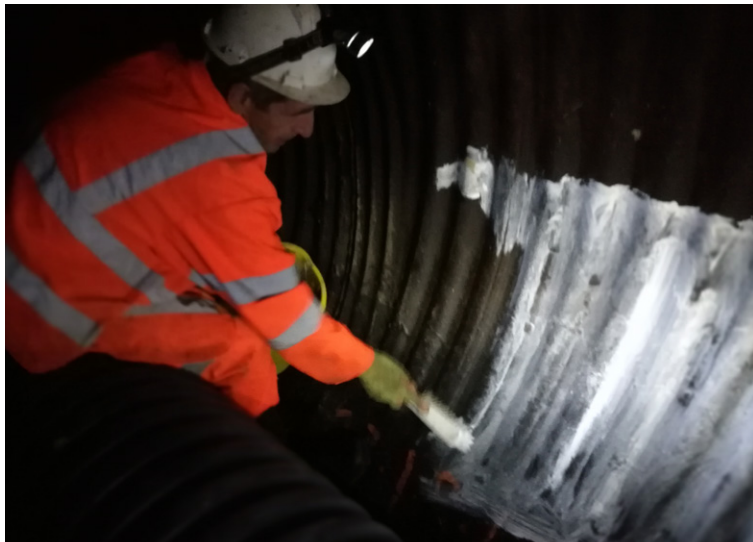
An Everbuild PVA adhesive & bonding agent was applied to crenulations

The contractor pressure washed the culvert to remove any sediment and debris, and removed any loose bitumen sections inside the culvert. An Everbuild Feb General Purpose PVA adhesive and bonding agent was then applied to the crenulations prior to filling them with a grout mix to provide a suitable fixing surface and to minimise void spaces underneath the CC.

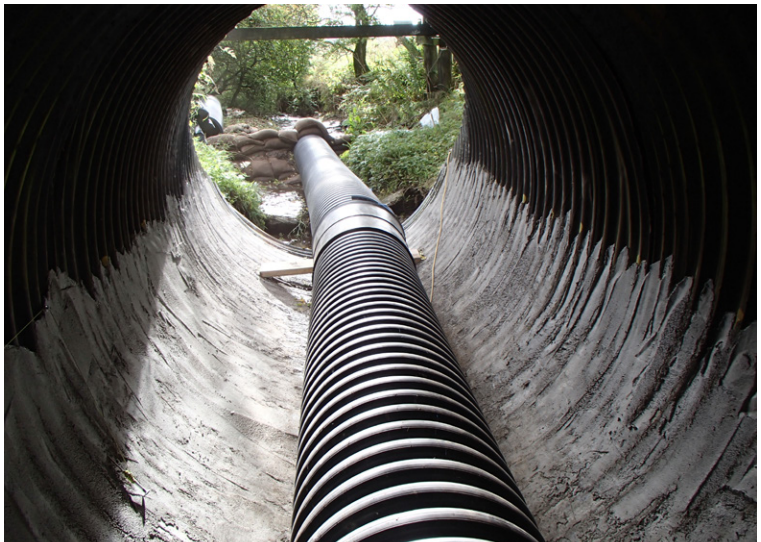
Semi-dry grout was applied to fill the corrugations

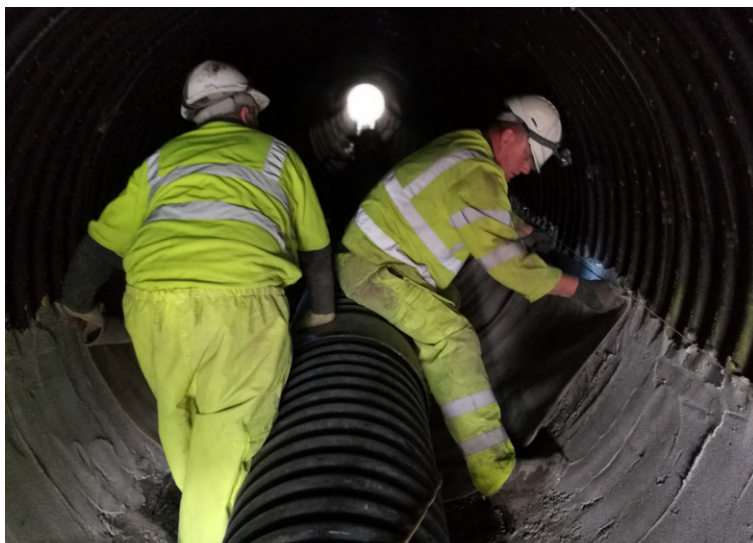
Batched rolls of CC8 were laid transversely across the width of the culvert

Due to restricted site access, batched rolls of CC8™ were delivered to site and unrolled by hand transversely across the width of the culvert. The adjacent CC layers were overlapped by 100mm and shingled in the direction of water flow. The CC overlaps were then screwed together and into the filled crenulations with 30mm stainless steel tech screws at 200mm centres and left unsealed, creating weep paths to prevent the build-up of any hydrostatic pressure behind the CC. The top edges of the CC were sealed with a line of grout to prevent water ingress behind the material. An anchor trench was dug on the upstream side to capture the CC edges and fixed with 300-500mm gabion stones before backfilling with material to prevent water ingress. The contractor used the water running in the HDPE pipe to hydrate the CC material with a hose pipe at the end of each day.

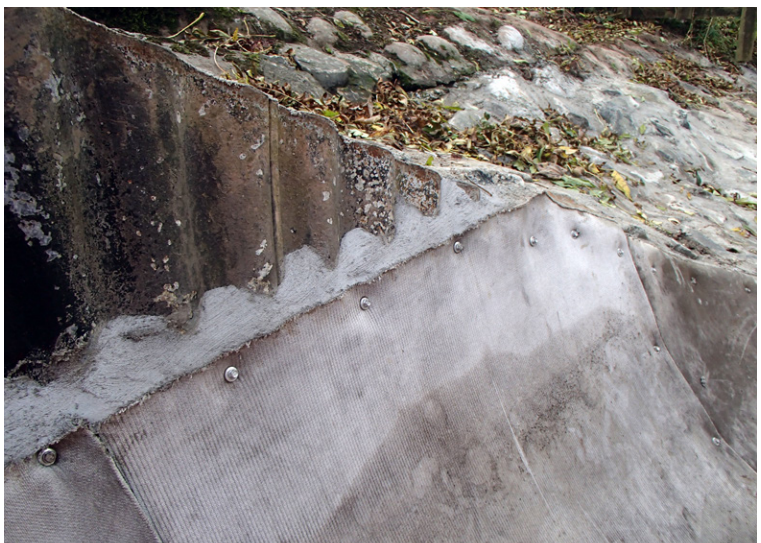
CC was fixed with tech screws & grout applied to prevent water ingress

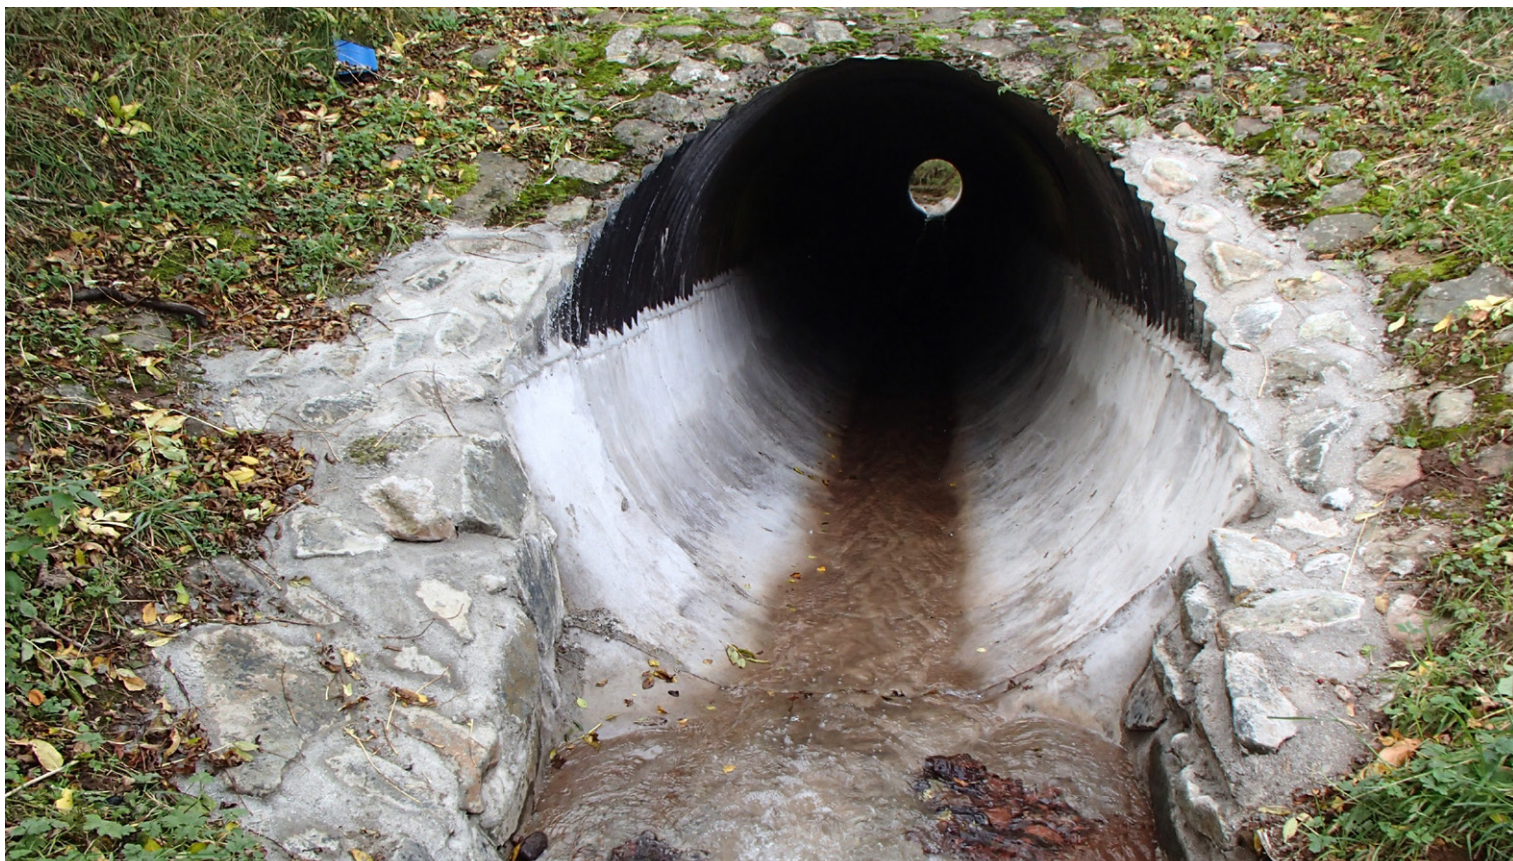
Completed relined culvert on upstream side
