CC8™ Batched Rolls

Newburn, Newcastle upon Tyne, England

Continuation of works within Newburn Culvert to provide scour protection to new section of old brick-built culvert

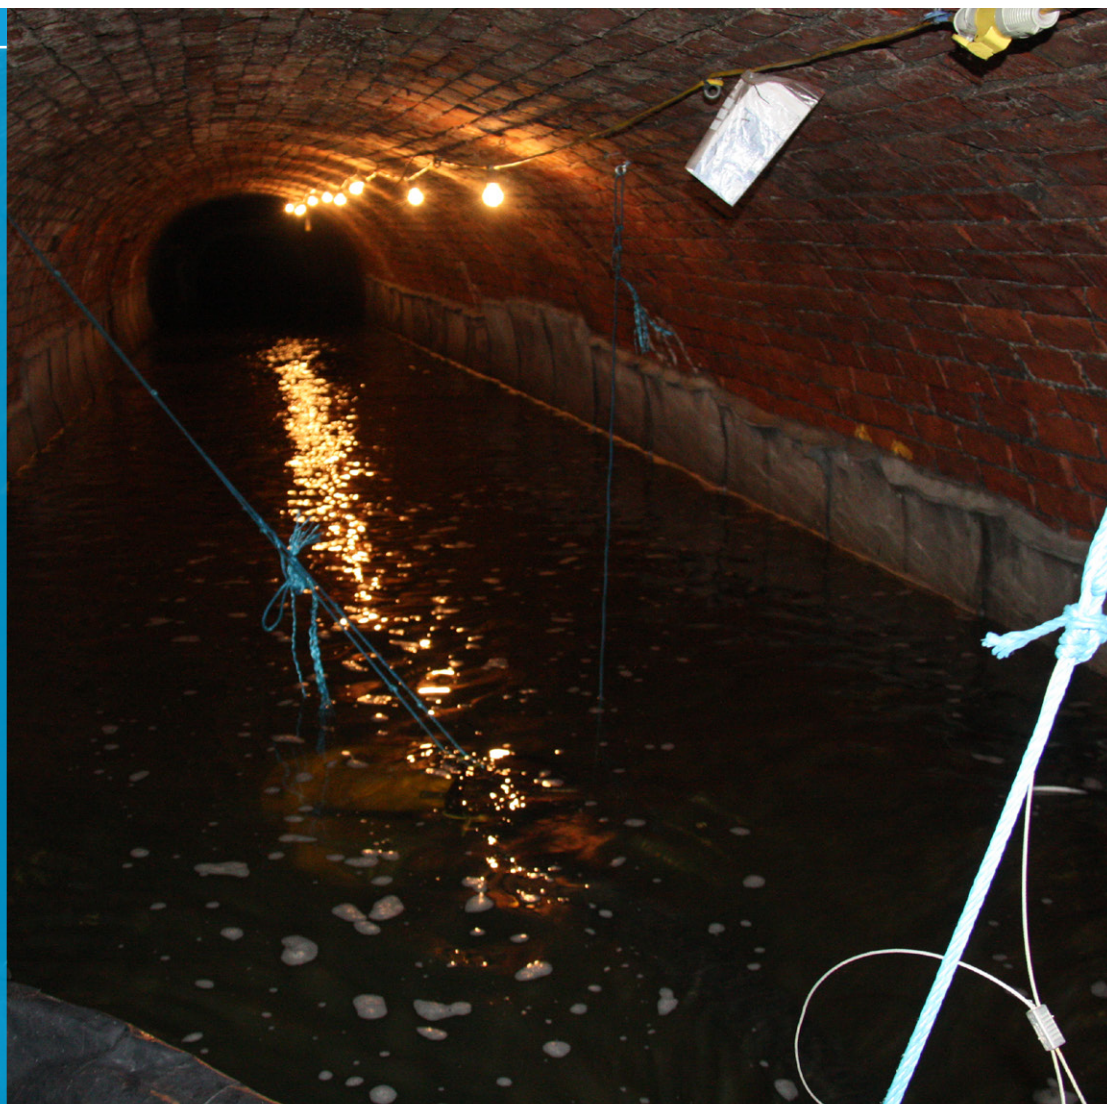
Completed CC installation within Newburn Culvert

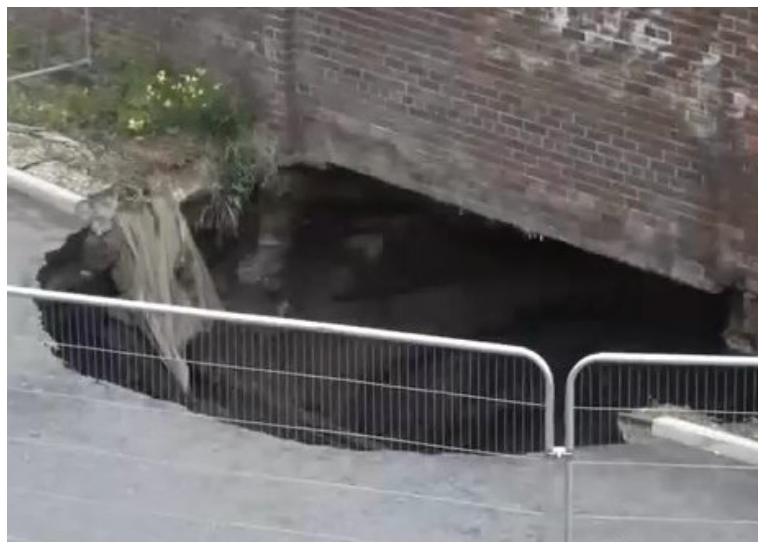
First signs of sink hole

In May 2012, residents of a block of flats known as Spencer Court in Newburn, northern England, were evacuated when a 6-metre-wide sink hole appeared on the site following a period of heavy rainfall.

Spencer Court was constructed on land which was owned by the Duke of Northumbria sometime in the mid-1800s. During the initial investigations, a privately-owned masonry culvert was discovered below Spencer Court. The culvert was a traditional brick Victorian structure and showed signs of damage due to erosion and flood events. It was thought that the culvert's poor state was a major contributor to the appearance of the sink hole.

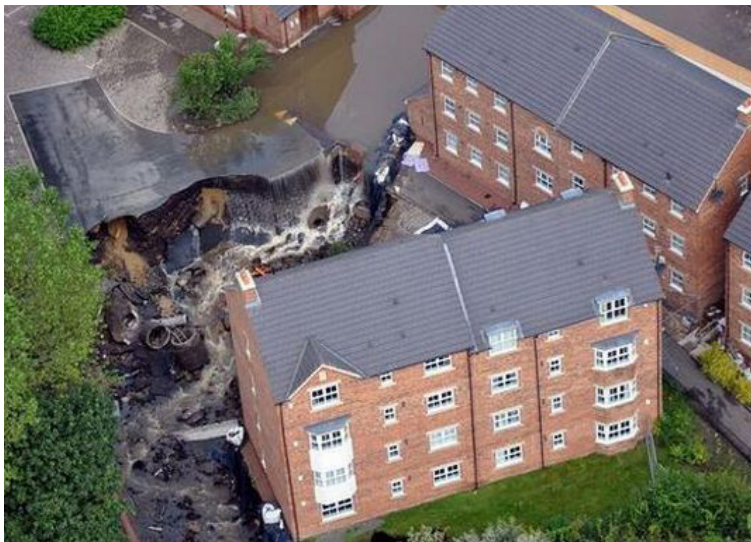
Extent of damage after significant storm events

The flats were again evacuated and the area was again hit by a storm just days later which was reported by the Environment Agency as the largest storm the Newcastle area had experienced since the 1900s. Further flooding was seen in Spencer Court, this time up to the second floor of the buildings. Further emergency works were carried out, with teams working 24 hours a day to pump out the flood water and put further precautions in place to prevent additional damage. However, in September 2012 Spencer Court was partially demolished after the discovery of a six-inch subsidence.

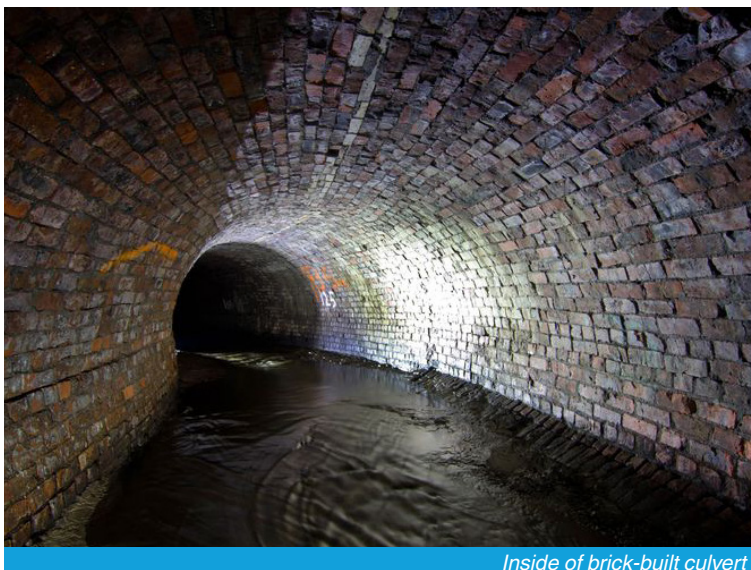
Inside of brick-built culvert

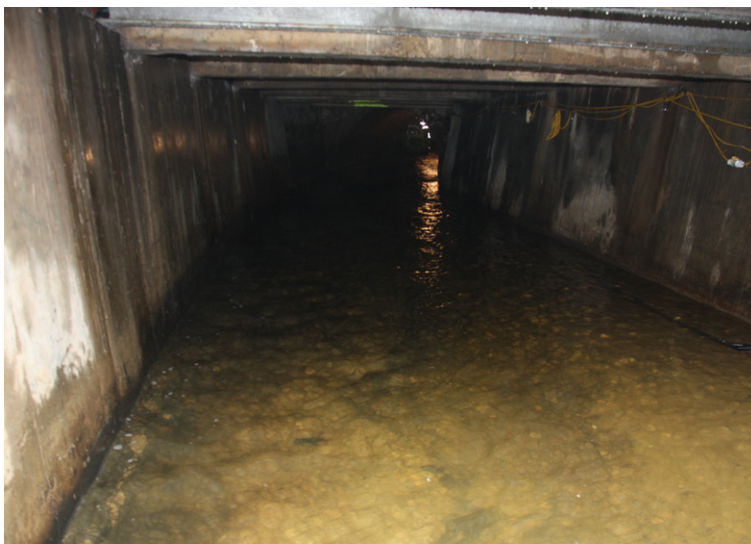
Section of culvert requiring work in 2019

It wasn't until 2016 that internal works began to protect the culvert structure. The first of three phases began, with Concrete Canvas® (CC) GCCM* being brought in to provide a hard-armoured erosion protection solution to the damage culvert. In 2019, Concrete Canvas Ltd returned for phase three. On arrival at the site, the existing material installed in 2016 was found to be performing as expected, however there were several areas of the culvert structure that still required repair and remedial works.

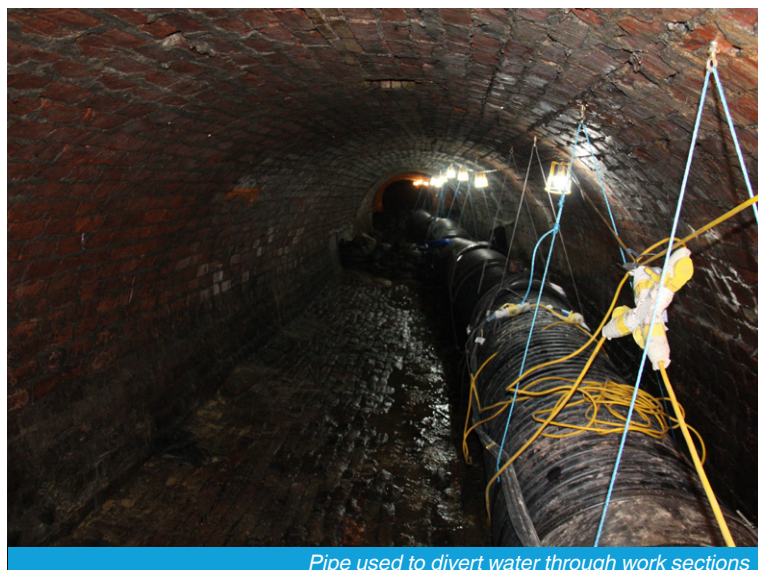
Pipe used to divert water through work sections

Prior to works, each section requiring repair was dammed off in turn using sandbags and plastic sheeting. A 600mm diameter pipe was used to manage the flow of water around these areas to allow for easy access and installation and a safe working environment. Debris was then removed from the culvert, including silt, rubble and chunks of brickwork that had been damaged and dislodged during storm events.

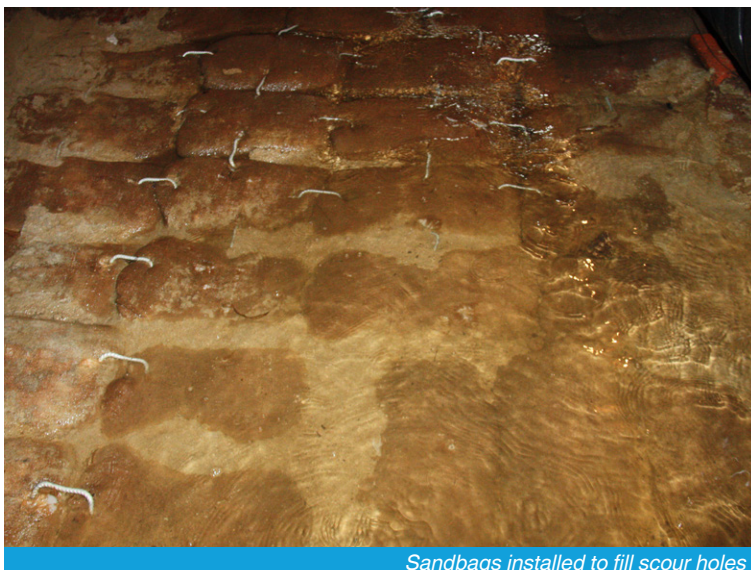
Sandbags installed to fill scour holes

Following preparation, the first section of works began approximately 50m inside the culvert. Colas rigged a number of lights and the crew wore head torches to aid with installation. Grout filled sandbags were used to fill the scour holes that had been created in the invert over time. Depending on the size of the holes, up to 200 sandbags were used to fill the voids. The sandbags were pegged into position and CC secured in place on one wall of the culvert using shot fired nails and stainless-steel fixings.

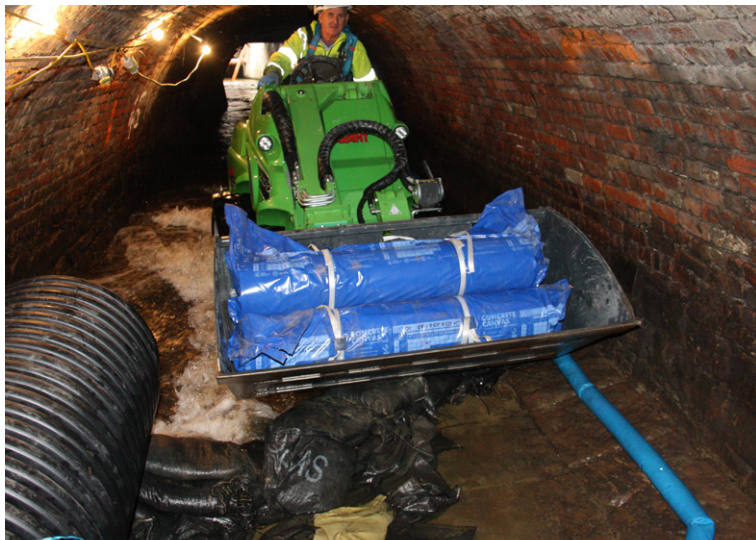
Batched rolls of CC transported through culvert

The CC had been batched to required lengths prior to being transported into the culvert to allow for manual transportation and easier installation. The material was then unrolled along the floor of the culvert and up the adjacent culvert wall where it was secured in the same way. The same fixings were used to secure the material along the culvert floor. Grout was used to fill any gaps between the wall and material to prevent ingress in the even of high water levels. At the leading and trailing edges of CC, a stainless steel 5mm thick plate were installed and bolted into position and finished with a small fillet of grout.

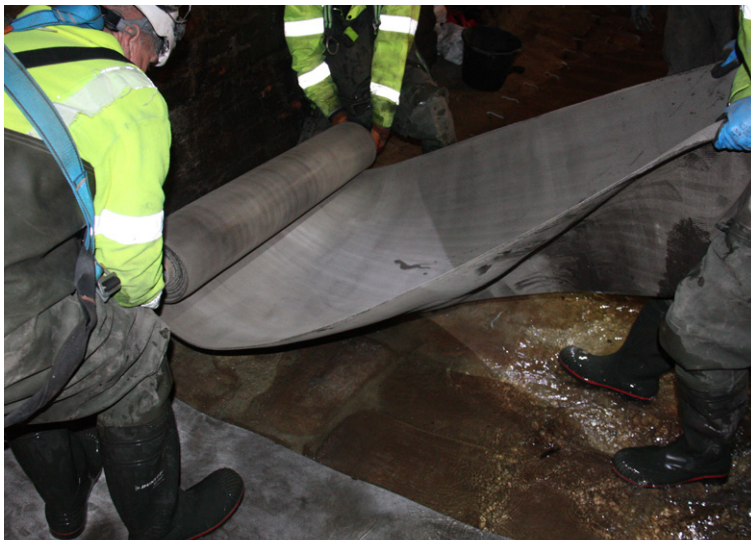
Deploying CC batched roll

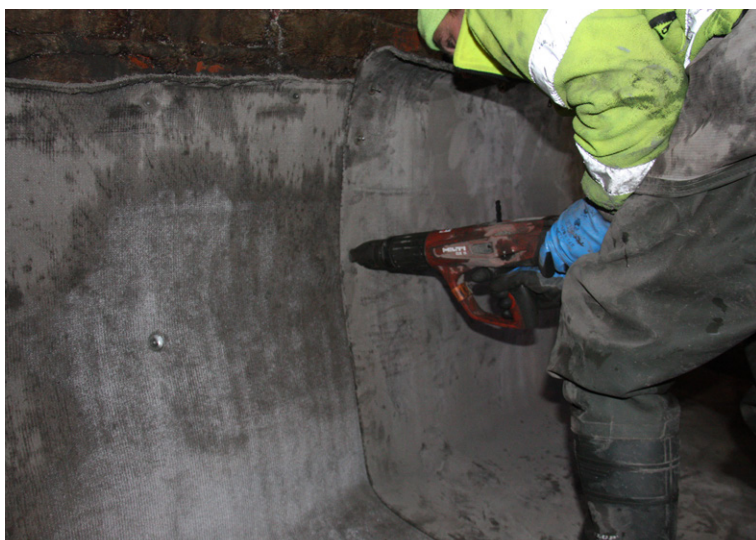
Securing leading edge of CC to culvert wall

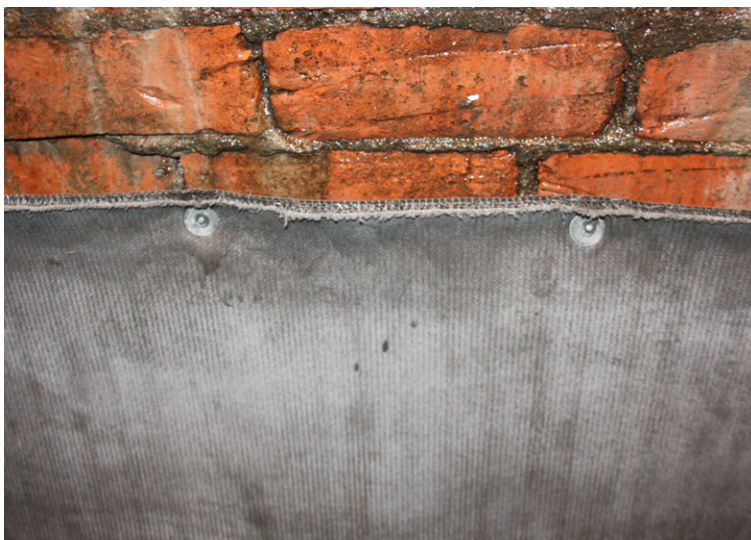
CC edges were trimmed for neat finish

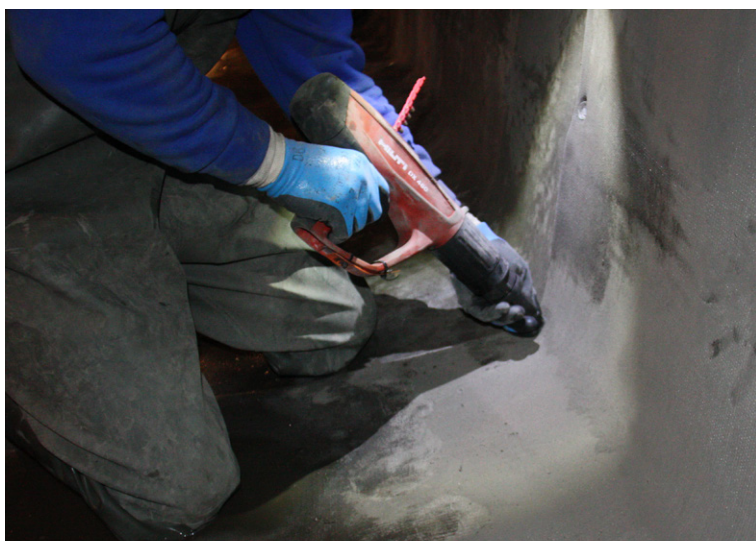
Securing CC to culvert floor

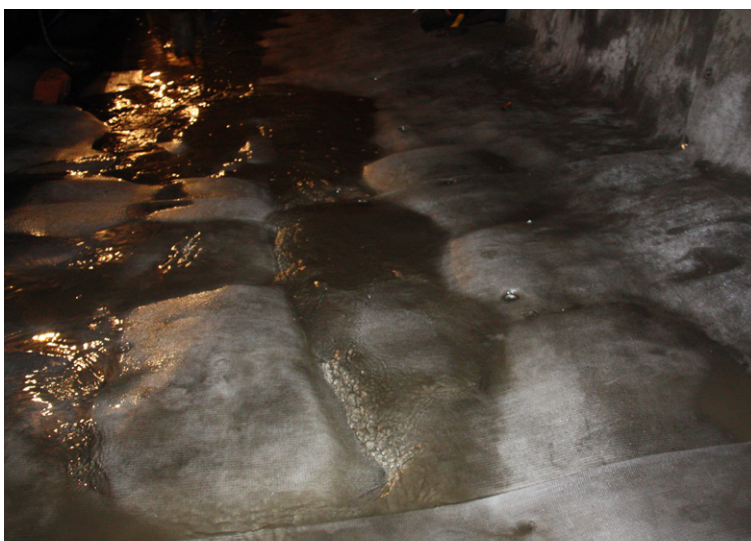
CC easily conformed to the culvert profile

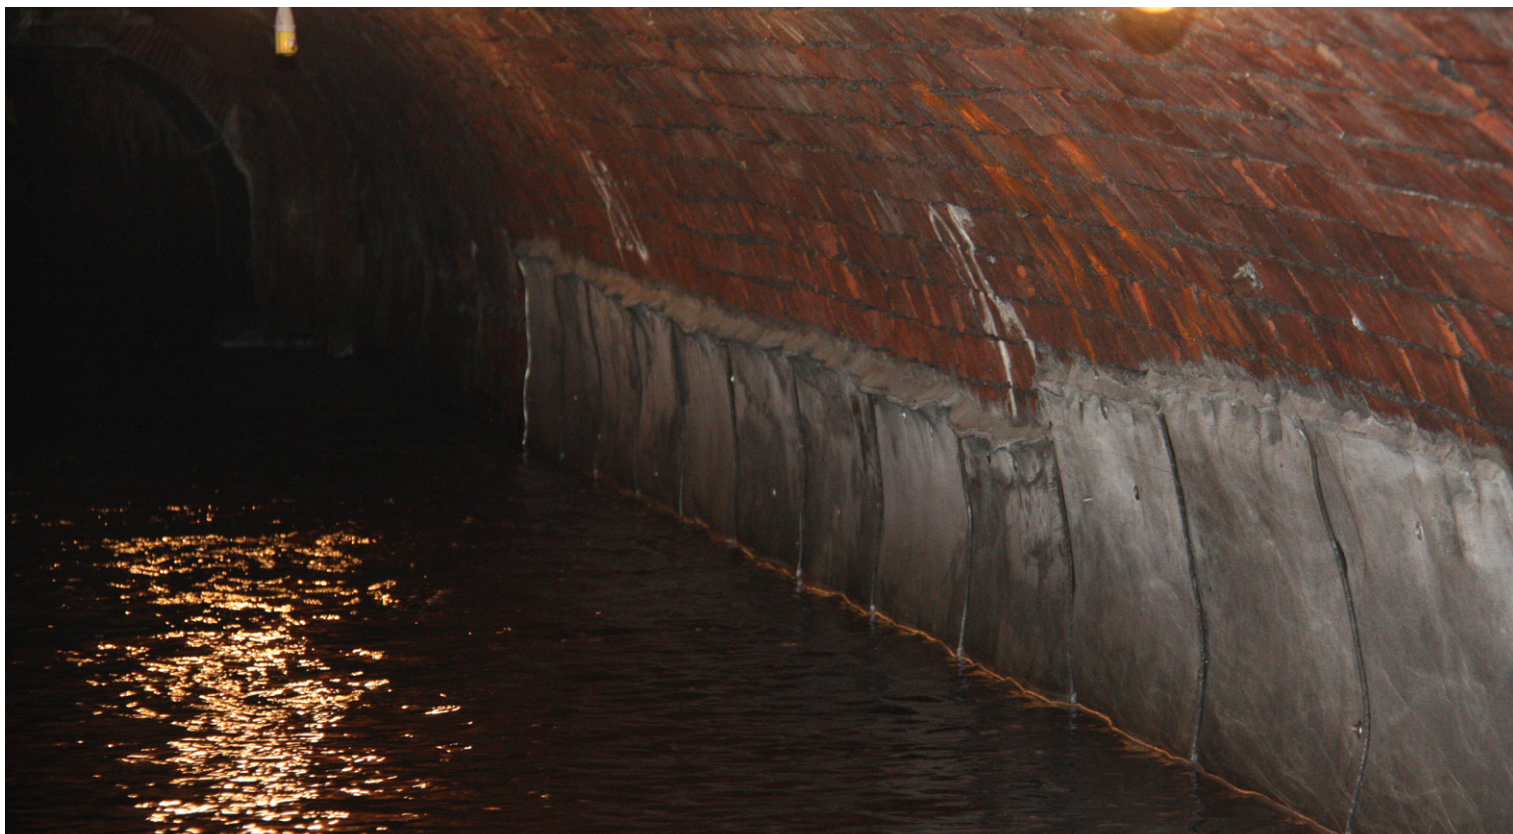
Completed section of CC installation within the culvert below Spencer Court

The installation was very difficult for the construction teams due to the cramped conditions and limited light. However, the team of four completed the installation of a 200m² of CC8™ within approximately five working days.

The CC installed during phase three of the works is expected to provide effective erosion and scour protection, as well as impact protection from any further debris carried through the culvert in future storm events. CC's high levels of abrasion resistance, lack of requirement for plant and specialist equipment and ease of transportation and installation on such a challenging site made it the ideal solution for this project.
