Porirua, Wellington, New Zealand

CC8™ used remediate a culvert to eliminate washout

In March 2014, Concrete Canvas® GCCM* (CC) was specified to remediate a culvert in Porirua, Wellington, New Zealand.

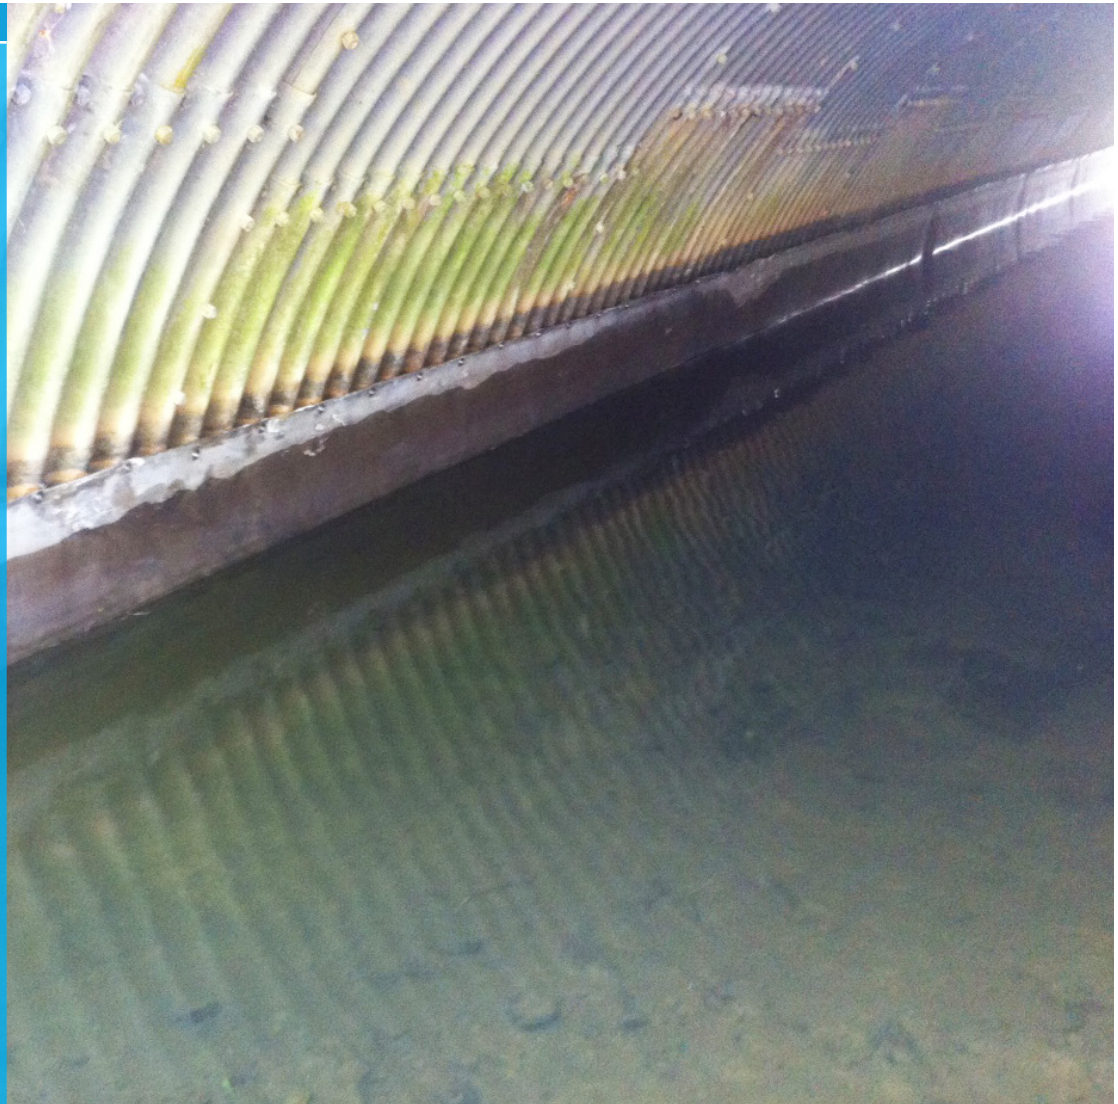
The completed project

In total, 80m² of CC8™ were installed by 3 people in just 6 hours (with 8 hours of site preparation) despite the client having allowed for 2 days. Furthermore, CC's low alkalinity and low wash out rate meant the works did not negatively impact the local ecology.

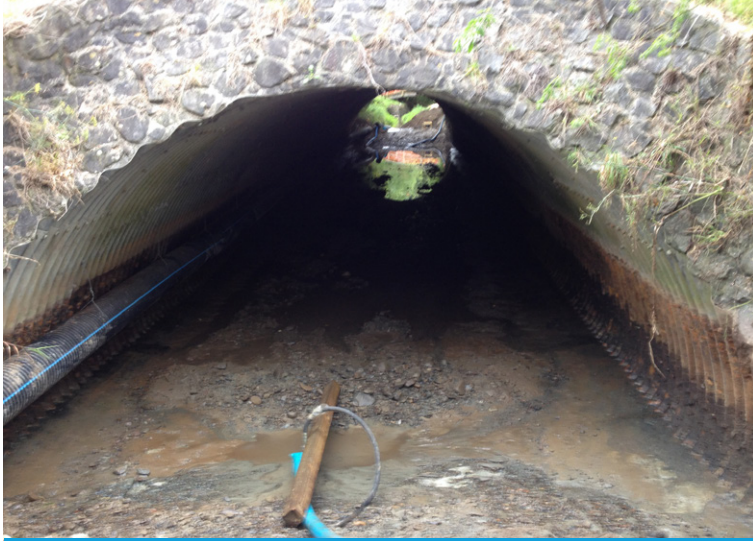
The culvert before work began

CC was selected due to the culvert being difficult to access, the installation speed and the cost effectiveness of CC. Sprayed concrete was considered, but the damp and cold conditions combined with the bed being lined with sediment would have made it exceptionally difficult to use this method. The works were carried out by Rasmax for Porirua City Council.

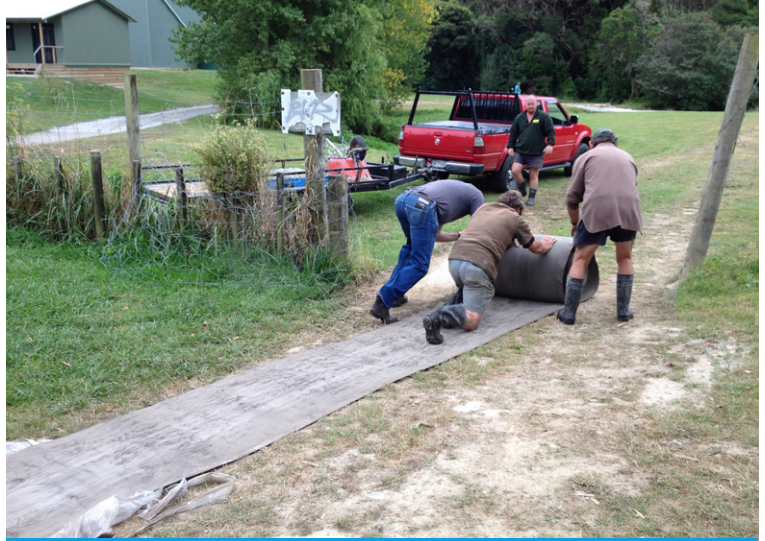
Unrolling the CC8™ to cut it to length

To prepare the site, the drain was cleared and the area dammed with the flow diverted. A bespoke length was cut from a bulk roll of CC8™ and delivered to site. This was then unrolled on the flat and cut to length, before being carried into the culvert. The CC was fixed to the existing corrugated metal using 32mm hex self drilling screws at 200mm centres. Where joints were needed, overlaps of 100mm were created and mechanically jointed with more hex screws. For hydration, the CC was submerged in water once work was completed.

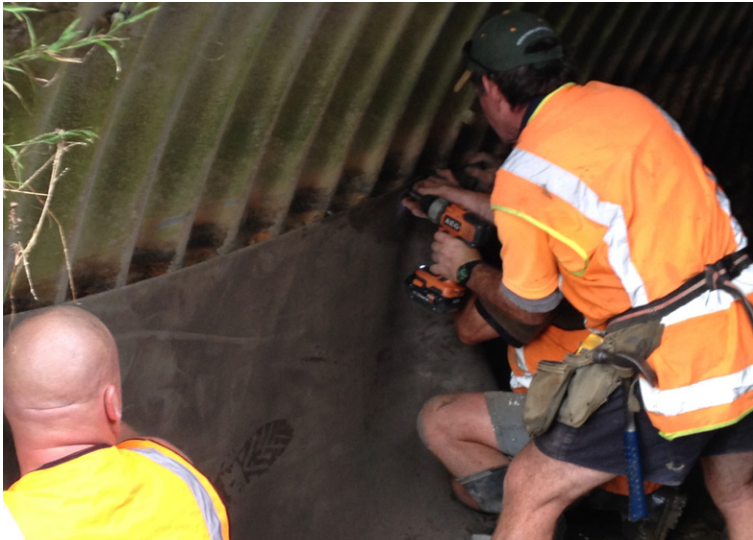
Fixing

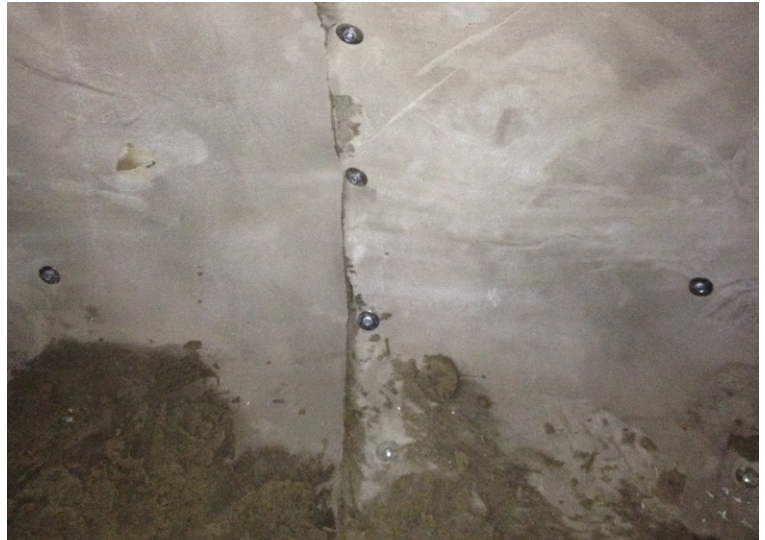
32mm hex screws

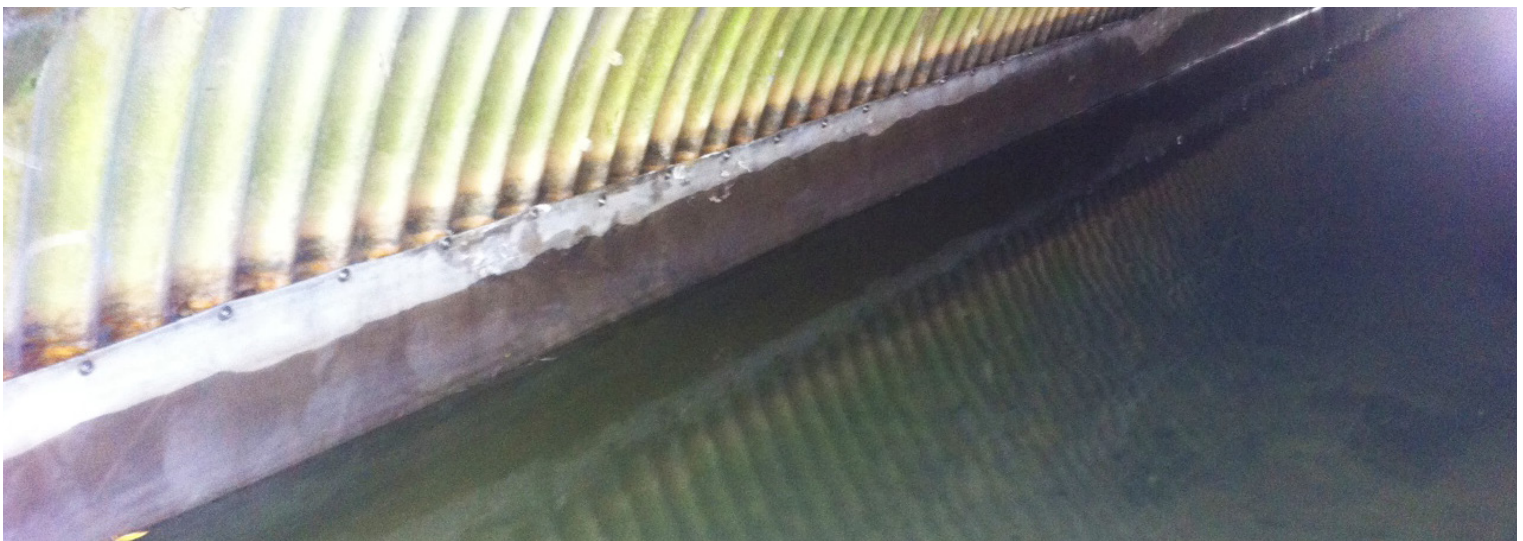
The finished project
