CC5™ Bulk Rolls

Scottish Borders,
Scotland, UK

CC5™ used to
remediate a dilapidated
ARMCO culvert.

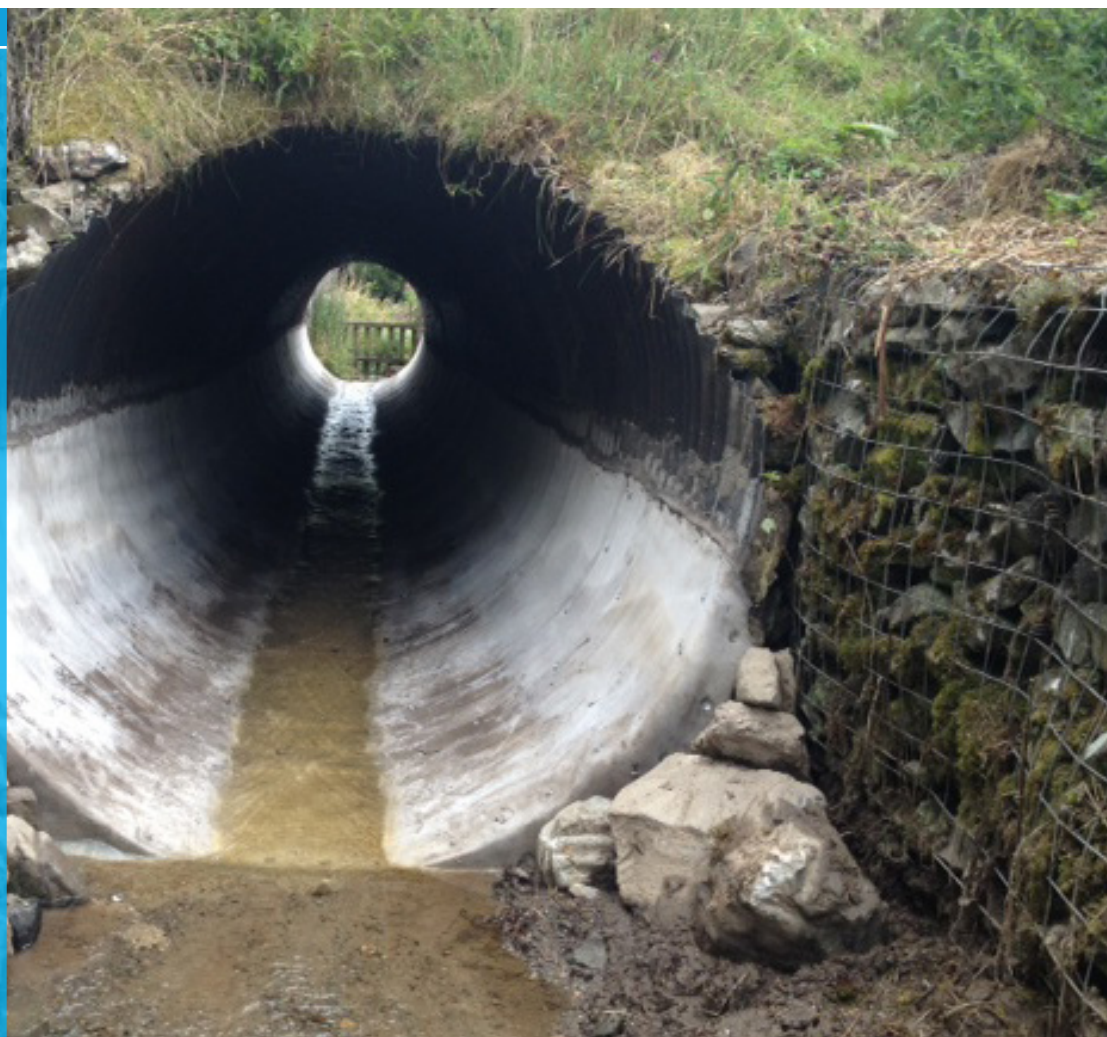
Completed installation

The installation was completed in a total of a week and a half, including preparation. Castle Group Scotland were impressed with the ease and speed with which CC was installed, as well as its minimal environmental impact and increased lifespan compared to bitumen. CC also provided a cost saving compared to using GRP.

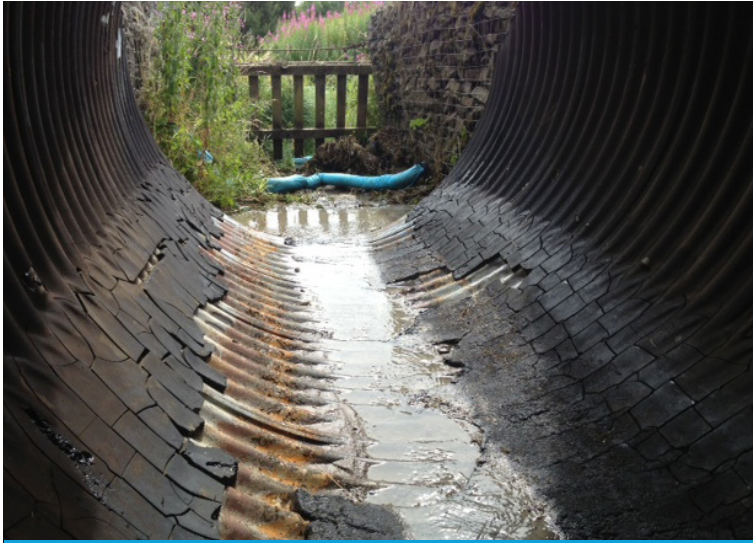
In August 2013, Concrete Canvas® GCCM (CC) was used to reline an ARMCO steel corrugated pipe which formed part of a culvert in the Scottish borders. The existing 1-2mm bitumen coating inside the pipe had broken down through flow erosion and weathering, resulting in an increase in silt, debris and vegetation growth within the culvert which had started to compromise it and cause the ARMCO to degrade. Installing a new culvert was cost prohibitive and would involve temporary lane closures of the nearby A7 trunk road. Re-spraying culverts with bitumen is now generally prohibited by the Scottish Environment Protection Agency (SEPA) due to the potential for environmental damage, and any remediation solution would need SEPA approval. Glass Reinforced Plastic (GRP) was also considered, but this would have to be specially made to fit the culvert, leading to increased cost and lead time. CC was chosen due to its speed of installation, ability to easily accommodate changes in culvert profile and minimal environmental impact, having been authorised for use in live water courses by the UK Environment Agency on previous projects.

Flow erosion had caused the existing bitumen lining to break down

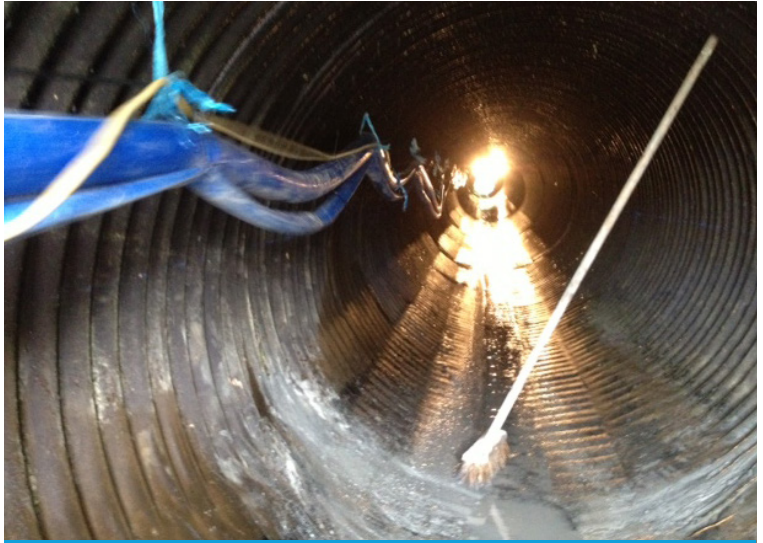
The culvert was pressure washed to remove the degraded bitumen

Prior to installation, the culvert was cleared of any silt and other debris and the bitumen lining removed using a pressure washer. A semi-dry grout mix was then applied to the lower half of the pipe to fill in the corrugations before bulk rolls of CC5™ were delivered and cut to length on site, minimising wastage. The CC was then laid transversely, with layers overlapping by 100mm in the direction of water flow and fixed to the pipe at 200mm centres using stainless steel tech screws before being hydrated.

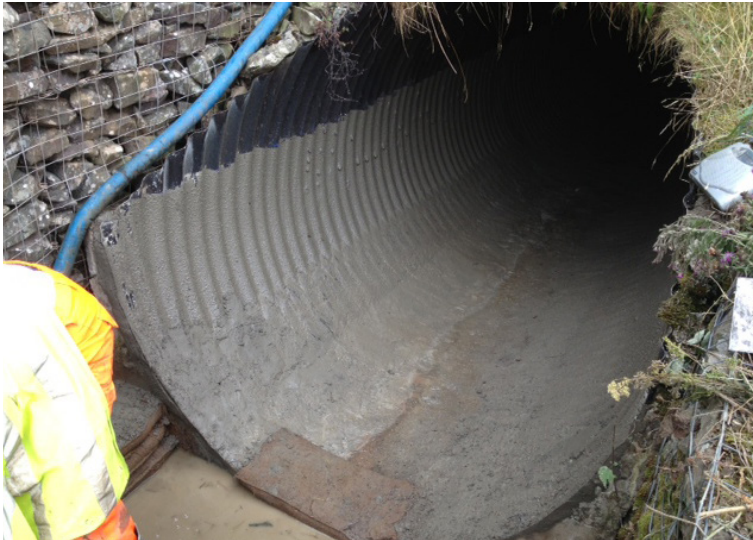
Semi-dry grout was applied to fill in the corrugations

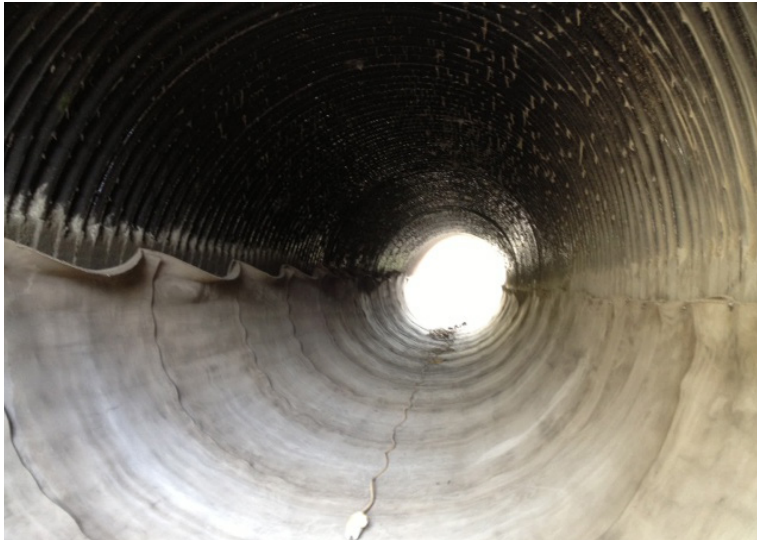
CC5 was applied in transverse layers inside the culvert

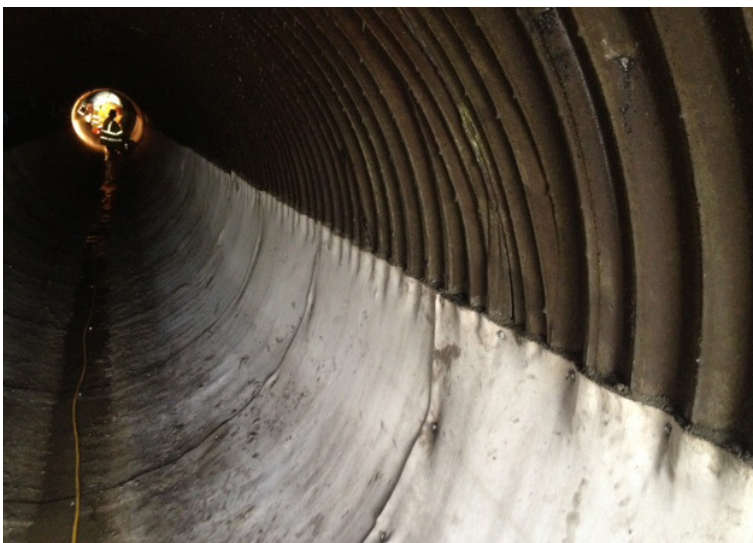
Stainless tech screws were used to fix the CC8 to the pipe

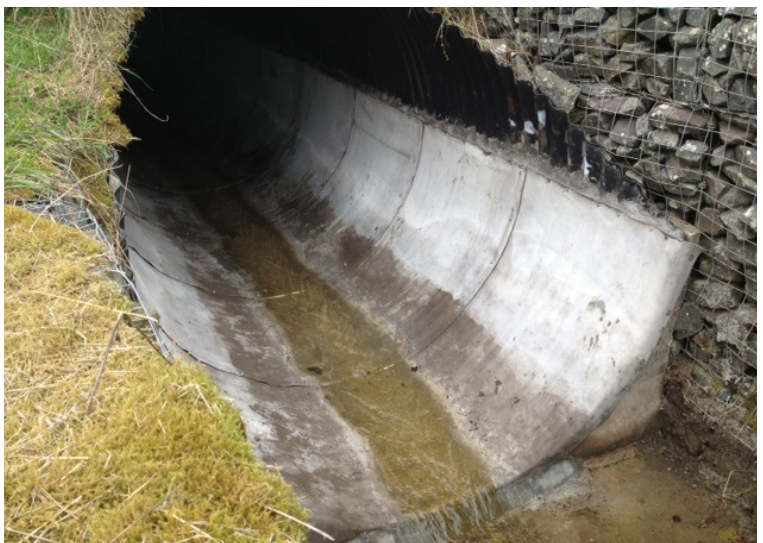
Relined culvert section
