CC5™ Batched Rolls

N4 Watervalboven,
Mpumalanga

CC5™ was used to
line a 48m long culvert
located along the N4 toll
road in Watervalboven,

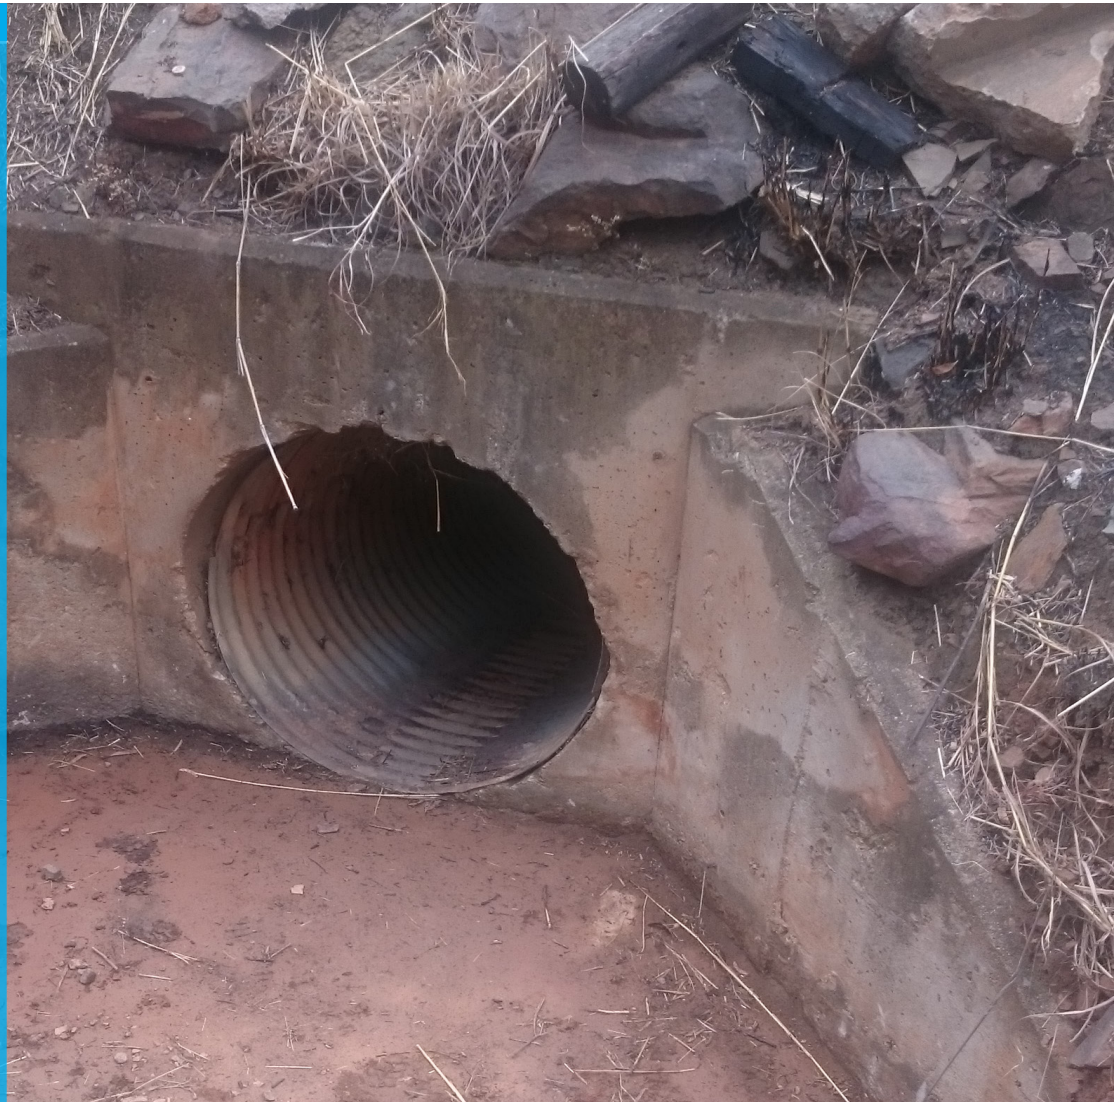
The culvert prior to installation

In September 2016, Concrete Canvas® GCCM* (CC) was used to remediate a culvert along the N4 toll route in Watervalboven, Mpumalanga, South Africa. The culvert had previously been lined with corrugated steel, however abrasion had damaged the galvanised layer of the material, which had lead to the rapid deterioration of the steel itself, particularly where water was trapped in the corrugations.

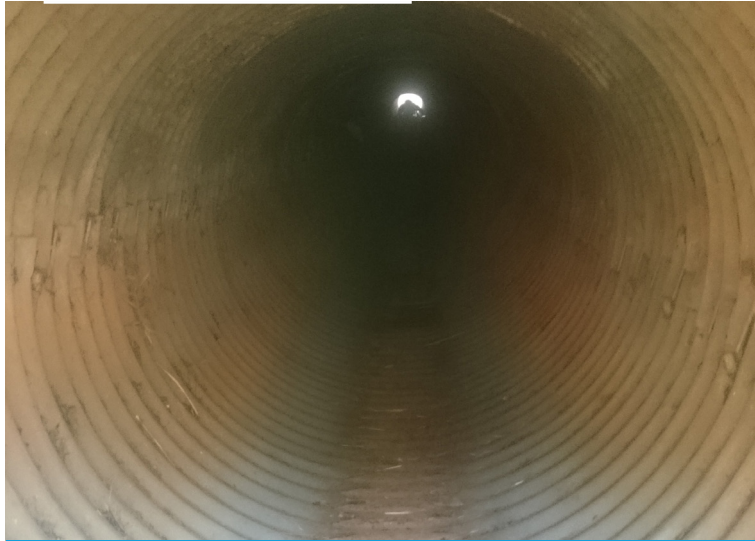
Existing corrugated steel culvert

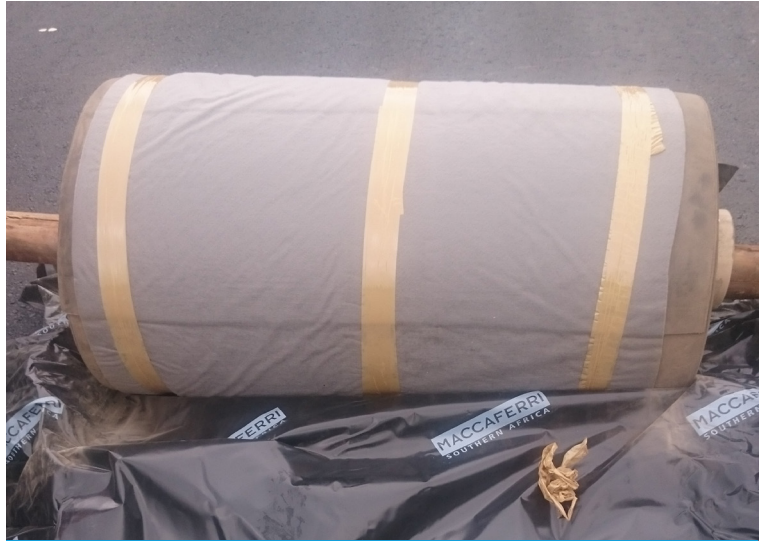
Bulk roll

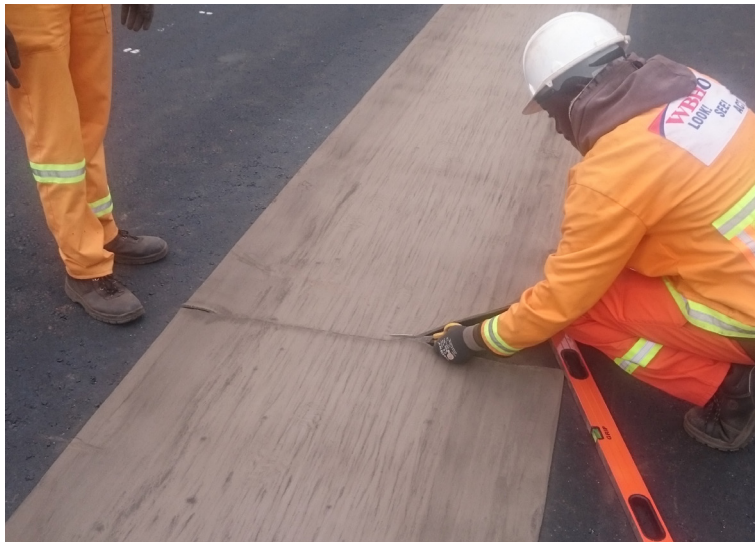
CC5™ was cut to 8m lengths for easy transportation on site

The culvert was cleaned of all debris and standing water, before the team began to chip away the head wall at the inlet end in order to create an exposed edge to fix the CC to. The CC5™ was then cut to manageable lengths of 8m and carried down the slopes by the team to the inlet end. It was drawn through the culvert by hand, placed in position and pop-riveted to the existing steel culvert. Finally, the 8m cut sections were overlapped by 100mm and pop-riveted at the joints for additional security, the CC was then hydrated by hose pipe.

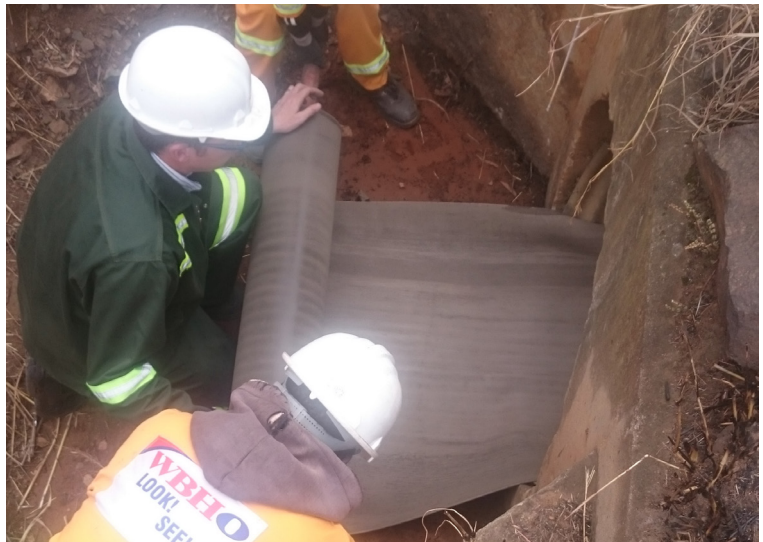
Laying CC5™ lengths in culvert

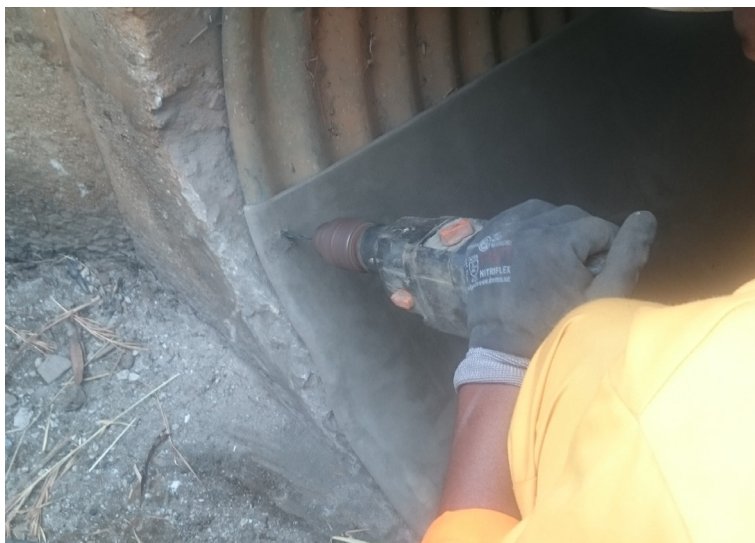
Fixing with pop rivets

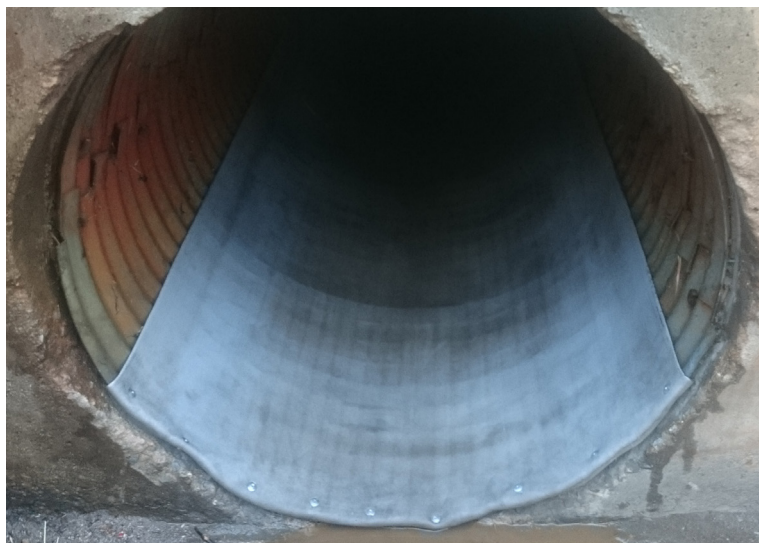
Completed installation

50m² of CC5™ were installed in ten days, despite cramped conditions in the culvert, restricted access to the site and the challenge of the team needing to transport the material by hand in 8m sections.

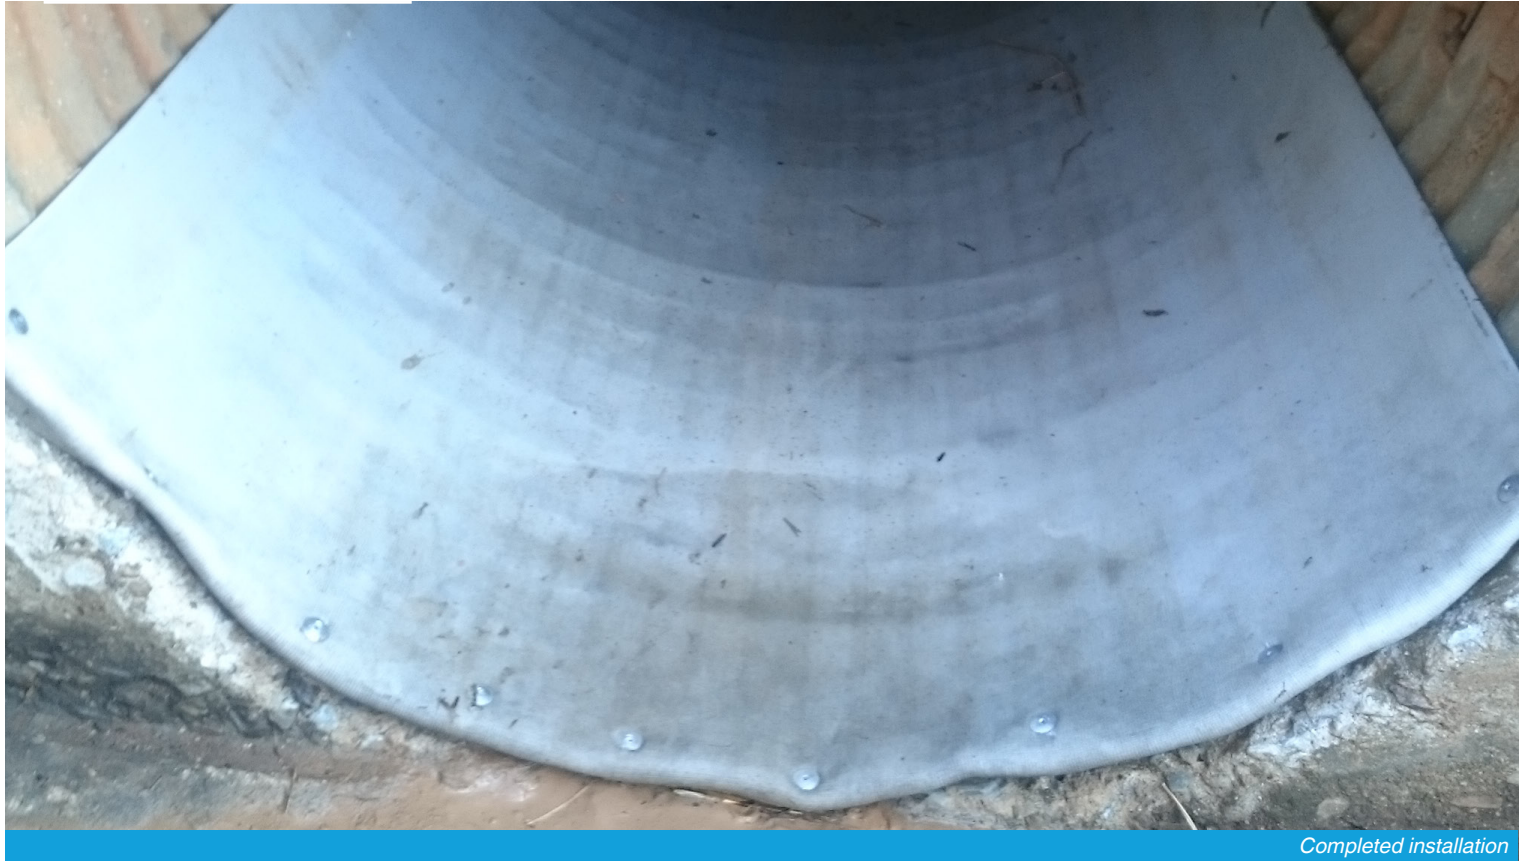
*Completed installation*
