Project Info

CC8™ Bulk Rolls

Otanche, Boyacá, Colombia

CC8™ was used to prevent rainwater runoff causing undermining of a nearby road.

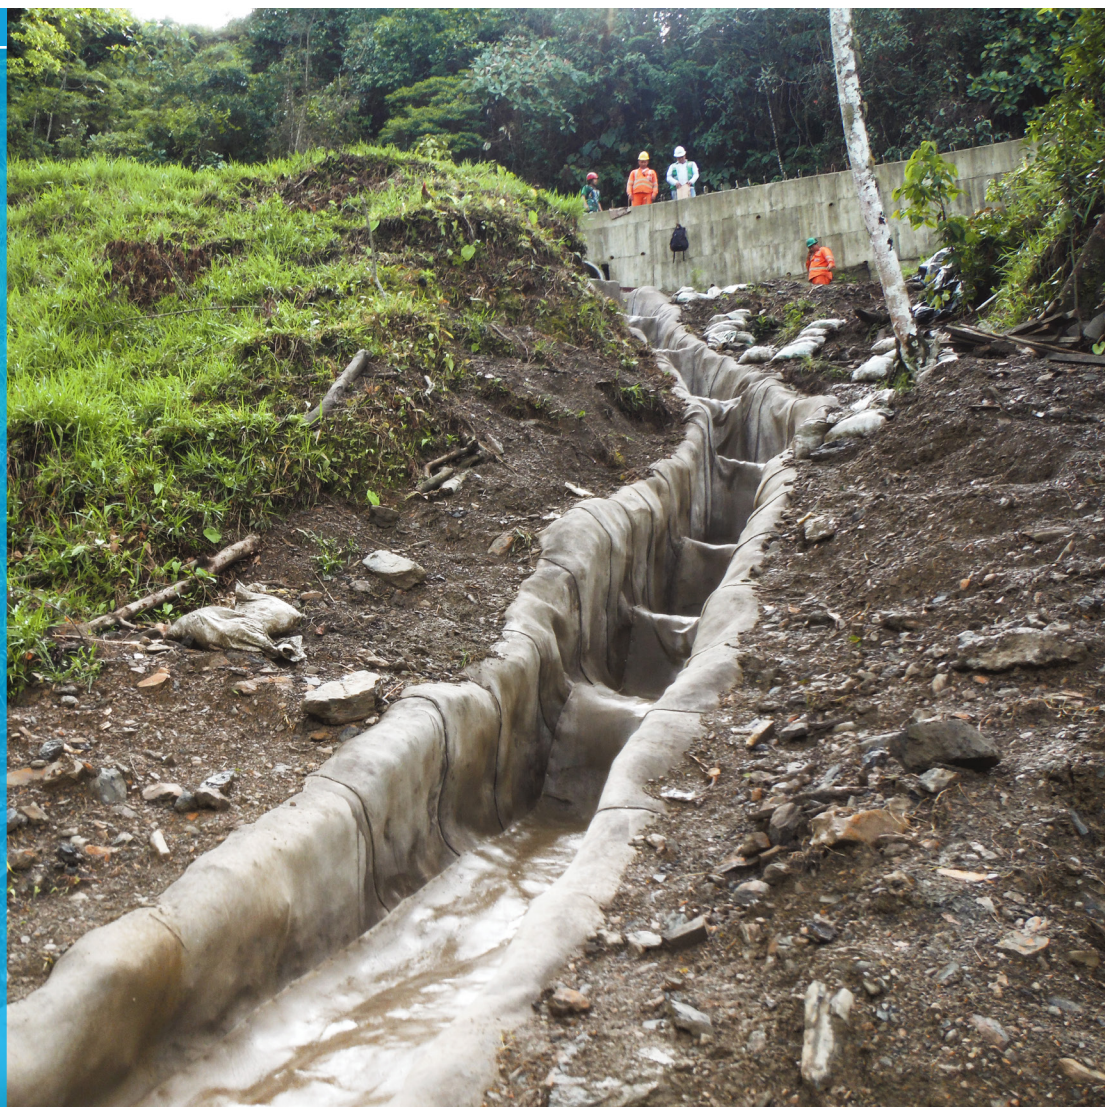
Completed installation

In December 2014, Concrete Canvas® GCCM* (CC) was used to line a dissipater ditch to prevent undermining of the nearby road. Pre-mixed concrete had been used on other parts of the project, however this was taking a long time to install; pre-mixed concrete needed exact ground preparation and the re-bar and formwork would have been logistically complex due to the steepness of the slope and tight turns. Installation was carried out by CONPROS for the National Roads Institute of Colombia (INVIAS).

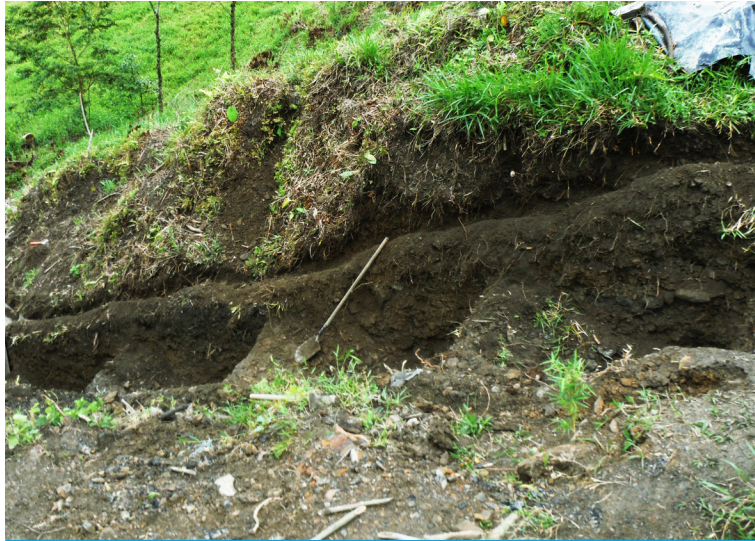
Ditch was excavated and steps introduced

The ditch was excavated and vegetation and loose rocks removed. The ditch was then graded to create steps that would reduce water velocity. Bulk rolls of CC8™ were delivered and batched to specific profile length on site, then unrolled into the ditch by hand. The sides of the ditch were lined transversely in the direction of water flow with an overlap of 100mm between layers. The edges of CC layers were placed in an anchor trench at each shoulder and fixed to the substrate using 500mm ground pegs at 1m intervals. Material beneath overlaps was hydrated, then overlaps were jointed using screws at 200mm centres. Two longitudinal layers were laid consecutively along the base of the ditch, hydrated and sealed with mortar and FT 101 sealant. The full installation was then hydrated using a hose and 800 gallon drum.

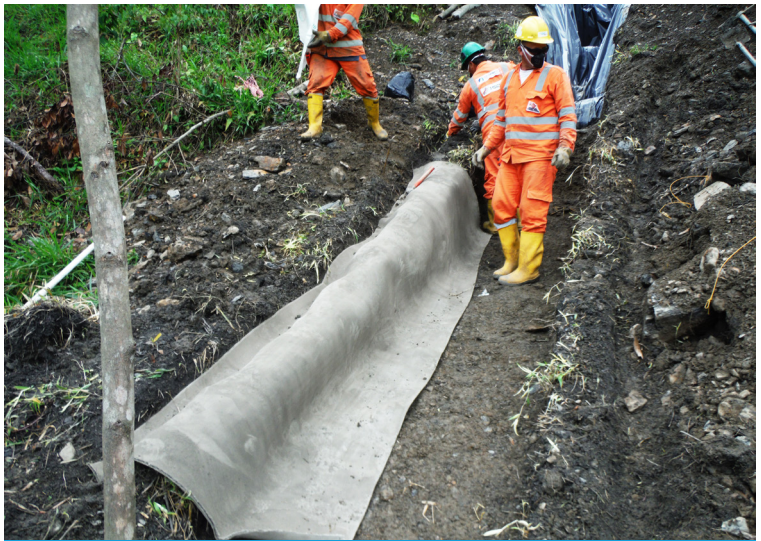
CC laid over the sides of ditch and into an anchor trench

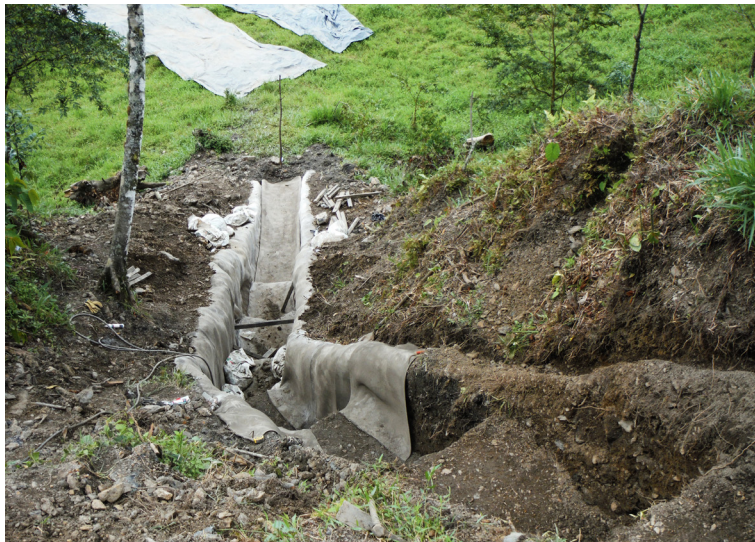
Sides were lined first, then CC applied to ditch base

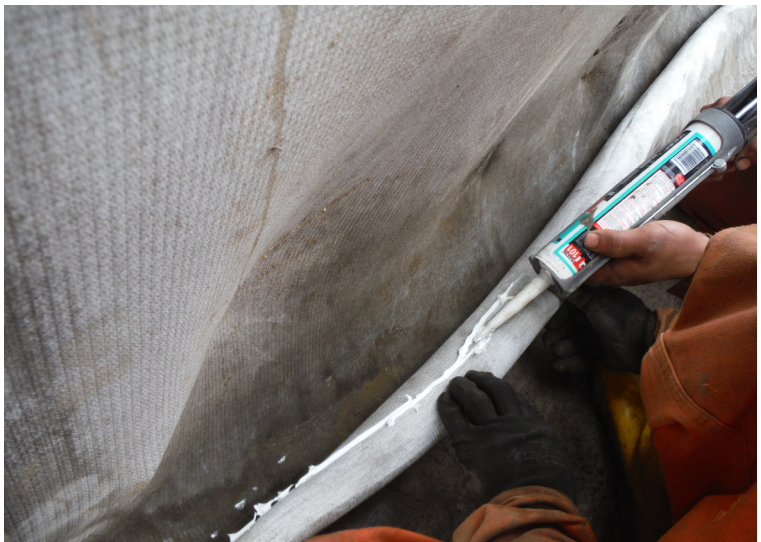
Sealing overlaps using FT 101 sealant

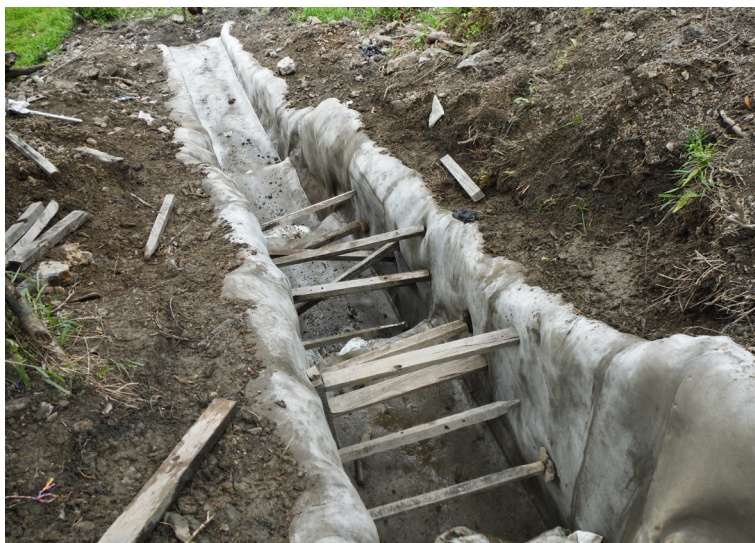
After hydration, planks were used to prevent voids behind the CC

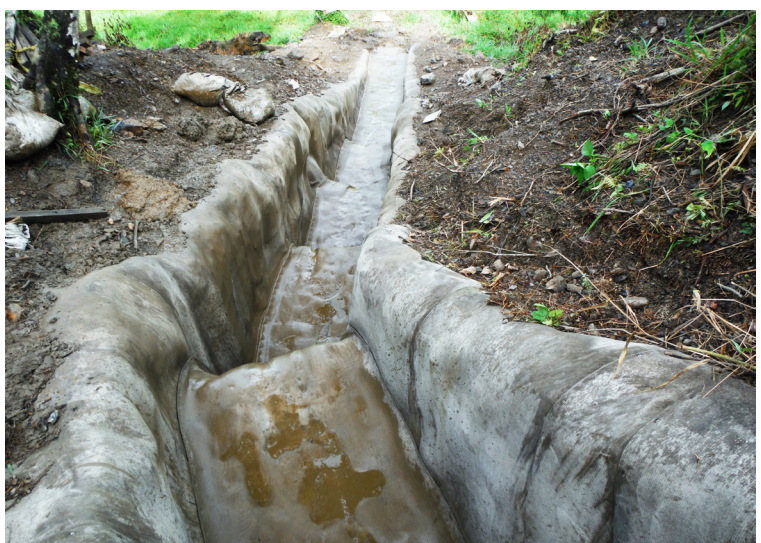
Finished project
