CC8™ Bulk Rolls

Minera Los Pelambres

CC was used to line a tailings ditch, directing flow to specific areas of a dam to ensure a uniform, safe and correct deposit of sediment

Completed channel lining installation in Chile

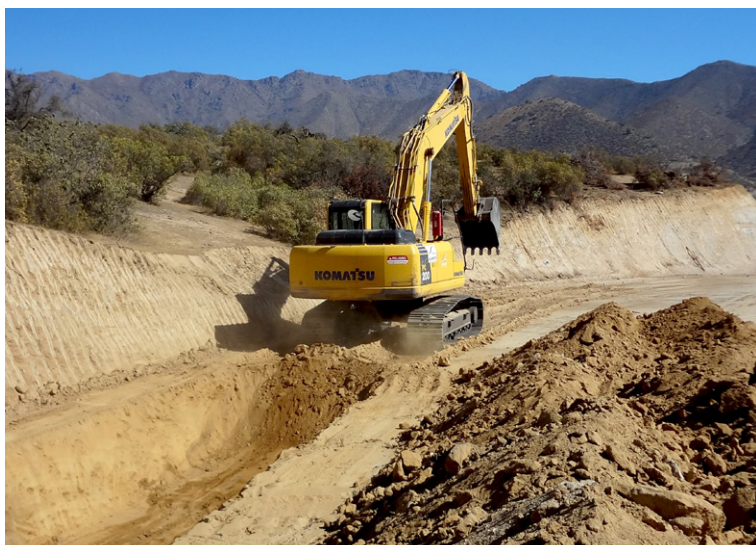
Ditch excavation

Prior to installation, the ditch was excavated and the ground cleared of any rocks or other debris. Bulk rolls of CC8 were delivered to site and cut to length, eliminating material waste. Each length was laid transversely across the ditch using a truck-mounted spreader beam, then fixed in place at each crest with steel ground pegs. Adjacent layers of CC were overlapped by 100mm and screwed together at 250mm intervals using steel screws. The material was then hydrated using a hose and water truck.

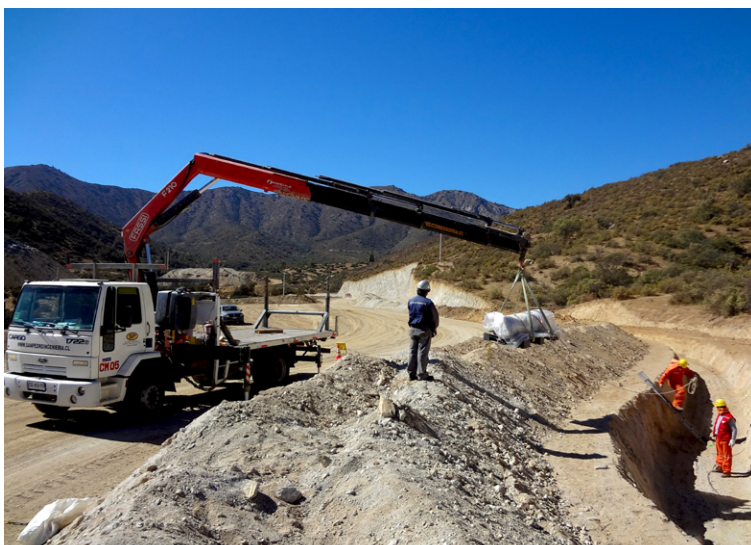
CC8 bulk rolls were cut to length on site, minimising material waste

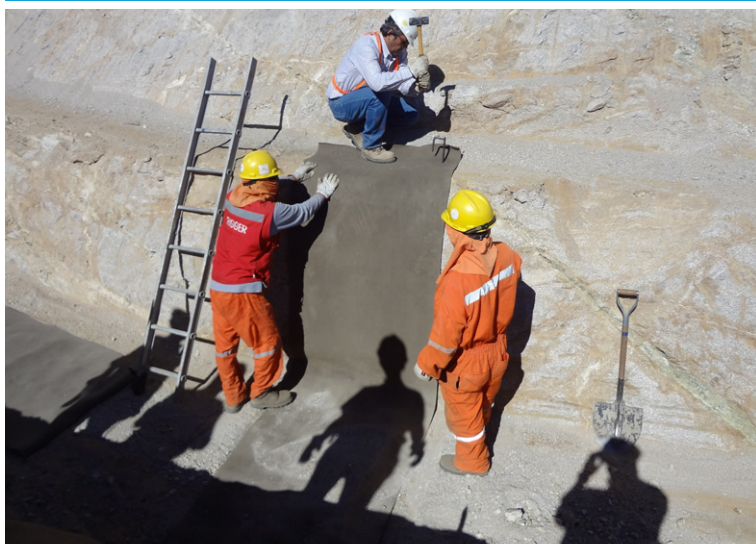
A length of CC being fixed to the crest of the ditch using steel ground pegs

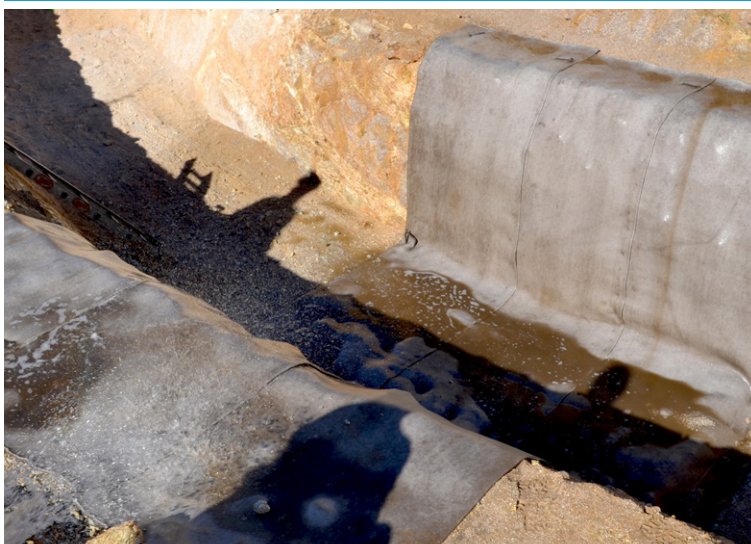
CC hydrated using on-site equipment

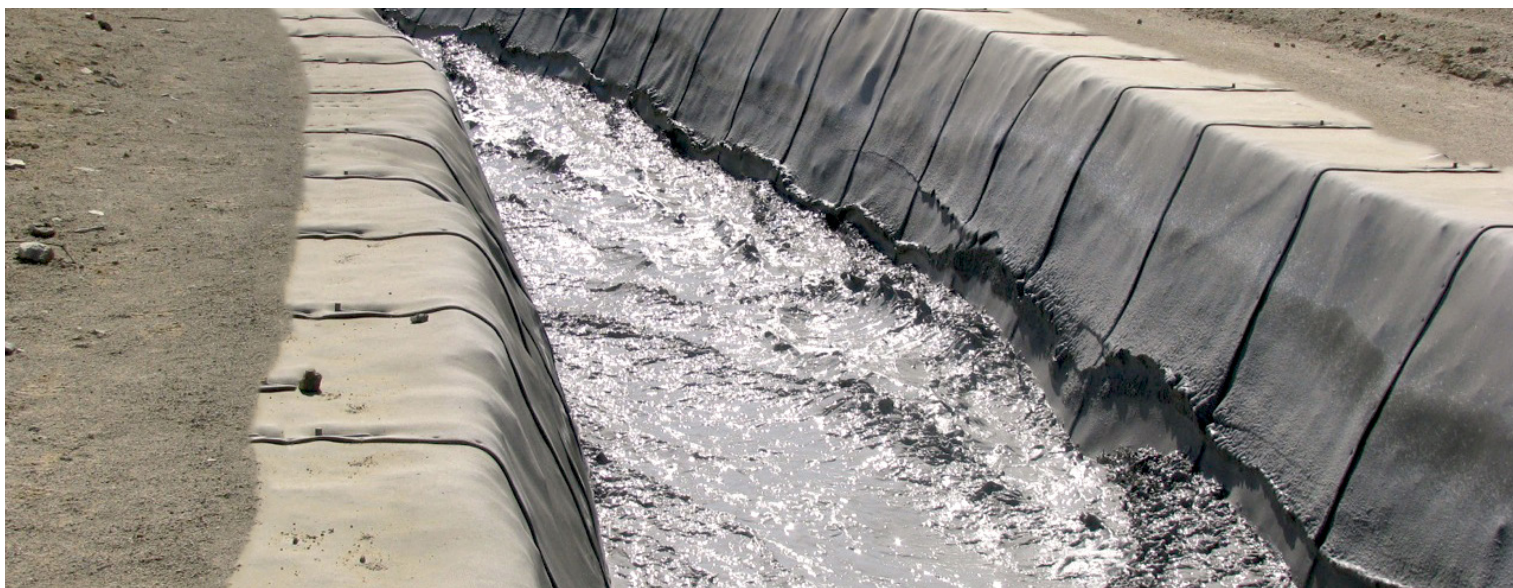
Completed installation showing sedimentation build up along ditch sides

The installation was a success, with the client stating they were likely to use the material in future projects. CC provided savings in both cost and time; a 9-man team was able to complete the 1000sqm installation in a day, in temperatures of up to 35°C. The CC lining the ditch was inspected after 7 months and showed no signs of abrasion damage, despite average flow rates of around 2.5m/s.
