Transverse and Longitudinal layers

TRI/Environmental – Erosion Testing Lab; Clemson, SC USA

i TRI Environmental, Inc. ran hydraulic testing for Milliken & Company to quantify the hydraulic flow capacity of the Concrete Canvas® GCCM, and answer the question “How much water can flow over CC8™ before it is dislodged, lifted up and/or washed away?”

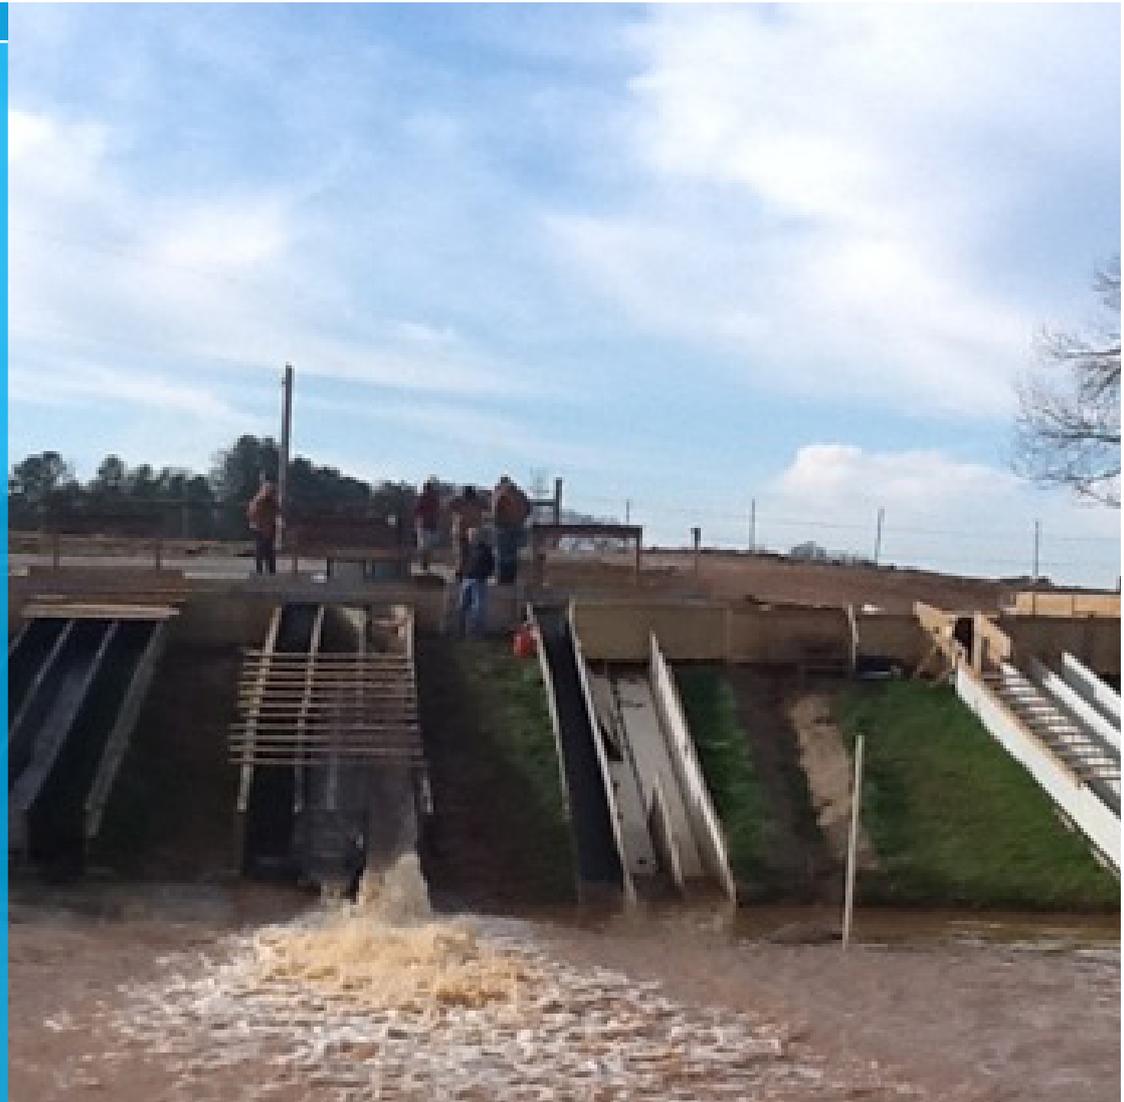
Flume test in progress

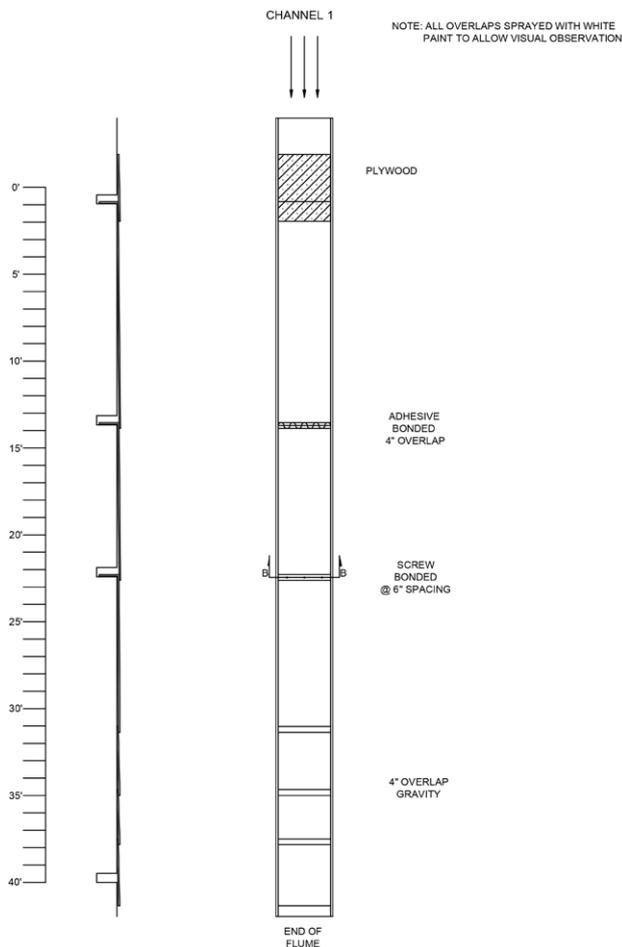
CC-TRI FLUME TESTING PLAN VIEW & SECTION
CHANNEL 1

The goal of the test was to understand the characteristics of CC when subjected to water flow under installation conditions that approximated a real-world installation of the product. To achieve this goal, it was decided to set up two channels, one with lap joints shingled transverse or perpendicular to the direction of flow and one with lap joints longitudinal to the direction of flow.

This variety of lap joints was constructed in order to assess capability of different overlapping techniques. An anchor trench was used to restrain the first two layers in the first channel with the lap joints shingled transverse or perpendicular to the direction of flow.

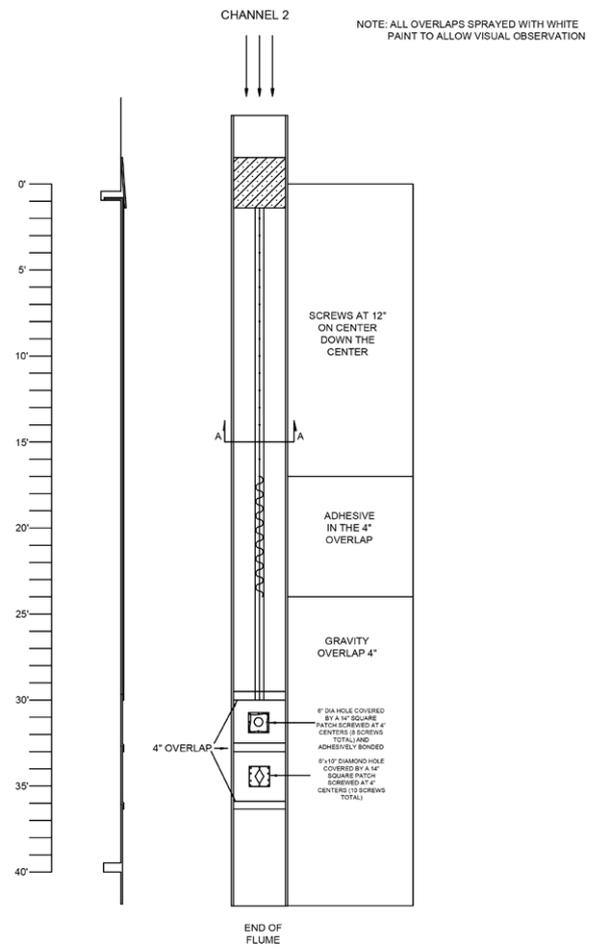
CC-TRI FLUME TESTING PLAN VIEW & SECTION
CHANNEL 2

In addition, to test the potential to use CC for repair applications, two patches that projected up into the water flow were installed at the end of the second channel. Both patches were connected to the underlying material with screws, and one also included an adhesive bead to provide additional sealing capacity.

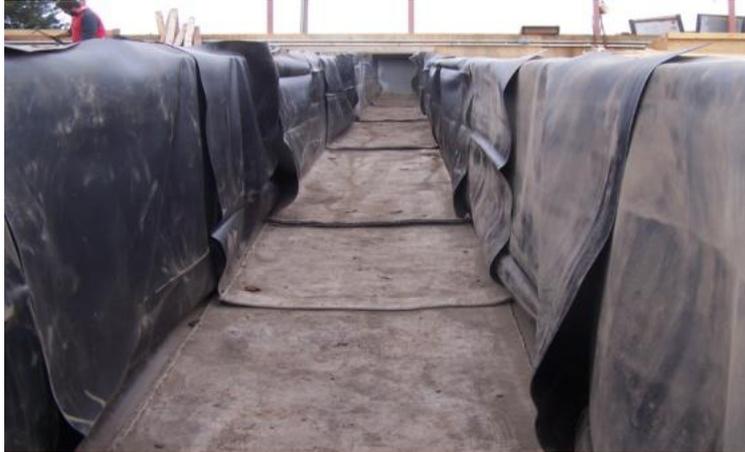
CC during installation

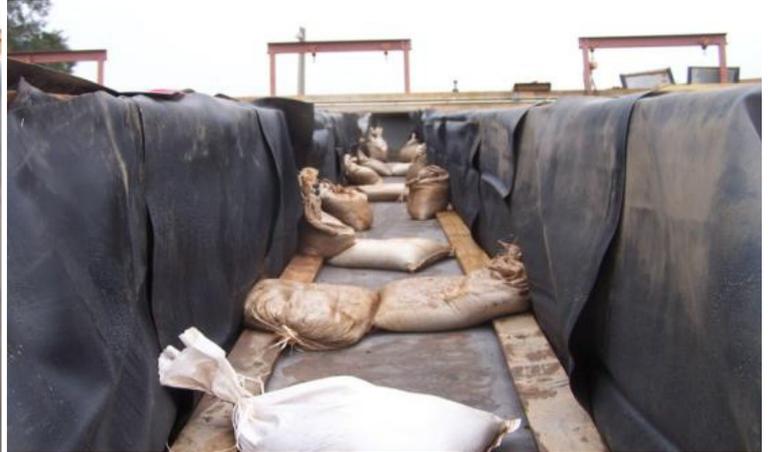
Weighting edges during initial 24-hour cure

The product was hydrated according to recommended procedures, and sandbags were placed on top of the joint overlaps to hold the CC layers together during setting. The sandbags were removed once the product was set and before testing commenced. The CC was allowed to cure to full strength (~10 days) prior to performing the flow test.

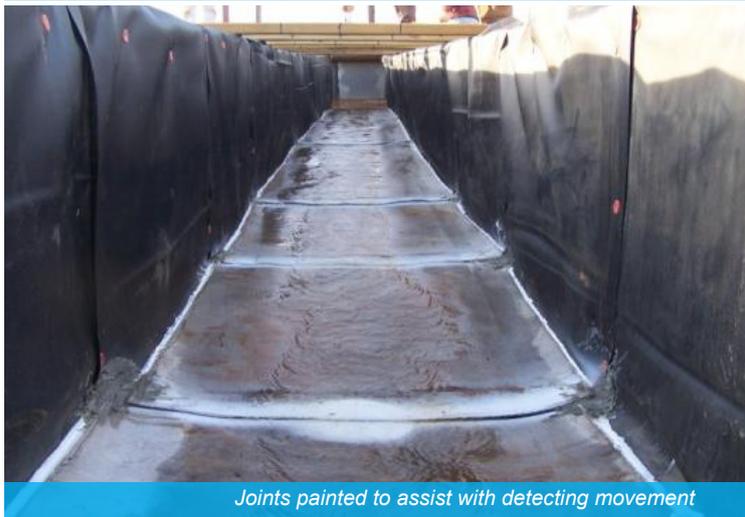
Joints painted to assist with detecting movement

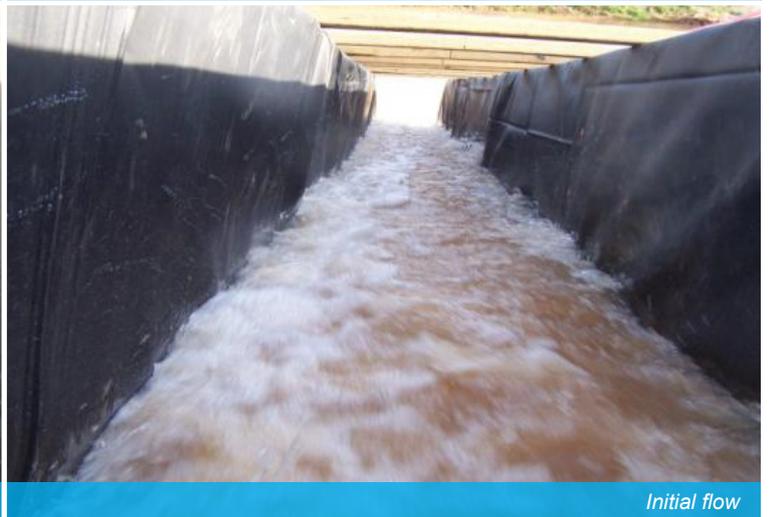
Initial flow

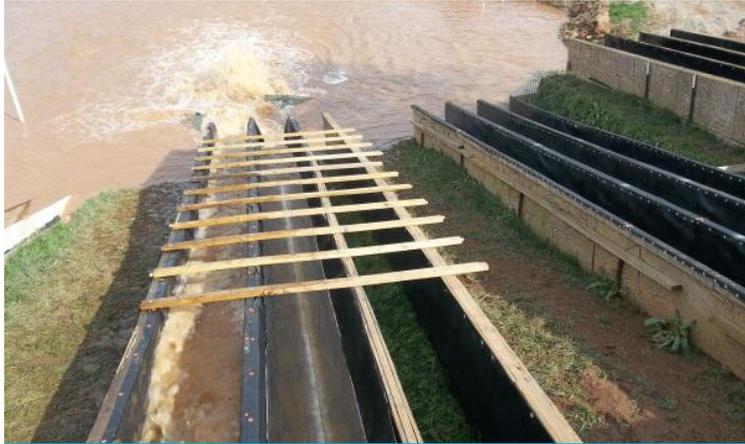
Maximum water flow over Channel 1

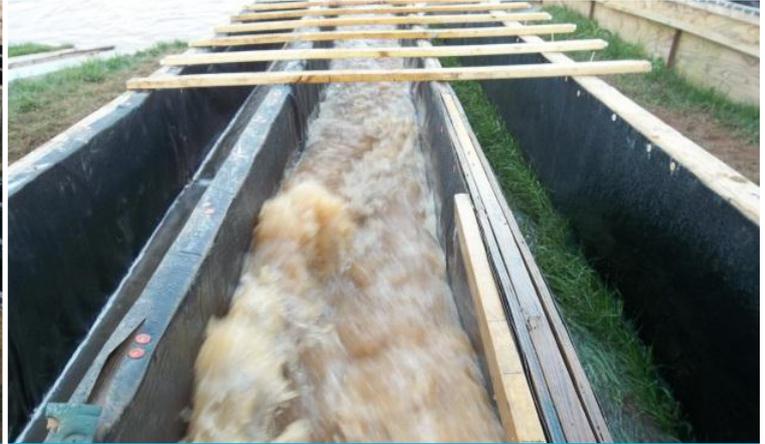
Maximum water flow over Channel 2

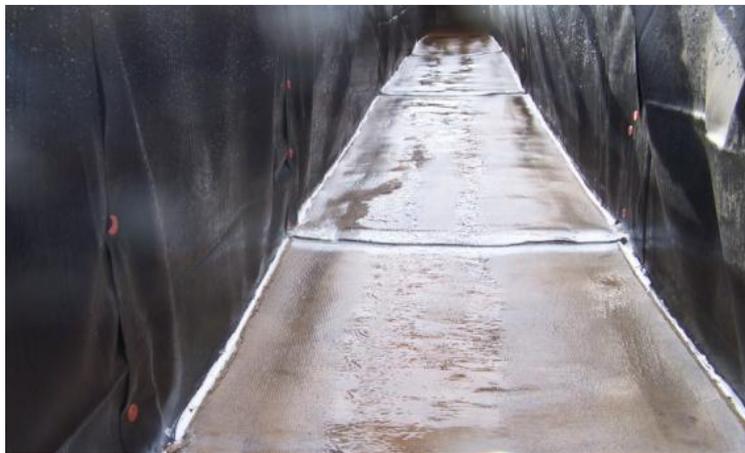
No separation at joints detected

No failure of any seam, and no movement was detected for any of the CC panels during the course of the test. In addition, no subgrade erosion was observed as a result of the test.

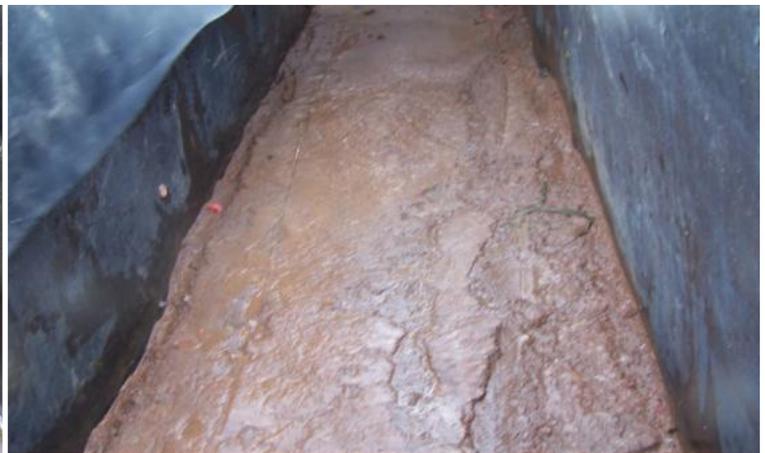
Only subgrade changes seemed related to wall seepage
