CC8™ Batched Rolls

CC8™ was specified as a rapid solution for a repair an eroding inlet to an existing drainage pit.

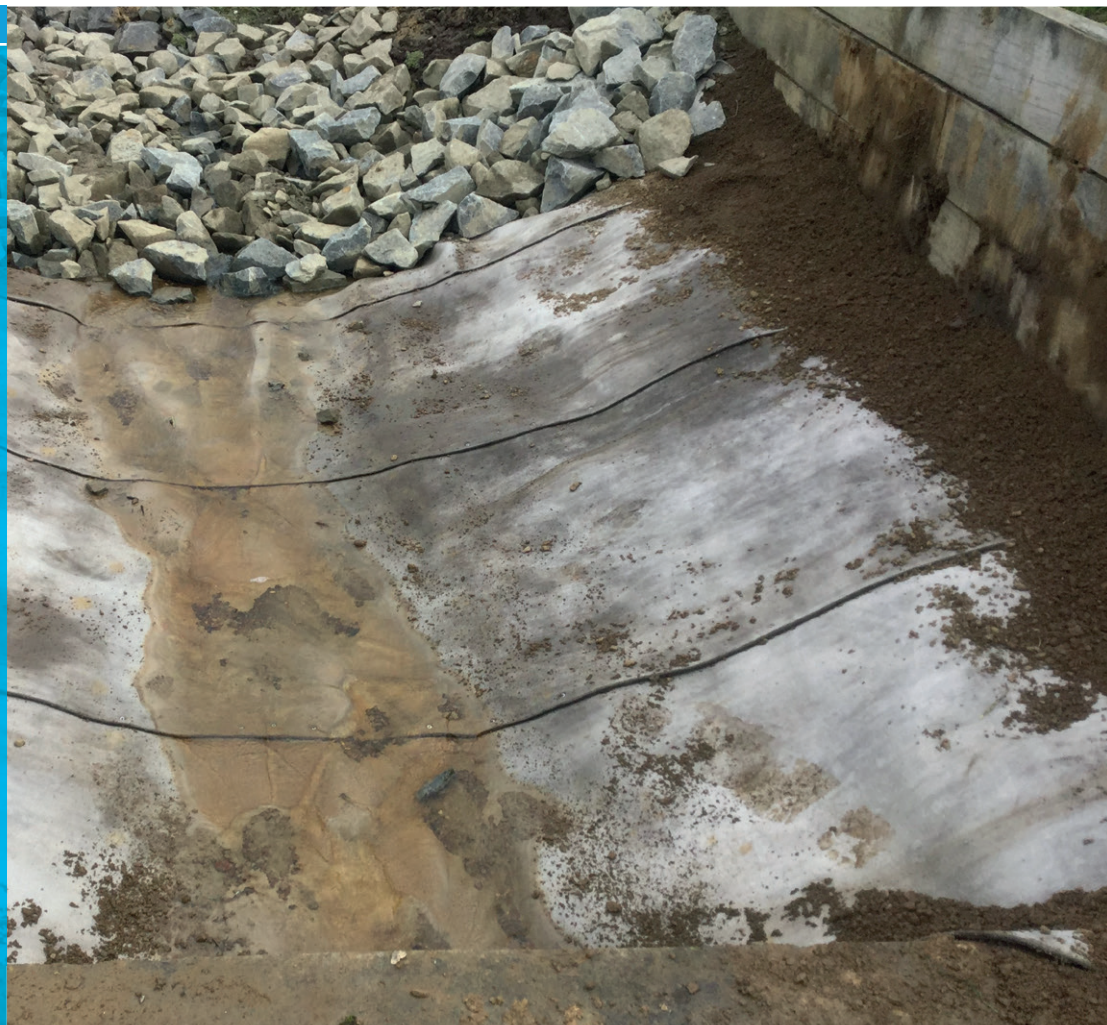
Completed installation

Works began with profiling of the channel, before delivery of the CC batched rolls to the site. The CC was transported and positioned by hand, with the material laid transversely to the channel, with subsequent layers overlapped by 100mm in the direction of water flow. Anchor trenches were created on either side of the inlet, and the CC pinned using 380mm anchor pegs. Overlaps of CC were fixed using stainless steel screws and an adhesive sealant approved by Concrete Canvas Ltd. Once installation was completed, the material was hydrated and the anchor trenches backfilled.

A total of 20m² of CC8™ was installed in half a day by a small crew. Following the success of the project, the local council is looking to continue its use of CC on a longer section of the same drain.
