CC5™ Bulk Rolls

Bella Vista, Norte,
Paraguay

CC5™ was used to
line the slopes of two
lagoons for use as
decanting tanks.

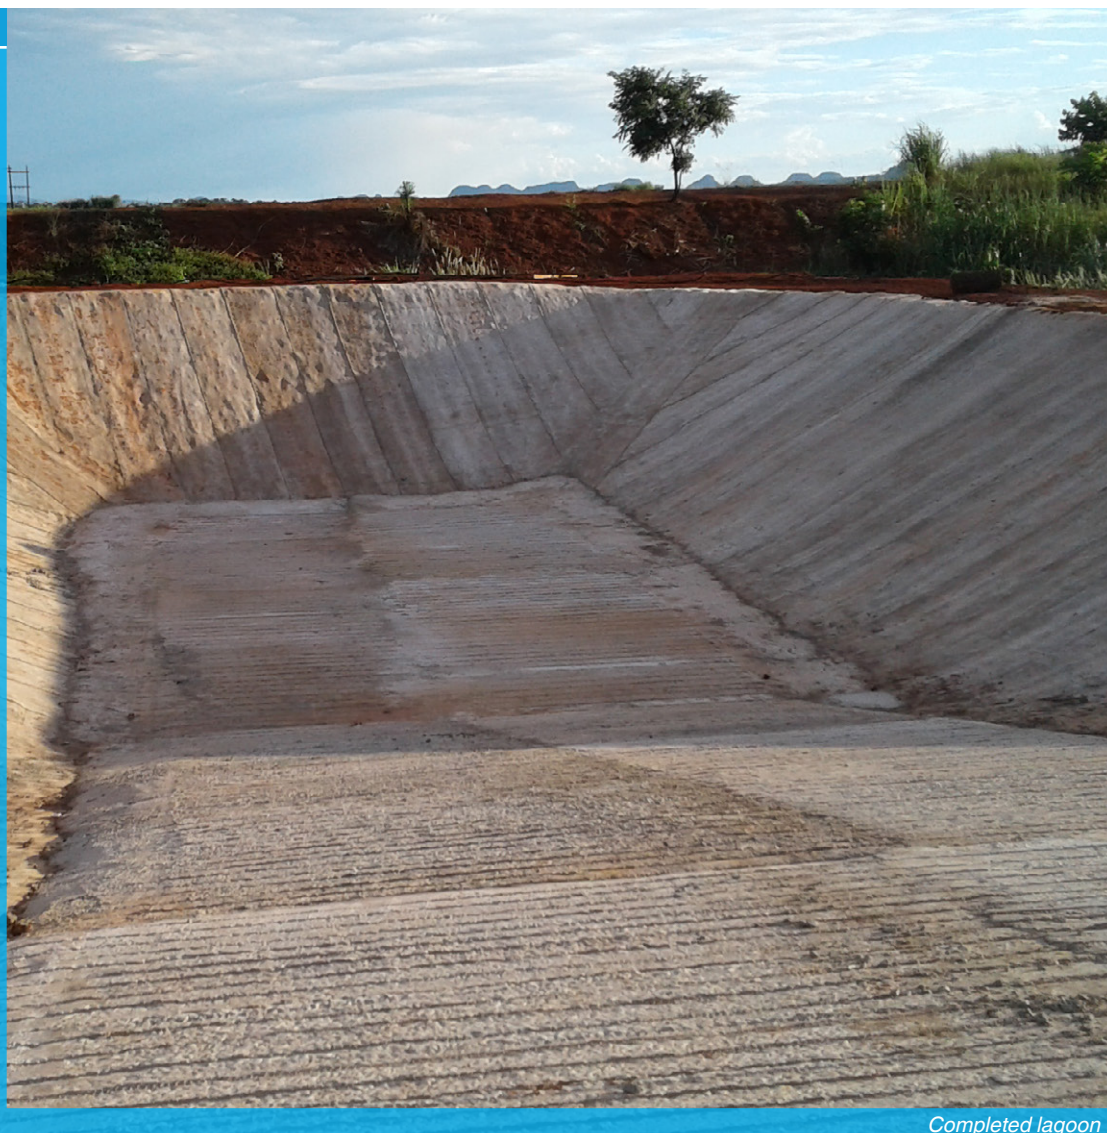
Completed lagoon

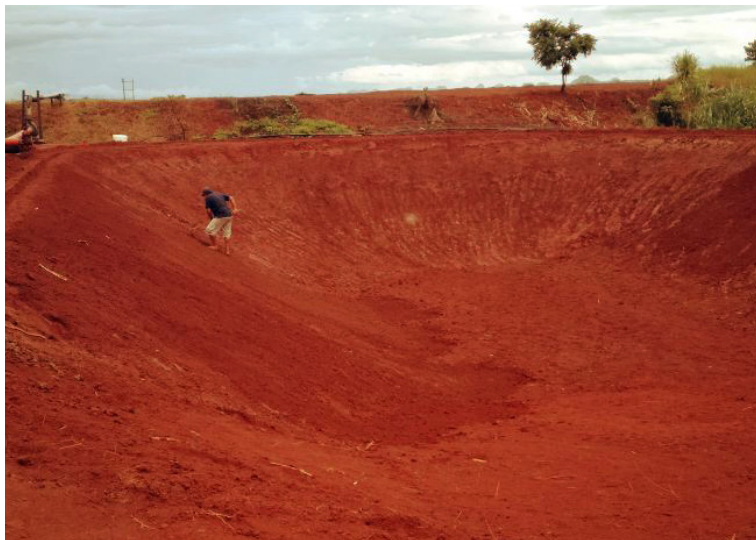
Prior to installation, both lagoons were re-profiled then graded manually

Prior to the installation, each lagoon was re-profiled using a backhoe, with some manual ground preparation to create a flat surface on which to lay the material. Bulk rolls of CC5™ were delivered on a truck and transported to the lagoons using a digger.

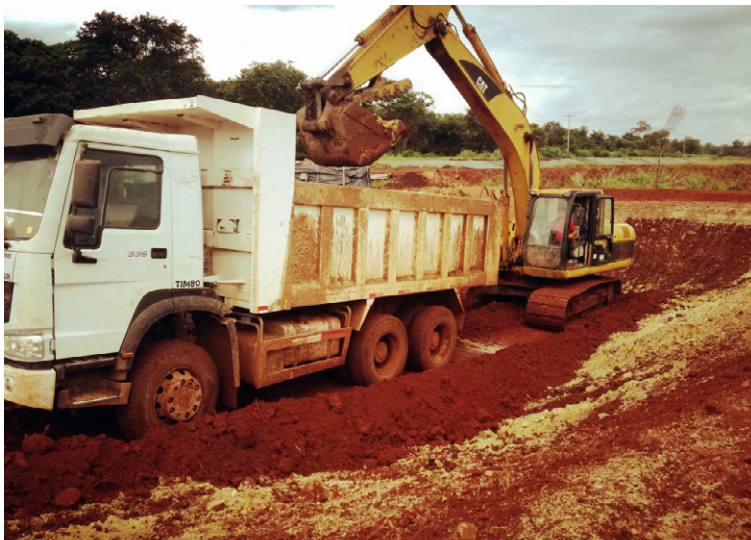
CC was delivered to site on a truck and transported using a digger

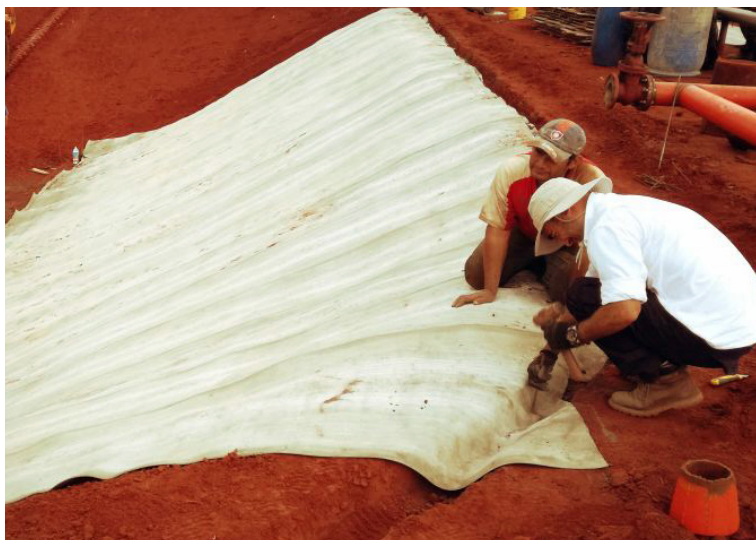
CC was deployed down each slope and pegged in an anchor trench at the crest

The material was cut to required lengths and, starting in the middle of a longer slope, was deployed from the crest of the slope, with each additional length overlapping the last by 100mm. The leading edge of the material was pinned into pre-dug anchor trenches at the crest using 350mm ground pegs at every 500mm at the centre and through overlaps.

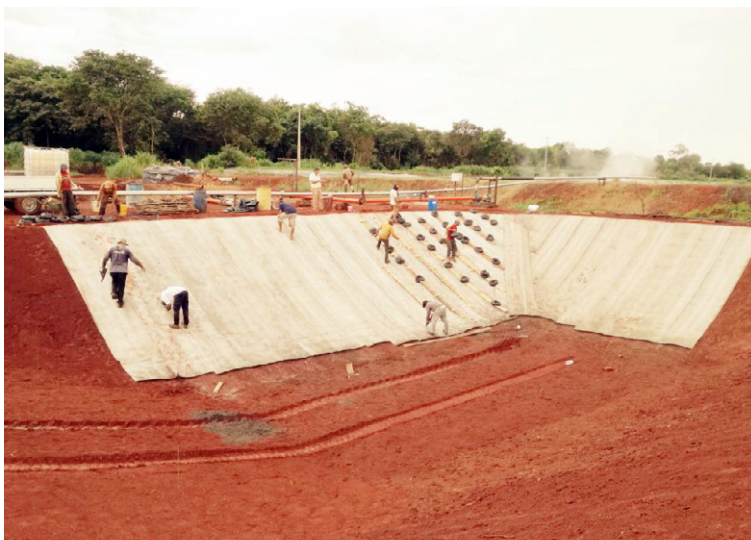
Installation started in middle of long slope, working clockwise

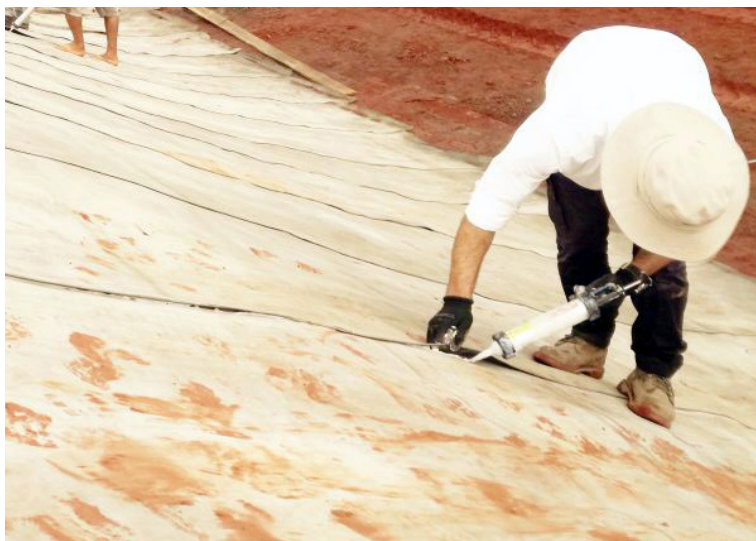
Overlaps were sealed using polyurethane sealant 3M 540

Once the CC had been laid on one side, the overlaps were sealed using a polyurethane sealant to protect against ingress

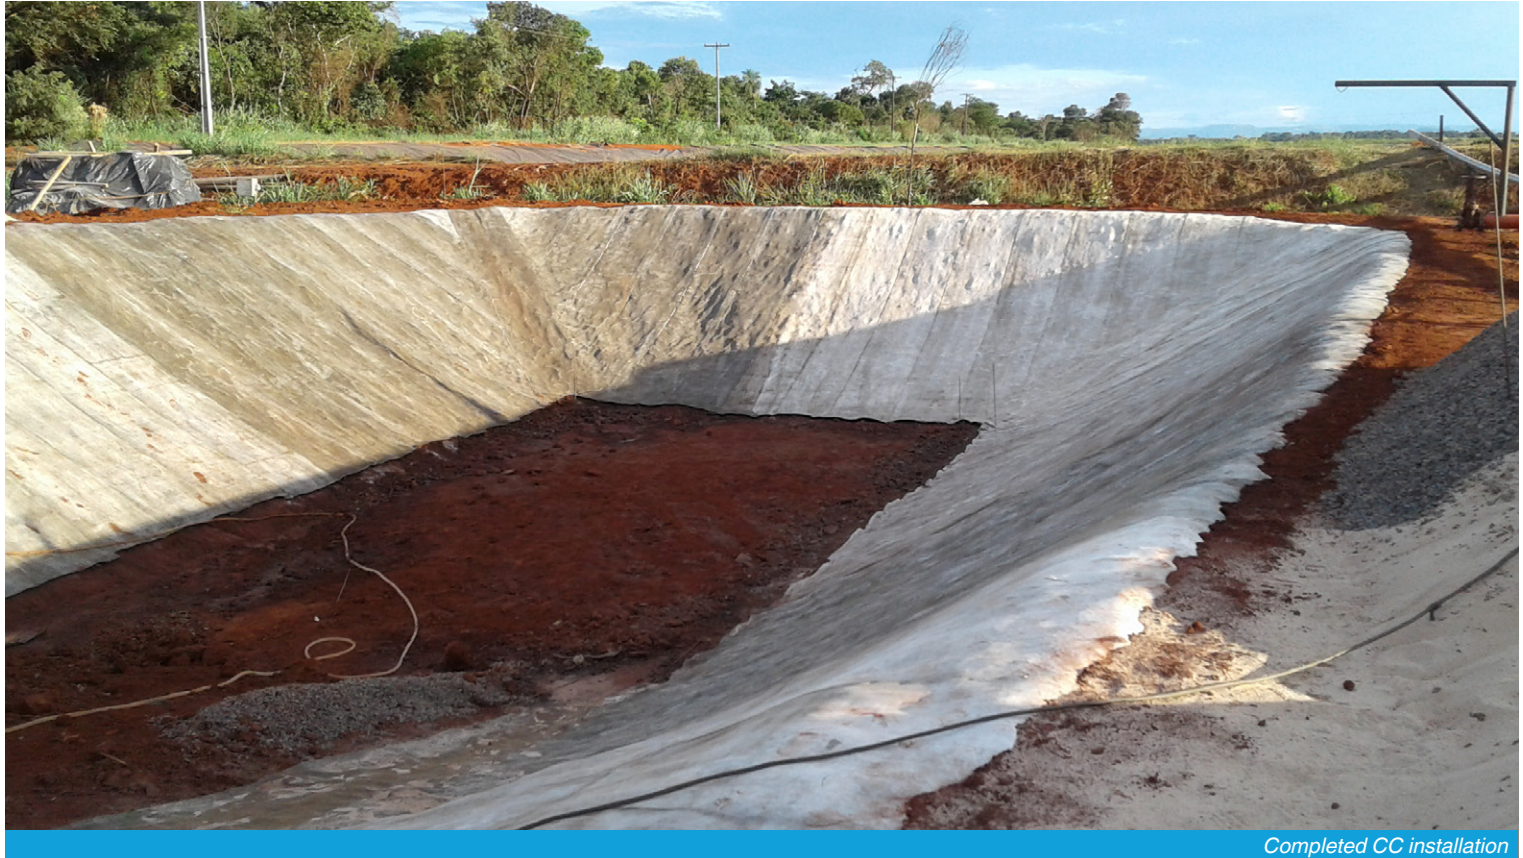
Completed CC installation

In total, 997m² of CC5™ were installed in 5 days by a team of 4, on a site with limited access and in temperatures of between 29-35°C. Some spells of rain were encountered during the course of the installation, but as CC can be installed in wet weather, the project was not affected.
