LAGOON LINING

In October 2013, Concrete Canvas® GCCM* (CC) was used to protect two sections of bank that are part of a Dredging Waste Temporary Storage Area (DWTSA) at a landfill site in Northampton.

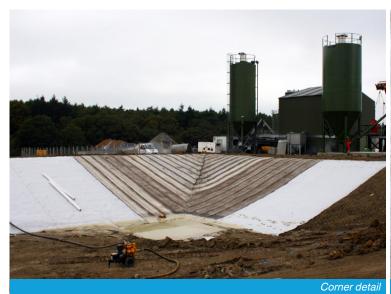
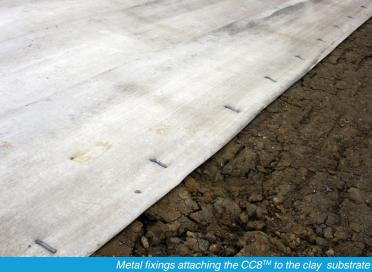
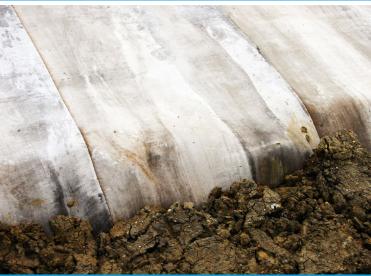
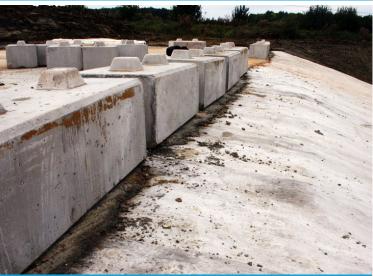
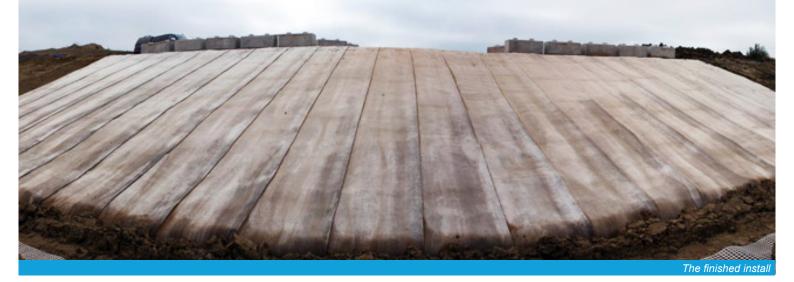
The clay substrate was formed by the excavation of an approximately 41m x 76m area at ground level to a depth of approximately 4.5m, with a bank gradient of 1:3. This has provided a holding capacity of roughly 5000m³. 8mm thick CC (CC8™) was installed on the southern and part of the eastern side slope, as filling and emptying activities will only be carried out along these edges. The CC will protect the clay liner from erosion and accidental impact when material is placed and removed from the DWTSA. The CC was anchor trenched at the toe of the bank, and mortar jointed at the crest to a concrete loading platform which was built to provide access to the lagoon. Metal peg fixings were used at regular intervals to fix the CC along its length.

675m² of CC8™ in bulk roll format was installed in 5 days by Moulding Contracts Ltd.
