CC13™ Bulk Rolls

Vazante, Minas Gerais,
Brazil

CC was used to line
drainage channels
and a drainage lagoon
constructed to decant
alkaline mine water

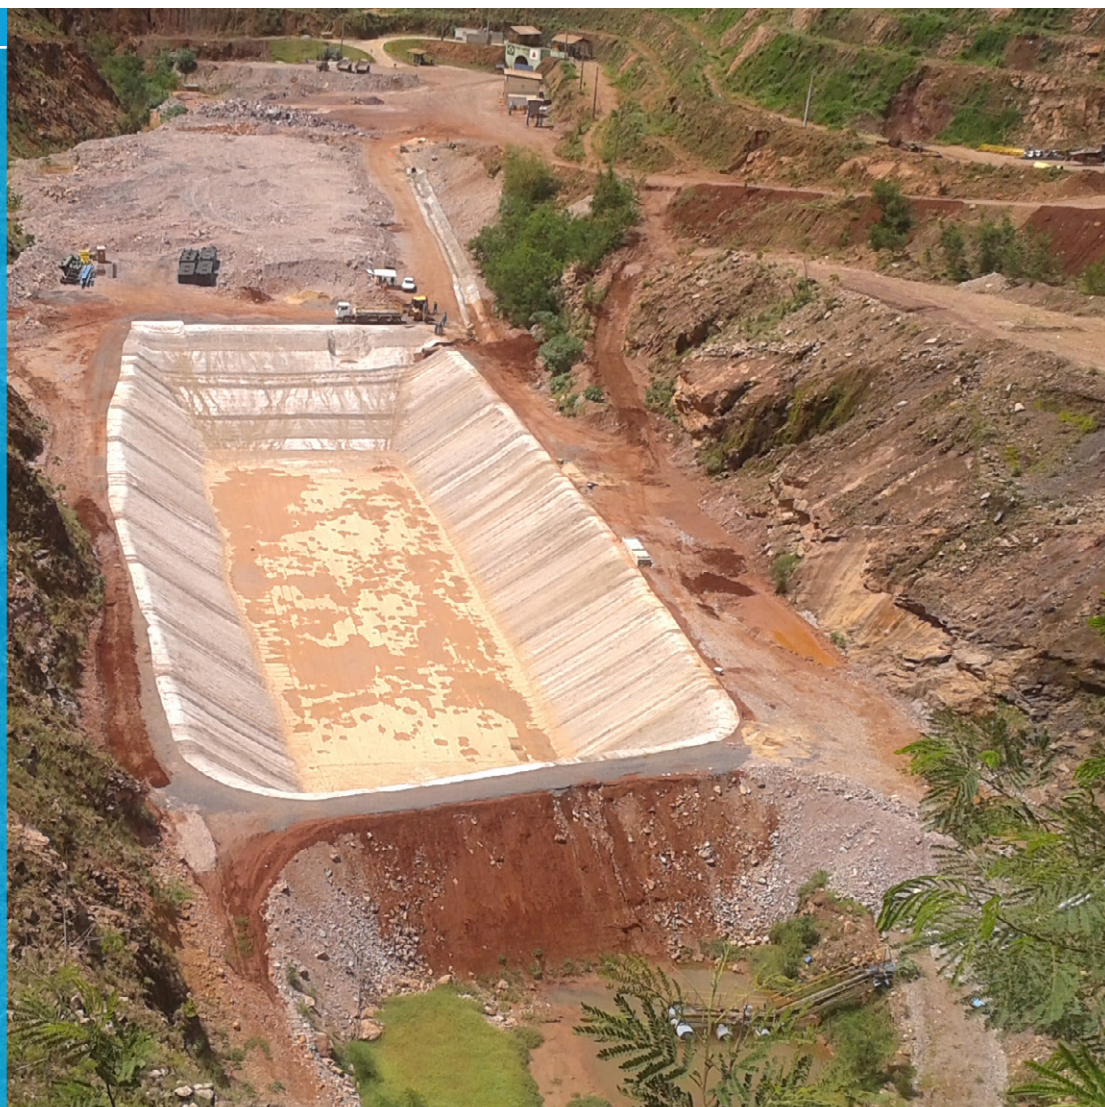
Completed lagoon

In October 2015, Concrete Canvas® GCCM* (CC) was used to line a newly constructed drainage lagoon at Votorantim Metais Zinco mine in Vazante, Minas Gerais, Brazil.

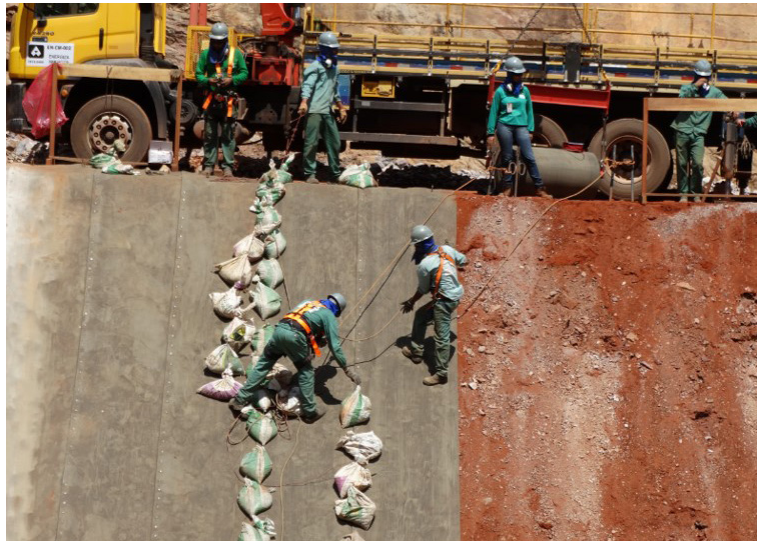
Compressing the joints

Vegetation was removed and the lagoon slopes graded and compacted. Bulk rolls of CC13™ were mounted onto a spreader beam and unrolled down the lagoon slope faces, before being cut to specific profile length. Subsequent layers overlapped the previous by 100mm and pegs were inserted through the overlaps at the crest. Everbuild Clearfix adhesive sealant was used to join the overlaps, and the joints were compressed to ensure an optimal bond. Hydration was achieved using a water truck and hose with spray nozzle attached.

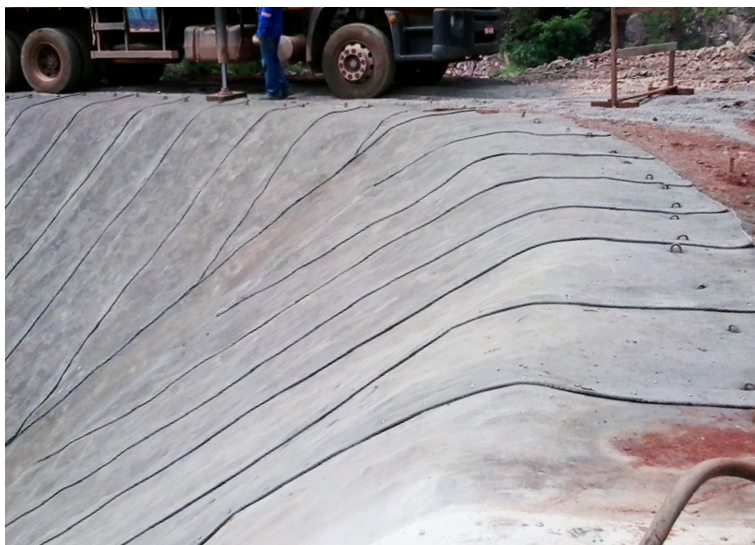
CC pegged at the crest

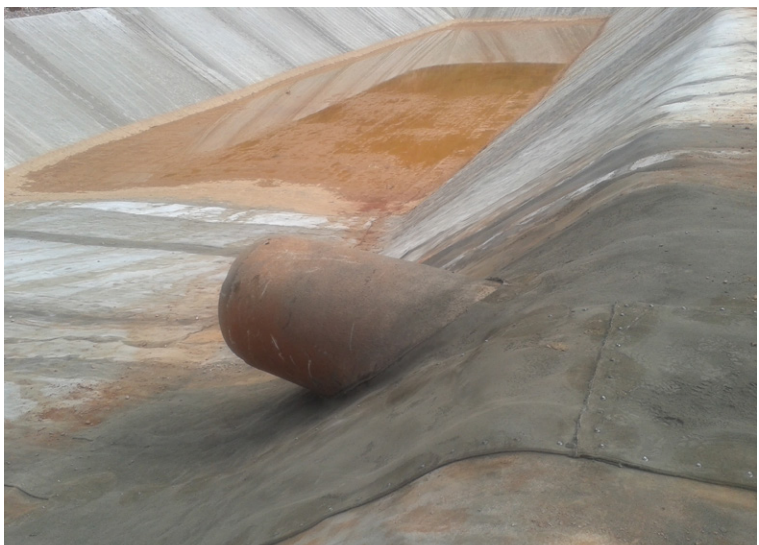
Pipe penetration

7000m² of CC13™ were installed in 2 months, compared to the 4+ months it would have taken with shotcrete. CC was able to easily accommodate pipe protrusions and be installed during rain and high temperatures of up to 42°C.
