WALL REINFORGEMENT

Novaky, Fortischem, Slovakia

CC8™ used to reconstruct and provide protection to corroded concrete walls in a salt storage facility.

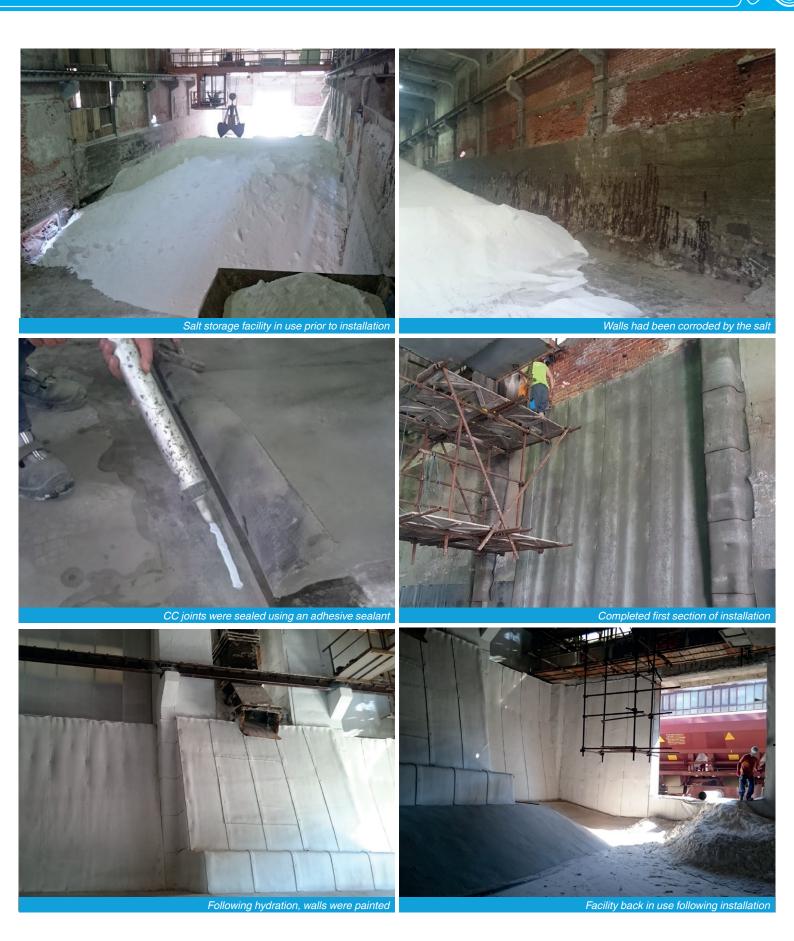
The installation itself involved relining the walls, which were near vertical and up to 8m tall in some places. The lower section of the walls, in direct contact with the salt once filled, was lined with a double layer of CC8 to avoid any degree of salt ingress. The CC was fixed to the substrate using a Hilti nail gun and x/cr 58 nails. Sika Adhesive sealants were used to improve impermeability between the layers of CC.
