CC5™ Batched Rolls

Naganohara-town,
Gunma-Prefecture, Japan

CC5™ used to line
an outfall to prevent
erosion.

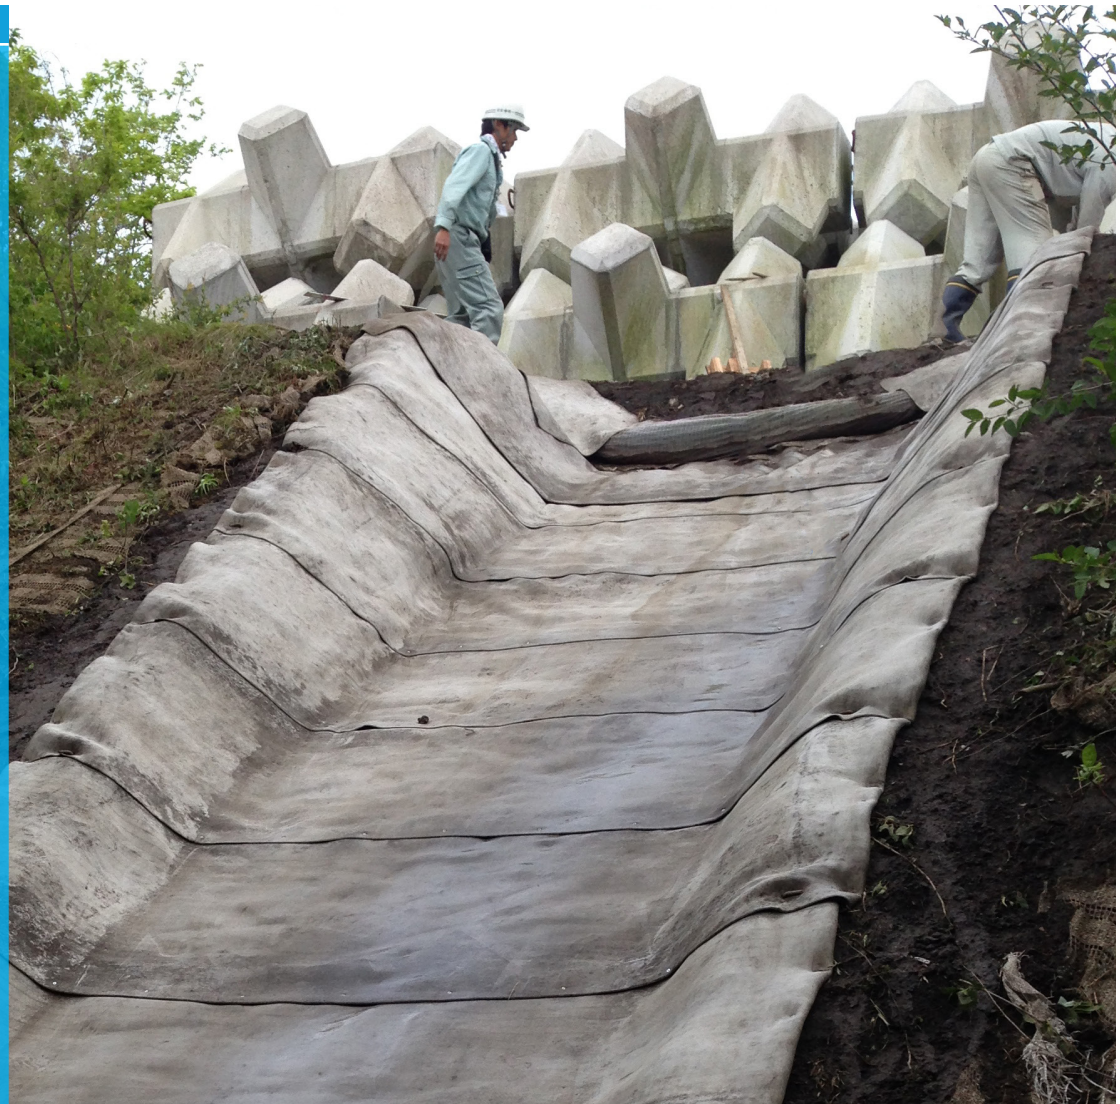
Completed installation

45m² of CC5™ were installed by 4 people in 3 hours in wet weather conditions. The client was impressed with the speed of and ease of installation and deemed the project a huge success.

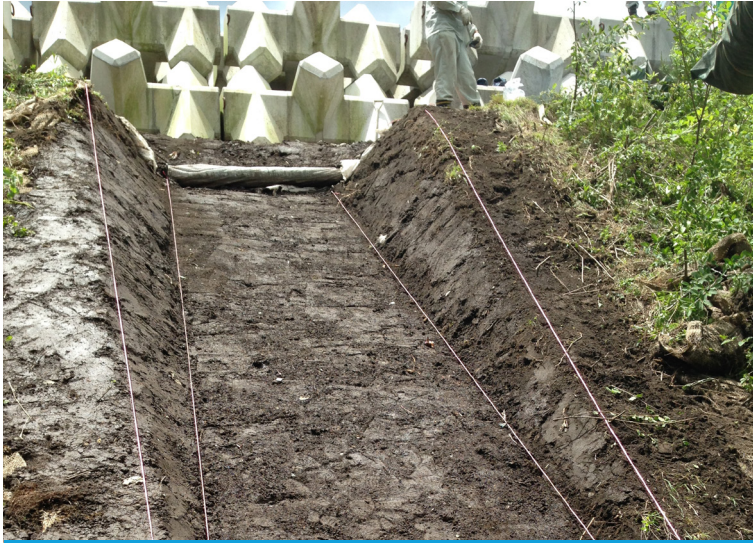
Ground preparation

The ground was compacted and any areas of deep erosion were filled to prevent any voids under the CC. The outfall was then profiled by hand and batched rolls of 5mm thick CC (CC5™) were delivered to site. The CC layers were manoeuvred into place by the labourers, who ensured each layer overlapped the previous by 100mm. Each CC layer was pegged at the crest and the overlaps were screwed at 200mm centres. The edge of each CC layer was folded back underneath itself to provide a neat termination. Hydration was achieved using a hose and bowser combination.

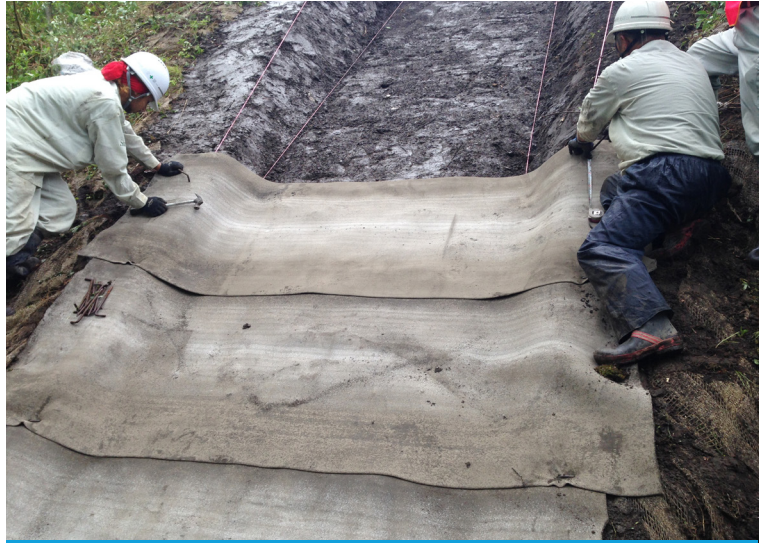
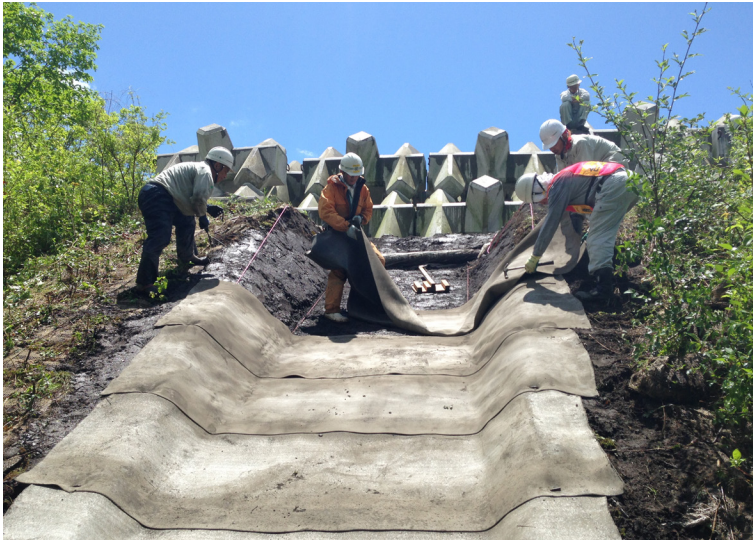
Overlapping the CC

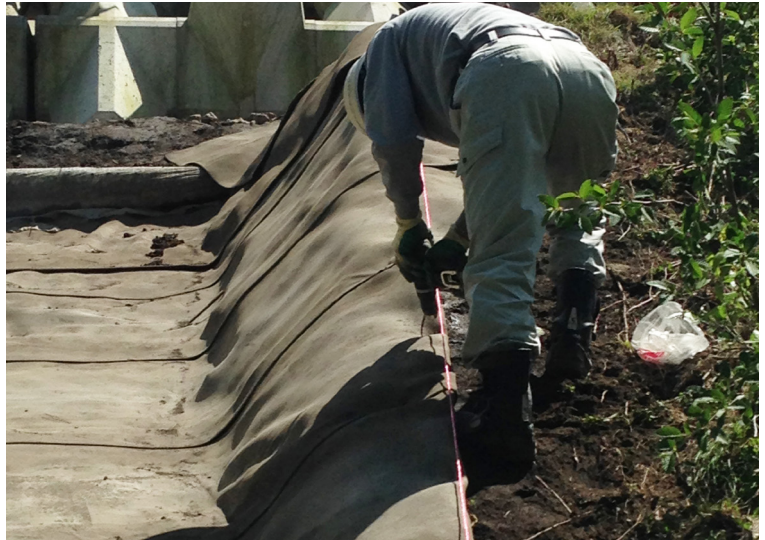
Edge treatment

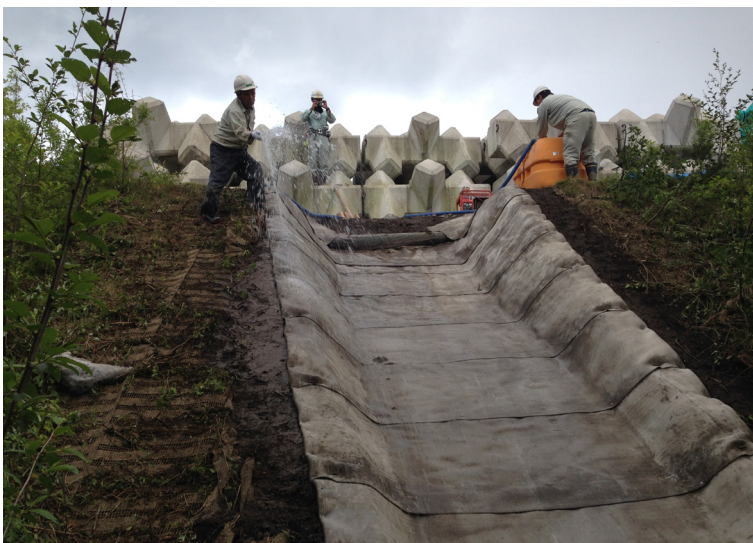
Hydration

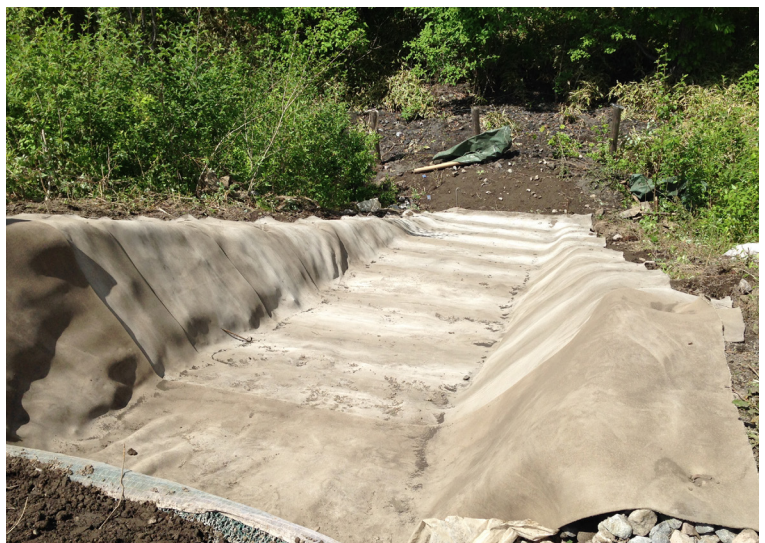
Completed installation
