Project Info

CC5™ Batched Rolls

Adelaide, Australia

CC5™ was used to line stormwater outfall slope and protect the road alongside it

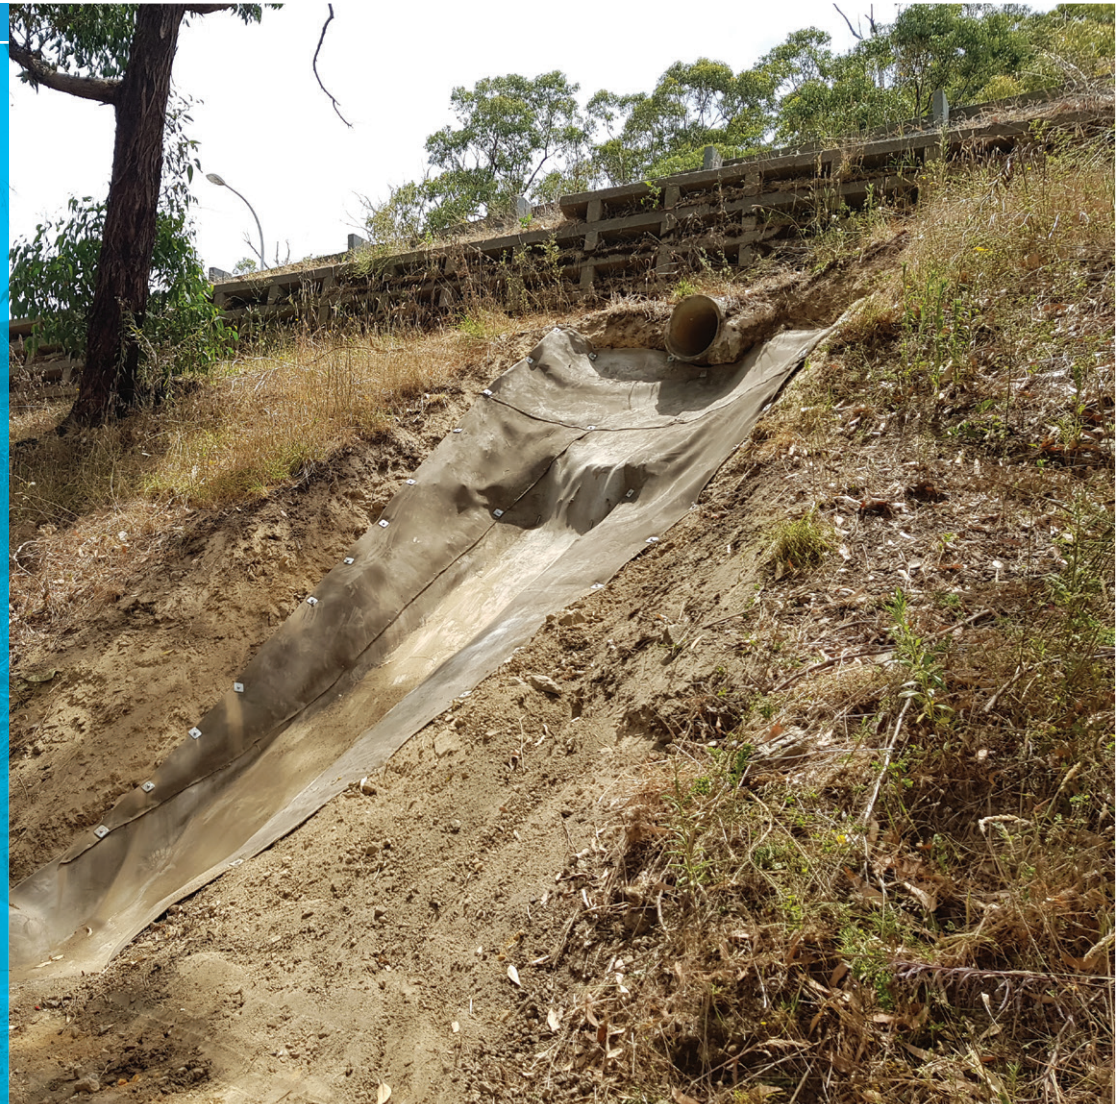
Completed outfall slope in Adelaide, Australia

In January 2018, Concrete Canvas® GCCM* (CC) was used to remediate a stormwater outfall slope in Adelaide Hills Council, Australia.

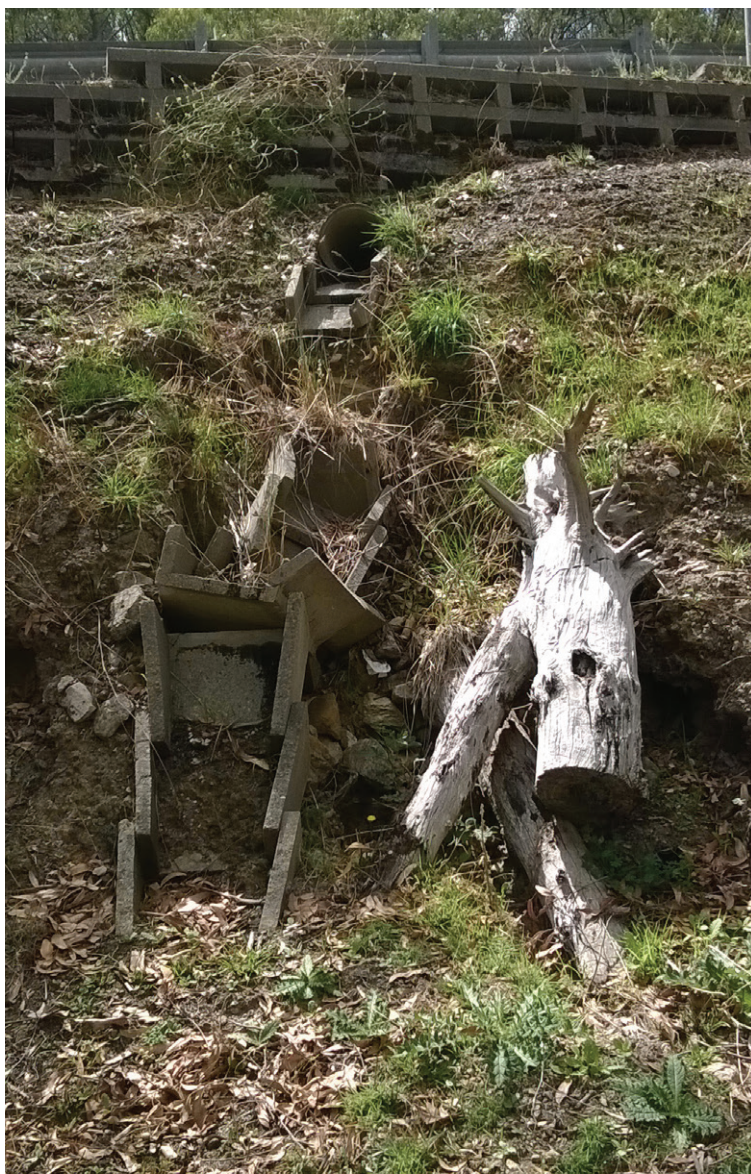
The outlet, situated in the hills east of Adelaide, comprised of a near-ancient concrete drop structure which had failed and collapsed, and was risking destabilisation of the slope along with the road under which the outlet was buried. The proximity of the outlet to the road edge, along with the angle of the slope, meant not only would the cost of the slope's failure be high, but it was likely that the scour would undermine the road and cause failure if action was not taken.

Slope prior to works

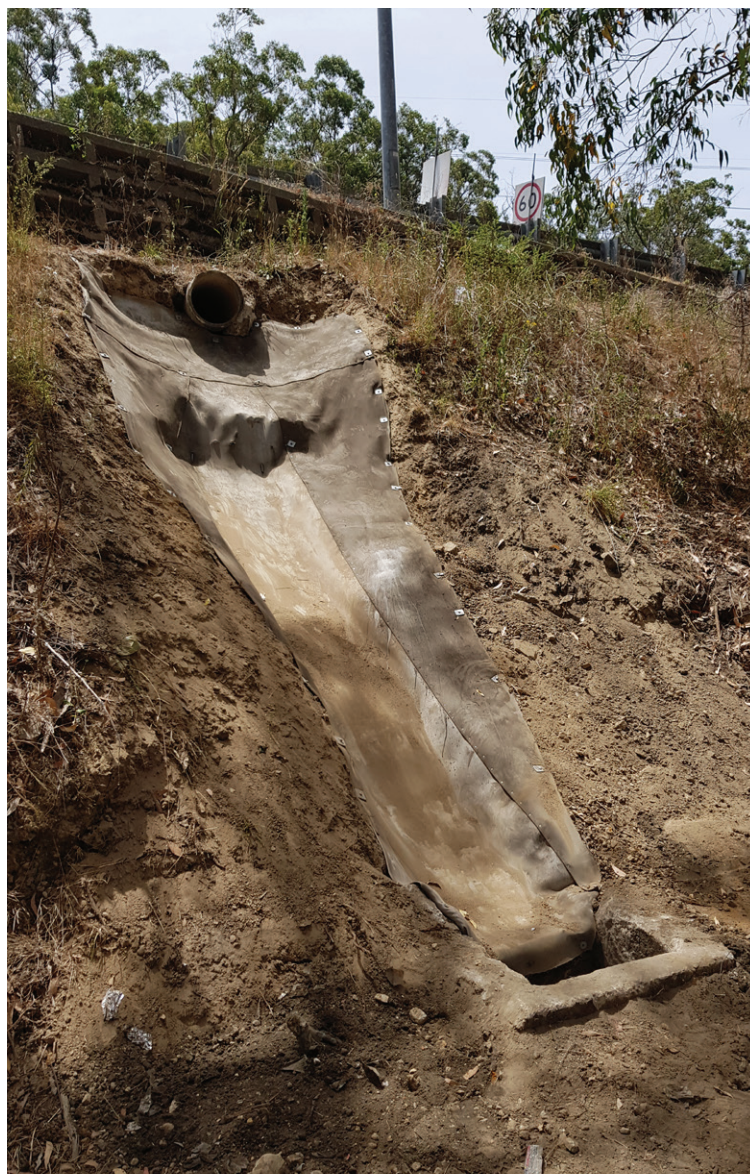
Completed installation

In preparation for the installation, the slope was re-graded to ensure any debris and vegetation was removed, and two batched rolls of CC5™ were delivered to the site. The CC was unrolled and cut to required lengths, with one layer laid transversely underneath the discharge pipe. The other layers were laid running longitudinally down the length of the slope, leading into the drain below. Layers of the CC material were overlapped by 100mm and fixed to the substrate using screws and rock bolts were required. Once the installation was completed, the CC was hydrated.

A total of 20m² of CC5™ was installed in less than a day by a team of 2 people, on a site with restricted access, and on a very steep slope.
