In April 2017, Concrete Canvas® GCCM* (CC) was used to remediate a 45-year-old concrete irrigation channel in Adloun, South Lebanon. The project was carried out as a trial for the client, Litani River Authority, to establish whether CC was a suitable solution for remediation of the full length of the channel.

REMEDIATION

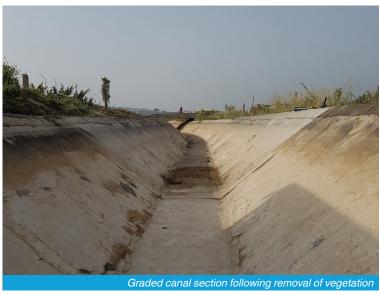
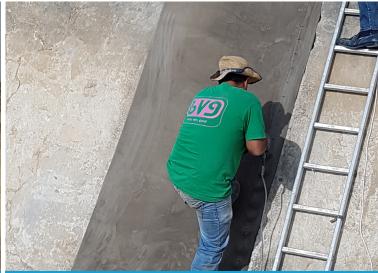
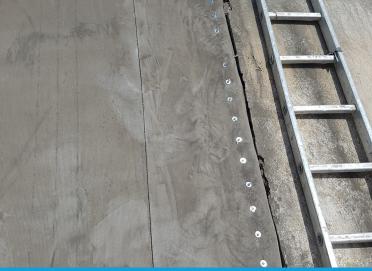
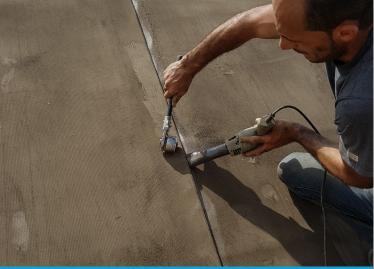
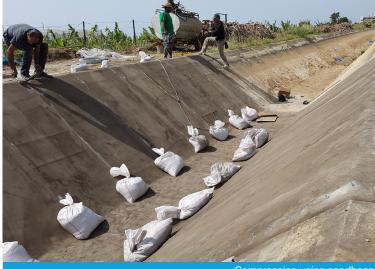
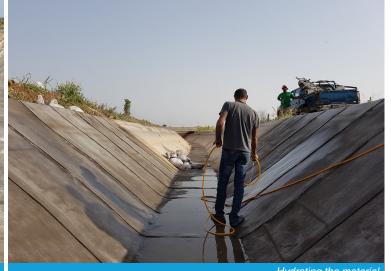
To prepare the canal for installation, any vegetation or damaged, crumbling concrete was removed, and cracks and voids were filled. Anchor trenches were then excavated and along the shoulders of the canal and CC was cut to size and brought in portable rolls to the remote access site.

The CC was unrolled across the channel, with the edges places into the anchor trenches. A lip of 50mm of CC was inserted into the construction joints at both ends of the installation where the material was fixed using thru bolts and epoxy grout at 100mm intervals. Adjacent layers were then thermally bonded at the inner 50mm of the overlap using a hot air gun, and the outer 50mm was sealed using a hybrid sealant. The CC was compressed using sandbags and then hydrated. Due to the high temperatures, a second hydration was undertaken 20 minutes later. The following day, construction joints were filled with grout mortar and painted with PU waterproofing membrane.

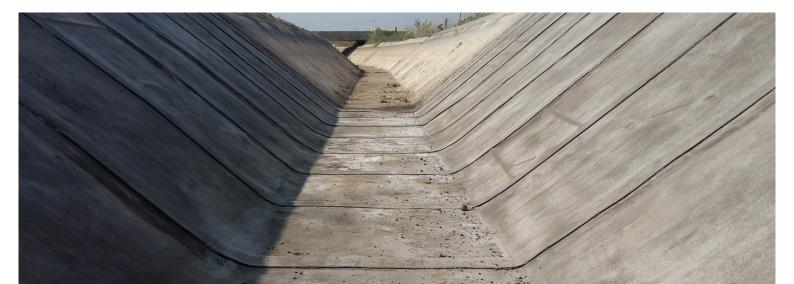
Completed section of channel post installation and close up of grout mortar termination
