## REMEDIATION

In August 2014, Concrete Canvas® GCCM\* (CC) was used to line an extinguishing lake to improve impermeability at the PCK Refinery in Schwedt, Germany.

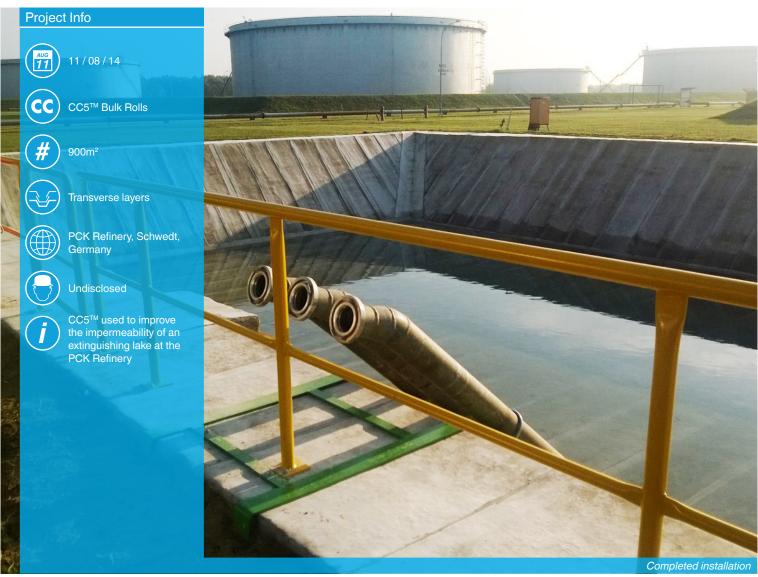
The original poured concrete structure had cracked and spalled, resulting in excessive water loss. Removing the incumbent basin and re-building it using poured concrete and form work was considered, however this would have been more time consuming and taken the basin out of operation for an extended period of time during construction. The works were carried out by an approved contractor, who had no prior experience of installating CC, for PCK. PCK is a joint venture between BP, Rosneft, Shell, Eni and Total.

Prior to installation, the failing concrete was cleaned and mortar applied to any larger cracks to eliminate voids under the CC. An anchor trench was created on the shoulder of the basin into which the CC edges would be secured and later backfilled. This would prevent water ingress beneath the CC and provide a neat termination. Bulk rolls of CC5™ were delivered to site before being mounted onto a spreader beam hung from a Zoom Boom for deployment.

The installation was completed in sections with the two shorter sides completed first. For these sections, the CC was unrolled on the flat, batched to specific profile length and positioned in the basin by hand with alternating perpendicular overlaps created at the corners. This allowed for the CC to be unrolled across the width of the basin for the remaining two sections, starting at each end and progressing towards the middle where a drainage sump is located.

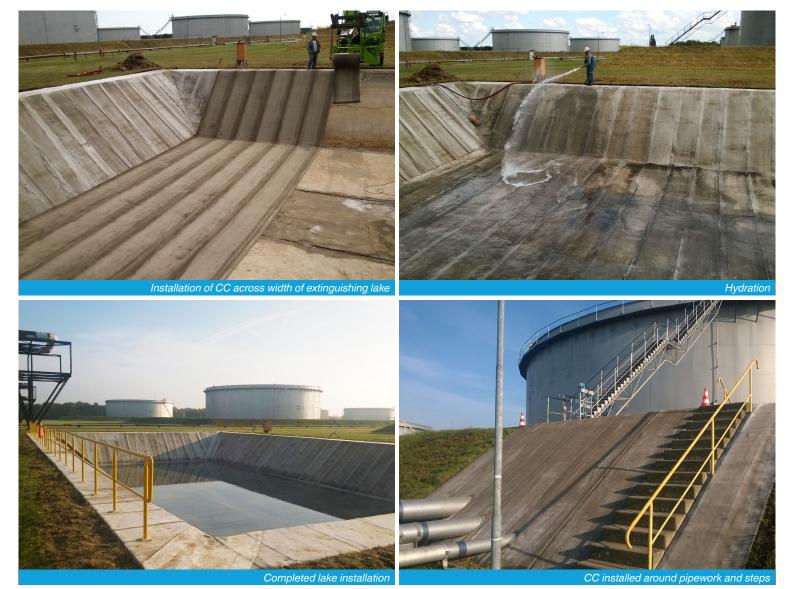
Each section of CC was jointed and hydrated using the same procedure: the leading edge of the CC was fixed to the concrete substrate using 40mm wedge anchors at 2m intervals, the subsequent layer was then positioned, overlapping the previous by 100mm. The construction team then hydrated under the overlap and applied an adhesive sealant. Hydration was achieved via an extinguishing hose connected to the main ring system on site.
